RESEARCH REPORT

**AN EVALUATION OF ENGINEERING TREATMENTS
AND PEDESTRIAN AND MOTORIST BEHAVIOR ON
MAJOR ARTERIALS IN WASHINGTON STATE**

September 2008

1. REPORT NO. WA-RD 707.1		2. GOVERNMENT ACCESSION NO.		3. RECIPIENT'S CATALOG NO.	
4. TITLE AND SUBTITLE AN EVALUATION OF ENGINEERING TREATMENTS AND PEDESTRIAN AND MOTORIST BEHAVIOR ON MAJOR ARTERIALS IN WASHINGTON STATE				5. REPORT DATE September 2008

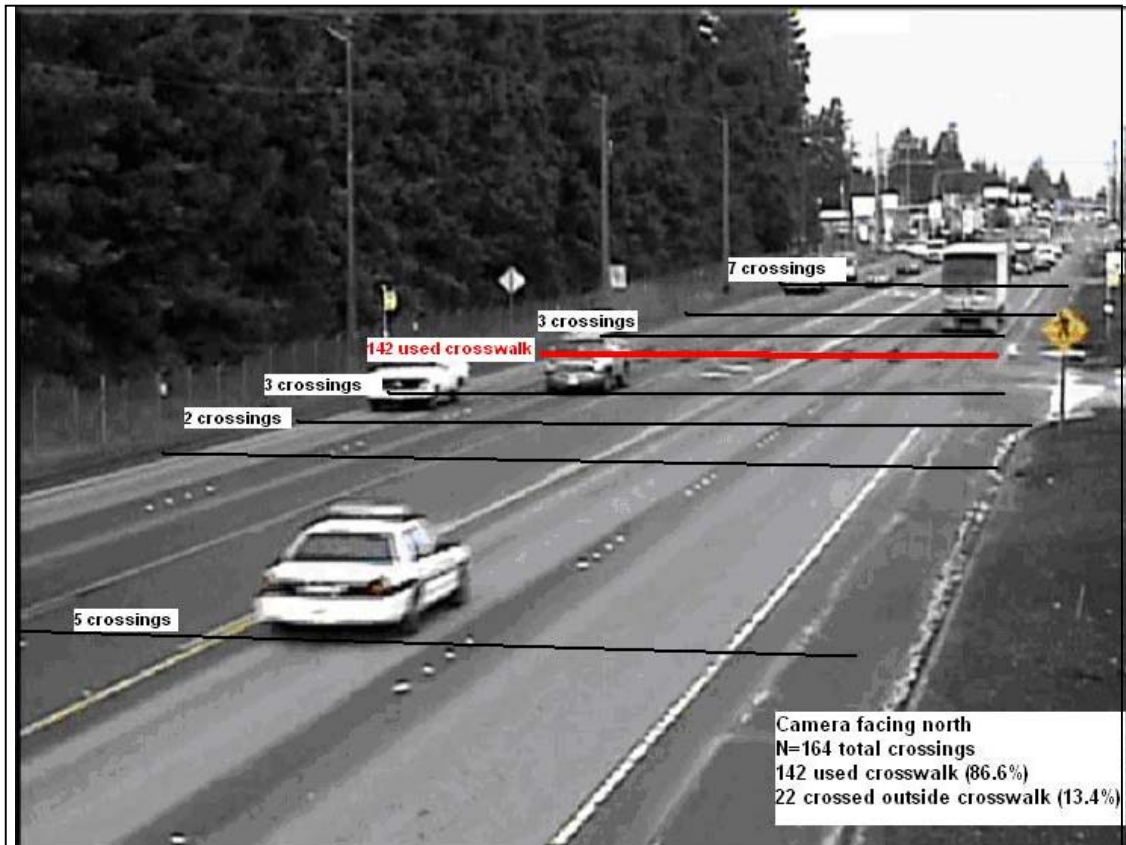
Figure B-8. Pedestrian crossing paths to the north of S. 180th Street—*before* condition (Spanaway) (Kopf and Hallenbeck 2005)

Figure B-8 and Figure B-9 display the crossing paths of the pedestrians in the *before* study near South 180th Street in Spanaway.

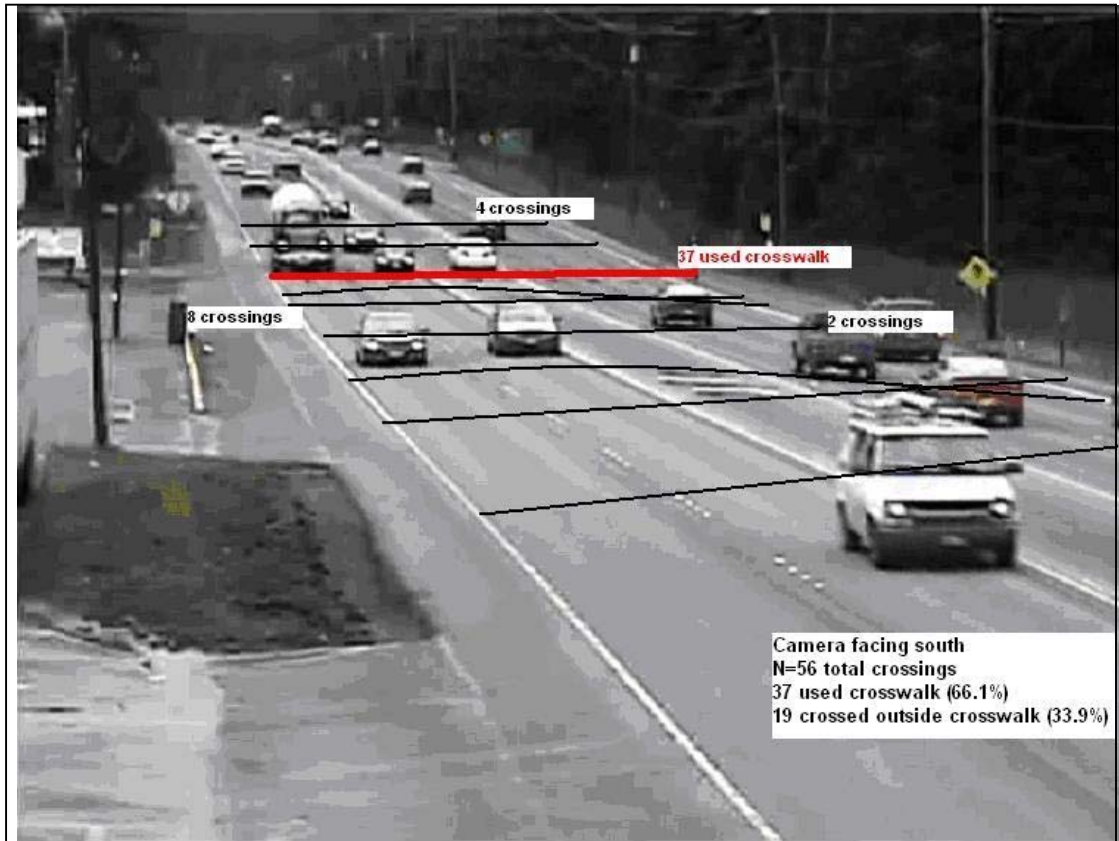
Figure B-9. Pedestrian crossing paths to the south of S. 180th Street—before condition (Spanaway) (Kopf and Hallenbeck 2005)

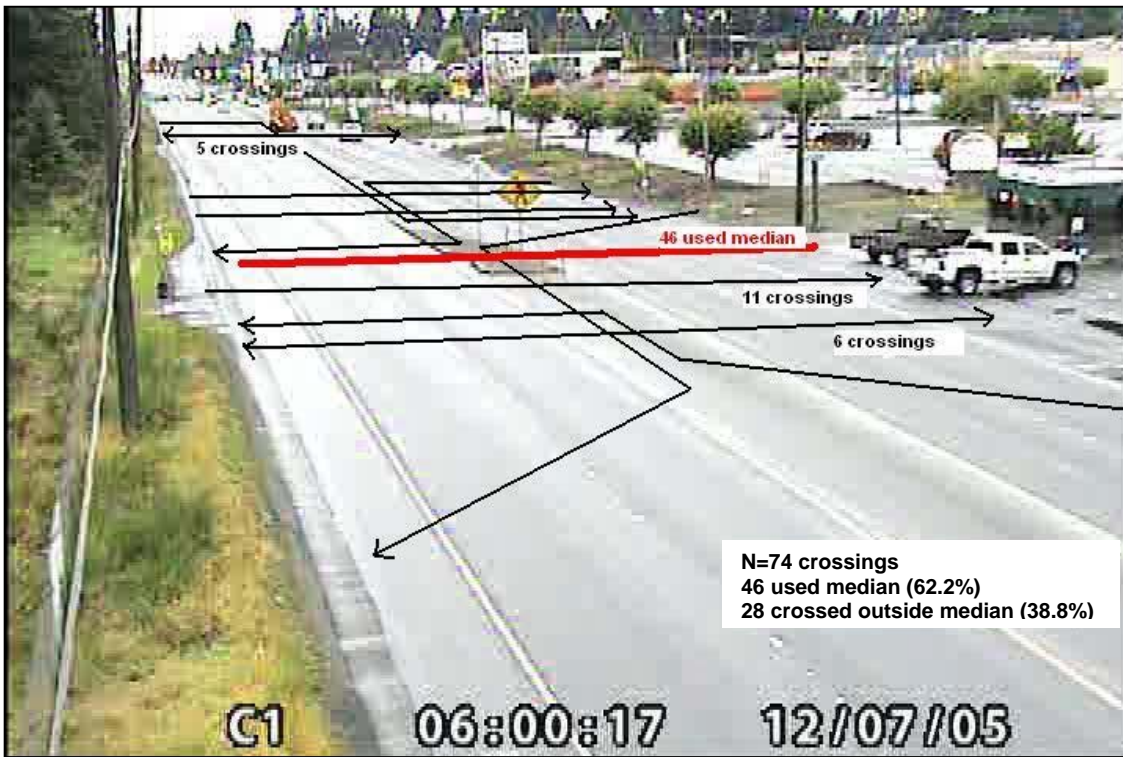
Figure B-10. Pedestrian crossing paths after median treatment —after—phase I condition (Spanaway) (Kopf and Hallenbeck 2005)

Figure B-10 displays the crossing paths after installation of the median. Note that an additional 15 percent of the crossings occurred just to the south of the median (path labeled “11 crossings” in Figure B-10).

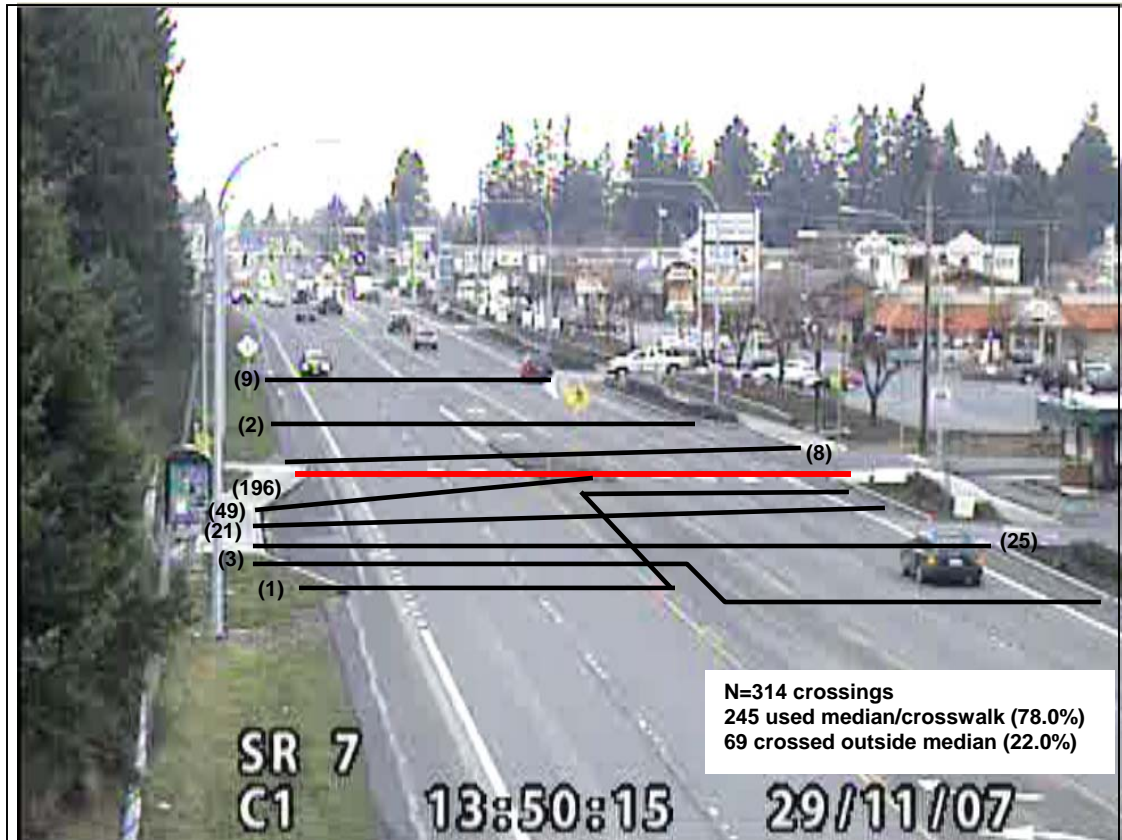
Figure B-11. Pedestrian crossing paths—*after*—phase II condition (Spanaway)

Figure B-11 displays the crossing paths after reinstatement of the crosswalk markings.

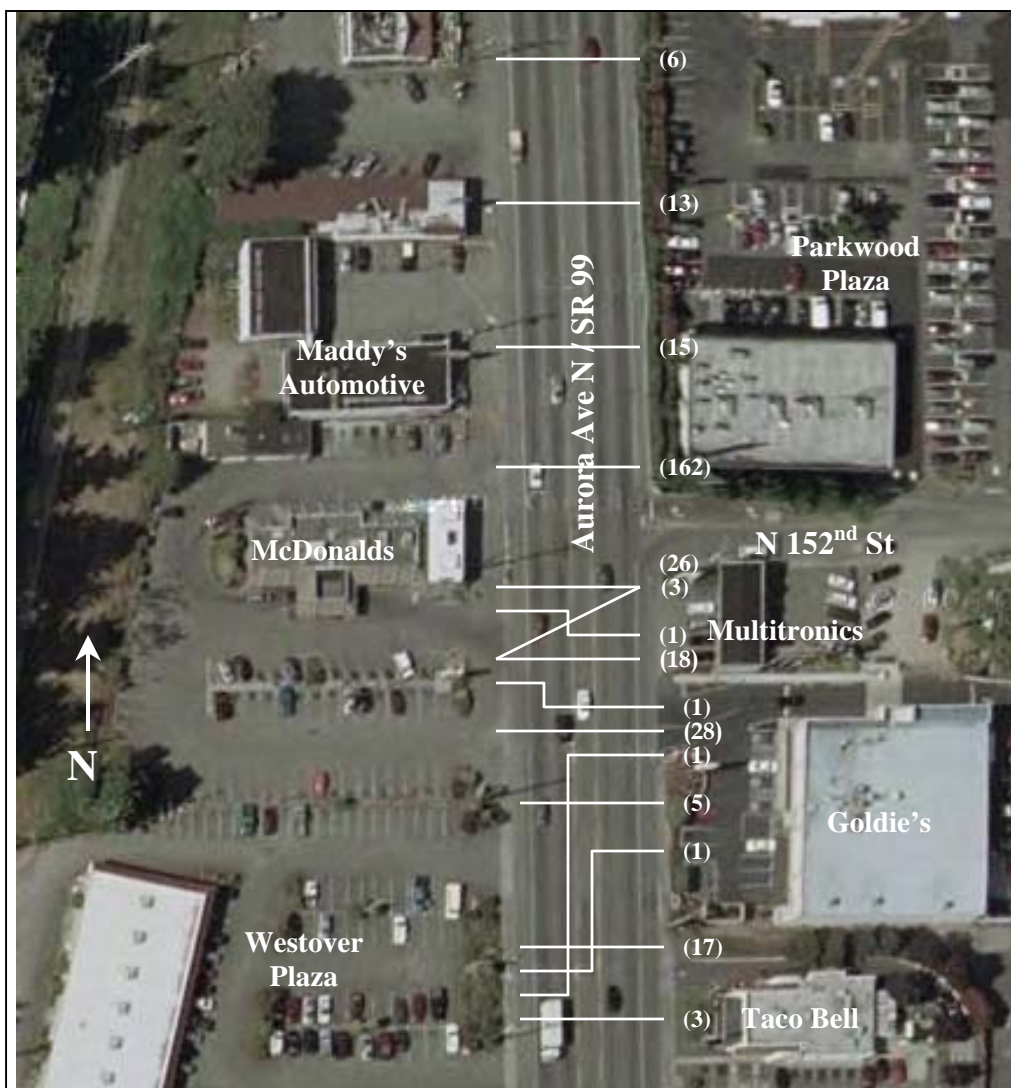
Figure B-12. Pedestrian crossing paths—Shoreline (Google Maps)

Figure B-12 displays the crossing paths at the Shoreline site.

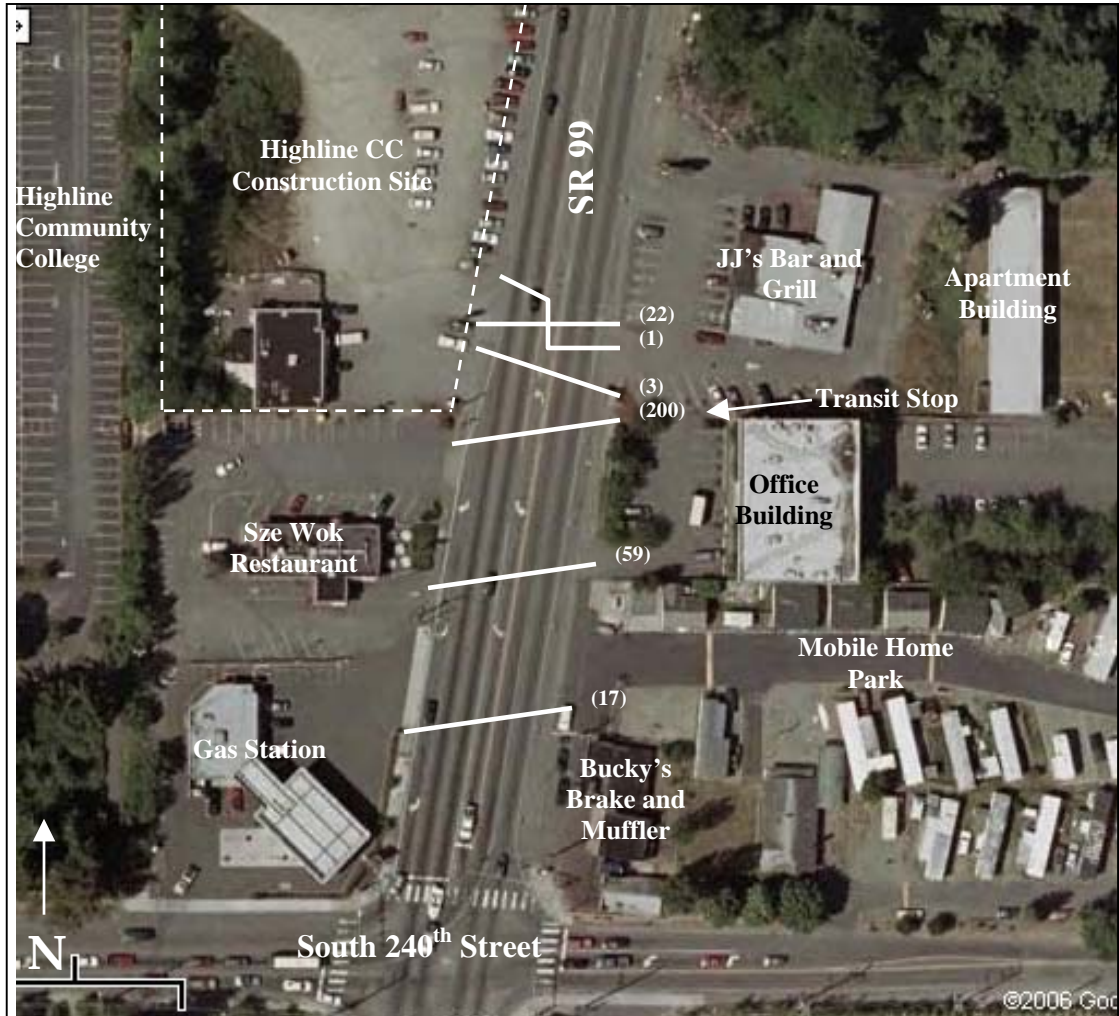
Figure B-13. Pedestrian crossing paths—before condition—Kent (Google Maps)

Figure B-13 displays the crossing paths at the Kent site, before improvements were made (includes only those pedestrians not using the signalized marked crosswalks).

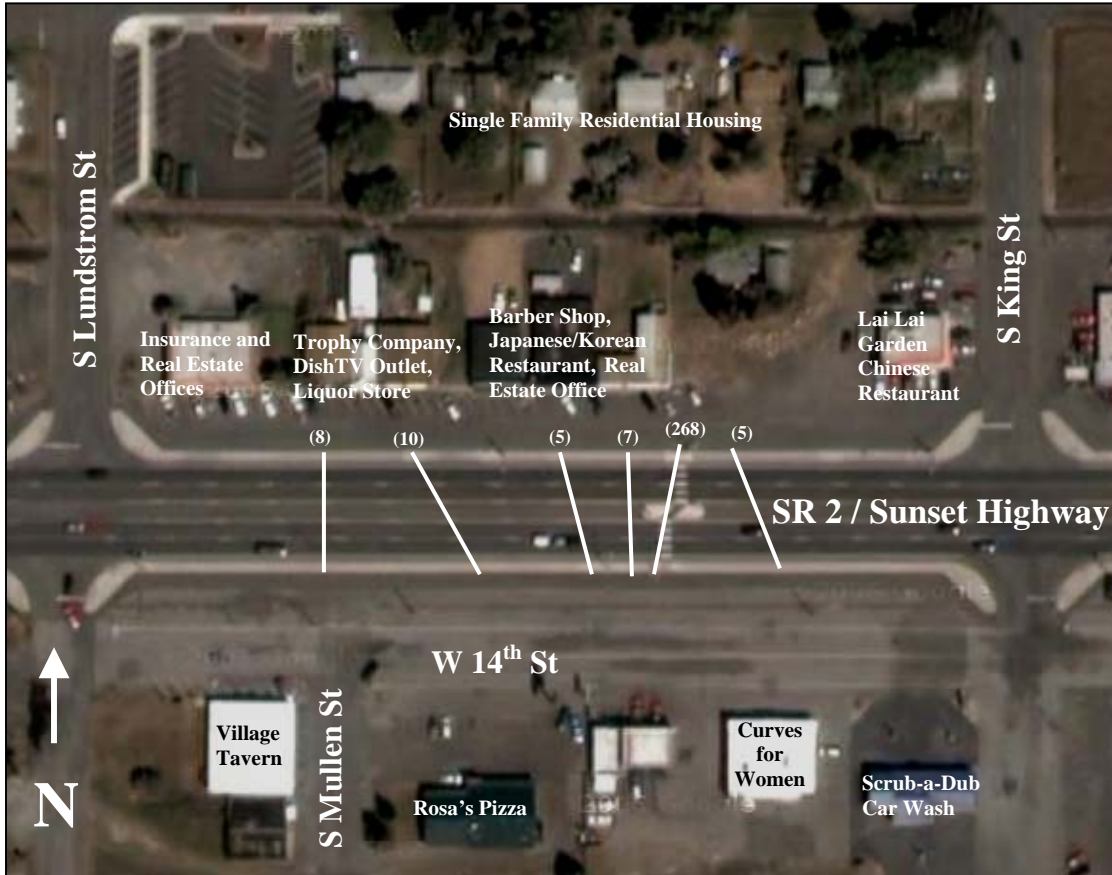
Figure B-15. Pedestrian crossing paths in the *before* analysis—Airway Heights (Google Maps)

Figure B-15 displays the crossing paths at the Airway Heights site, before improvements were made.

In Airway Heights, there appears to have been very little change in the crossing paths of pedestrians from the *before* to the *after* study. This was the expected result because the changes made to the crossing treatment for the *after* condition were fairly minor and concentrated more on vehicle safety where they interacted with the pedestrians, rather than on channeling pedestrian movements to the crossing.

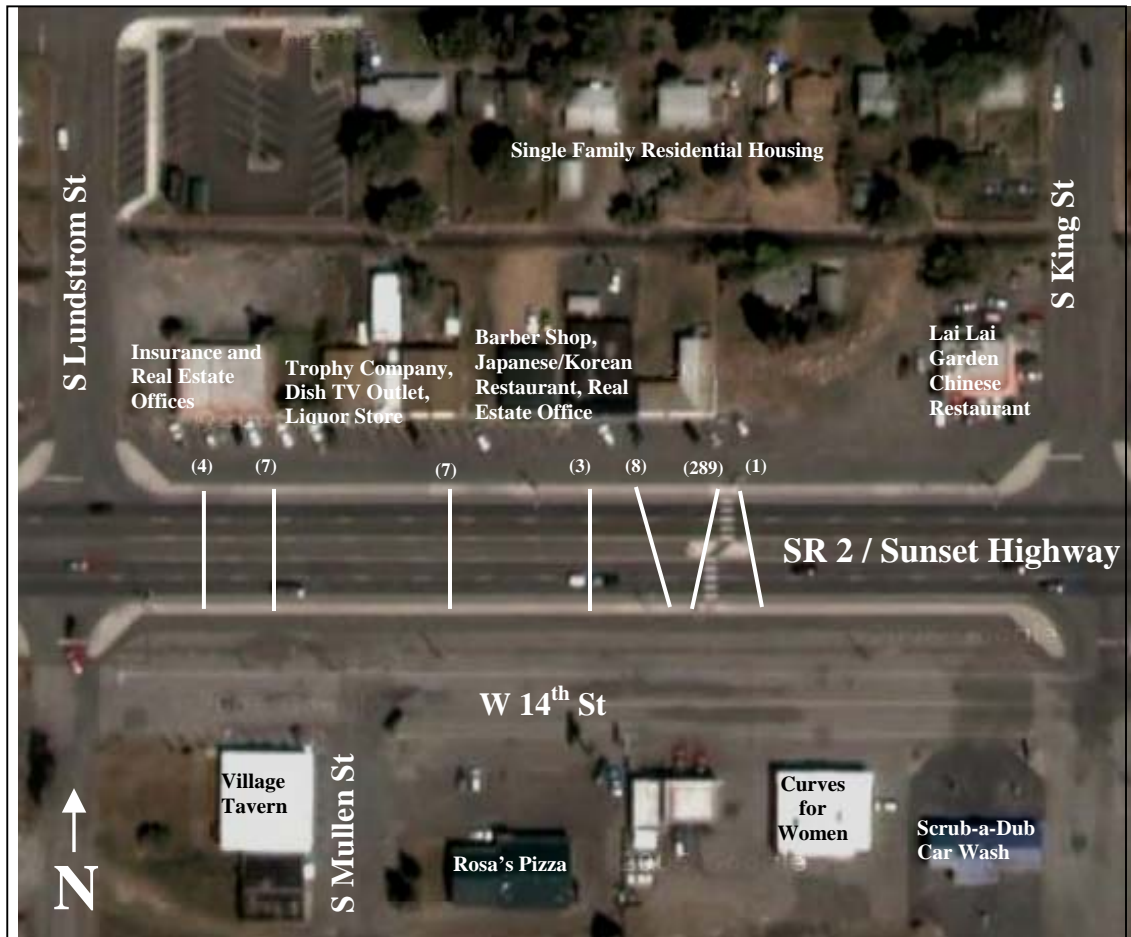
Figure B-16. Pedestrian crossing paths in the *after* analysis—Airway Heights (Google Maps)

Figure B-16 displays the crossing paths at the Airway Heights site, after improvements were made.

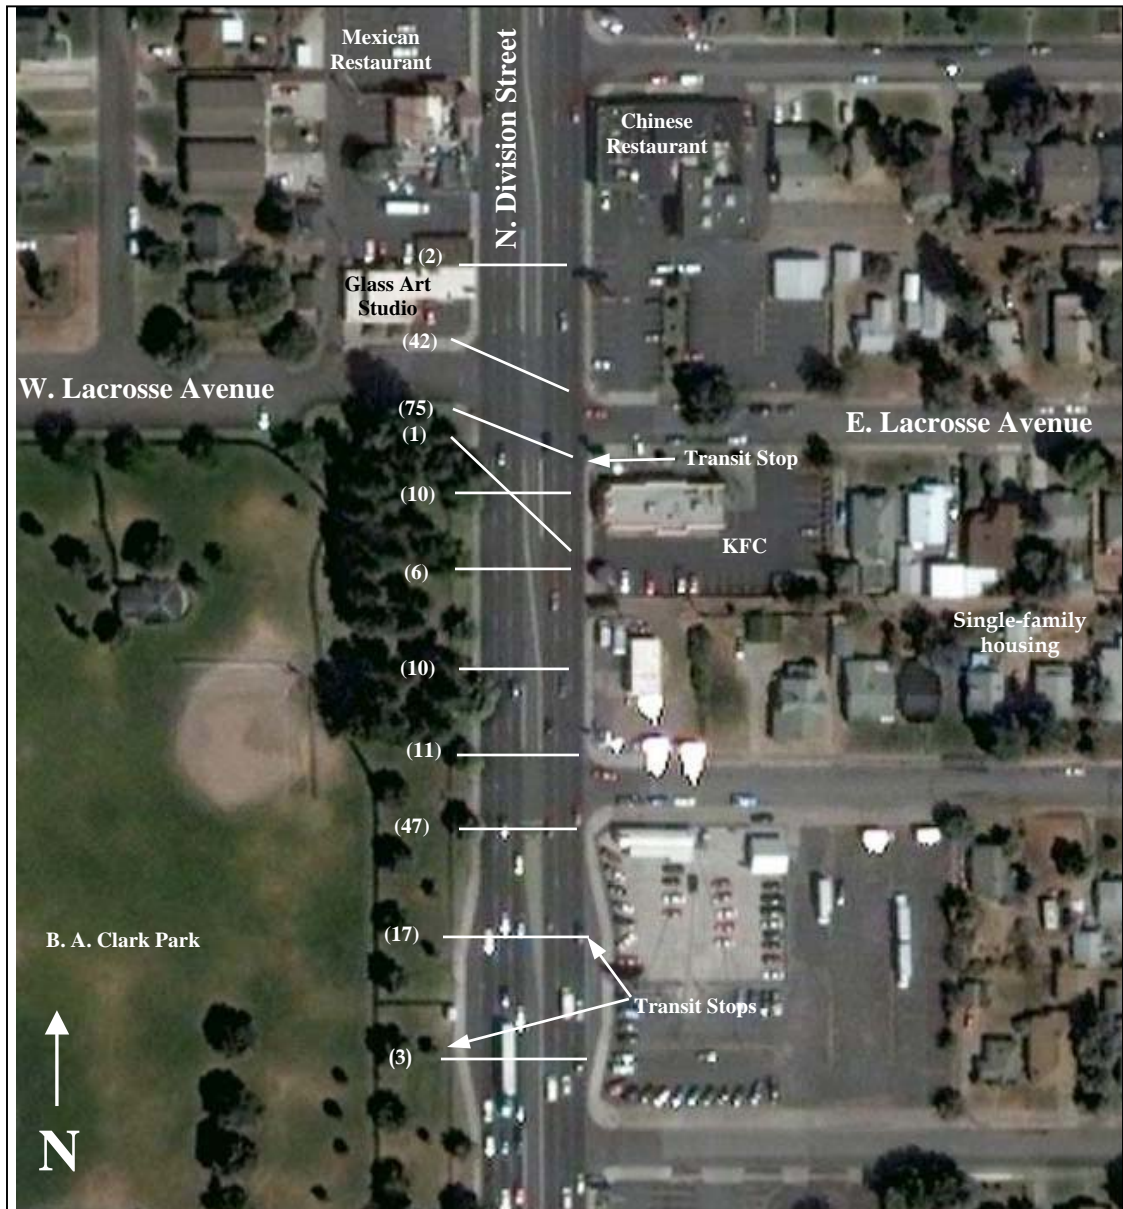
Figure B-17. Pedestrian crossing paths at Lacrosse Avenue—Spokane (Google Maps)

Figure B-17 through Figure B-19 display the crossing paths at the Spokane sites.

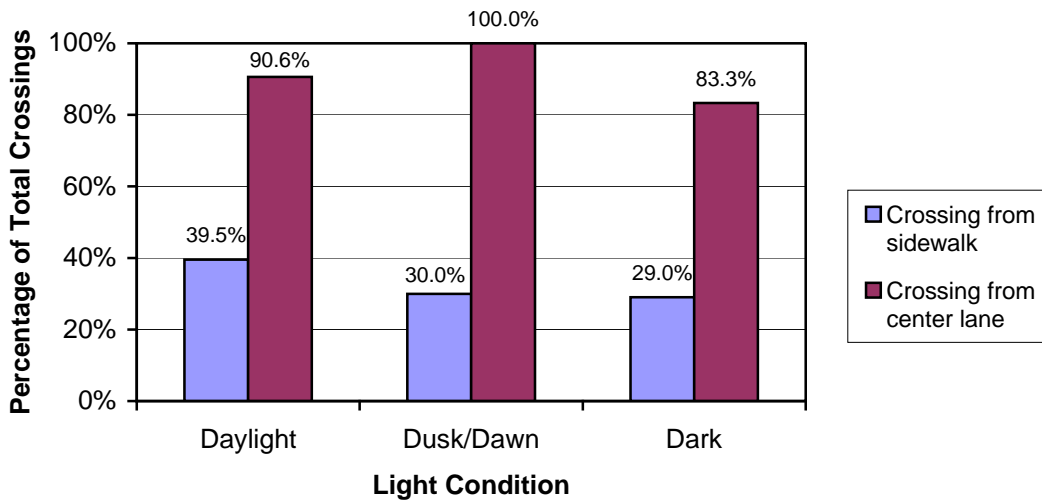
Figure B-28. Percentage of vehicles yielding based on light condition—*after* conditions—Airway Heights

These figures suggest similar yielding behavior in Airway Heights for all light levels in both the *before* and *after* conditions and a marked decrease in yielding behavior in the *after* condition. The change between the *before* and *after* phases for vehicles yielding to pedestrians crossing from the sidewalk in both daylight and dark conditions was significant at the 0.0001 level. (Crossings made during dusk/dawn conditions were not numerous enough to determine statistical significance.)

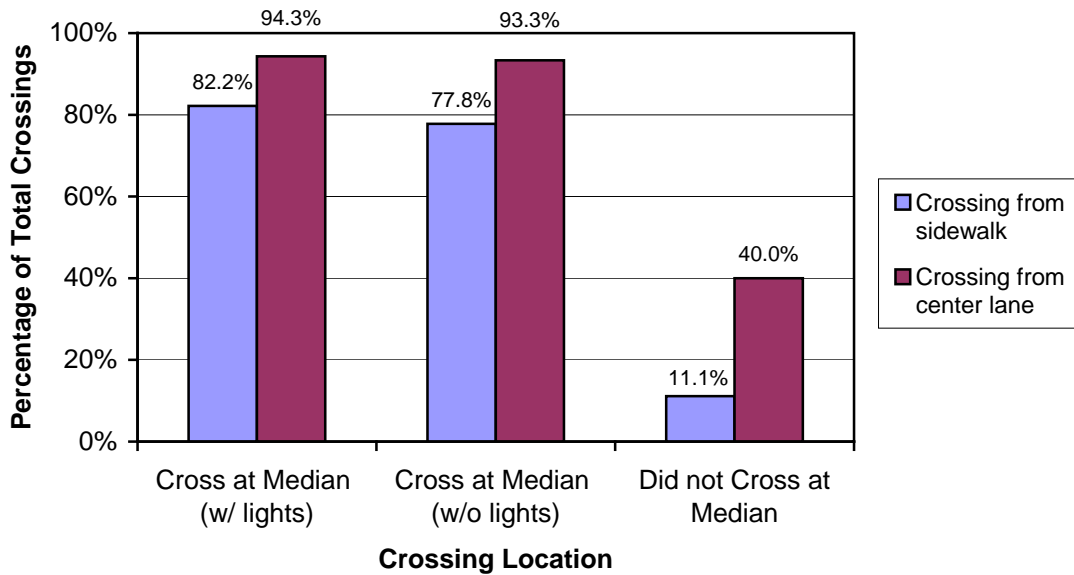
Figure B-29. Percentage of vehicles yielding based on crossing location/flasher use—before condition—Airway Heights

Vehicle yielding at the Airway Heights site was also examined in relation to crossing location and use of the flashers. Figure B-29 and Figure B-30 show these results.

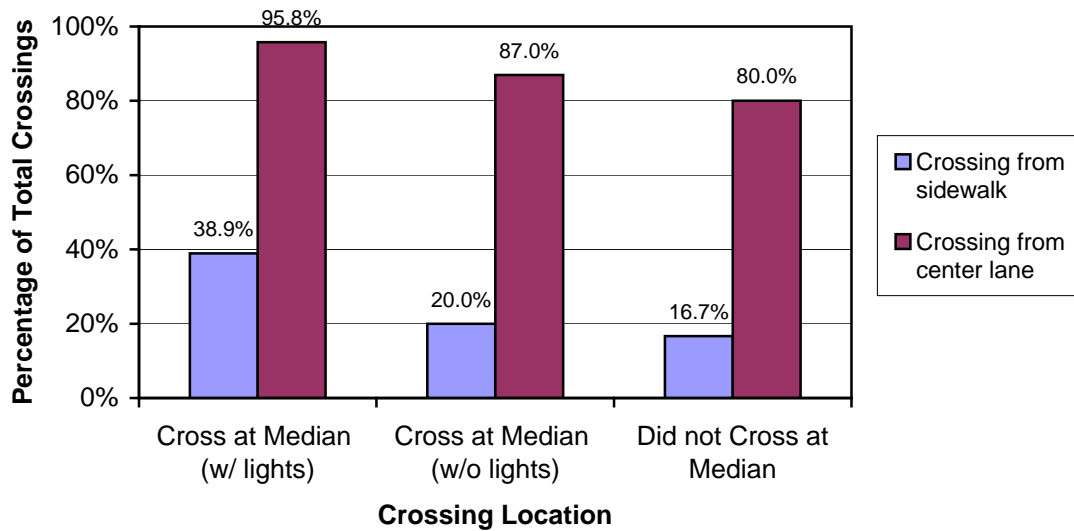
Figure B-30. Percentage of vehicles yielding based on crossing location/flasher use—after condition—Airway Heights
