# A Brief History of Long-Life WSDOT Concrete Pavements

WA-RD 744.2

WSDOT Research Report

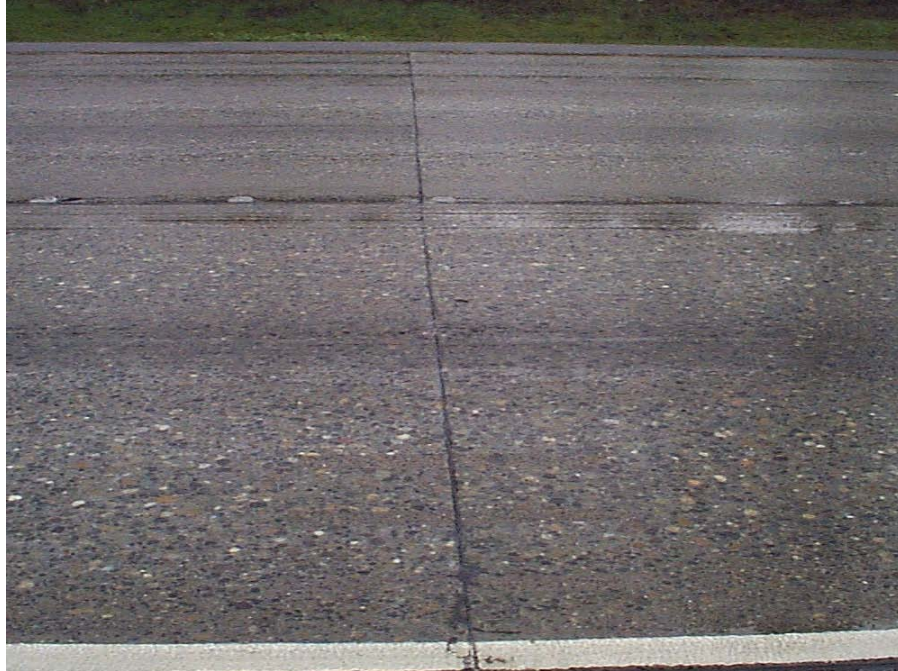
**Figure 1. Single sawed transverse joint (1969 construction, diamond ground in 2000, photo taken in 2001)**

Joints were sealed with hot poured sealant, a practice that continues today. Joint construction practice allowed for the use of taped joints, for both the longitudinal and transverse joint, from 1966 until 1992. The use of the taped joint was found to contribute to joint spalling and panel cracking and was therefore removed from practice in 1992. Since the early 1960's WSDOT has specified the use of a sealed single sawcut for the transverse and longitudinal joints (excludes taped joints); a practice that is still used today (Figure 1).

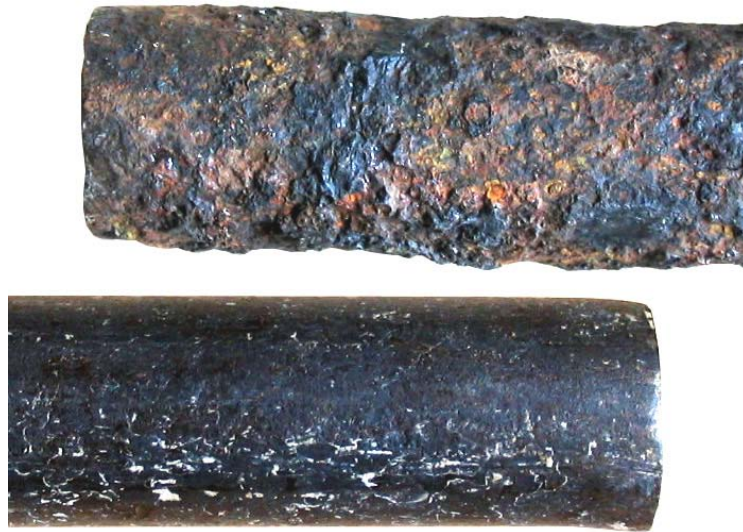
**Figure 2. Plain steel dowels: corroded (top) and not corroded (bottom).**

None of the original concrete pavements constructed in Washington state contained dowel bars at the transverse joints, however, dowels were used at the construction joints. The original decision to forgo dowel bars seems to have been based largely on the potential for the plain steel dowel bars used at the time (1950s) to corrode (Figure 2) and lock up their associated transverse joint. It was felt that potential joint locking was a larger issue than faulting, thus no dowel bars were used (personal communication with Newton Jackson, Nichols Consulting Engineers, 2006).

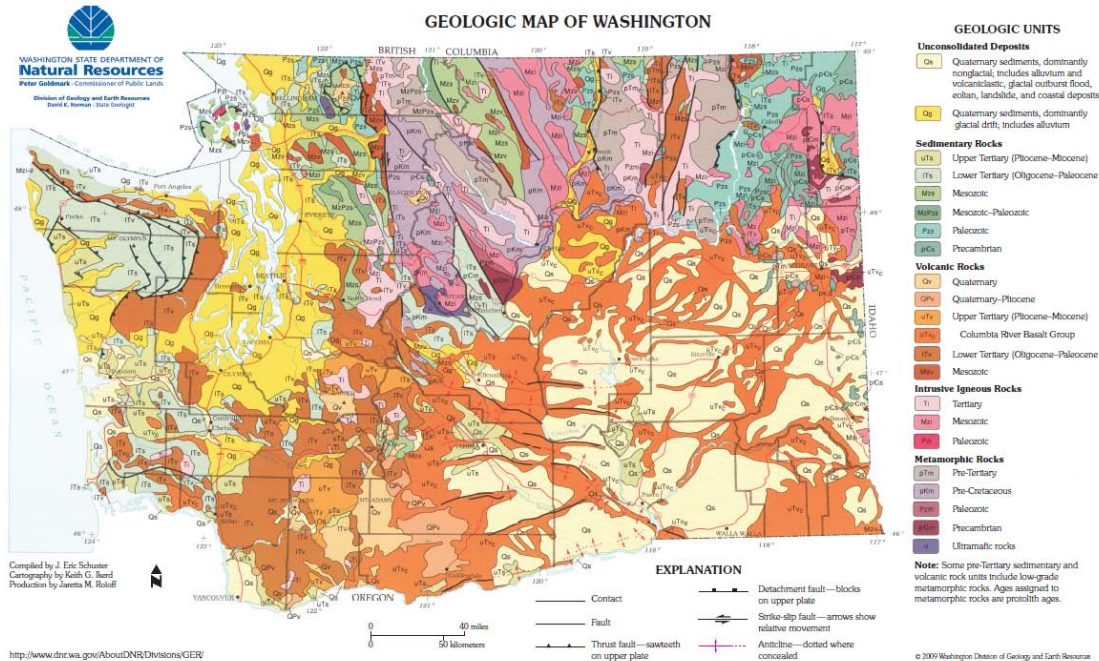
**Figure 3. Geologic map of Washington State (from the Washington State Department of Natural Resources 2009). See online at: [http://www.dnr.wa.gov/Publications/ger\\_geol\\_map\\_washington\\_pagesize.pdf](http://www.dnr.wa.gov/Publications/ger_geol_map_washington_pagesize.pdf)**

Washington is fortunate to have a considerable supply of high quality aggregates, primarily glacial outwash on the west side of the state and basalt on the east (Figure 3). All aggregates used in concrete were compared to the aggregate material found in a very high quality source located in Steilacoom, Washington (approximately an hour's drive south of Seattle). The comparison eliminated all variables except the aggregate source. Aggregate source acceptance was based on cylinders made from the proposed aggregate source being within 90 percent of the compressive strength of the Steilacoom standard at 14 days.
