# Studded Tire Wear on Portland Cement Concrete Pavement in the Washington State Department of Transportation Route Network

WA-RD 744.3

Research Report  
Agreement T2695, Task 88  
PCCP Best Practices

June 2010

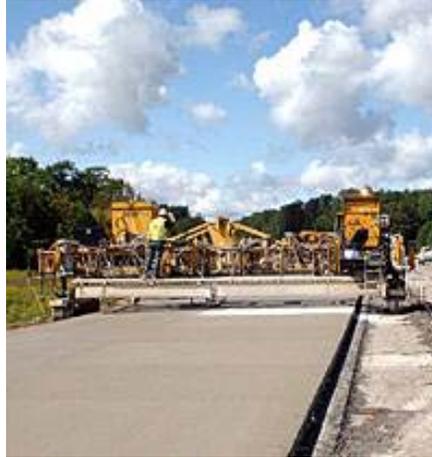
**Process.** There are two main types of PCC overlays applied to existing PCC pavements: bonded and unbonded (FHWA 2007b). A bonded overlay is a thin (typically 4 inches or less) PCC overlay over an existing PCC pavement with a prepared surface. As with a typical HMA overlay, a bonded PCC overlay relies on creating a good bond between the existing pavement and the overlay such that the result behaves as one unified structure (rather than two independent ones). An unbonded overlay is a thicker PCC overlay (usually 6 inches or more) placed over an existing PCC pavement (Figure 16). The overlay is intended to act as a separate pavement and thus steps are taken to ensure bonding to the existing pavement does not occur (ACPA 1998).

**Figure 16: Thin unbonded PCC overlay (Kuennen, 2006)**

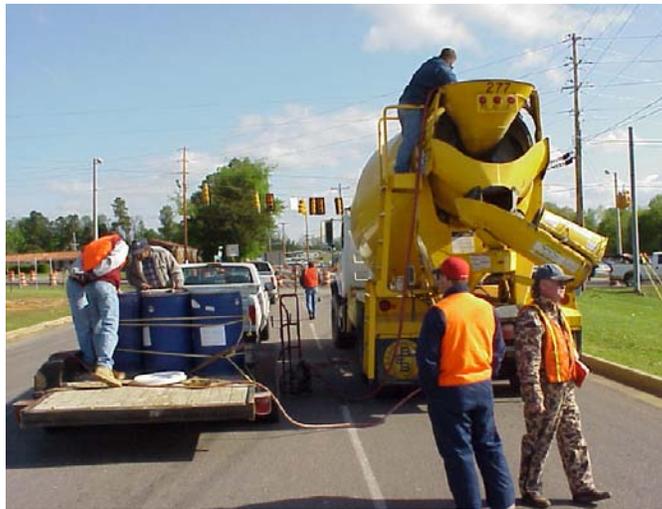
For the past two decades resin has been used in conjunction with HMA to resist rutting and abrasive traffic primarily on military bases. In recent years test sections have been researched on highways as well. RMP is a surface overlay of an open graded HMA mixture where 25-35% of air voids are filled with a latex-rubber modified portland cement grout (Figure 17). In the overlay procedure the open-graded mixture and grout are produced and placed separately to result in a 1.8 to 2.5 inch thick composite material. The benefit to this option is that it provides many of the performance characteristics of PCC but can be constructed easier and less expensively. Also, the additive is believed to increase the flexural and compressive strength of the hardened material, thus increasing abrasion resistance, and potentially studded tire wear as well (Battey & Whittington 2007).

**Figure 17: Latex additive going into the grout (Battey & Whittington, 2007)**

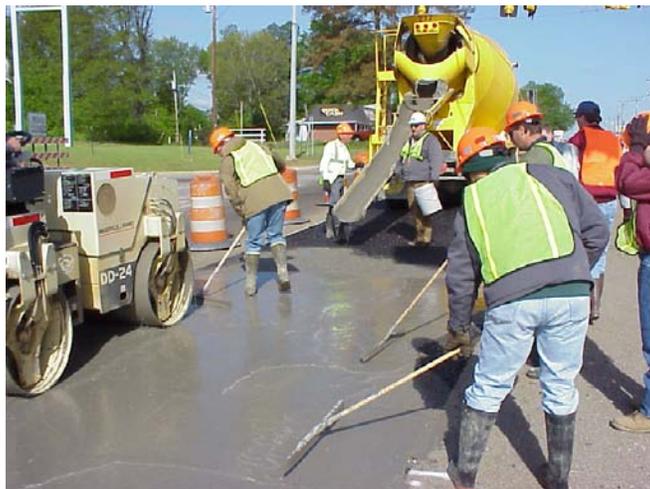
A Mississippi study placed RMP test sections on two HMA pavement intersections on US 72 with histories of traditional rutting (from pavement deformation) (FHWA 2006b). Ultimately, after 5 years of observation between 2001 and 2006, the Mississippi Department of Transportation (MDOT) published a final report in 2007 which featured both positive and negative reviews of their experience with RMP. From the construction end, the project was reported to be very challenging overall. Despite attention to detail, as shown in Figure 18 below, there was one area of failure where the removal of a 75-ft section of the pavement due was required due to a lack of grout penetration of the mat.

**Figure 18: Excess grout worked into areas needing more (Battey and Whittington 2007).**

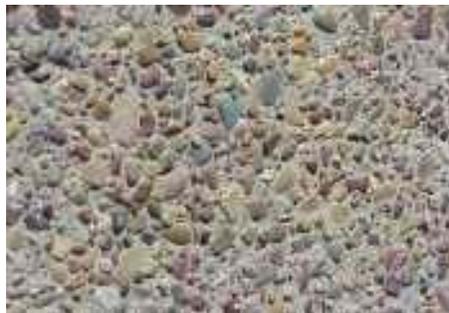
It is possible to construct a new PCC pavement in two separate lifts, which allows different materials to be used in each lift. This technique has been Germany, Austria and Belgium to place a high-quality, carefully engineered top lift over a more basic bottom lift. Often the top lift is constructed with an exposed aggregate finish to lessen tire-pavement noise (Figure 19).

**Figure 19: An exposed aggregate surface (Silent Roads, 2003)**

Noise reduction is attributed to the aggregate structural design in the top layer. For example the maximum aggregate size typically used in Europe is 0.8 inches and the top layer of concrete usually has a 0.3- to 0.4-inch maximum aggregate size. In the Netherlands, where more single-lift construction is done, 1.25 inches is the maximum

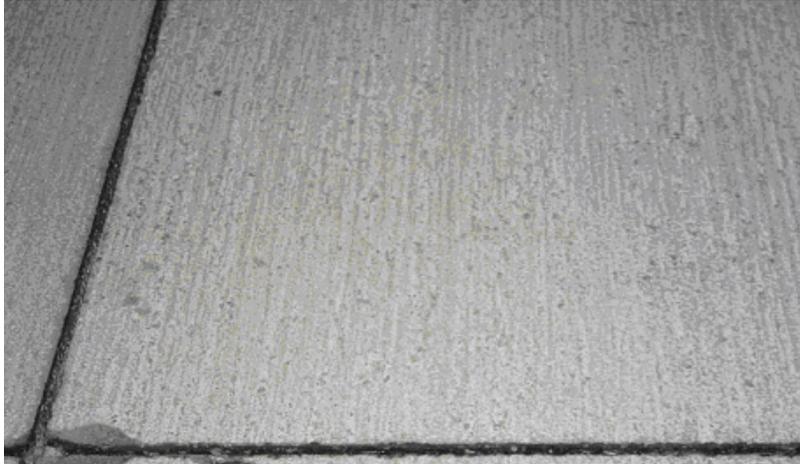
Surface texture is thought to have some correlation to studded tire wear. As the two primary textures used in Washington, the results of transverse tining and artificial turf carpet drag were explored in a WSDOT experiment on the performance of different surface textures (Figure 20). The amount of exposed aggregate relating to surface wear was also examined and it was recognized that pavements initially wore at a higher rate when first exposed to studded tires but then stabilized with time (Anderson et al. 2007). One idea suggested that the difference could be attributed to the paste on the surface of the new concrete. For example the paste wears quickly but then when the aggregate underneath is exposed the pavement wears at a much slower rate. One final conclusion noted was that all of the tined sections in this experiment had faster wear rates than other sections with equivalent mixes. Due to this it was suggested that tining may weaken the surface of the pavement by exposing more surface area to rapid drying, which is an idea that the Texas DOT has also proposed. The additional paste on the tined surface was also noted as a possible contributor (Anderson et al. 2007).

**Figure 20: Surface texture from a carpet drag (Anderson et al. 2007).**

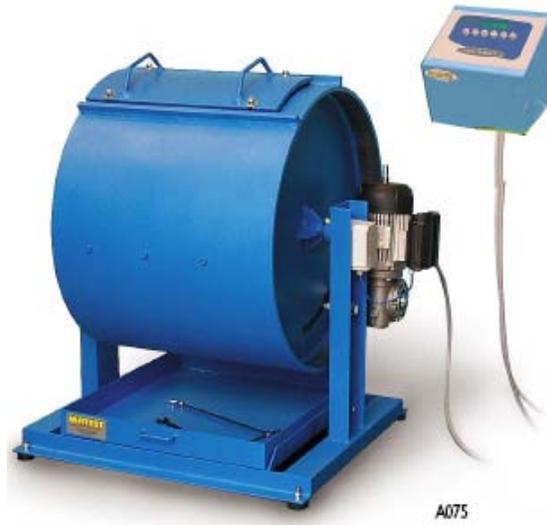
standard Los Angeles abrasion test is AASHTO T 96 or ASTM C 131. Figure 24 is an example of the LA Abrasion machine.

**Figure 24: LA Abrasion machine (Qualitest International, Inc. 2009).**

Studies of the LA Abrasion tend to conclude that it has little relationship with field performance (Rangaraju et al. 2005; Mokwa, et al. 2007; Folliard, et al. 2003).

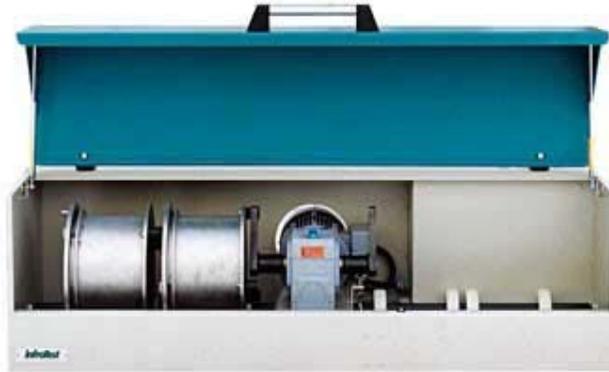
The Micro-Deval test (Figure 25) is another test used to evaluate the performed of an aggregates resistance to wear, and is similar to the LA Abrasion test. There are two versions of the test available. The test is described as placing the sample in a steel jar with steel balls (9.5 mm in diameter) and water, then rotating the jar at 100 rpm for 2 h for coarse aggregates, as previously described, or 15 min for fine aggregates (Land et al. 2006). Then the aggregate damage is assessed by mass loss using a 1.25-mm sieve for coarse aggregates and a 75- $\mu\text{m}$  sieve for fine aggregates (Lang et al. 2006).

**Figure 25: A Micro-Deval test machine (Inopave 2003).**

Unlike the LA Abrasion test, this test method is unique in that the aggregates are tested in saturated conditions rather than dry-conditions. According to the South Carolina DOT, analysis indicated that Micro-Deval test method is a better test in characterizing aggregate's field performance. The SCDOT found that for any given source of aggregate, finer gradation consistently yielded higher losses compared to coarser gradations (Rangaraju et al. 2005). Further, a Micro-Deval loss limit of 17% identified nearly all of the aggregates that were rated as being “fair” or “poor” in field performance.
