# Effects of Loop Detector Installation on the Portland Cement Concrete Pavement Lifespan: Case Study on I-5

WA-RD 744.5

August 2010

WSDOT Research Report

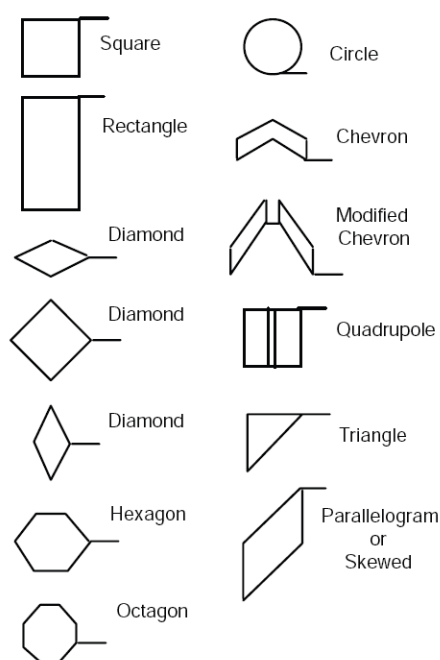
There are a variety of loop shapes and sizes, but on freeways short loops, typically 6-ft x 6-ft, are used for detection. Wide (normally 6 ft in length and up to 46 ft for four lane approach) and long (often 6 ft wide and 20 – 80 ft long) loops are primarily used for presence detection, usually near an intersection. Figure 2 shows some common loop shapes used in practice.

**Figure 2. Small loop shapes (from USDOT 2006).**

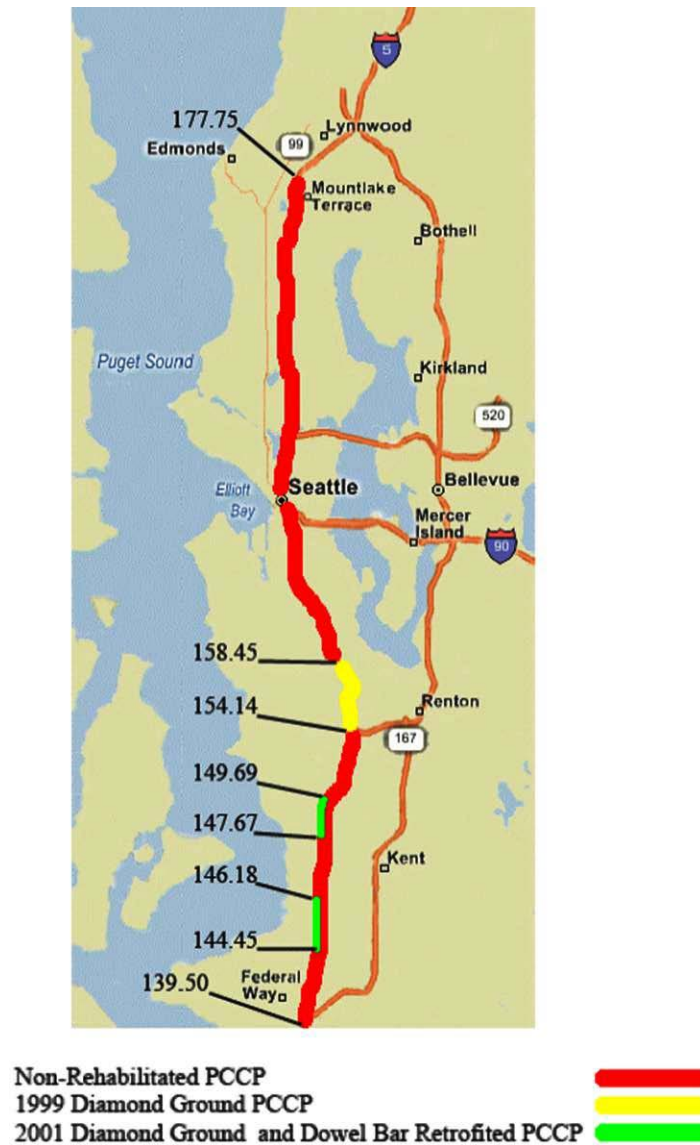
Two sections of the study corridor were reconstructed with dowel bar retrofit (DBR) and diamond ground PCCP in 2001. Southbound I-5 from milepost 144.45 to 146.18 and from milepost 147.67 to 149.69, total of 6.04 lane miles or about 3% of total lane miles in I-5 in King County. Figure 3.1 shows the study corridor and which sections have been reconstructed and which have not (Hansen et al. 2007).

**Figure 5. Rehabilitation of PCC pavement on I-5 in King County as of 2004 (from Hansen et al. 2007).**

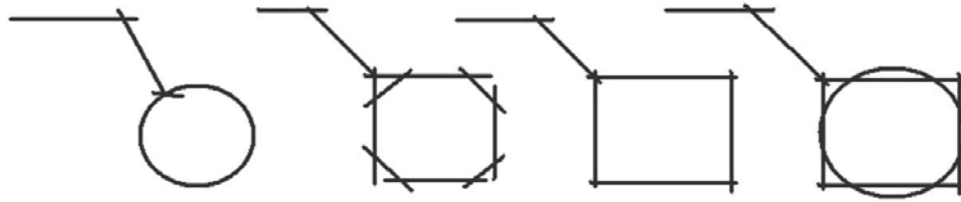
There are three types of loops embedded in the pavement of I-5 in King County: Circle loop, rectangular loop with softened corners and rectangular loops with sharp corners. The fourth category is a combination of those three loop types, e.g. when more than one loop detector is embedded in one concrete slab (Figure 6).

**Figure 6. Types of loops: circle, rectangular with soft corners, rectangular with sharp corners and loop combo.**

The oldest type is the rectangular one with sharp corner, first installed in the mid 1960's. Later it was realized that the sharp corners tended to rupture the loop detector wires and their use was largely discontinued. In the mid 1980's the first loops with softened corners were installed which solved somewhat the wire problem but increased the number of cuts in the pavement. Since the 1997 to 2000 time frame (the exact date is not known) only circle loops have been installed; these require only one cut and are considered the best for loop wire integrity. WSDOT estimates the lifespan of loop detectors to be about 8 – 12 years, but they do not keep records to document this (Dedinsky 2008). Other construction and maintenance activities can significantly decrease loop detector life span (Dedinsky 2008).

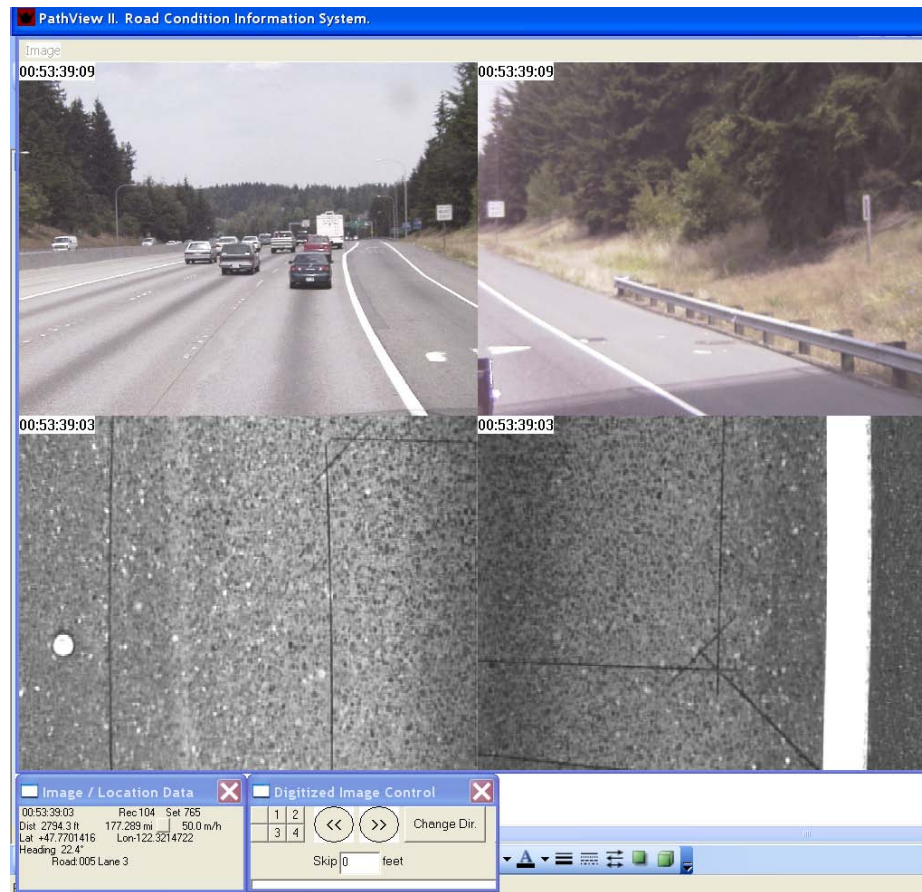
During the data collection process roughly 618,000 images were collected (e.g., Figure 8); 515,000 of which were downward-looking pavement images. The digital images of the pavement surface are displayed using Pathview II software. “Pathview II is a Windows 32-bit application which integrates all the pavement surface sensor data, digital images and location in a powerful and user-friendly system” (Pathway 2008). Each image shows about  $1/8 - 1/6$  of the length of a typical 15-ft long concrete slab, thus to view a whole slab 6 to 8 images have to be assembled (“stitched”) together.

**Figure 8. Pavement images displayed in Pathview II software.**

Originally, the research plan was to view the images and grade the panels accordingly using the view shown in Figure 8, but the pavement images were often skewed and it was difficult to see whether a line was part of a loop detector or if it was a connection between a different loop and the cabinet. Also if a panel is cracked it can be difficult to decide if there are one, two or multiple cracks. To overcome these difficulties, the images that contained concrete panels with embedded loops were identified and assembled into larger aggregate images, each of which showed an entire loop embedded concrete panel (Figure 9). About 20% of this work had already been completed at the

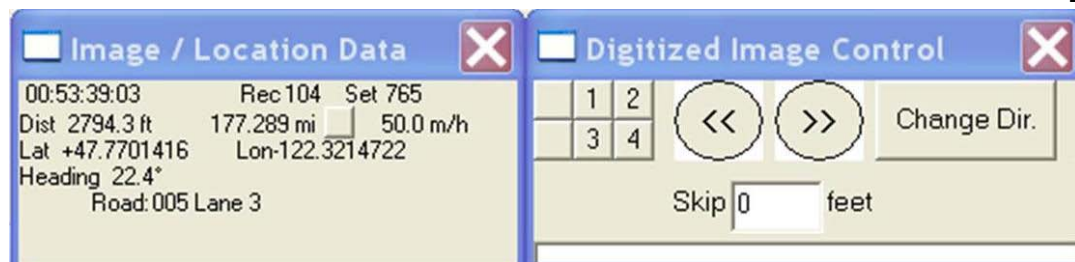
Image numbers are displayed in the Image/location window (at the bottom left corner of Figure 8, enlarged in Figure 10). The file names are connected to numbers shown in the window: Set 765 means that the file is in folder 765 inside the database and the time which the data was collected, 00:53:39:03. The last digit can be 1, 2, 3, or 4 depending on from which camera the image is from. The total file name is a combination of these numbers: 765005339033.jpg.

**Figure 10. Enlarged image of bottom left corner of Figure 8.**

Other information used for the study were the milepost (177.289 in Figure 10), highway designation (“Road 005” in Figure 10) and lane (“Lane 3” in Figure 10). While WSDOT refers to the right-most lane as lane 1 and then increases lane numbers towards the center of the road, Pathview II does the opposite; referring to the left-most lane as lane 1 and increasing lane numbers towards the outside of the road. This can be confusing at times, however it is consistent. The Digitized Image Control window (Figure 10) is used to go to the next image, or a user-defined distance (in feet) can be entered in to skip images.

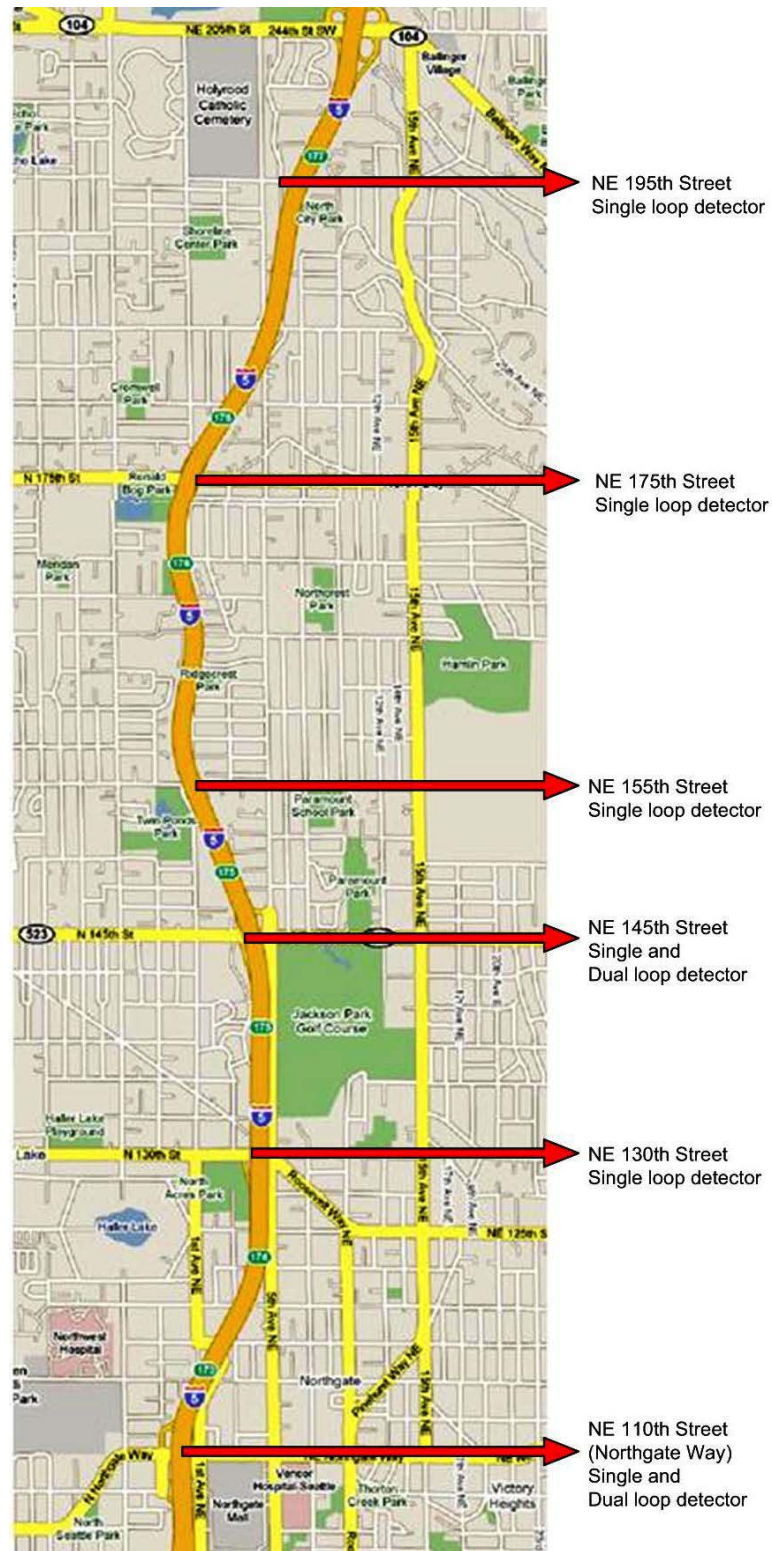
square (6-ft by 6-ft), circle loops and combo loops. There were 11 mainline loop detection stations in the simulation corridor. Six of these were chosen to get lane-by-lane volume data. These six were chosen because they were generally equidistant from one another with about 20 city blocks between them and they also contained most of the on/off-ramp locations (Figure 11). Speed data and vehicle classification were attained by using dual loop detectors. There are four dual loop stations in the simulation corridor but only two were used: one in the middle of the simulation corridor (NE 145<sup>th</sup> street) and one in the end (NE 110<sup>th</sup> street). Dual-loop detectors are two consecutive single-loop detectors, placed about 16 feet apart. Time is measured from the time the first loop detects a vehicle until it is detected on the second one. The distance between the loops is known and therefore the vehicle speed can be calculated. To determine the length of the detected vehicle, the calculated speed and occupancy is used.

**Figure 11. Loop detectors used in the simulation corridor.**

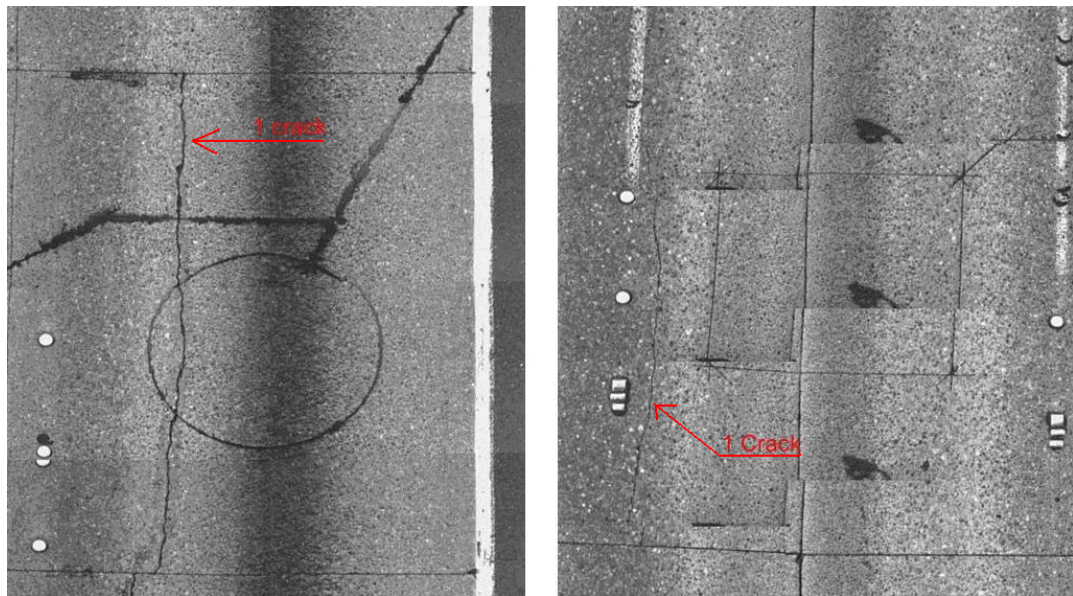
**Figure 13. Example of analyzed panels: cracks that were counted. One crack for each of these panels was counted as annotated by the arrows.**

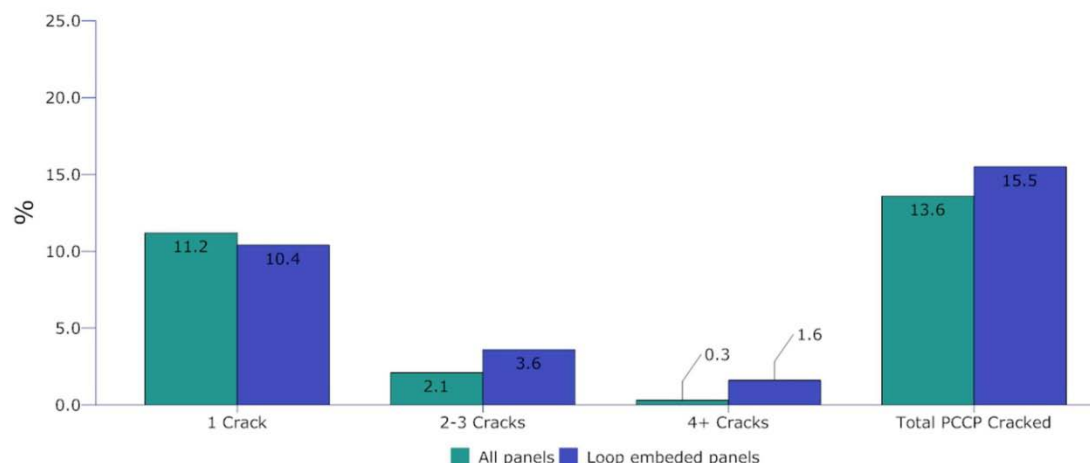
**Figure 16. Average cracking for non-rehabilitated PCC pavement.**

On average there is higher percentage of LEPs cracked than the LFPs. Results by number of cracks are:

- 1 crack: Slightly fewer LEPs with 1 crack as compared to LFPs.
- 2-3 cracks. LEPs have roughly 70% more cracked panels than LFPs.
- 4+ cracks. There are five times as many LEPs with 4 or more cracks than LFPs.

One possible explanation is that loops do not have much effect on the start of panel cracking but once a panel is cracked, some characteristic of the loop embedment hastens the deterioration process and the panel cracks more quickly.

Most of I-5 in King County was constructed in the 1960's and about 83% of it has still not been rehabilitated. In general, non-rehabilitated PCC pavements show signs of substantial wheel path wear from studded tires and contain an average of 29% faulted slabs (Hansen et al. 2007). Table 8 compares average cracking in non-rehabilitated pavement between all panels in I-5 in King County (data from Hansen et al. 2007) and the ones embedded with loop detectors (data from this study). Figure 16 shows this visually.

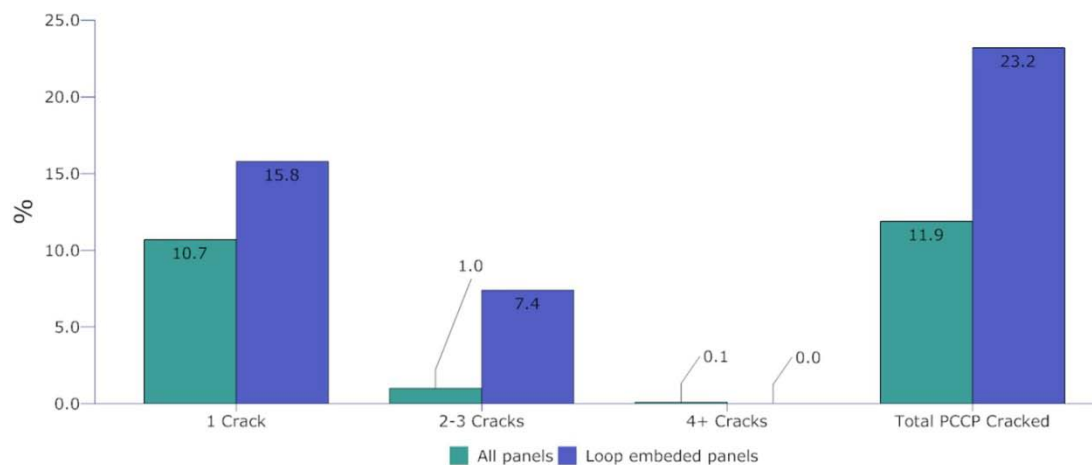
**Figure 17. Average cracking for diamond ground PCC pavement.**

On average there is higher percentage of LEPs cracked than the LFPs. Results by number of cracks are:

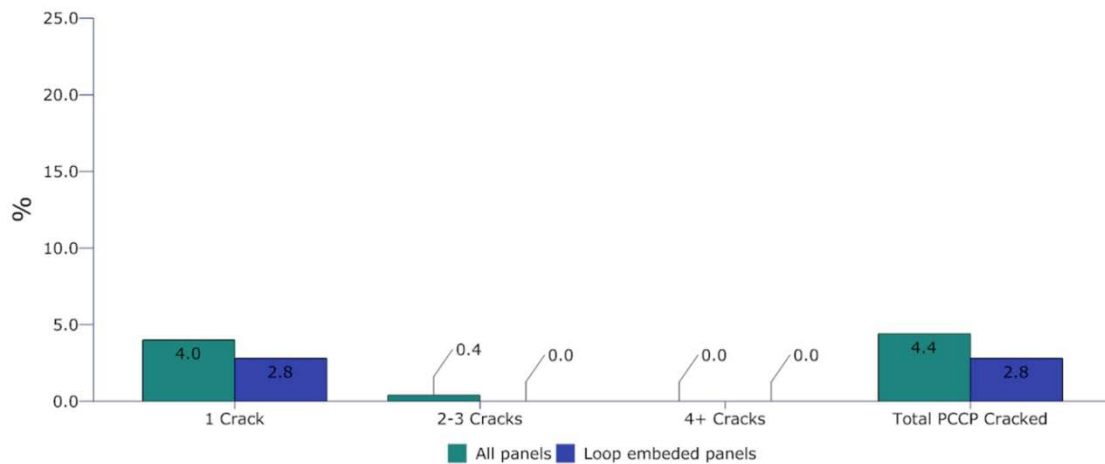
**Figure 18. Average cracking for DBR PCC pavement.**

On average there is lower percentage of LEPs cracked than the LFPs. Results by number of cracks are:

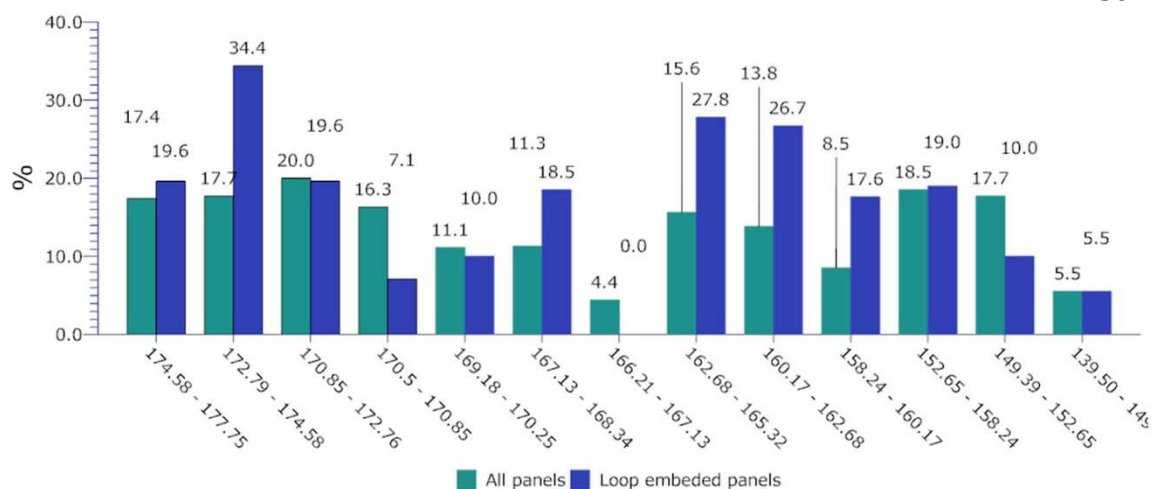
**Figure 19. Comparing LEPs and LFPs by section.**

The sections vary in length, the longest section is about 10 miles and the shortest less than a mile, so the number of panels (sample sizes) in each section are different. The LEPs have higher percentage of cracking in 7 of the 13 sections. In three sections the LFPs have higher percentage of cracking. It seems that LEPs perform worse compared to LFPs from mileposts 158 – 165; the section around and north of King County Airport (Boeing Field). No apparent correlations exist between cracking and any data contained in Table 3 (construction year, number of lanes, base type, base thickness).

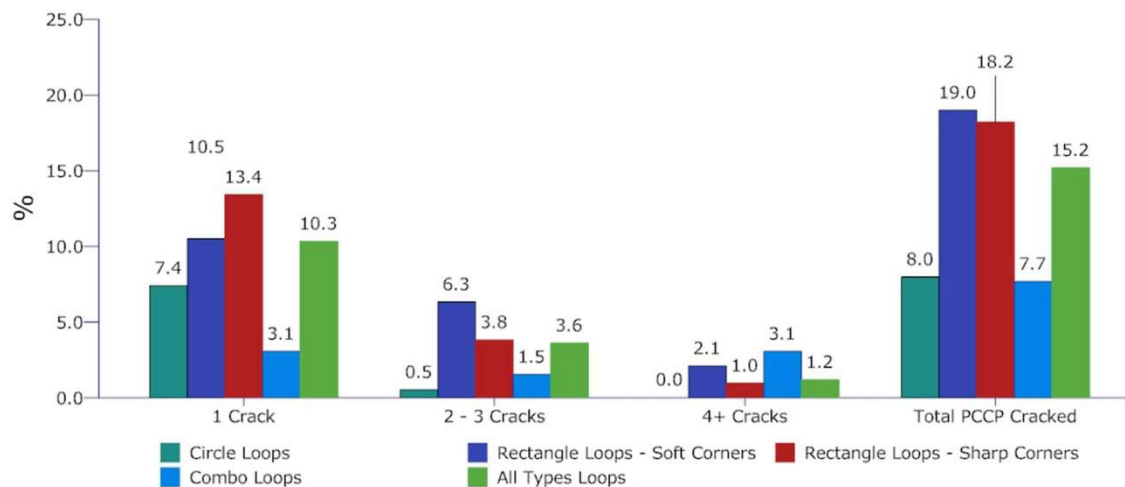
**Figure 20. Number of cracks in LEPs by type of loop detector.**

There is a significant confounding effect that makes direct comparison by loop type difficult: loop type is highly correlated with the age of a loop (e.g., circle loops were installed most recently so are younger than rectangle loops, etc.). Thus, of the three types of loops the circle loop performs best as would be expected since they were installed

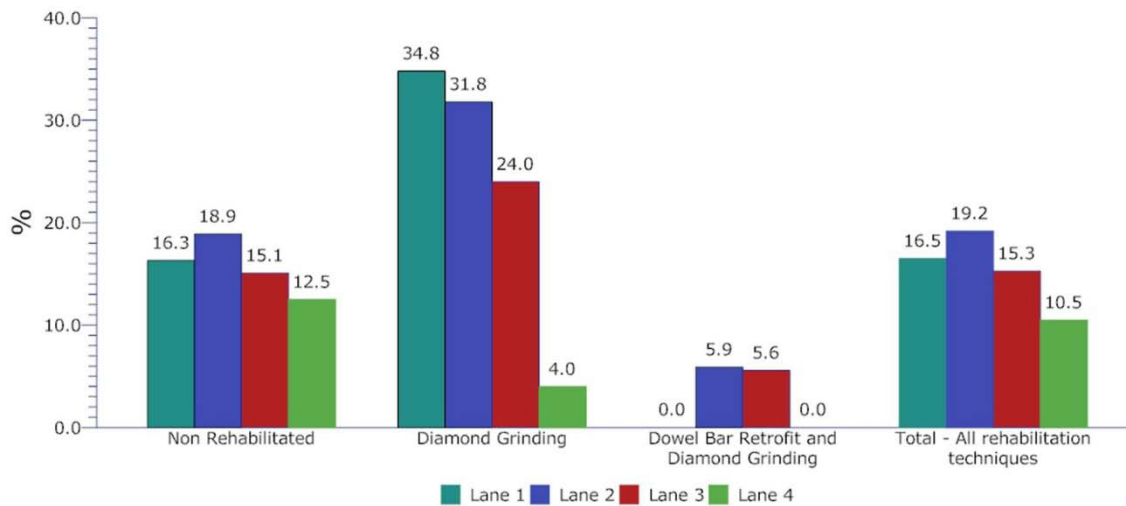
**Figure 21. Percentage of cracked LEPs by lane and rehabilitation type.**

It is hypothesized that lanes with the highest truck traffic (including buses) will have a higher fraction of LEPs with cracks. To test this hypothesis, a small sample of truck traffic by lane was taken on southbound I-5 at NE 145<sup>th</sup> Street and NE 110<sup>th</sup> Street. On these locations there are 4 and 5 lanes respectively. The sample was taken in August 2006 and contained 4 hours of average evening (8:00 pm – 12:00 am), 4 hours of average weekday (Monday – Wednesday from 6:00 am to 12:00 pm) and 4 hours of average weekend (Saturday and Sunday 12:00 pm – 16:00 pm) traffic. Traffic volume was not taken into account, just the ratio between small vehicles and trucks (including buses) and simple averages were taken from these three time periods and the results are shown in Table 14.

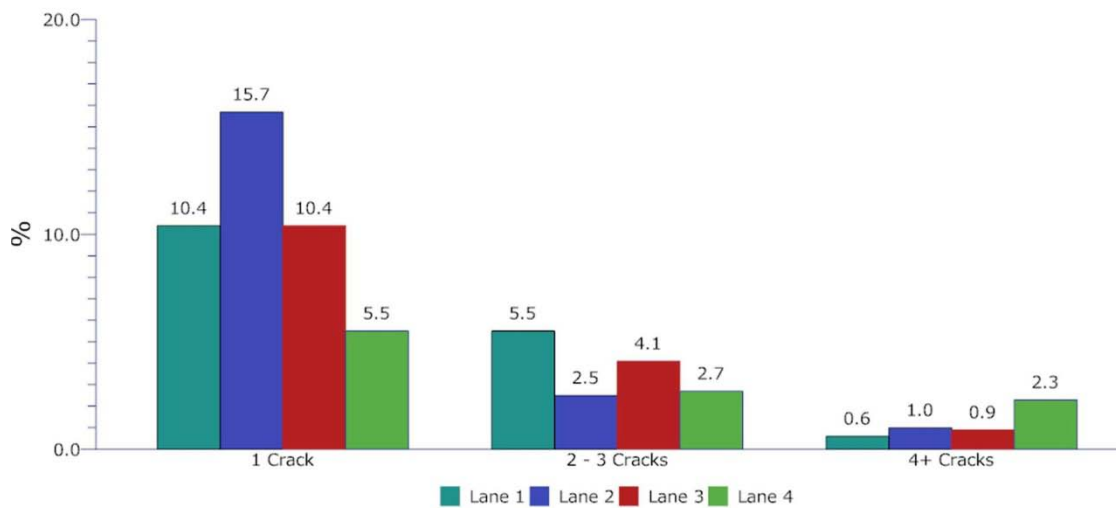
**Figure 22. Number of cracks by lane.**

The results for 1 crack per panel is very similar to the overall percentage of cracked panels but for 2-3 cracks there is a spike in lane 3 which might not be expected. The most unexpected result is in 4+ cracks, lane 4 has the highest percentage of 4 or more cracks per panel. If sample size were increased (here the sample size is low) it is unknown if this trend would still be prevalent.

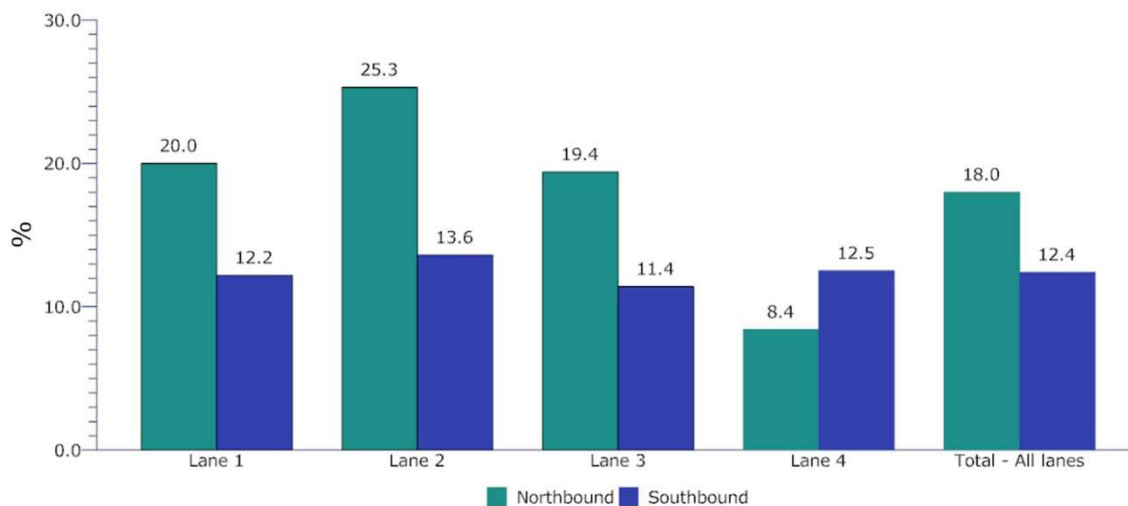
**Figure 23. Cracked LEPs by lane and direction.**

With the exception of lane 4, the northbound direction is in significantly worse shape than the southbound. One hypothesis to explain these results is that truck traffic in the northbound direction is higher. To test this hypothesis, a small sample of truck traffic by direction was taken on northbound and southbound I-5 at NE 145<sup>th</sup> Street. There are five lanes on this location in the northbound direction compared to four in the southbound direction. As with the previous truck sample, the sample was taken in August 2006 and contained 4 hours of average evening (8:00 pm – 12:00 am), 4 hours of average weekday
