# Identification of Test Methods for Determining Wood Guardrail Post Integrity

WA-RD 843.1

June 29, 2015

**Final Report  
WA-RD 843.1**

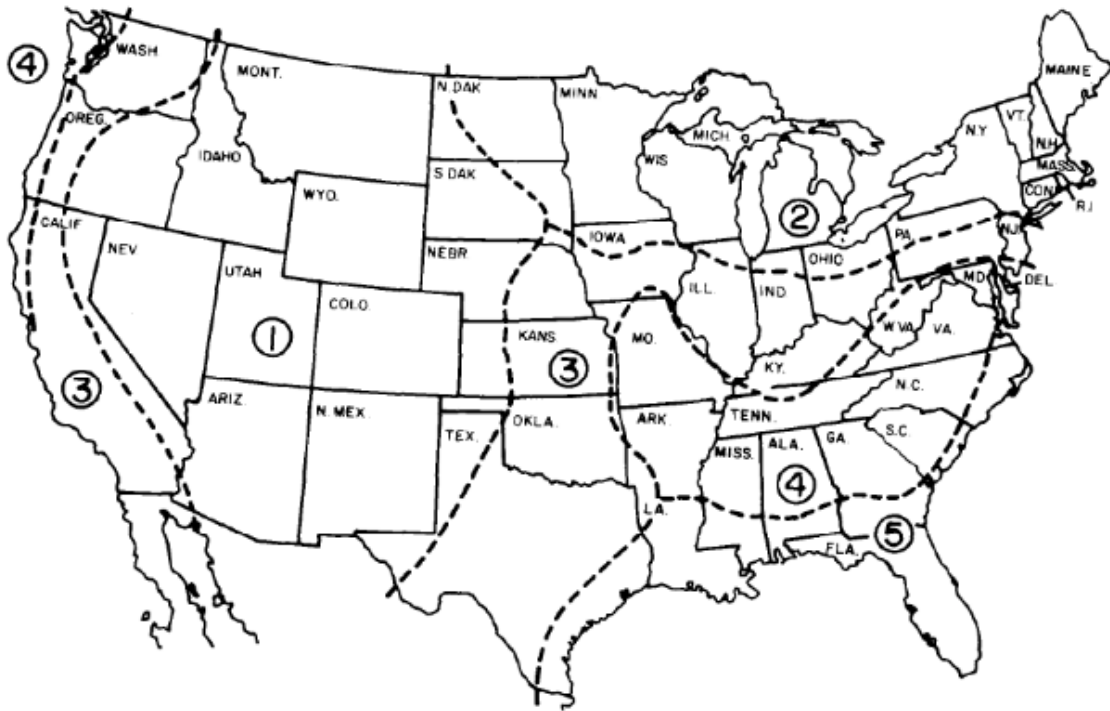
Figure 2. Decay severity zones for wood poles, ranging from the least severe decay conditions in zone 1 to the most severe decay conditions in zone 5 (USDA 2013).

A comparison of the responses in Figure 1 to the map of US decay regions in Figure 2 indicates that the survey responses were collected from locations with varying decay hazard risks.

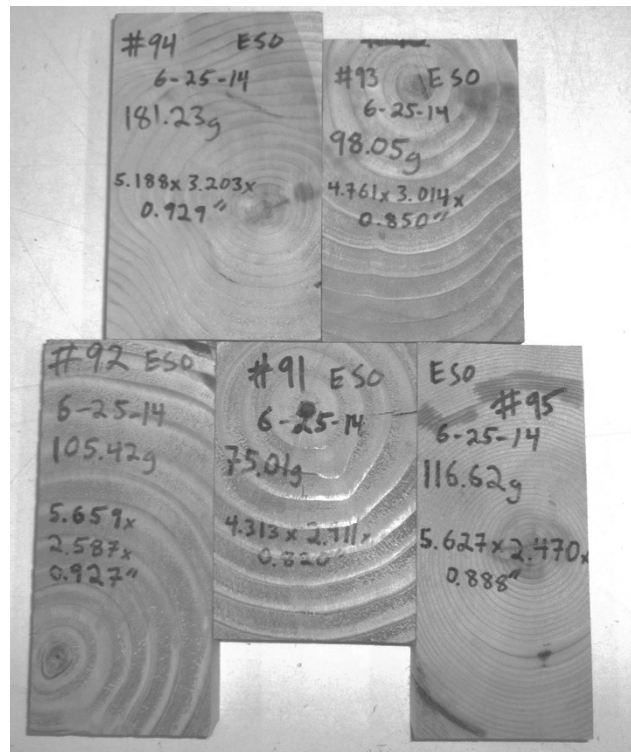
Following destructive testing, a small slice was removed from each post, just beyond the testing area. This location was selected to be as close as possible to the test area, while keeping that tested section of post intact for later characterization of internal post condition. Once the slice was obtained, it was trimmed to remove the sections with preservative treatment. The dimensions of the remaining slice were then recorded. The sample slice was weighed, then oven-dried, and finally weighed again to estimate moisture content. Some example specimens, before oven drying, are shown in Figure 7.

Figure 7. Example moisture content samples. The pictured samples have been trimmed to remove the outer treated areas but they have not been oven-dried.

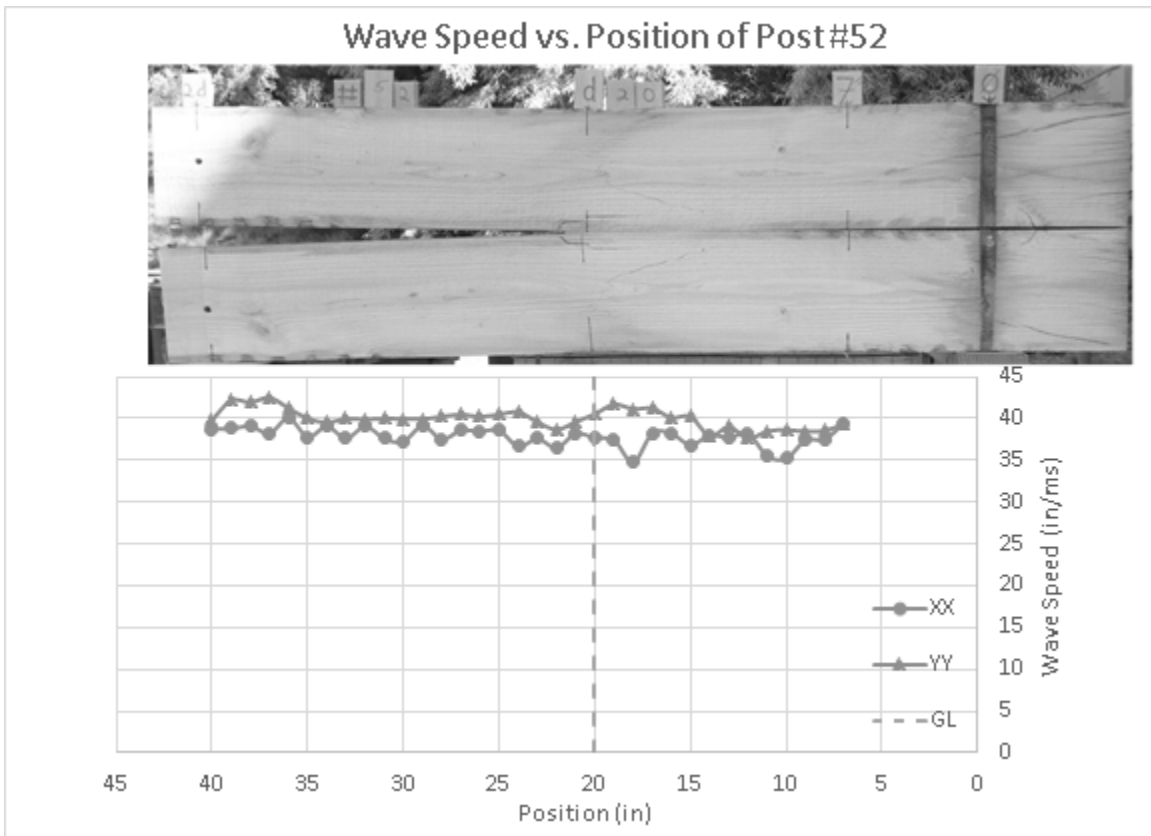
Figure 12. Internal view of a sound post (post #52) over wave speed vs. position.

Following DT, each post was cut in half, length-wise, using a portable sawmill. The resulting halves were then inspected for signs of decay. The NDT plots of post #52 are aligned with the resulting halves and displayed in Figure 12. Similarly, the NDT plots and resulting halves of post #58 are shown in Figure 13.

These figures suggest that visual inspection is not adequate for gauging internal decay. In fact, post #58, which had severe internal decay and extremely low stress wave speeds, showed little to no exterior signs of decay. This lack of external decay indicators emphasizes the need for more rigorous NDT inspection procedures to estimate the true internal condition of wood guardrail posts.

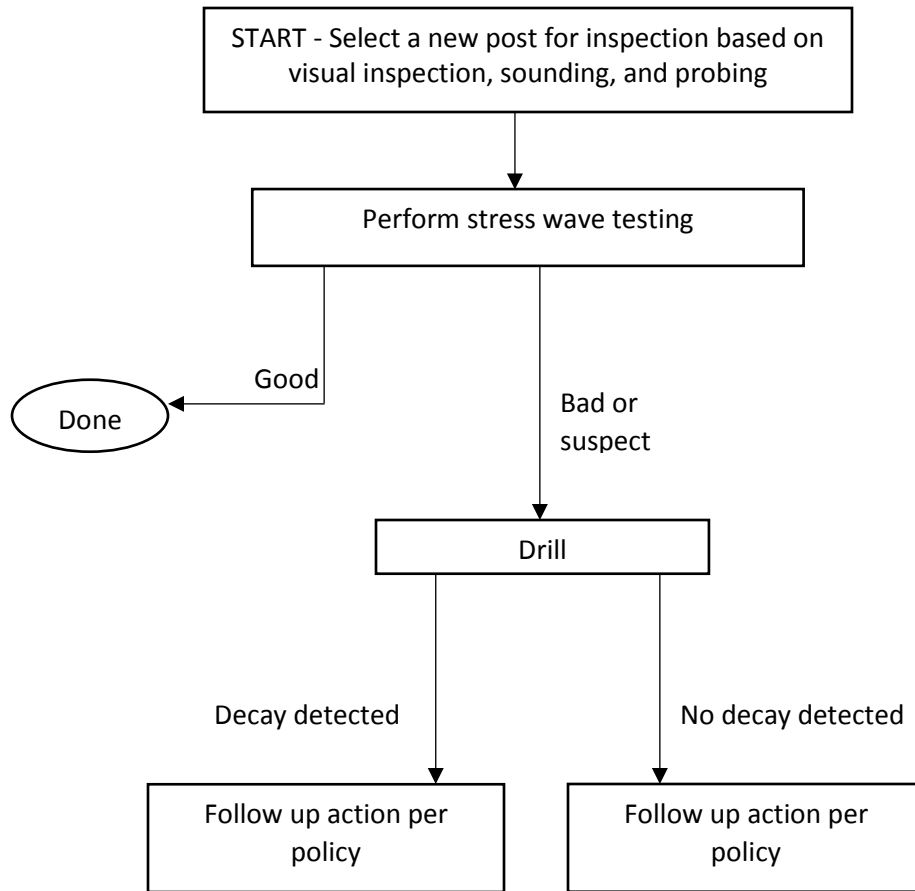
Figure 15. Suggested field testing procedure flowchart.

Based on the field test, conducted to validate the prototype, and the strengths and weaknesses of each testing method used, a possible field testing procedure has been outlined in the flowchart in Figure 15. To determine the internal condition of a posts, in a section of guardrail, the following supplies are recommended, at a minimum: a stress wave timer and console; a sounding hammer or other sounding device; an electric hand drill, a resistance drill, or a test screw (described in Appendix D); a tape measure or a ruler; a sharp metal object for probing; treated wooden dowels, caulk, or other sealant to seal drill holes; gloves; weather-
