Recommendations for Extending Asphalt Pavement Surface Life within Washington State

WA-RD 860.1

Research Report
WA-RD 860.1

**RECOMMENDATIONS FOR EXTENDING ASPHALT PAVEMENT
SURFACE LIFE WITHIN WASHINGTON STATE**

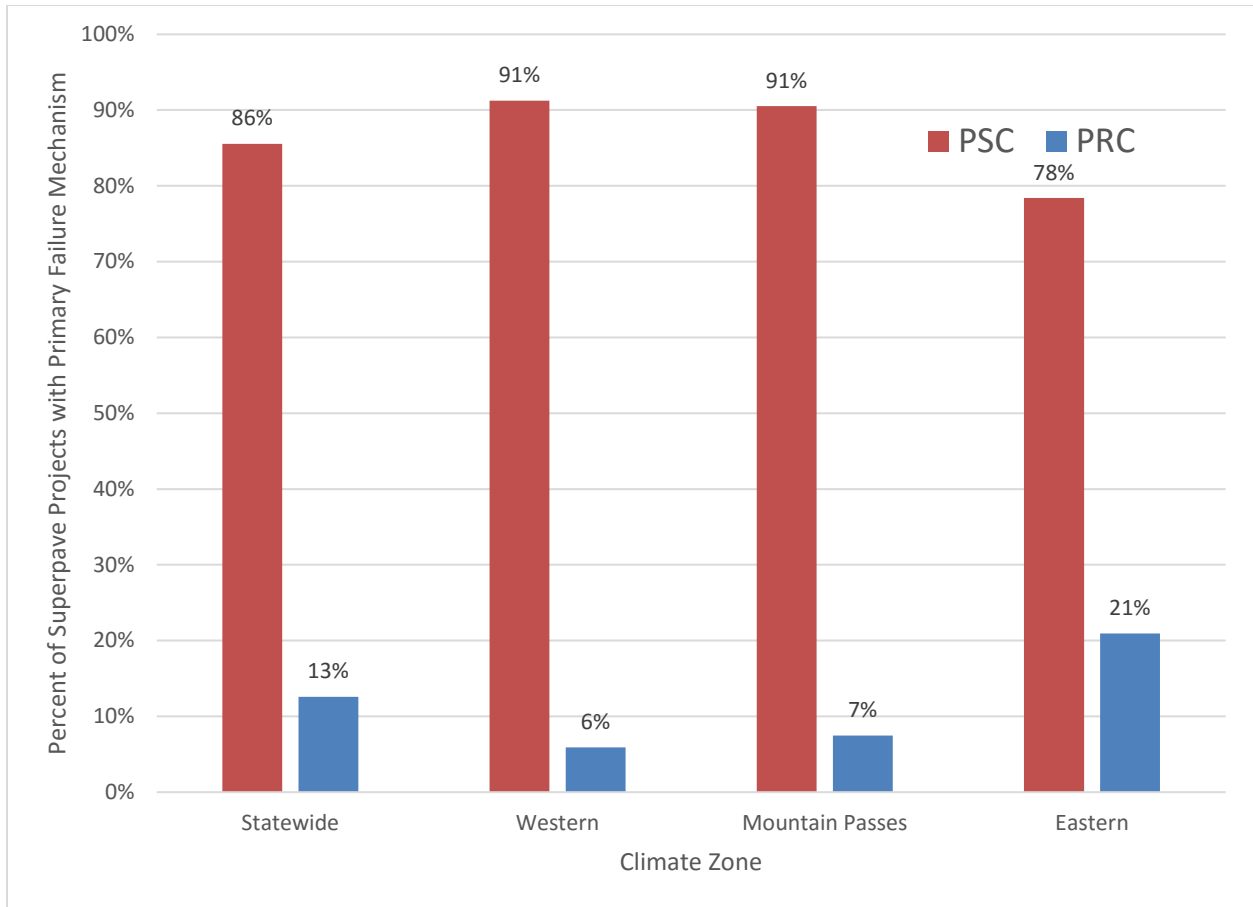
Figure 2. Primary failure mechanism by climate zone for Superpave projects completed through 2007. Most projects reach a cracking index rehabilitation threshold first indicating that cracking is the predominant failure mode.

**PSC = Pavement Structural Condition; pavement fails due to cracking first.
 PRC = Pavement Rutting Condition; pavement fails due to rutting first.**

Figure 2 shows the distribution of failure mechanisms across the entirety of Washington, as well as in Eastern Washington, Western Washington, and over Washington mountain pass areas. In general, PSC reaches the WSPMS index failure threshold before PRC for most pavements across the State of Washington, indicating that cracking is the predominant failure mechanism. This does not mean that rutting does not exist, but simply that cracking reaches its index threshold value for rehabilitation before rutting does. Instances of rutting were somewhat higher in Eastern Washington than other areas, which may be an indicator of studded tire wear (Cotter and Muench, 2010) rather than mixture deformation. This is consistent with results from the state agency survey in Appendix A that indicates cracking is a primary failure mechanism in states with harsh climates similar to that of Eastern Washington. The states of Alaska, California, Utah, Colorado, Nevada, Nebraska, Oklahoma, Missouri, South Dakota, and Wisconsin indicated that top pavement failure modes include thermal and fatigue cracking.

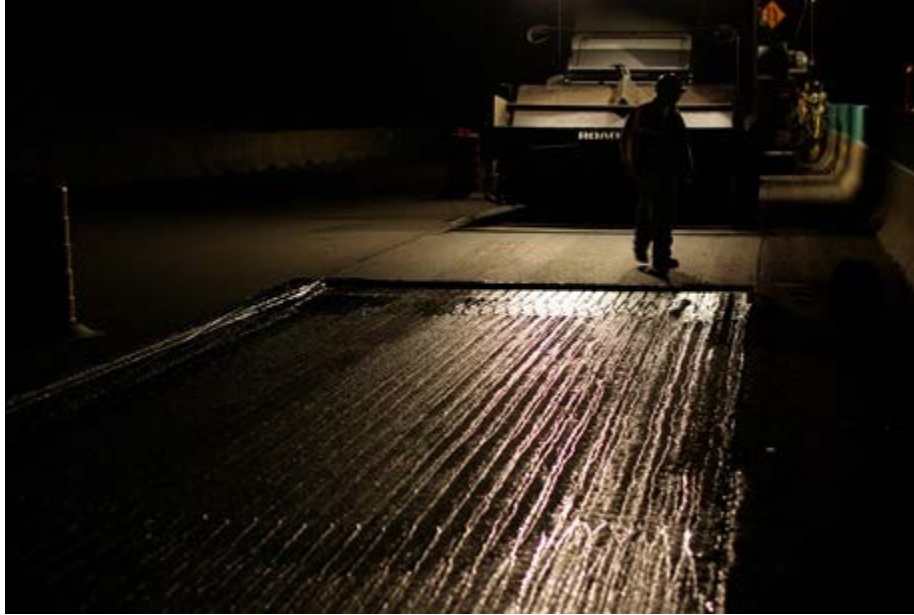
Figure 7. Straight PG grade tack coat placement.

A straight PG binder asphalt tack coat (no emulsion) was specified for this contract (Figure 7). The contractor used a sub-contractor to place the tack coat. Tack coat placed on the existing concrete pavement suffered from excessive pickup in the wheelpaths as noted by direct researcher observation and WSDOT Inspector Daily Reports (Hicks, 2015). Several methods were used to ensure the tack coat was being placed on a clean surface (i.e., multiple sweeper passes along with individual workers walking the milled area behind the sweeper with air compressors to remove as much of the fine material as possible) but it could be seen that the majority of the tack in the wheel paths was being picked up by the trucks on the night observed. When placed on the newly laid asphalt the majority of the tack remained in place.

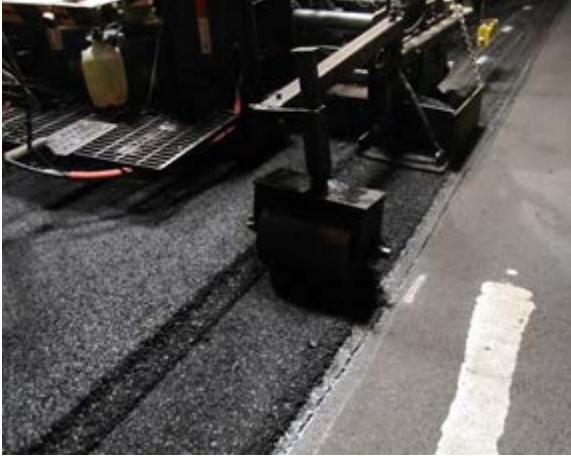
Figure 8. Notched wedge joint.

For this contract both a notch wedge joint (westbound lanes, Figure 8) and a saw cut joint (eastbound lanes, Figure 9) were used with performance grade asphalt binder applied to all joints. Specifically, notched-wedge joints were used for all lifts on the WB lanes and all but the top lift of the EB lanes. The top lift for the eastbound was specified as a cut back joint. The contractor chose to place an extra 6-inch width and then use a milling machine to remove that extra width. Both types of wearing course joints were coated with a joint adhesive (Figure 10 and Figure 11), which was done after the sweeper had removed all debris.

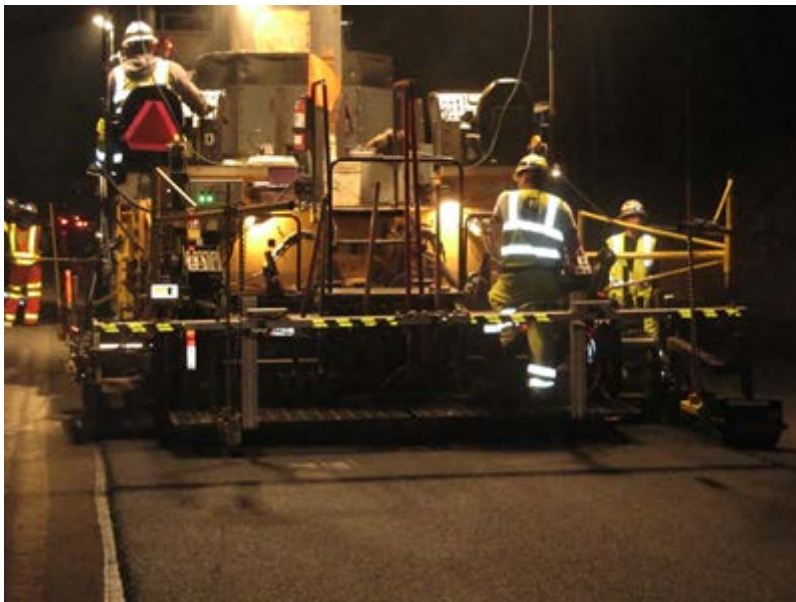
Figure 12. Pave IR installed.

- The Pave IR equipment initially provided was faulty, which eliminated time the contractor had planned for training on it.
- Issues with the GPS occurred on the first night the replacement equipment was used. A MOBA representative was able to come to sight the second night of using the Pave IR and resolved the GPS issue along with answering some questions the crews had. The repair was short lived as the issue reappeared shortly thereafter.

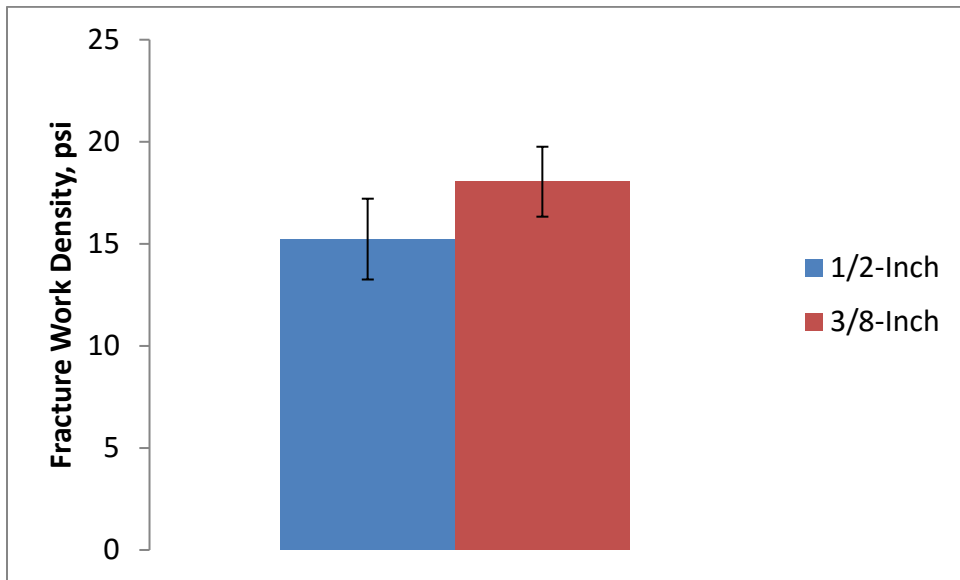
Figure 16. Contract 8611 fracture work density at intermediate temperature for fatigue results comparison.

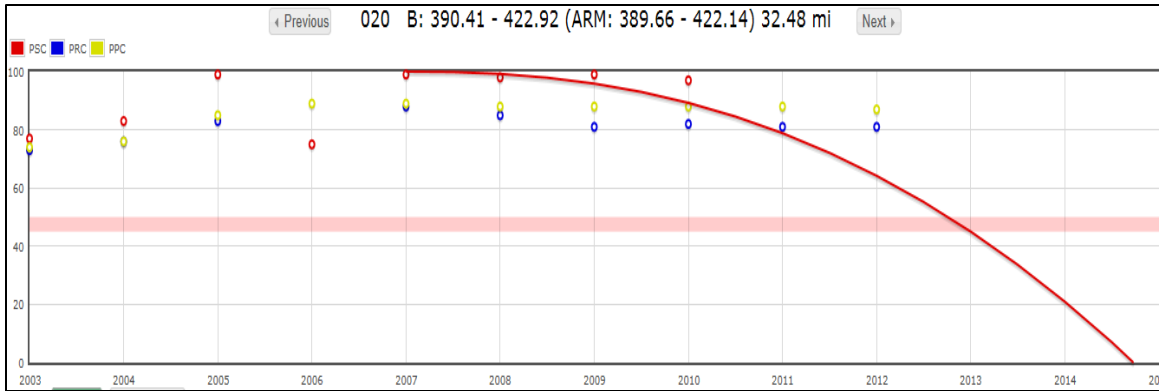
Figure 32. Contract 7109 WSPMS plotted condition ratings and performance curve.

The performance curve from WSPMS for a section of Contract 7109 is shown in Figure 32. It can be seen that this section of pavement performed well after seven years in service.

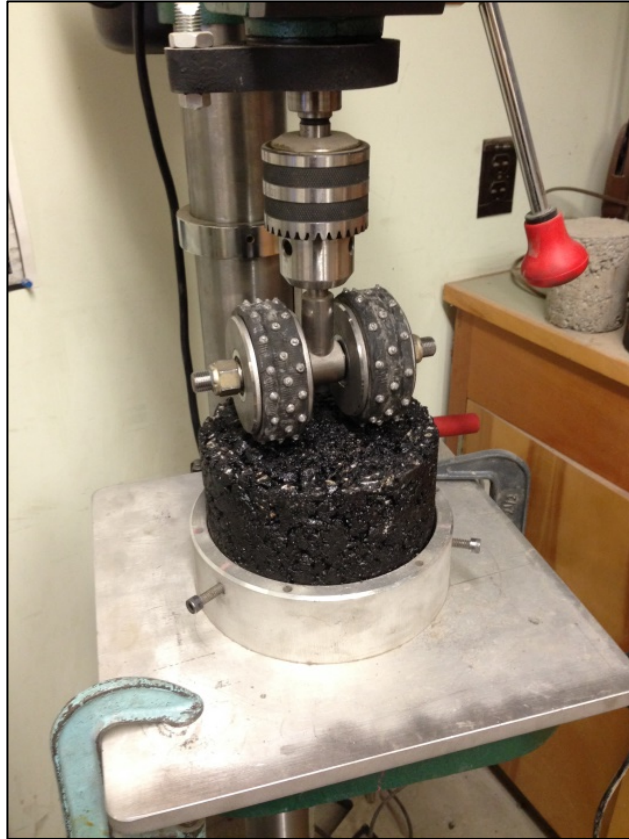
Figure B.145 Studded Tire Wear Simulator with Gyrotory Sample

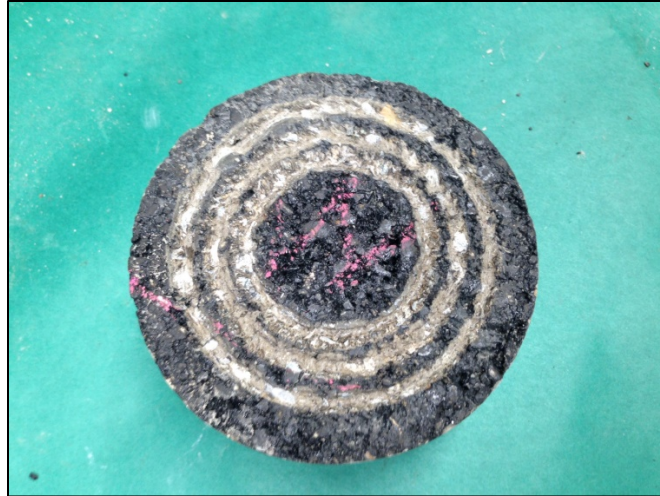
Figure B.2 Field Core Sample after Studded Tire Simulation

The resulting wear on a field core is shown in Figure B.2. The studded tire wear simulation tests were performed at a temperature of 69.8°F.

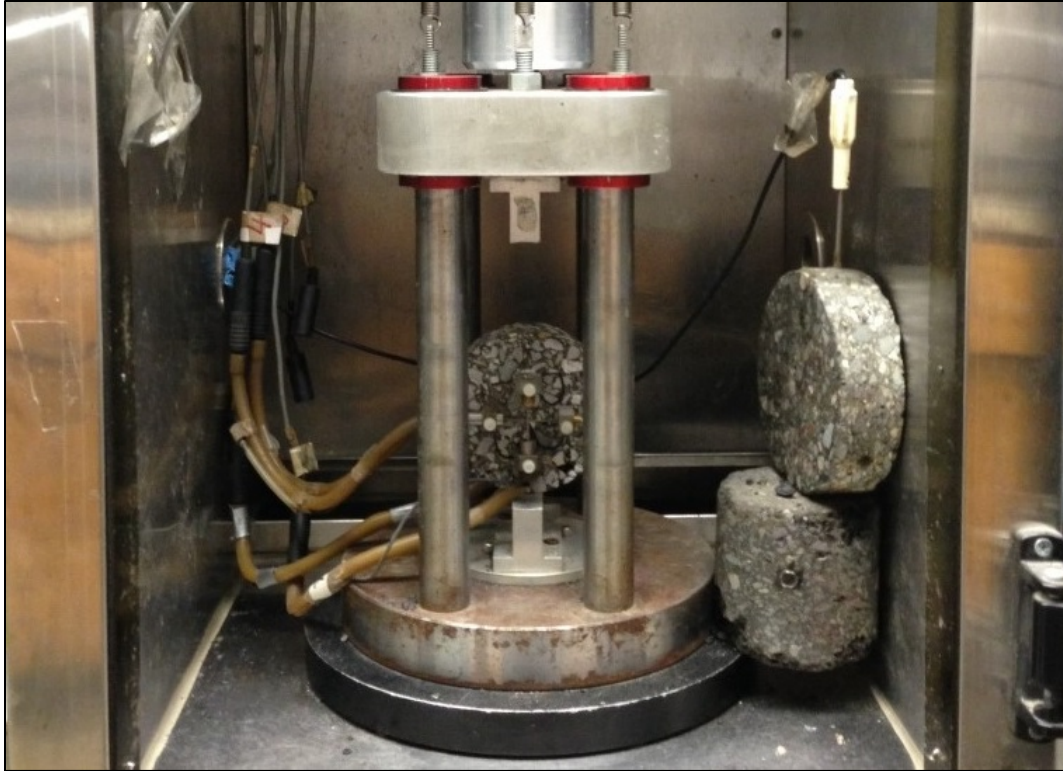
Figure B.4 IDT Test Machine Setup

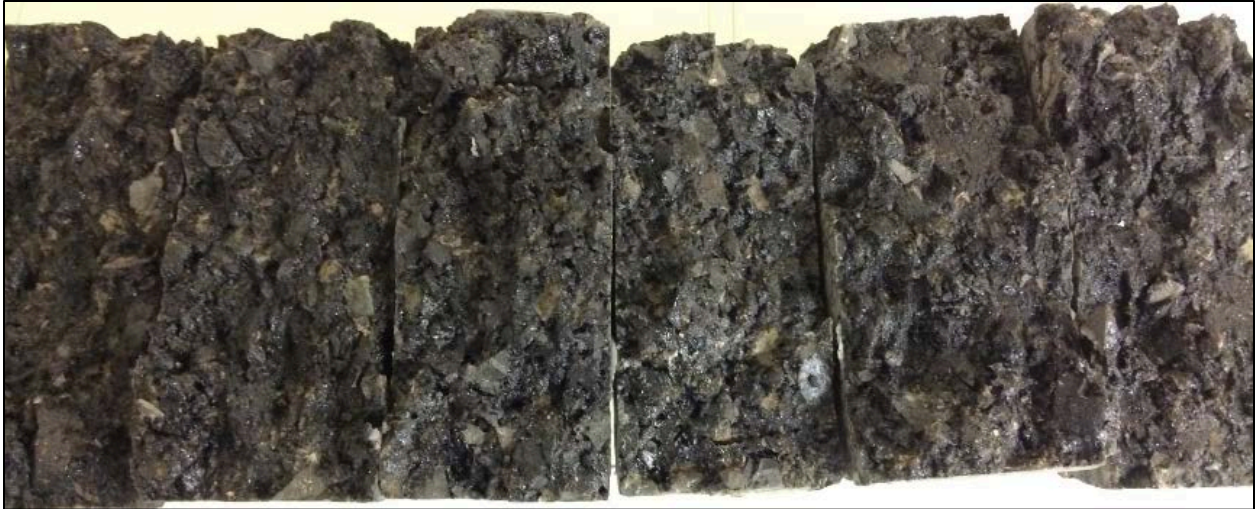
Figure B2.4 HMA Samples after IDT Fatigue Test

The fractured HMA and SMA samples after the IDT fatigue test are shown in Figures B2.4 and B2.5. From visual inspection, the samples often failed by the aggregate fracturing. Because the cores are taken between the wheel path, the fractured aggregates indicate that the pavements were over-compacted during construction, causing the aggregate to break. Graphical results for IDT strength, fracture work density, and horizontal failure strain of the HMA and SMA sections are shown in Figures B2.6 through B2.8. Results of the IDT fatigue tests are summarized in Table B2.3. Based on the fracture work density and the horizontal failure strain, the SMA is better than the HMA for bottom-up and top-down cracking resistance, respectively.

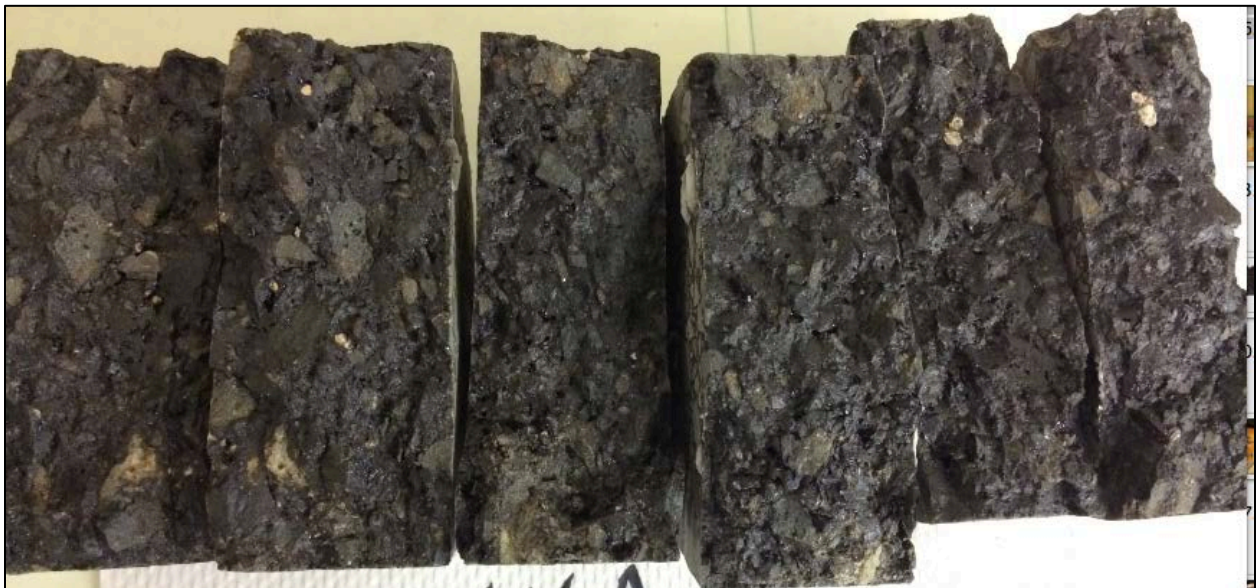
Figure B2.9 HMA Samples after IDT Thermal Cracking Tests

The fractured HMA and SMA samples after the IDT thermal cracking test are shown in Figures B2.9 and B2.10. Results of IDT thermal cracking tests are shown in Figures B2.11 and B2.12. Results of the IDT thermal cracking tests are summarized in Table B2.4. There was no statistically significant difference between the HMA and SMA for IDT strength. Based on results of the IDT test performed at a low temperature, the SMA mix performed better than the HMA mix for thermal cracking resistance.

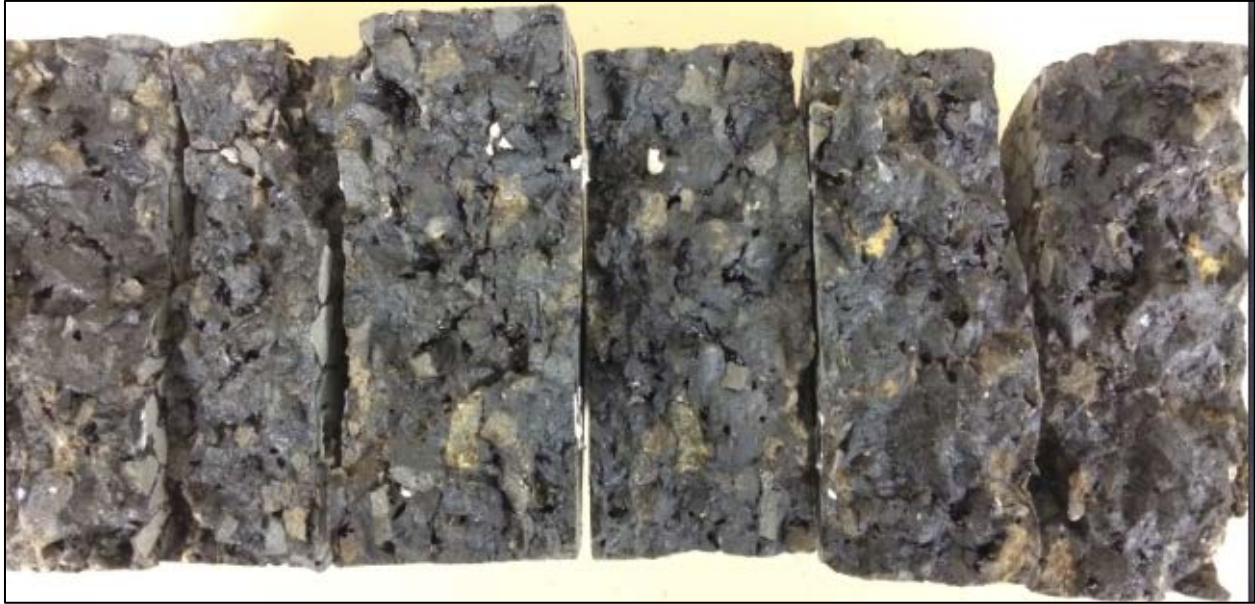
Figure B2.10 SMA Samples after IDT Thermal Cracking Tests
