# Flume-Based Design Recommendations for Coarse Bands and Boulder Bars to Improve Retention of Channel Shape in Stream Simulation Culverts

WA-RD 903.1

December 2020

WSDOT Research Report

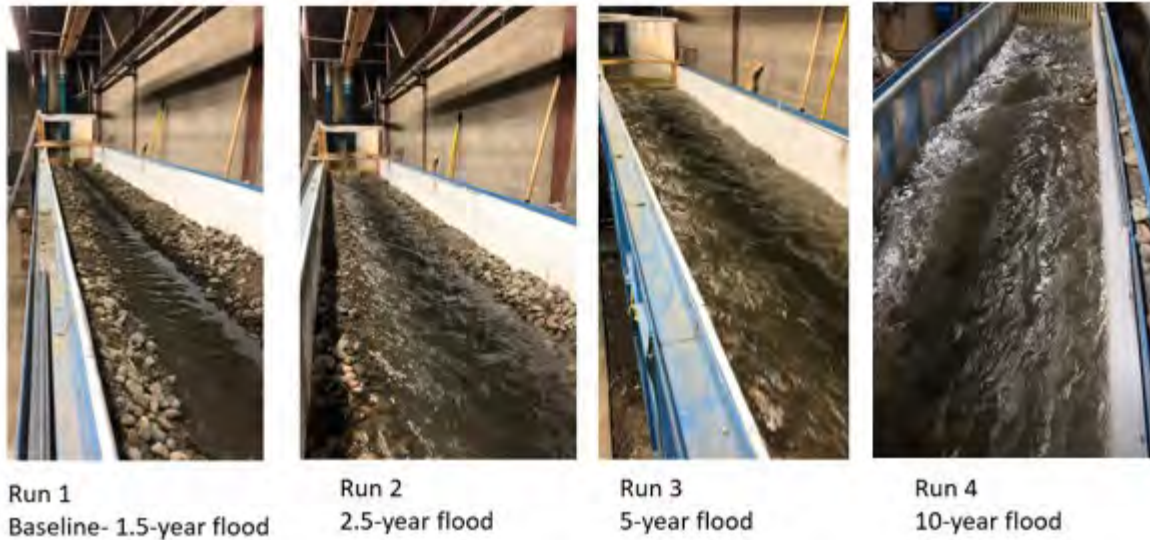
Figure 5 Shows each flood event in the study section. The figure on the far left shows the channel during run 1. The middle figure shows the flow in the channel during run 2. The flow has filled the U-shape channel. The figure on the right is run 3 in the channel. This final run has submerged the whole channel and extends up the side of the flume.

Cross-section profiles were collected at one-foot intervals in the study section. Forty-one measurements were taken across the streambed for each cross-section profile. The measurement locations across the channel were spaced as follows: 2 inches spacing between stations 1-5 & 37-41 and 1/2 inch spacing between stations 5-37. The measurements were taken to 1/16<sup>th</sup> inch with a  $\pm 1/32$ -inch precision. This data collection scheme reduced the workload in the area that exhibited less transport to increase efficiency. Three flow scenarios were used: 1) baseflow 1.5-year flood event; 2) a 2.5-year flood event; and 3) a 5-year flood event (Figure 5 shows the flood

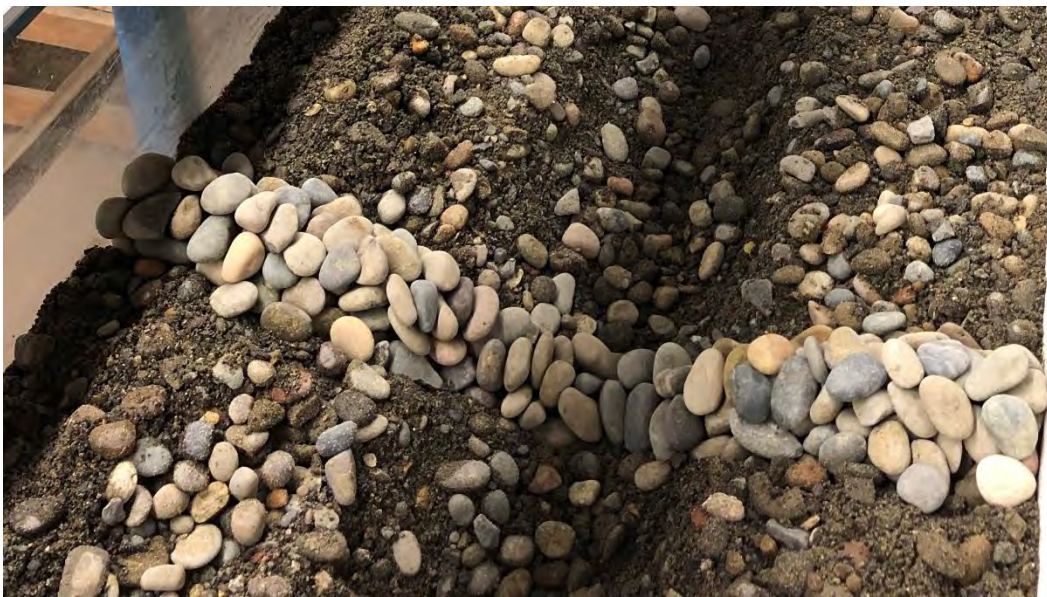
*Figure 7 Coarse band design that replicates the channel shape and sits about the streambed 1.5-2 particle diameters.*

look like a straight line across the channel (Figures 7 and 8). Undersized culverts are a confined area with limitations (length and width), which lead to having little room for structures designed for a natural stream channel. The replacement of the cross vane with a coarse band(s) reduces the amount of material needed and time of construction. Placing the coarse band(s) in a straight line across the channel has multiple benefits; they may be constructed after the channel is built, which facilitates mimicking the channel shape and no limit to the number of coarse band(s) being applied to the culvert. Both designs provide a similar function to channel hydraulics, but the coarse band(s) are more cost effective compared to u-shape cross vanes. The plan view of a cross vane vs. coarse band(s) shows more material is needed for construction of a cross vane.

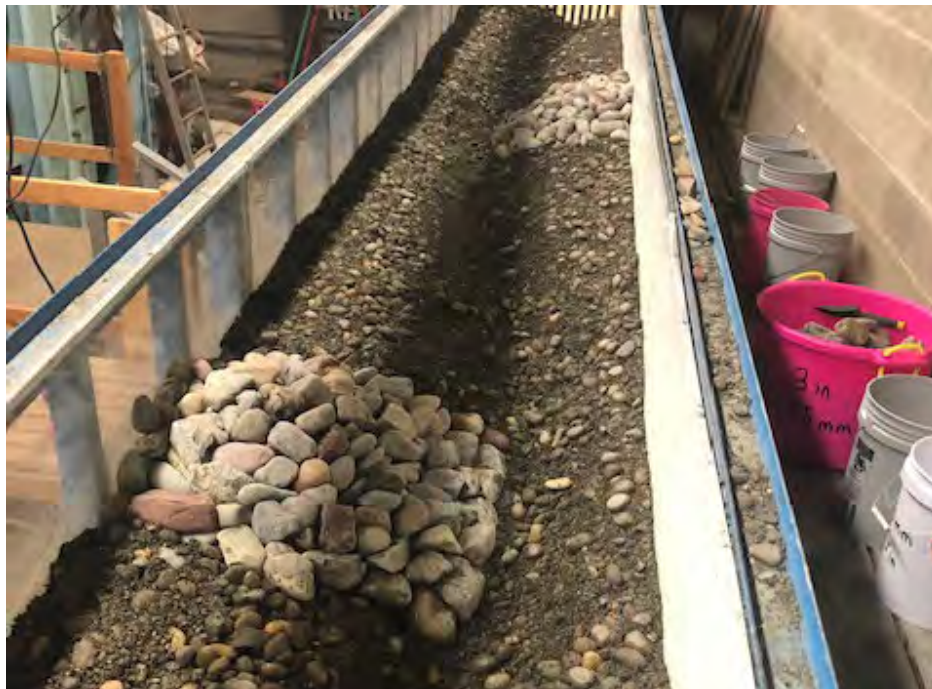
Figure 13 Construction of boulder bars spaced three channel widths apart.

meanders given the limited cross-sectional width of the flume. The meandering channels have a tendency of becoming flat. With a flat channel fish are not provided with a significant water depth to move through during a low flow event. The use of coarse band(s) designs from the straight channel section would lead to erosion of streambed material on the downstream side of the point bars. To ensure the point bars would not see a significant amount of erosion boulder bars were used. The boulder bars were made up of D200-300 material and extend slightly past half the channel width and had a length of 2/3 of a channel width along the flume wall. The height of the boulder bars at the flume wall were four particle diameters. Figure 13 shows the construction of a boulder bar. The boulder bar's purpose is to keep a meandering channel throughout the culvert. The sinuosity of the channel changes depending on the layout being looked at. Description of the layouts tested can be found in table 4. For example, the sinuosity of a channel with three boulder bars at one channel width is larger than a channel with two boulder bars at three channel widths. Two channel types were investigated in this research: 1) one channel width spacing between boulder bars, and 2) three channel widths spacing between boulder bars (Figure 14). Two channel widths spacing could not be examined due to time constraints.

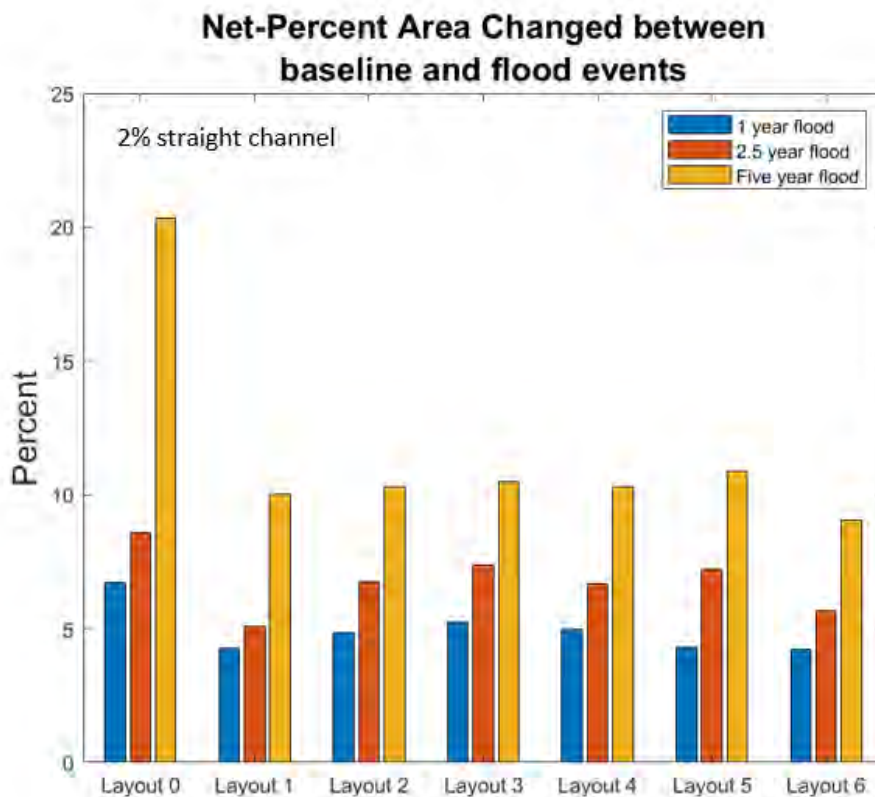
Figure 17. The percent difference of cross-sectional area changes between baseline elevation and each flood event for every layout. Layout 0 shows that a five-year event will significantly change the observed channel. With the addition of coarse bands, the channel will have about half the change of Layout 0. There is difference of about 3 percent between the lowest and highest percent cross-sectional area changed for the coarse band layouts.

had the largest net percent cross-section area change and layout 6 (four coarse bands spaced one channel width apart) had the lowest change (Figure 17). It is clear from Figure 17 that there was only small variability among the different layouts in terms of net mobility, but it should be noted that there were different patterns of change associated for each layout shown in Figure 16.

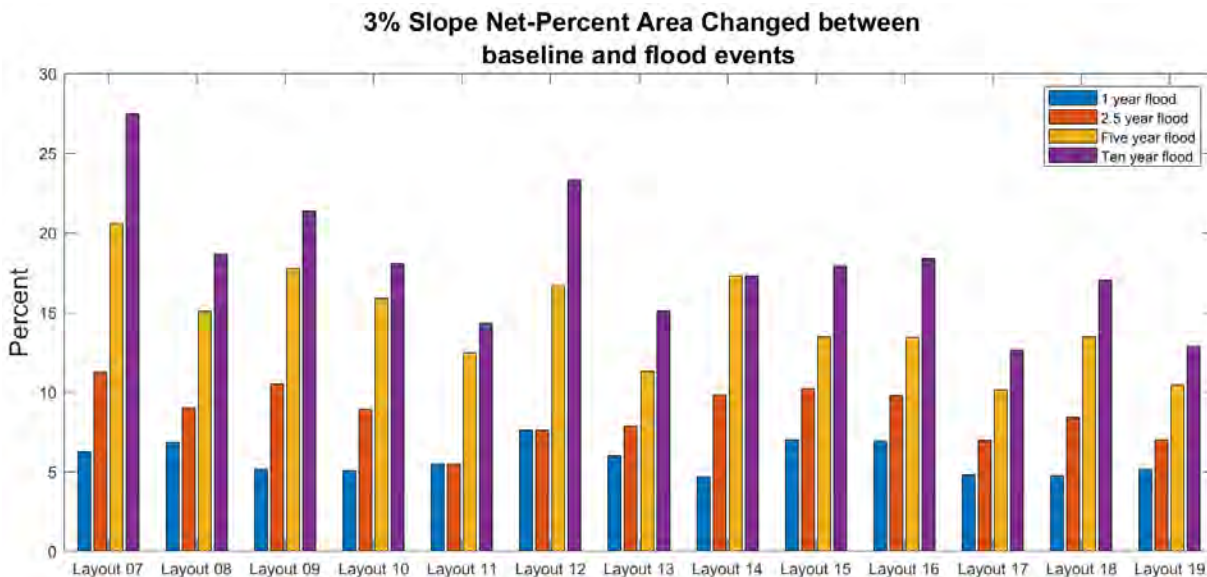
Figure 20 The percent difference of cross-sectional area change between baseline elevation and each flood event for every layout. Layout 7 shows that a ten-year event will significantly change the observed channel. The addition of coarse bands and the bowtie design reduce sediment transport. The lowest net-percent change is Layout 17.

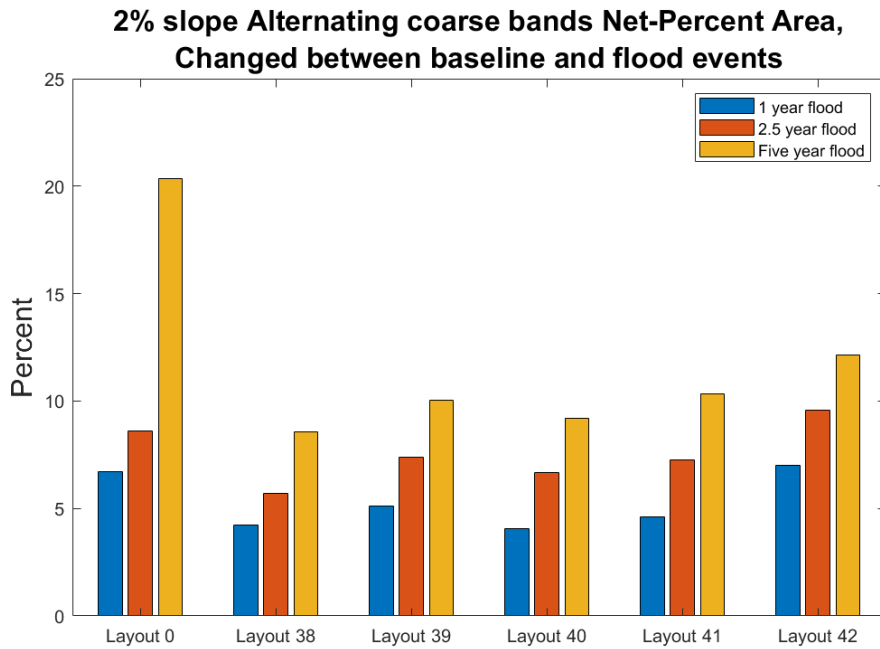
Figure 23 The percent difference of cross-sectional area change between baseline elevation and each flood event for every layout. Layout 0 shows that a ten-year event will significantly change the observed channel. The addition of alternating coarse bands reduced sediment transport.

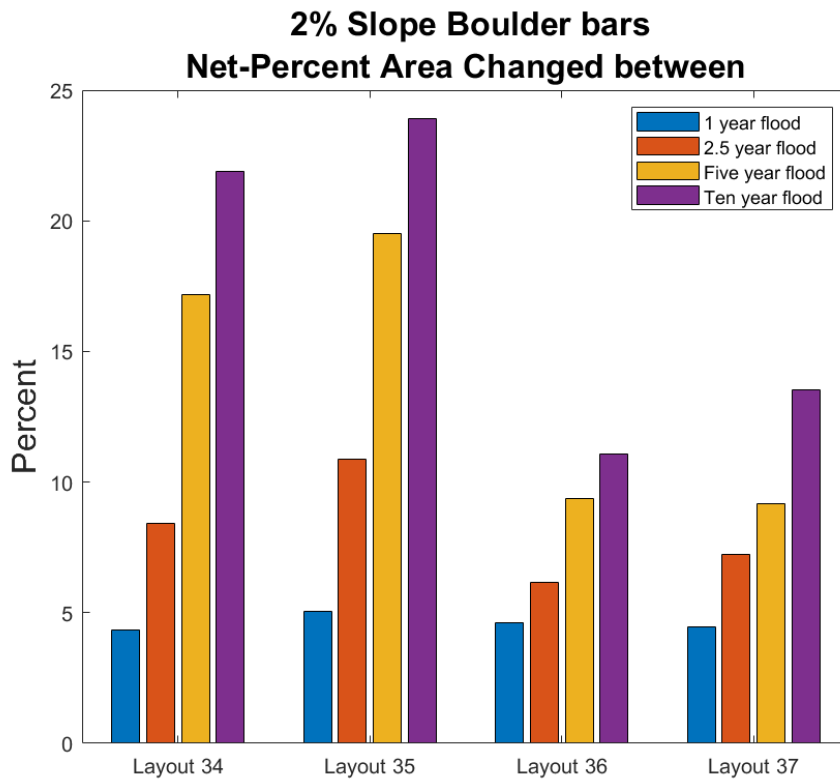
*Figure 26 Layout 34 and 35 shows that a ten-year event will significantly change the observed channel. The addition of boulder bars to both channel types reduce bulk sediment transport. The lowest reduction was Layout 36.*

deep blue color on the colormap Figure 26). The movement of material appeared to be caused by unstable stacking of material on the downstream side.

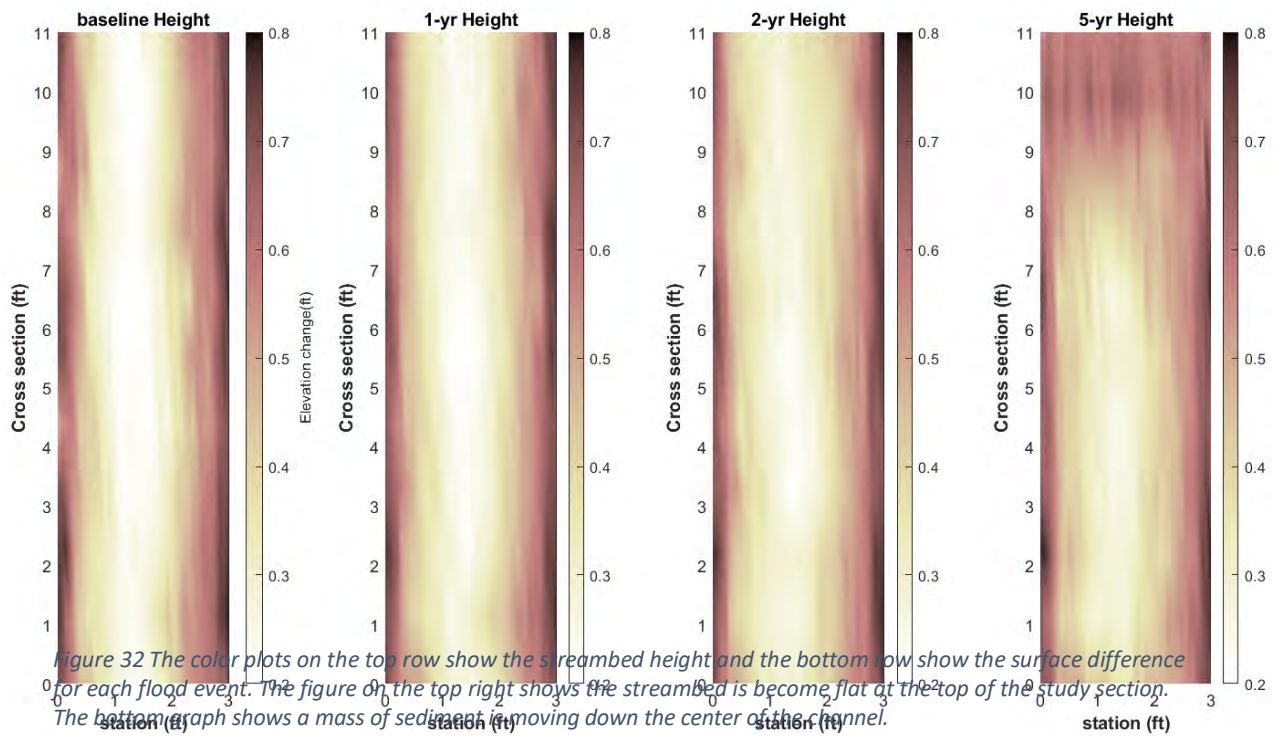
Figure 32 The color plots on the top row show the streambed height and the bottom row show the surface difference for each flood event. The figure on the top right shows the streambed is becoming flat at the top of the study section. The bottom graph shows a mass of sediment is moving down the center of the channel.

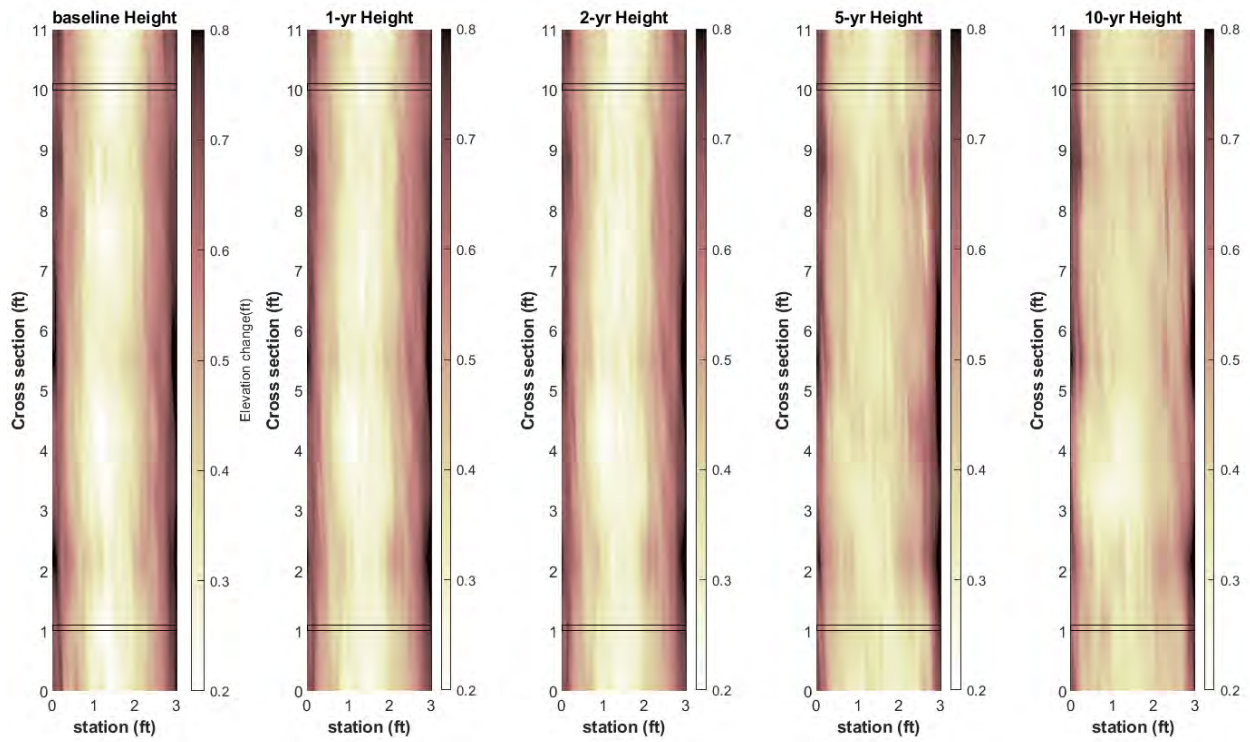
Figure 56 The channel height was stable until the five-year flood event. An increase in streambed height occurred at the five-year flood event. The increase in streambed height continued for the ten-year flood event but erosion around cross-section 3 & 4 also occurred.
