Kincaid Ravine Restoration Project: A Two Year Progress Report with a Focus on Hydrology Improvements and Place Making

July 2016

In partial fulfillment of a Master's of Environmental Horticulture degree University of Washington, School of Environmental and Forest Sciences

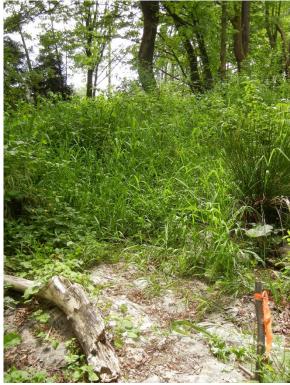
Figure 3-J. Treatment 1 in April 2016

After an initial mowing of all RCG during Phase I restoration in February of 2014, RCG cover was measured at roughly 90% across all three treatment plots when they were established in April of 2015. However, due to poor demarcation and incomplete grubbing and removal during the previous year, Treatment 3 was removed from consideration during the follow up data collection on April 28, 2016. As seen in Figure 3-J, mowing and covering of RCG with 3 layers of

burlap sacks overlapping at the margins was fairly successful at hindering RCG growth in year 2 of the experiment. Percent cover was reduced to 30%, although this likely would not hold true long term.

While this experiment is very anecdotal and short term, it does give some evidence for the usefulness in using burlap sacks to suppress RCG during the phase of restoration when you are trying to get native plants established. It is very likely that between the seed bank present on site and the ability of RCG to sprout from rhizomes that it will re-establish as the burlap sacks continue to biodegrade. However, RCG was mowed again in the locations of both Treatments 1 and 2 and two layers of burlap sacks were re-applied in the area of Treatment 1 during April of 2016. Follow up data and observations should be collected in spring of 2017 to see if burlap

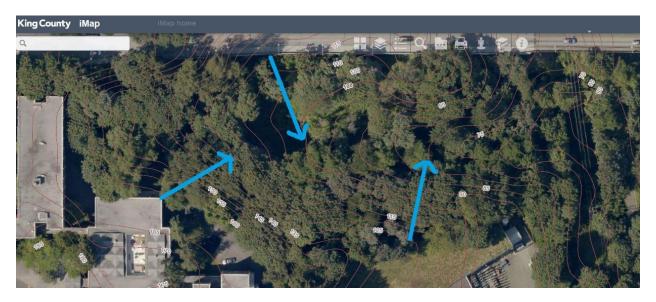
The existing topography and hydrology of Kincaid Ravine includes two delineated wetlands and a small stream that are fed by 3 small groundwater seeps (seeps mapped in Figure 4-A). Two of these seeps flow out of the south slope of KR, one occurring roughly at the northeast corner of McCarty Hall (Figure 4-A), and the other sits about midway through the ravine, near the northeast corner of the North Physics Laboratory (Figure 4-A) building. The last and the biggest of the three seeps is located on the north side of KR, under the 45th Street Viaduct, roughly across the viaduct from the building located at 2221 NE 46th Street (Figure 4-A).

Figure 4-A. Locations of Groundwater Seeps feeding central Wetland and Stream. Map Credit: King County Imap 2013.

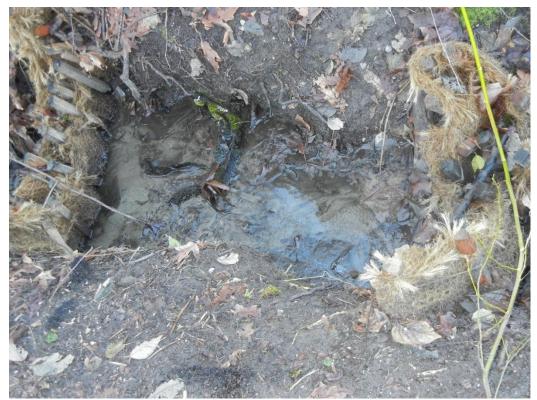
The actual construction of the Picket Fence check dams required pounding 3 foot long oak stakes approximately 2.5 feet into the stream banks and bed. Stakes installed into the stream bank were hammered perpendicular to the angle of the stream bank and stakes hammered into the stream bed were angled approximately 15-20 degrees upstream. At each Picket Fence stakes were installed at a rate of 4 stakes per foot of channel width and stakes were staggered

from one to another with a 4" offset. This offset allowed for coir fabric to be weaved in between the oak stakes and then fastened to the top of the stakes with twine. Sketches and instructions for Picket Fence construction were provided by Natural Systems Design and can be found in Appendix G.

Figure 4-D. Picket Fences 2 months after installation shown increasing sediment deposition

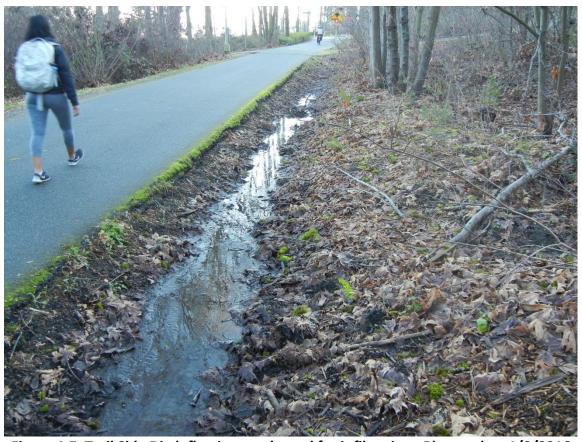
The use of these parallel trailside ditches to improve infiltration on site and limit flooding of the BG Trail was the first consideration of the hydrology assessment since it would be a relatively low tech, easy solution that would not require excavation or fill in wetlands. However, after consulting with project stakeholder and UW Landscape Architect Kristine Kenney, it was determined that long term she would prefer the ditches be filled in to improve safety along the BG-Trail and better access to the "Educational Nook" sign and bench area in KR. Kenney supported the use of ditches in the short term to alleviate flooding of the BG Trail and so in November of 2015, very minor excavation using shovels was conducted to remove some fine sediments that had accrued and to promote flow of water into the trailside ditch flowing south towards Pend Oreille Road.

Figure 4-E. Trail Side Ditch flowing south used for infiltration. Photo taken 1/8/2016

While some storm water still flowed north into the Wetland 1 trailside ditch, the majority of water after mid-November of 2015 was flowing and infiltrating into the south ditches. This reconfiguration of flows at KR had immediate short term success in terms of limiting flooding on the BG Trail. Student PM Dan Hintz checked the site every Friday from November through February and Stewardship Partners consultant Aaron Clark monitored the ditches almost every weekday during that same span as a commuter on the BG Trail. During the winter of 2015/2016, the BG Trail was never observed to have flooded due to flows from KR. The closest the ditches came to breaching the trail occurred on January 22, 2016 after 1.15 inches of precipitation was recorded in the previous 24 hours at SeaTac and 1.91 inches in the previous 72 hours (National Weather Service Daily Climate Data). This heavy amount of rain in a 3 day period caused the ditches to fill within 2 inches of the trail grade.

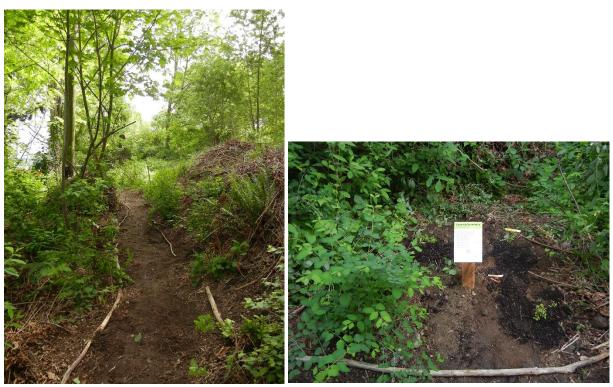
In April of 2016 an approximately 120 foot trail was constructed to connect the "Educational Nook" area along the BG Trail to the path leading up to the parking lot at the North Physics laboratory. This "cut through" trail site was selected since it would further develop the Educational Nook area and since it was regularly observed that walkers on the BG Trail would use the path to the N. Physics Building parking lot as a shortcut to campus. This way people on the BG Trail can now cut that corner while walking through an area of KR with interpretive signs on pollinator habitat, climate change and native species identification and descriptions. Access from the BG Trail across the infiltration ditch to the Educational Nook area and interpretive trail has also been improved from a single wooden plank to a 4-foot wide crossing structure with concrete footings that was built in the Gould Hall Woodshop by student PM Dan Hintz and Jeni Chan.

Figure 5-A. Interpretive Trail (left) and one of 6, mini native species ID signs installed along the trail (right).

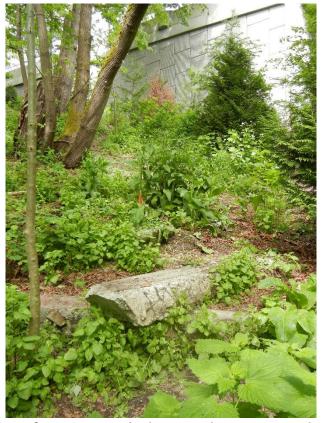
Figure 5-B. Proposed site for seating and educational signage on value of wetland habitats

Plans to develop a similar, small seating area along the path to the 45th street Viaduct (north of the entrance to the Educational Nook) are also in the works with MLA intern Jeni Chan. This area (pictured in Figure 5-B) would use existing remnant concrete slabs for terraced seating and would be right above the area proposed for infiltration (Chapter IV). With remaining funds in the CSF "Signs and Benches" budget an interpretive sign on the benefits of wetland habitat could also be installed in this area.
