Monitoring Plant Performance at Two Restored Beaches:  
Bowman and Cornet Bay  
Deception Pass State Park, WA

A thesis

submitted in partial fulfillment  
of the requirements for the degree of  
Master of Environmental Horticulture

University of Washington 2018

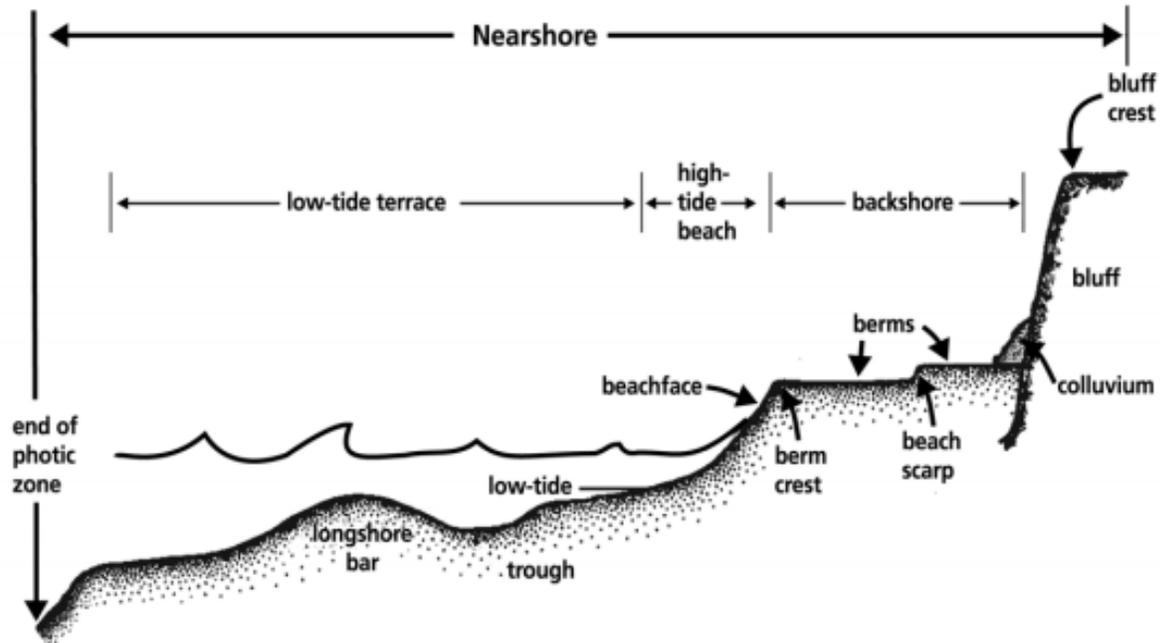
Figure 2: Diagram of the nearshore

vegetation whose role provides valued ecosystems services and ecological functions (Figure 2). Despite the complex role backshore plant community's play in nearshore ecosystem processes, the role of marine riparian vegetation has received scant research attention (Brennon & Culverwell 2004). Much information on the subject comes from studies of outer-coastal and dune environments, which are generally different systems than the more protected Puget Sound backshore. If marine riparian plant communities are discussed, it is usually as an aside to more central research questions, such as geomorphology or effects on fish habitat. Until recently, the definition of a riparian area did not include marine waters. Due to the lack of a consistent definition, which was identified as a major problem of federal and state programs that might manage and protect these areas, the National Resource Committee (NRC 2002) developed the following definition:

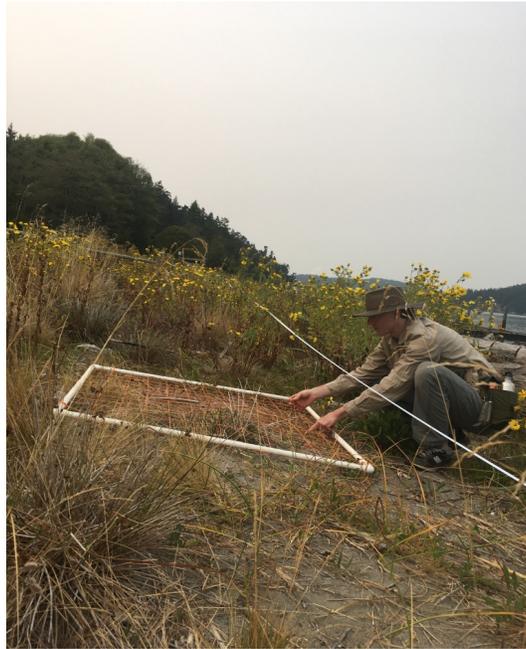
**Figure 5: Example of 4 ft. spacing of transects**

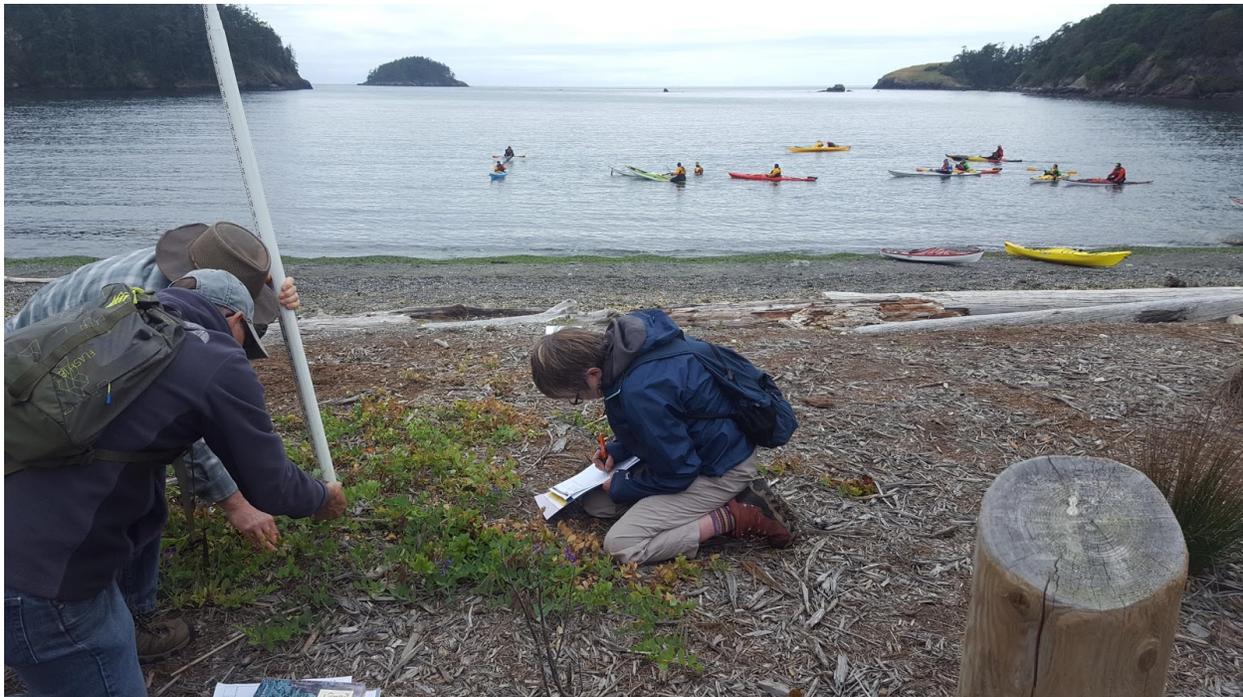
**Figure 7: Volunteer's assessing height and Survivorship of *Lathyrus japonicus* at Bowman Bay**

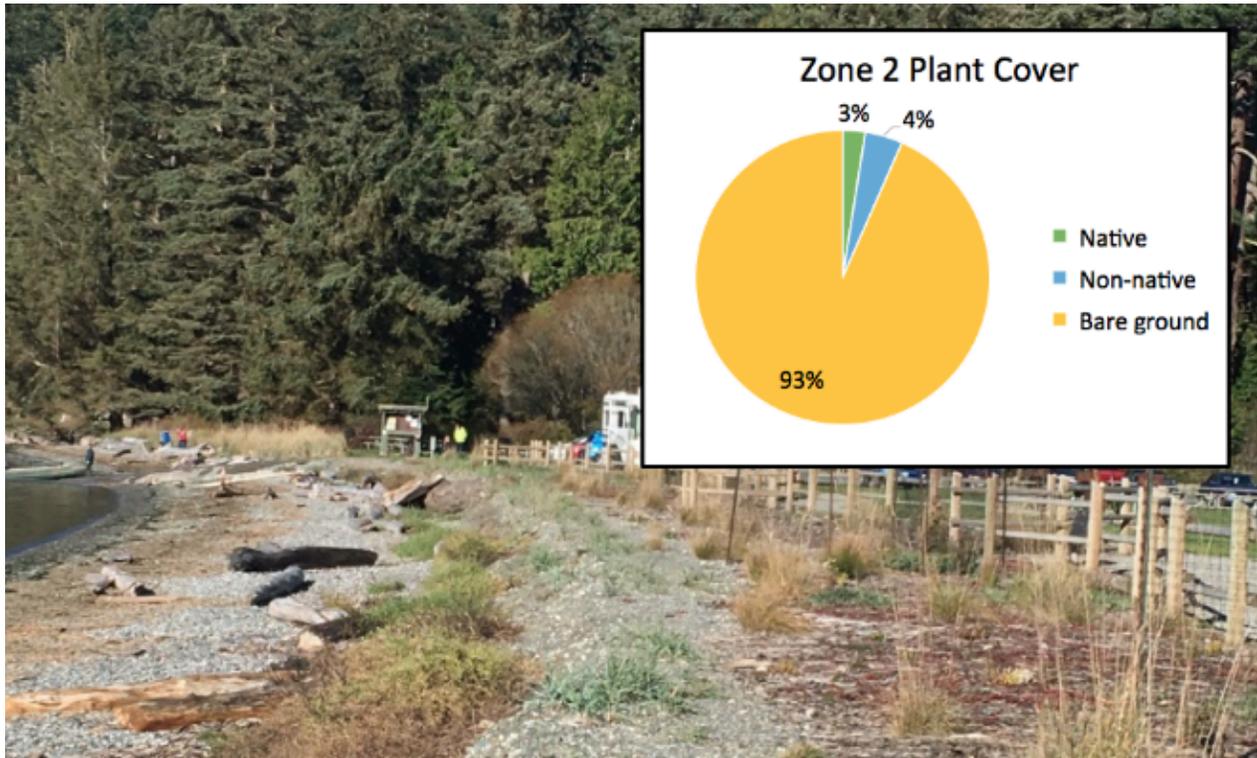
Figure 9: Photo illustration and Plant Cover in Zone 2 at Bowman Bay

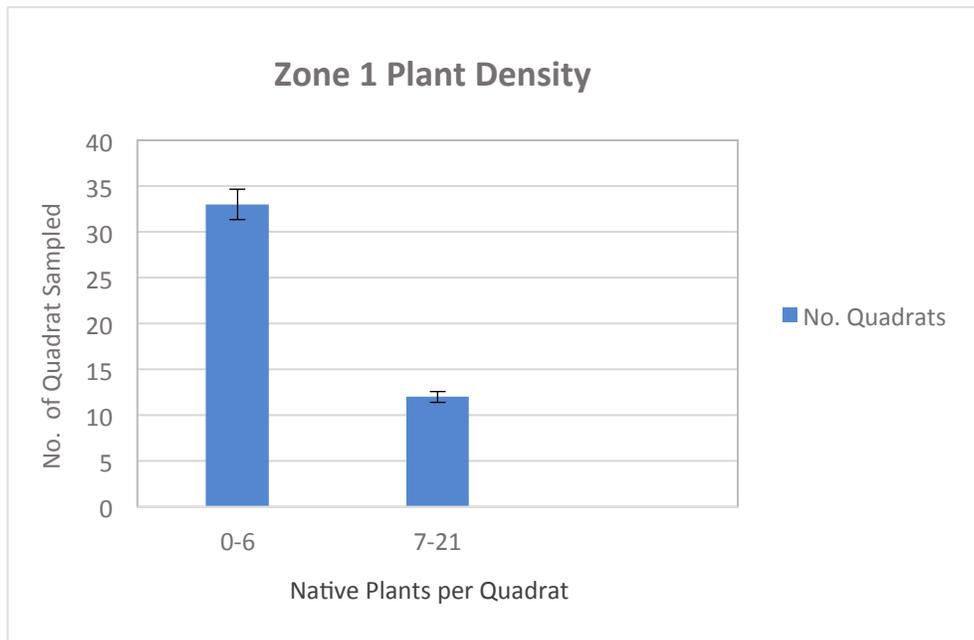
Figure 10: Zone 1 Stocking at Bowman Bay

Plant density (Figure 10 and 12) in the beach grass community is low signifying that plants are still struggling to become established. This is the first full year since plant installation and due to the harsh conditions found on-site; plant mortality in this area is palpable. Yet as compared to last year, *Leymus mollis* and *Argentina egedii* individuals in Zone 1 (Figure 8) are increasing, from 138 total live plants in Zone 1 the previous year to 162 plants in 2017. This is considered to be an upward trend, partly due to exclusionary fencing installed on an ephemeral trail, which is most likely discouraging park visitors from trampling vegetation.

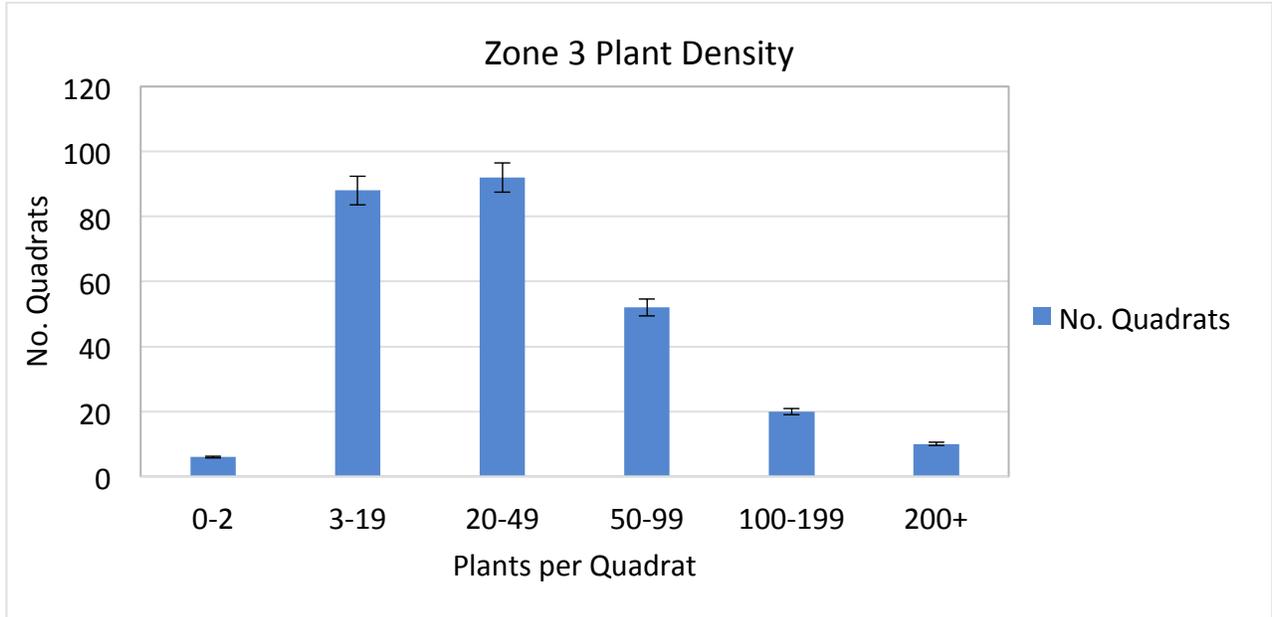
Stocking was moderate in Zones 2 and 3. Of 75 total quadrats sampled, 12 quadrats were under-stocked with 6 or fewer native plants per quadrat. 47 quadrats had 7-21 native plants per quadrat and 16 had 22-130 native plants per quadrat (Figure 12). Therefore, the predominate cover class in Zone 2 and 3 is bare ground (Figure 13). Note that non-native plant cover was measured at 0%.

Figure 12: Plant density in Zone 2 and 3 at Bowman Bay

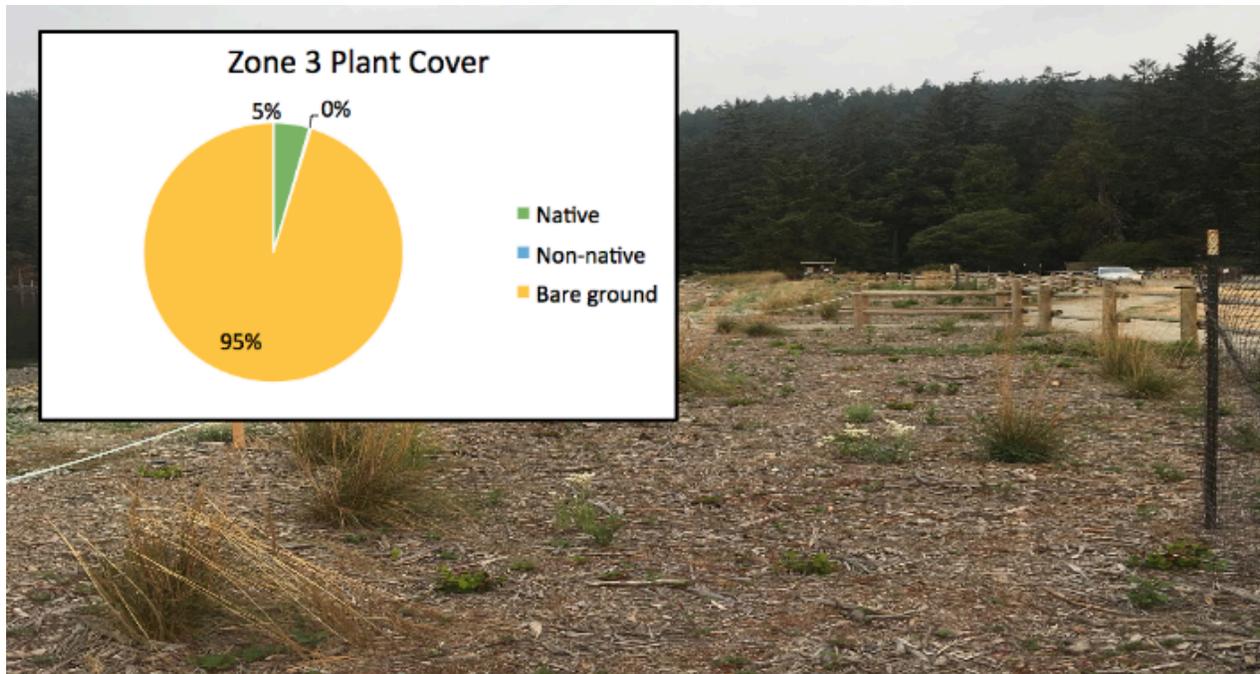
Figure 13: Plant cover in Zone 3 at Bowman Bay

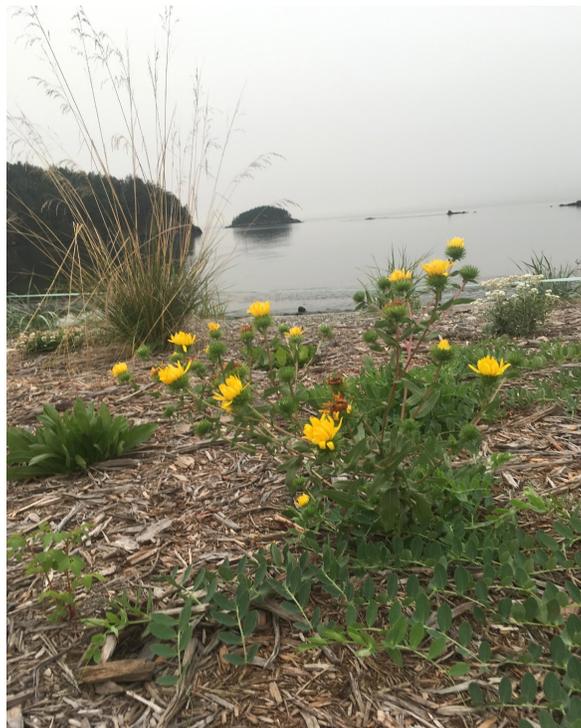
A total of 81 plants were measured as naturally recruited in Zone 2 (Figure 14). This included many conifer and *Alnus rubra* seedlings in addition to *Grindelia integrifolia* (Figure 15).

**Figure 15: Recruited *Grindelia integrifolia***

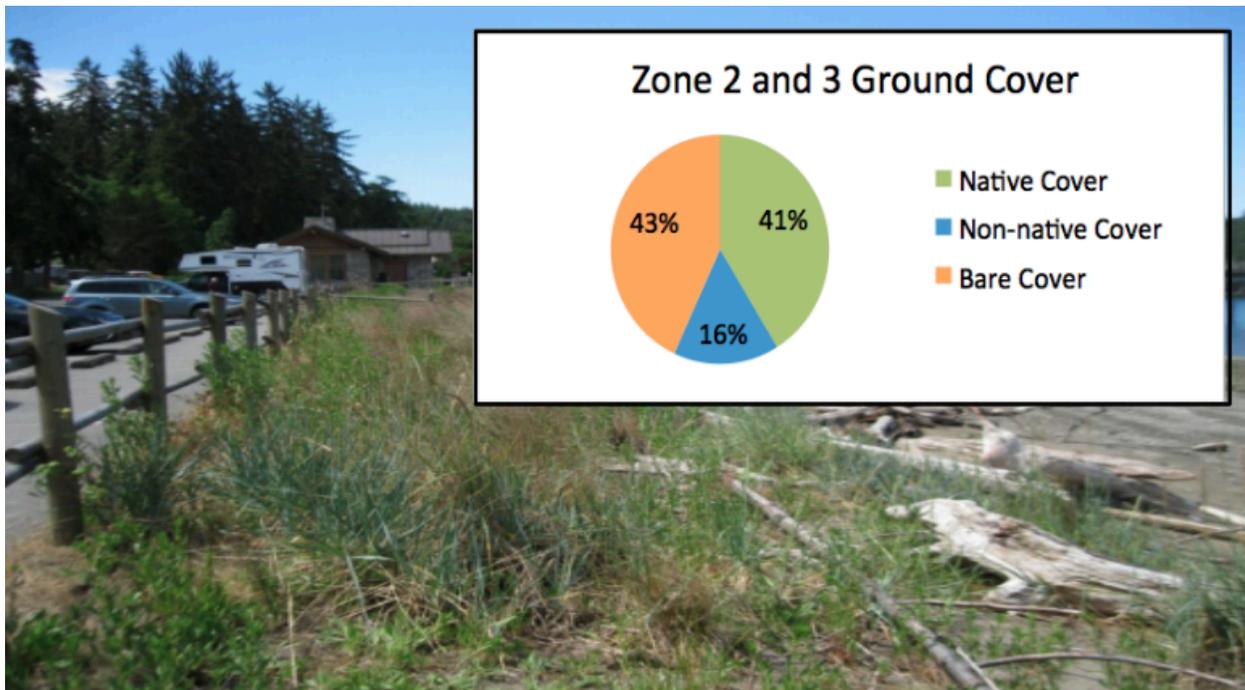
268 quadrats were sampled for coverage and stocking in Zones 2 and 3 of Phase 1. A total of 4,850 plants were originally installed in the 0.63 acre area, at a spacing of approximately 2 foot centers. There is still a significant percentage of bare ground cover at 43% (Figure 16). Native vegetation covers 41% of the area and non-native ground cover is at 16%. Native cover slightly decreased from the previous year (from 51% to 41%).

**Figure 16: Plant cover in Zones 2 and 3 at Cornet Bay Phase 1**

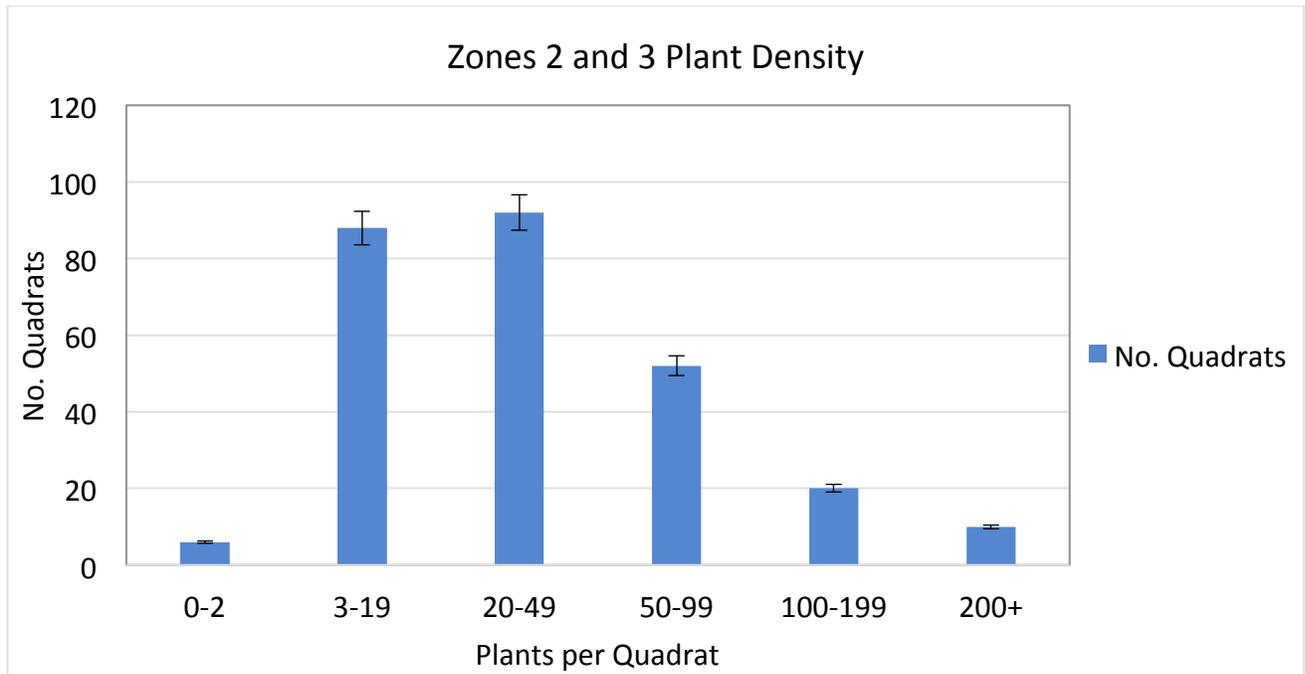
Zones 2 and 3 are well stocked. 98% of quadrats sampled had 3 or more native plants per quadrat. 6 quadrats were poorly stocked with 0-2 native plants per quadrat however; the majority of sampled quadrats had 20-49 native plants or more per quadrat (Figure 18).

**Figure 18: Native Plant Density in Zones 2 and 3 of Phase 1 at Cornet Bay**

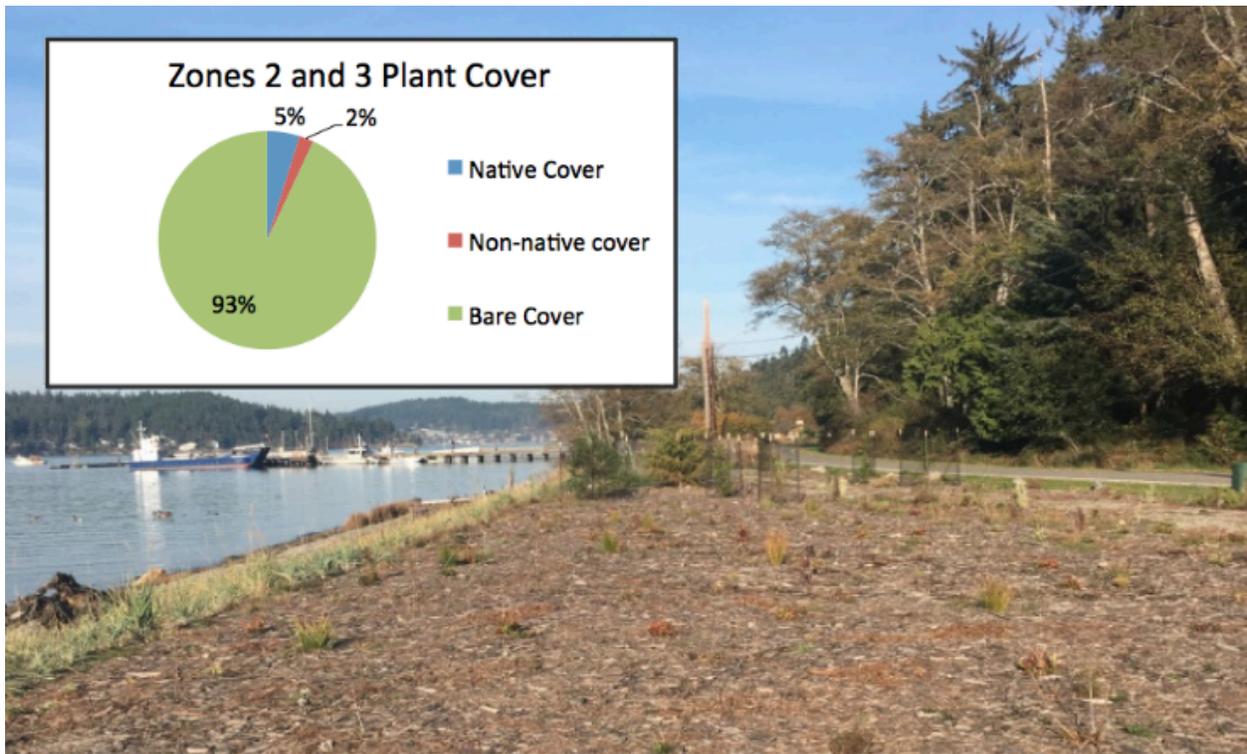
**Figure 21: Plant Cover in Zone 2 and 3 at Cornet Bay Phase 2**

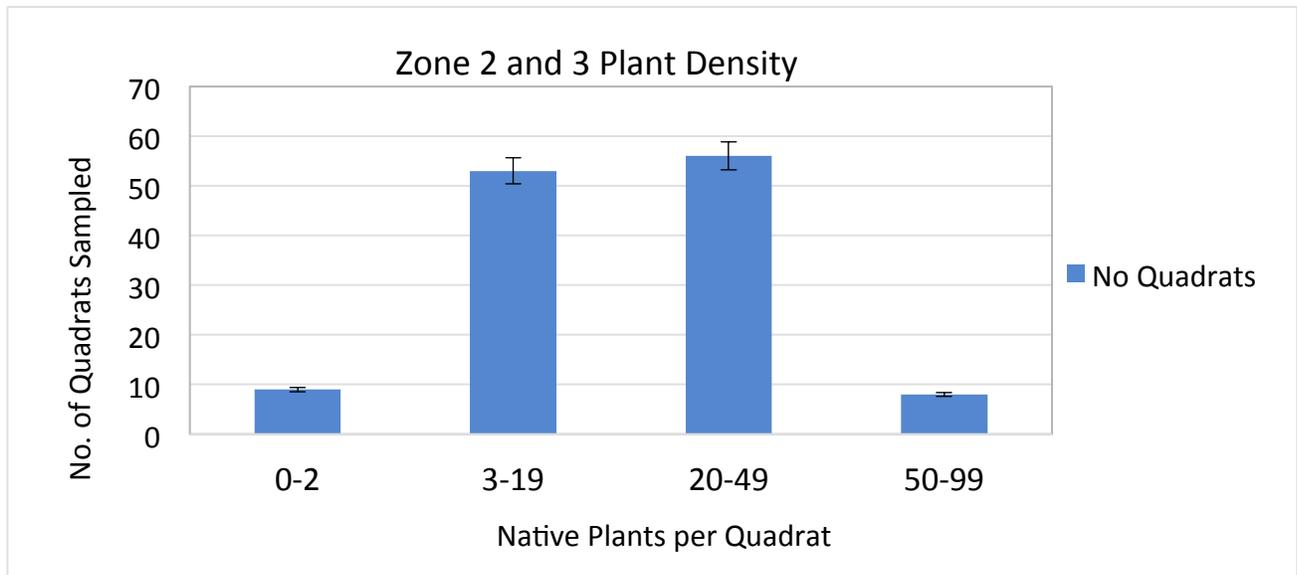
Plant density at the time of plant installation was estimated to be 3 native plants per quadrat by SFEG. Therefore, quadrat samples with 3 or more plants were considered well stocked at an 80% survival rate. Zones 2 and 3 of Phase 2 are faring well, with only 3 of 23 quadrats under- stocked (i.e. 0-2 plants per quadrat) (Figure 23). 14 quadrats are well-stocked with 3-19 plants per quadrat and 5 have more than 20 plants per quadrat. 93% of all sampled quadrats were above the 80% threshold for plant density.

**Figure 23: Plant density in Zones 2 and 3 at Cornet Bay Phase 2**

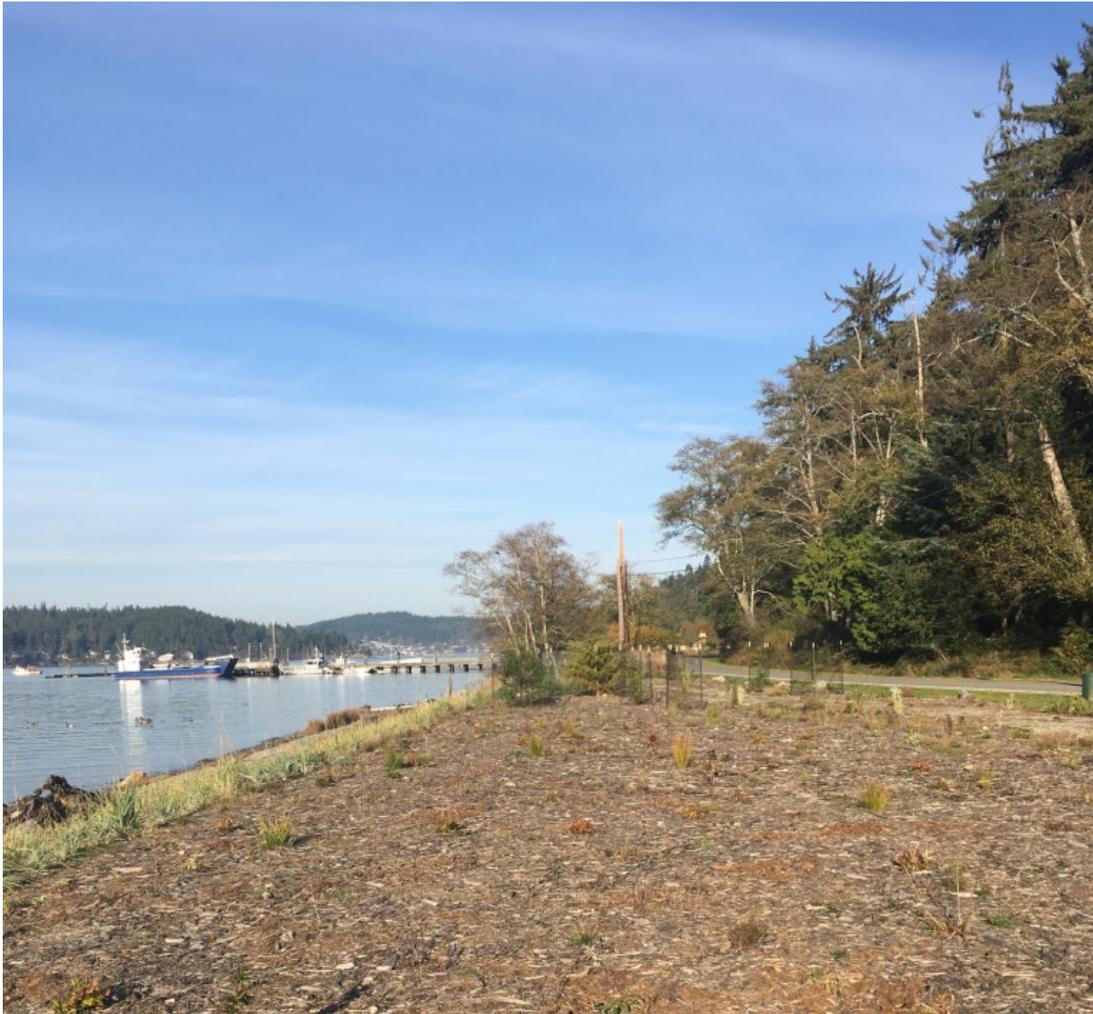
Plant survival in Zone 4 of Phase 2 was over 100% (Figure 24 and 25). This is an increase from 74% the previous year. However, note that 196 plants were given a mortality rating of 2 (live plant with dead portions and/or signs of stress). This signifies that though overall plant survival is high many plants are struggling. Willow species had the poorest survival rate at 14%, however this is an increase from 0% the previous year. In contrast, *Gaultheria shallon* is the most abundant plant species with a survival rate of over 100%. This signifies this species' ability to actively colonize the site with rhizomes, producing plant recruitments. A total of 35 plants were recorded as naturally recruited (Figure 26) including *Ribes lacustre* and *Rubus ursinus*. Additionally, all *Alnus rubra* plant recruitments were seedlings.

Figure 25: Photo of Zone 2, 3 and 4 Phase 2 at Cornet Bay
