# *CACRC Process Parameters Investigation*

*NIAR – Wichita State University*

JAMS 2018 TECHNICAL REVIEW – MAY 23, 2018

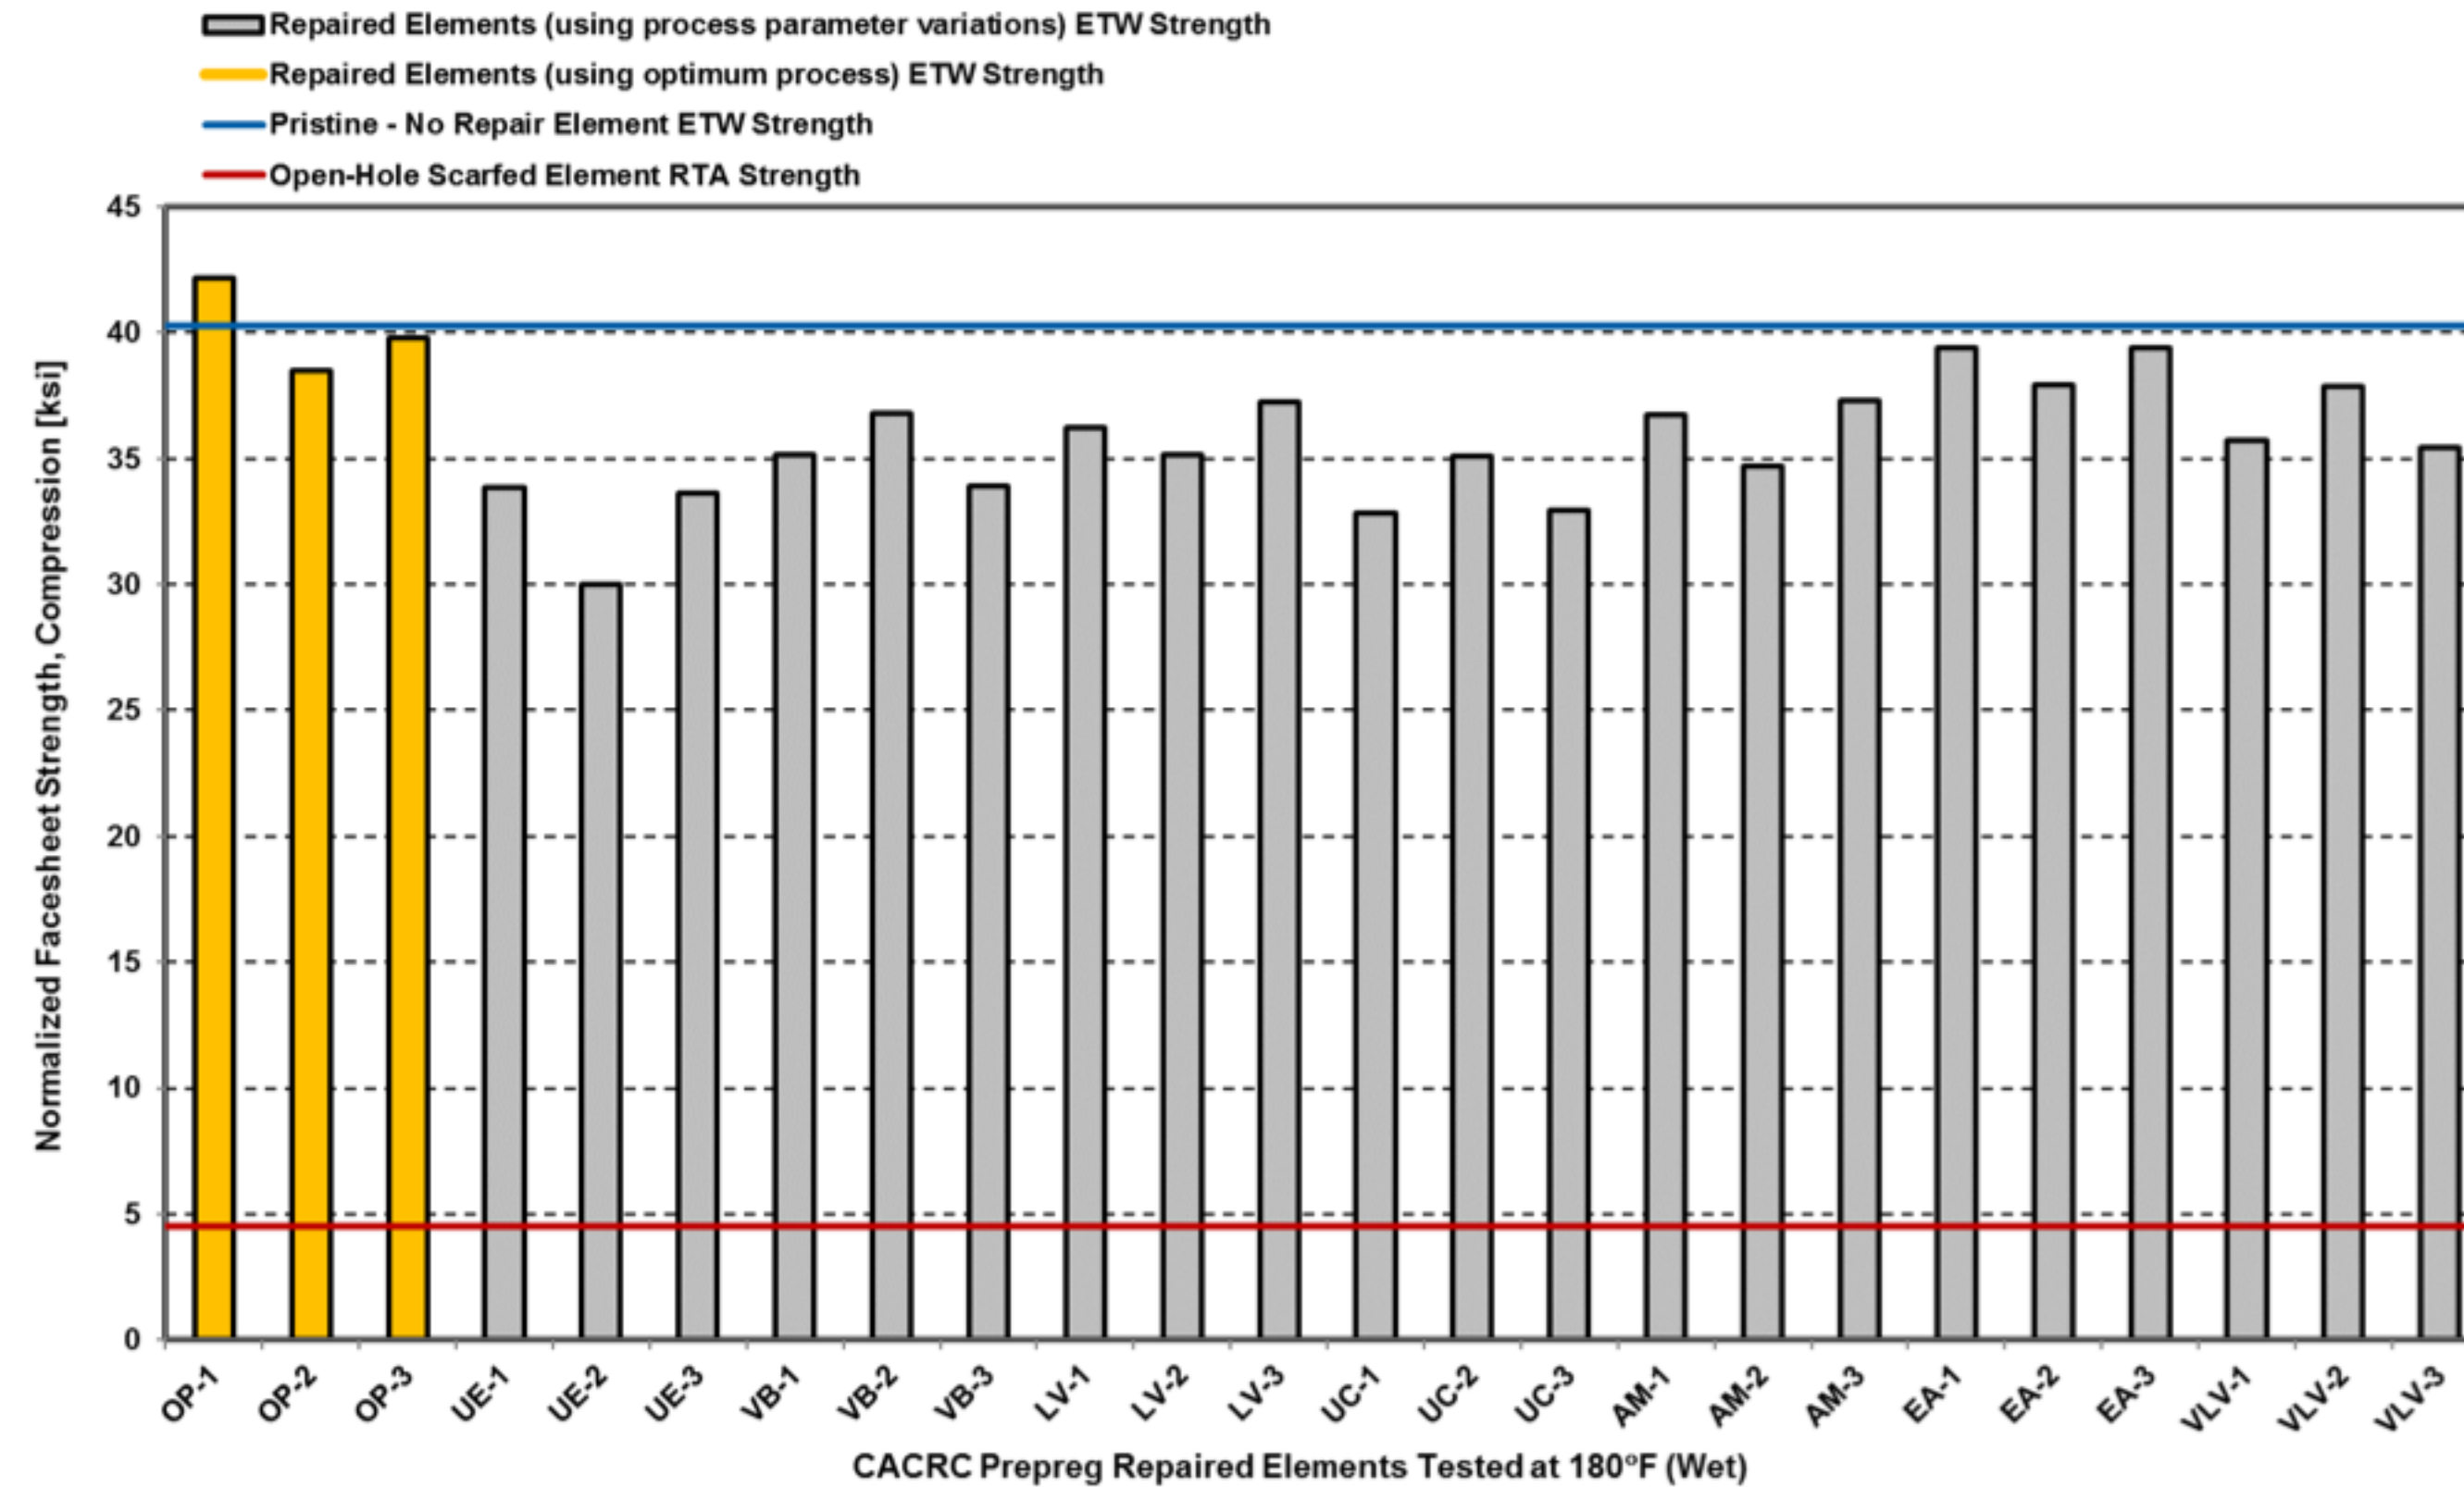
# Results – Prepreg Repair

- 24 data points (instead of 48), ETW Fatigue results not presented
- Optimum repair strength: Avg=40.2 ksi, Min=38.5 ksi, Max=42.2 ksi
- Repair process parameter variations strengths: Avg=35.6 ksi, Min=30.0 ksi, Max=39.4 ksi

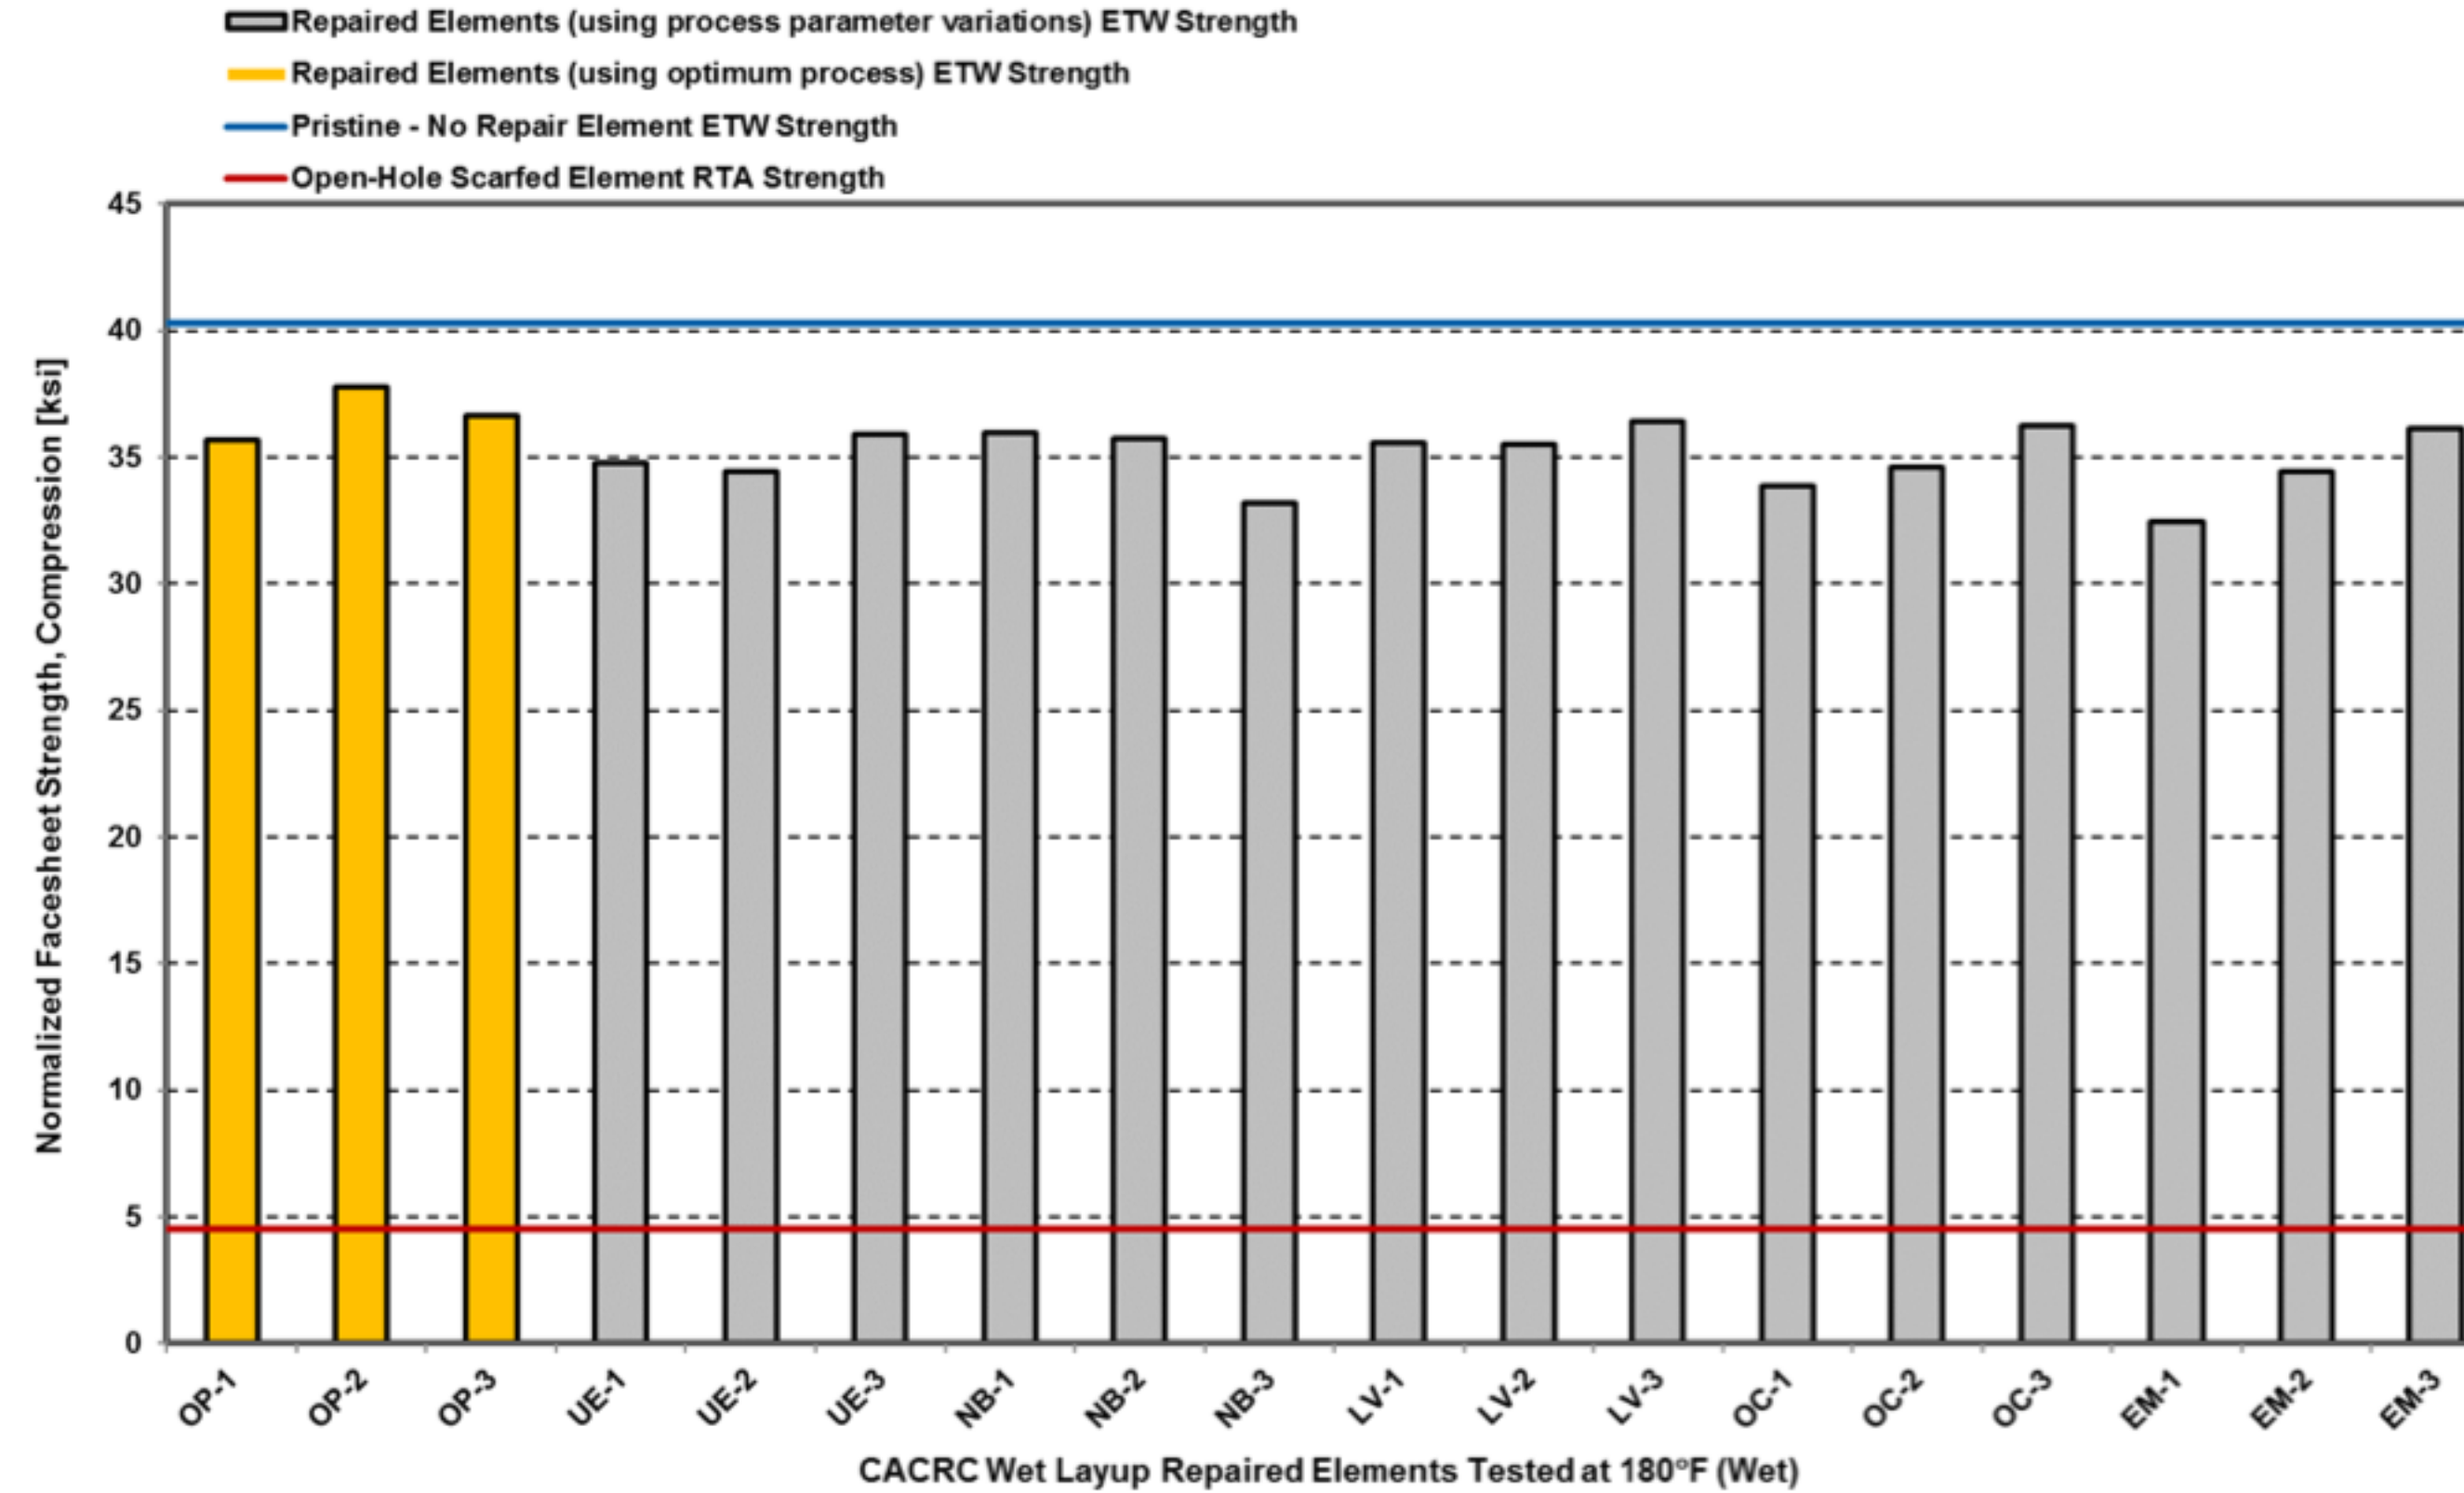
# Results – Wet Layup Repair

- 18 data points (instead of 36), ETW Fatigue results not presented
- Optimum repair strength: Avg=36.7 ksi, Min=35.7 ksi, Max=37.8 ksi
- Repair process parameter variations strengths: Avg=35.0 ksi, Min=32.4 ksi, Max=36.4 ksi
