JOINT ADVANCED MATERIALS & STRUCTURES
CENTER OF EXCELLENCE

Non-Destructive Evaluation Methods for Detecting Major Damage in Internal Composite Structural Components

JAMS 2016 Technical Review
March 22-23, 2016

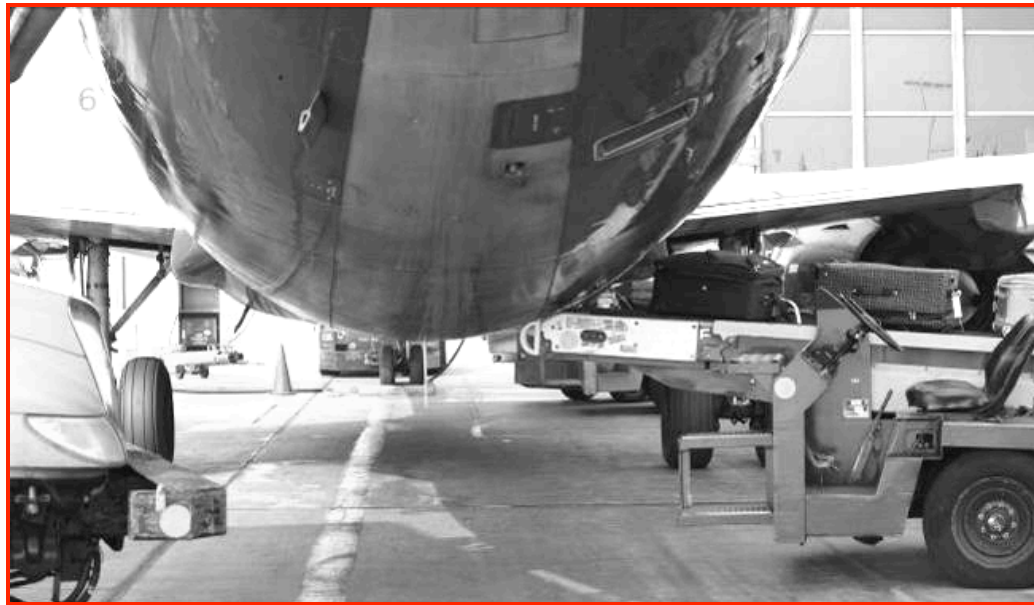
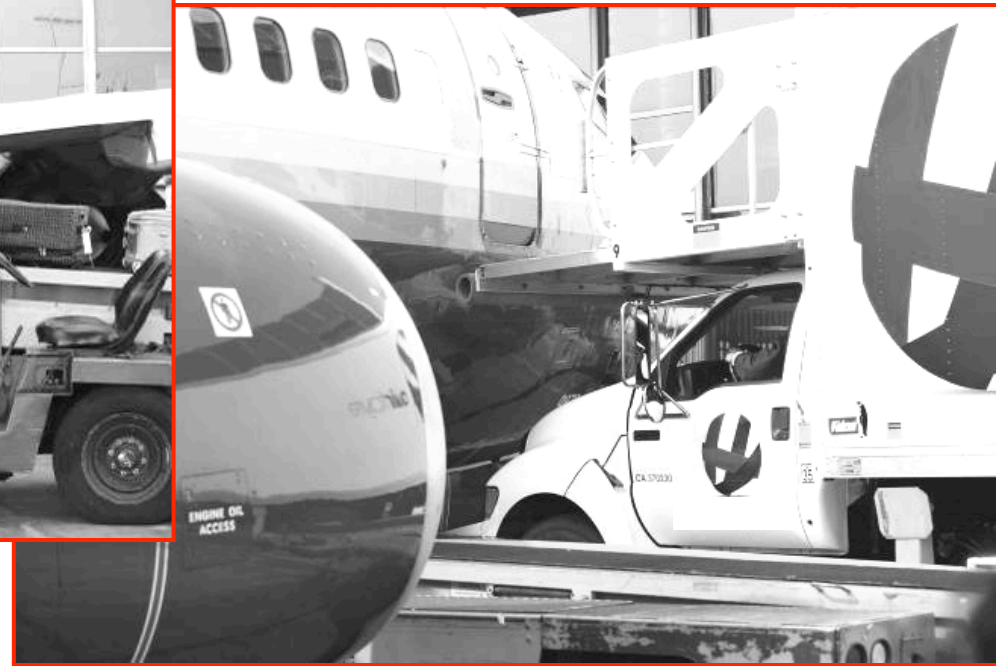
- damage from Ground Service Equipment (GSE) can be difficult to visually detect
 - blunt impact damage problem
- key interest: presence of **major damage to internal structure** (frame, shear tie, stringer)
 - cracks usually not detectable by typical one-sided NDE from external skin
 - need quick NDE tool to decide if further inspection/action needed

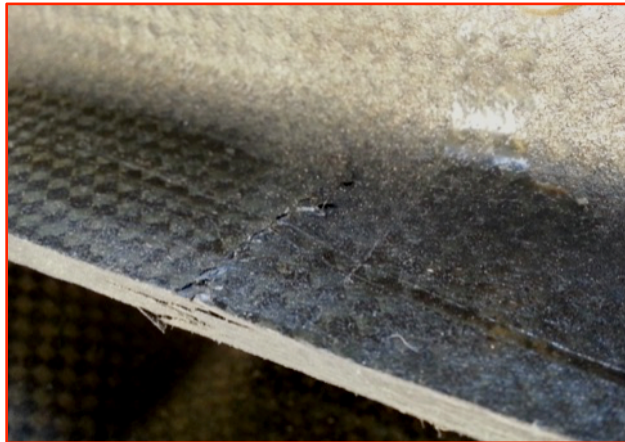
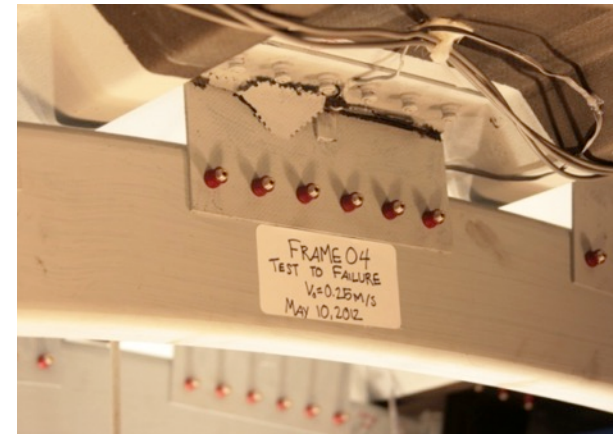
- establish detection method for finding major damage to internal structure
- detection performed only from exterior skin-side
- longer-term: relate NDE measurements with damage location, mode, and severity

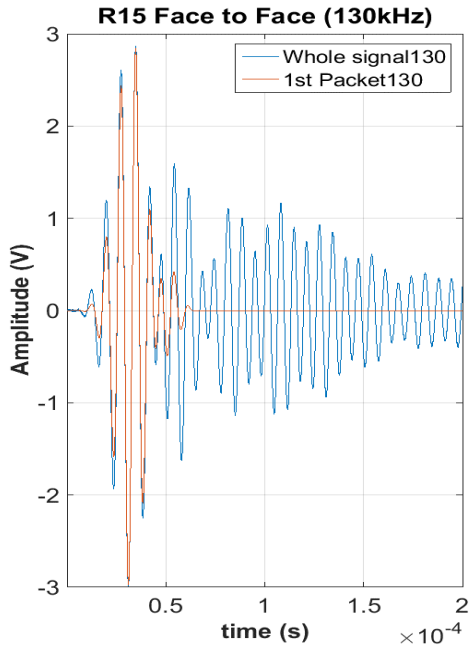
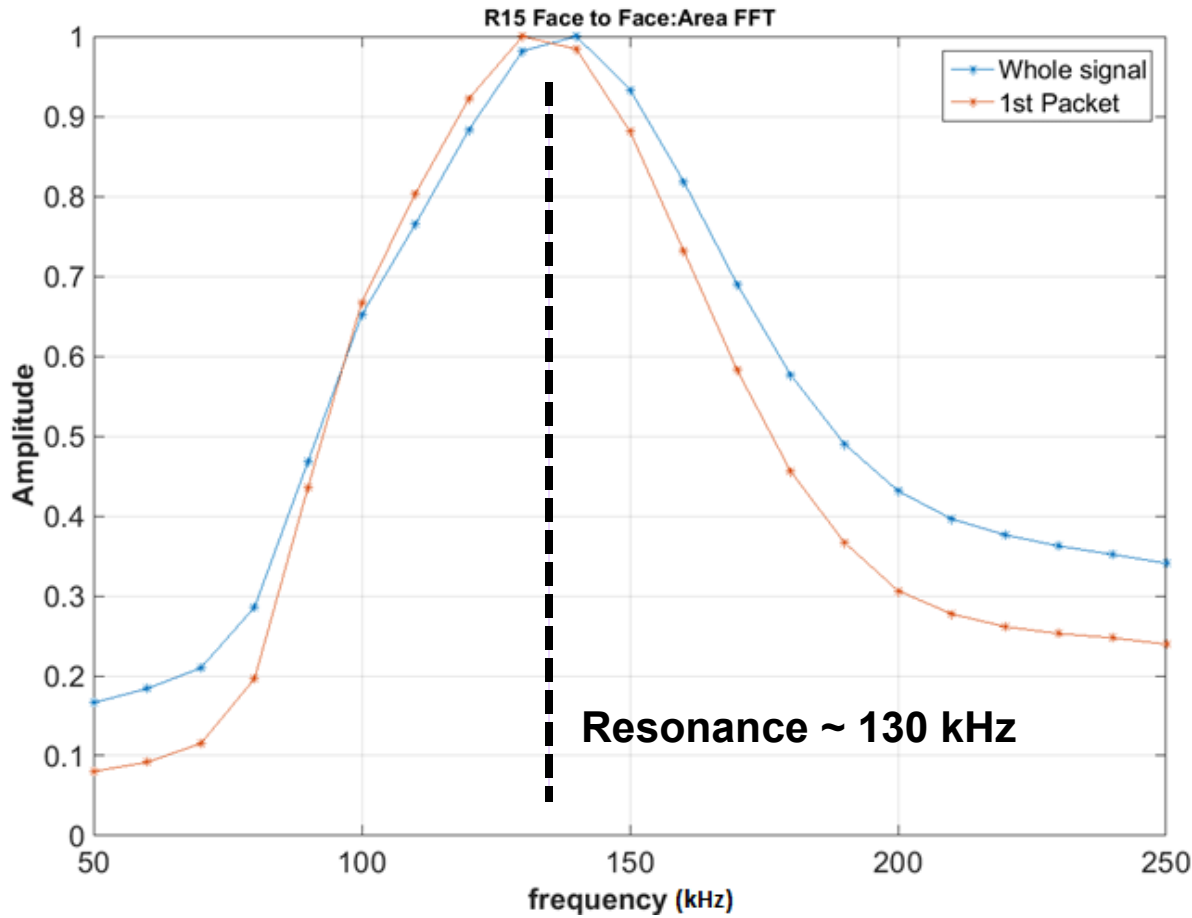
R15 transducers frequency response: face to face

Transducer frequency response = $T(\omega)$

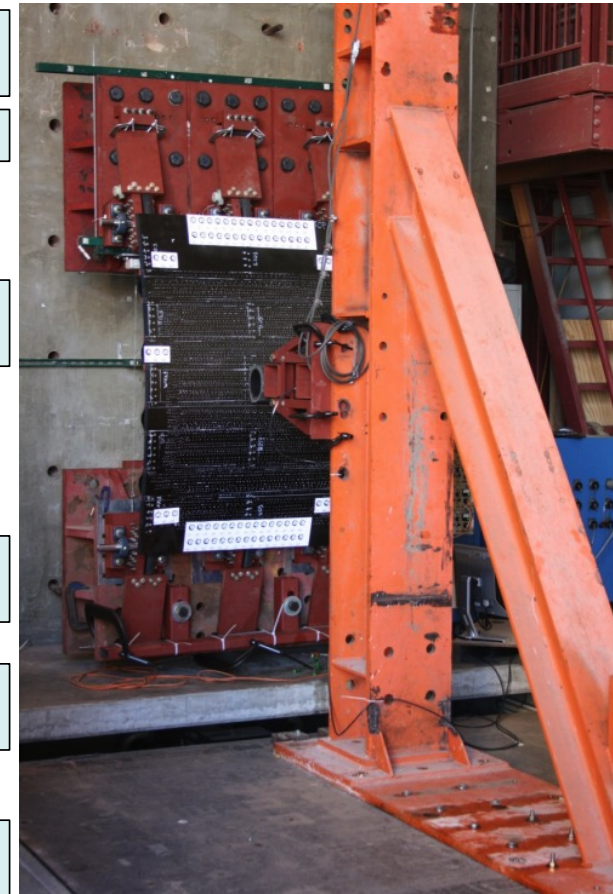
- previously-tested specimens from FAA project “Impact Damage Formation on Composite Aircraft Structures”
- FrameXX panel series

1D Dynamic Shake Table. Impactor head moves into specimen – simulating GSE contact.

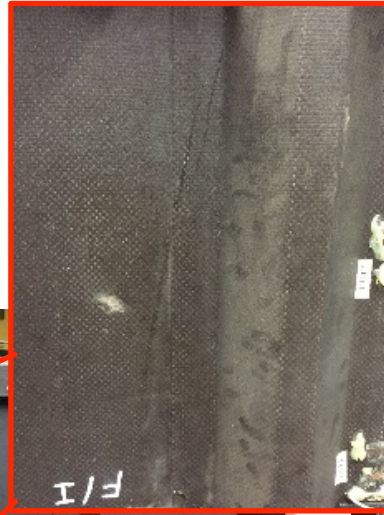
Delaminated stringer

- 3 frames, 4 stringers
- delaminated stringer
- detached stringer
- cracked frames

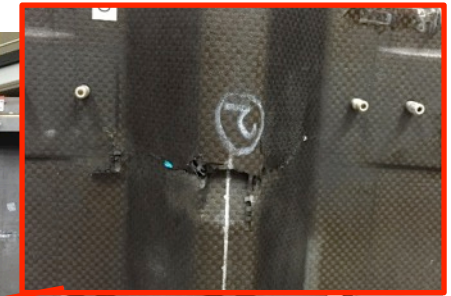
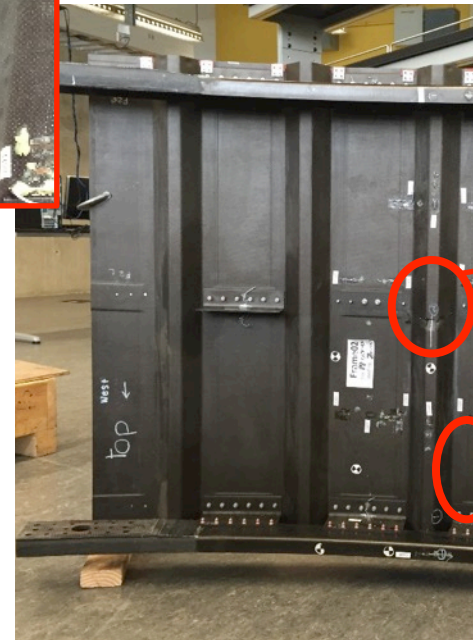
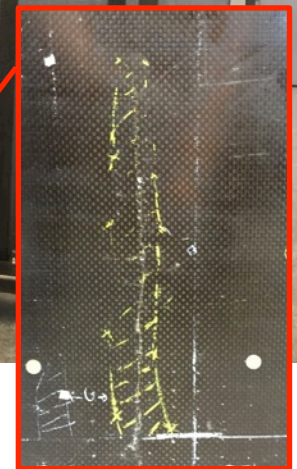
Cracked stringer

- 3 frames, 5 stringers
- cracked stringer
- cracked skin
- cracked frames

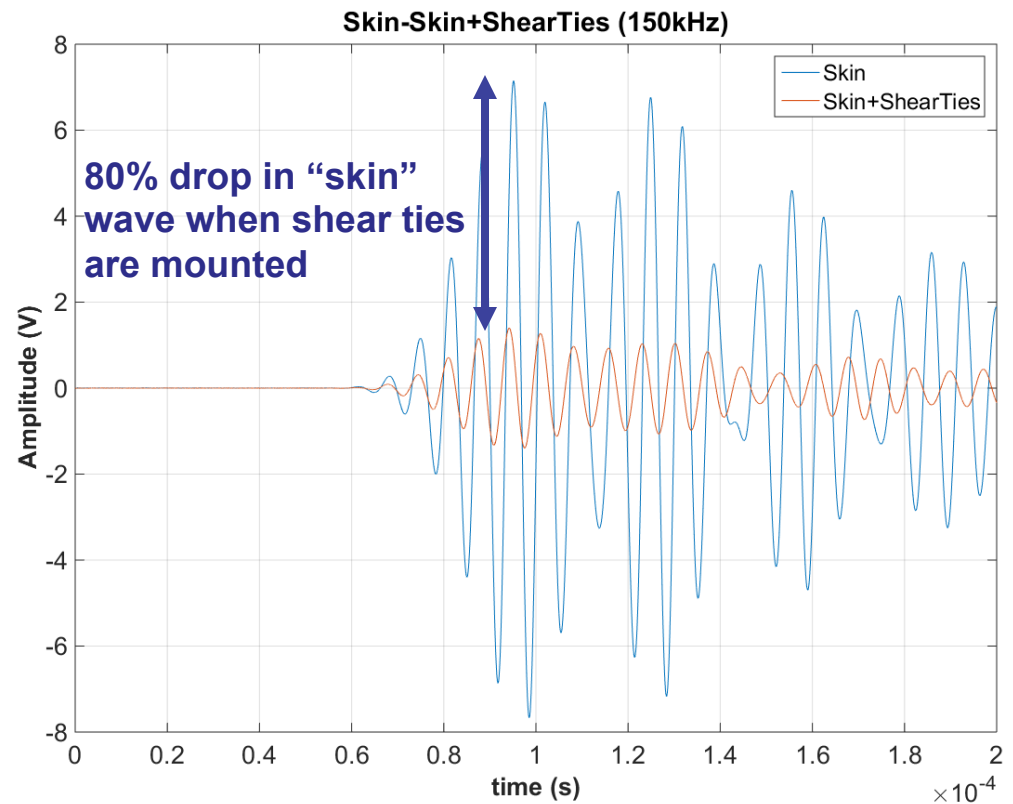
Selected Component Testing: no C-frames

- Frequency sweep range: 130-180 kHz
- Conclusion: shear ties absorb much of the wave energy travelling through the skin (good to detect internal damage from the skin side).

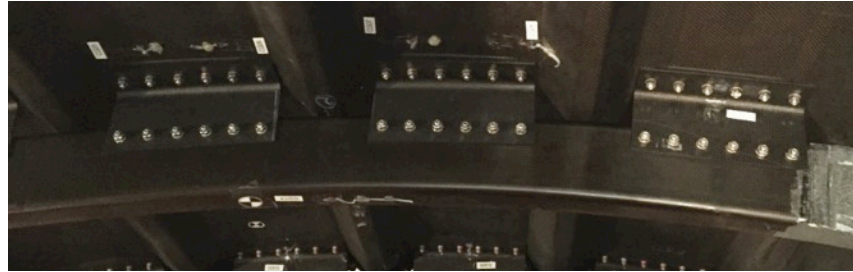
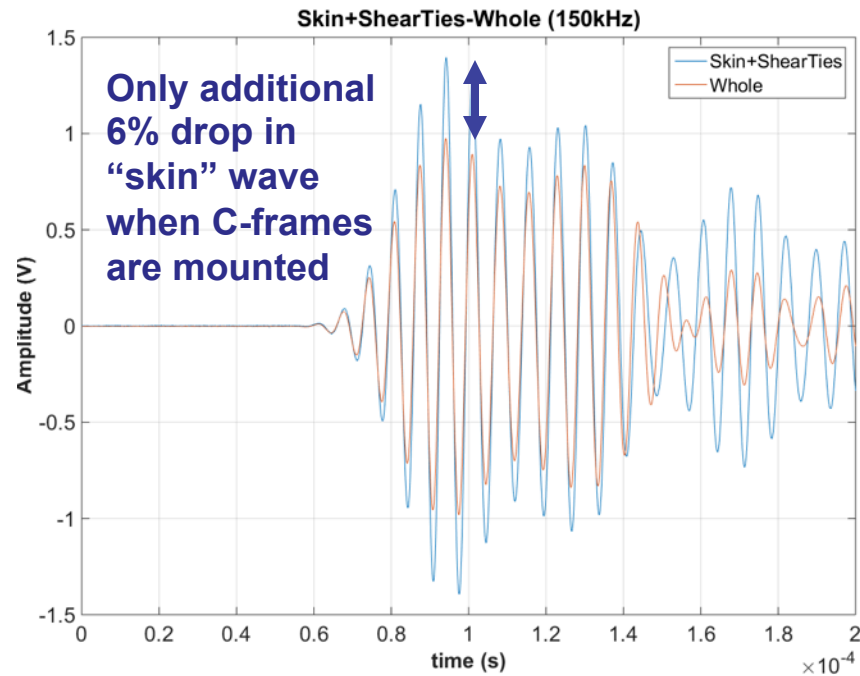
Selected Component Testing: fully assembled panel

- Frequency scan range: 130-180 kHz
- Conclusion: C-frame absorbs little of the propagating wave energy (could test lower frequencies to penetrate C-frames from the skin side)

- The probing ultrasonic frequencies utilized in the first-generation prototype (largely determined by PZT transducers used) were likely too high to penetrate into the C-frames, i.e. damage in frames would be currently difficult to detect. Lower frequencies (i.e. different transducers) should be considered to detect damage in frames.
- A larger variety of damage types should be tested for a more comprehensive assessment of the NDE prototype through the computation of additional ROC curves.
- Additional tests could also be used to identify a statistical correlation of the ultrasonic measurements with the location, mode and severity of damage.

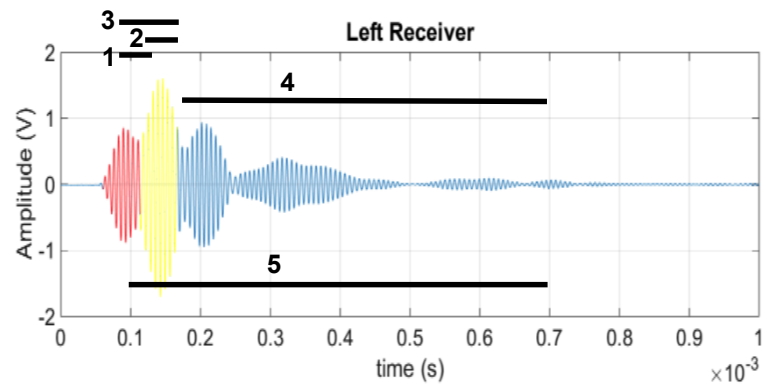
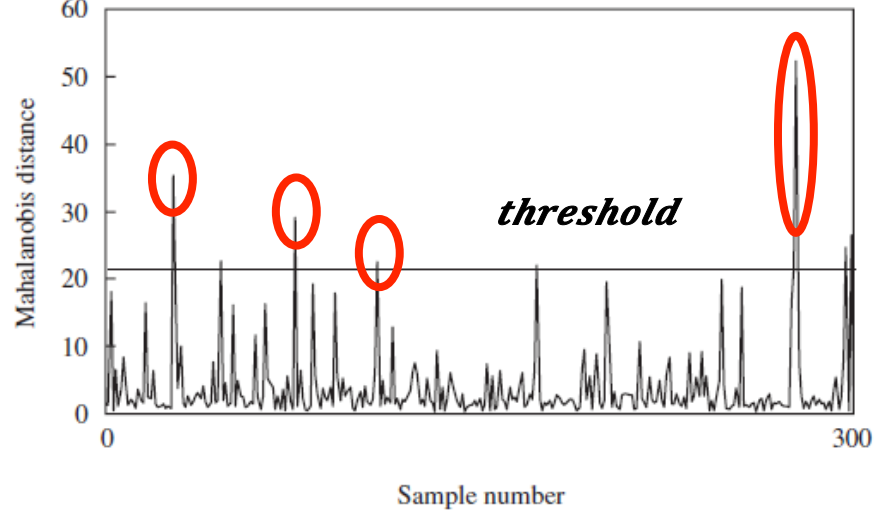
Statistical processing algorithm:

Feature Vector
("balance" metric)

Damage Index (DI) :
(Mahalanobis Squared Distance)

$$(x - \bar{x}) * C^{-1} * (x - \bar{x})^T$$

If $DI > threshold \Rightarrow$ **DEFECT**

- Rms Ratio: $RMS\downarrow 1 / RMS\downarrow 2$
- Rms Normalized: $|RMS\downarrow 1 - RMS\downarrow 2| / \sqrt{RMS\downarrow 1 * RMS\downarrow 2}$
- Max (DI Max): $Max(Max\downarrow 1 / Max\downarrow 2, Max\downarrow 2 / Max\downarrow 1)$
- Area Ratio: $Area\downarrow 1 / Area\downarrow 2$
- Peak to Peak Ratio: $|Ppk\downarrow 1 - Ppk\downarrow 2| / \sqrt{Ppk\downarrow 1 * Ppk\downarrow 2}$
- Max (PPk Ratio): $Max(Max\downarrow Ppk\downarrow 1 / Max\downarrow Ppk\downarrow 2, Max\downarrow Ppk\downarrow 2 / Max\downarrow Ppk\downarrow 1)$
- Area FFT Ratio: $|AreaFFT\downarrow 1 - AreaFFT\downarrow 2| / \sqrt{AreaFFT\downarrow 1 * AreaFFT\downarrow 2}$
- Rms Difference: $RMS(2-1)$

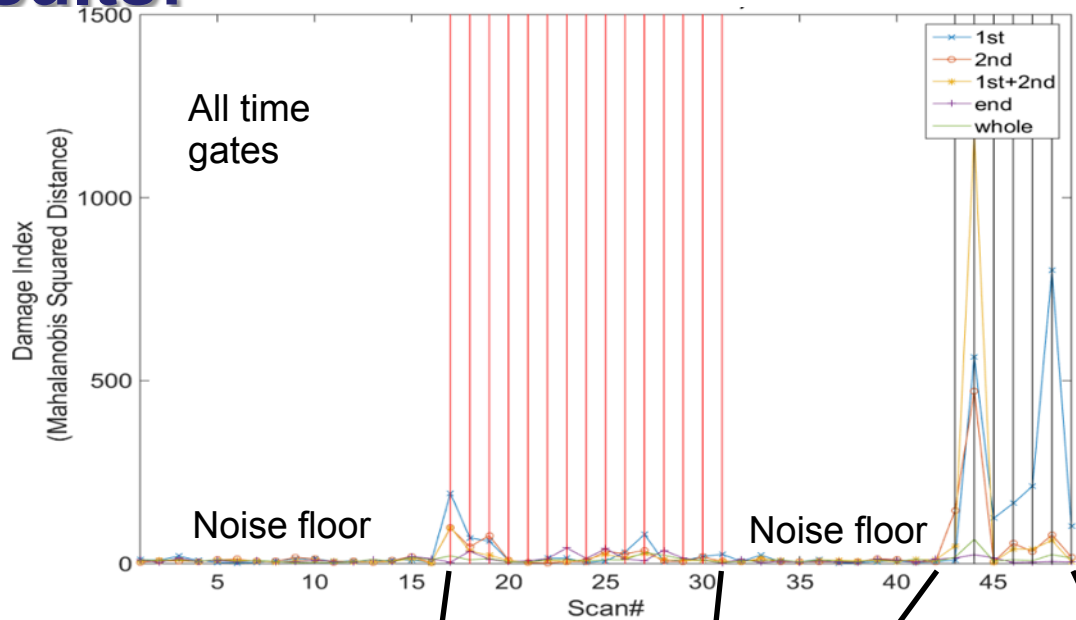
Outlier Analysis Results: Panel 2

- Total scan lines: 49
- Scan lines at damage sites: 15 (cracked stringer), 7 (cracked skin)
- Scan step: 2 cm (nominal), 0.5 cm for cracked stringer

Conclusion: both defects clearly detected by large Damage Index values. Very low “noise” floor.

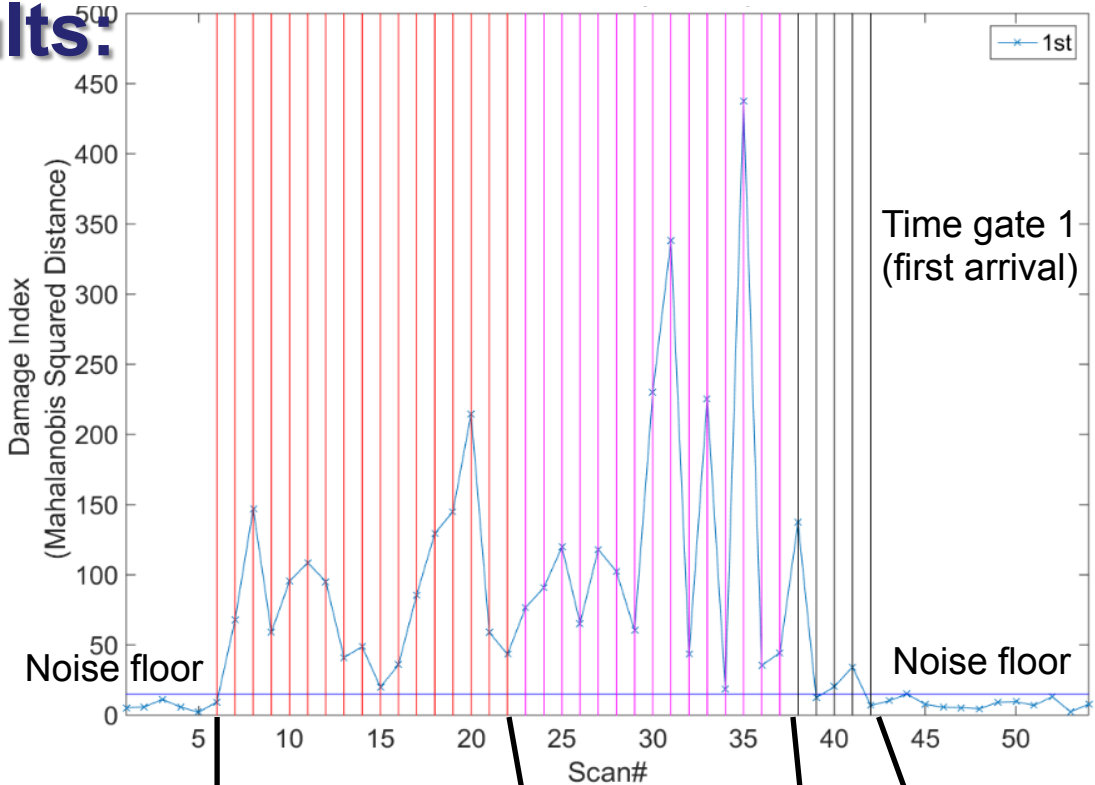
Outlier Analysis Results: Panel 1

- Total scan lines: 54
- Scan lines at damage sites: 17 (delaminated stringer #1), 15 (detached stringer), 5 (delaminated stringer #2)
- Scan step: 2 cm (nominal), 0.5 cm for delaminated stringers, 1 cm for detached stringer

Conclusion: all three defects clearly detected by large Damage Index values. Very low “noise” floor.

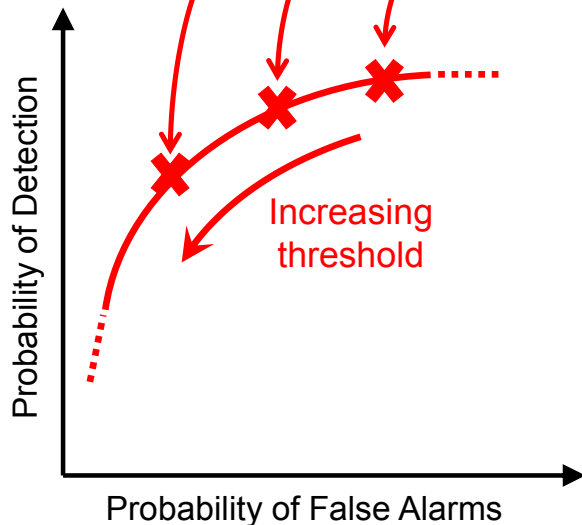
Receiver Operating Characteristic (ROC) Curves Computation

ROC curves (Probability of Detection versus Probability of False Alarms) are the most representative detection performance metrics for the proposed system. They are computed point-by-point by changing the value of the threshold in the Damage Index traces.

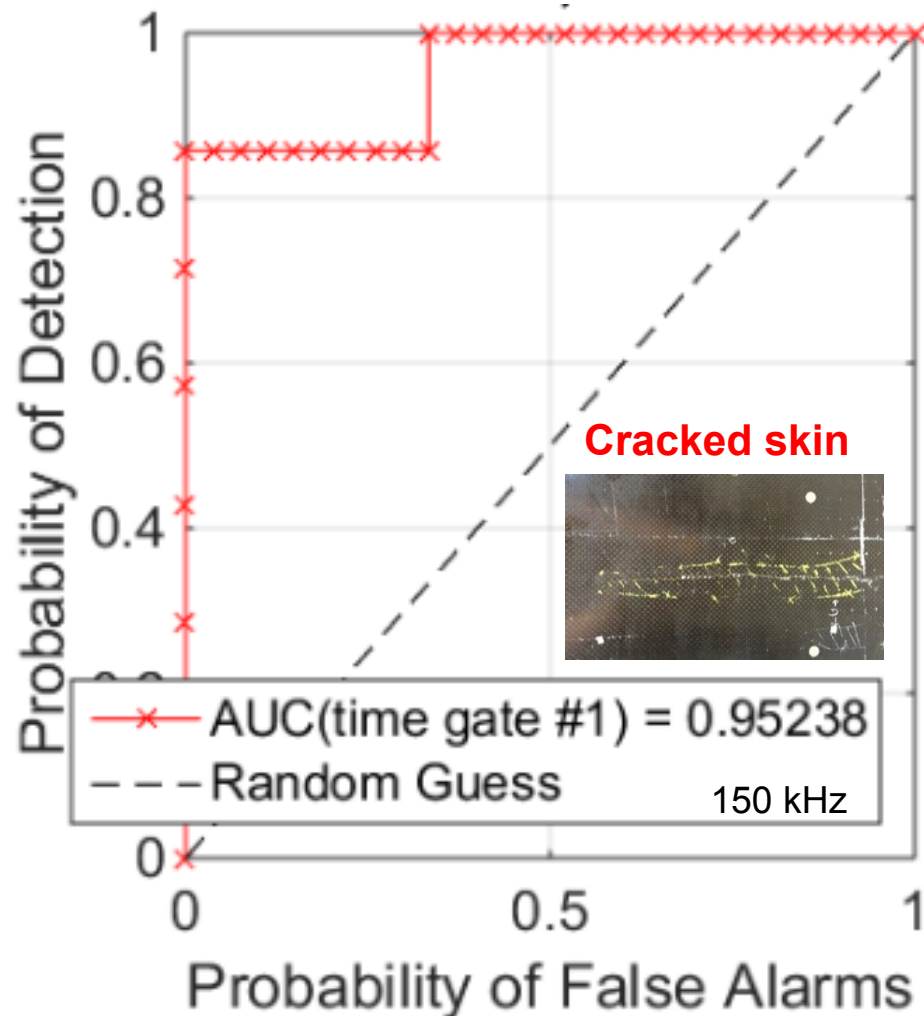
ROC Curve Results: Panel 2

**Excellent detection : 85% POD with 0% PFA, or
 100% POD with 30% PFA**

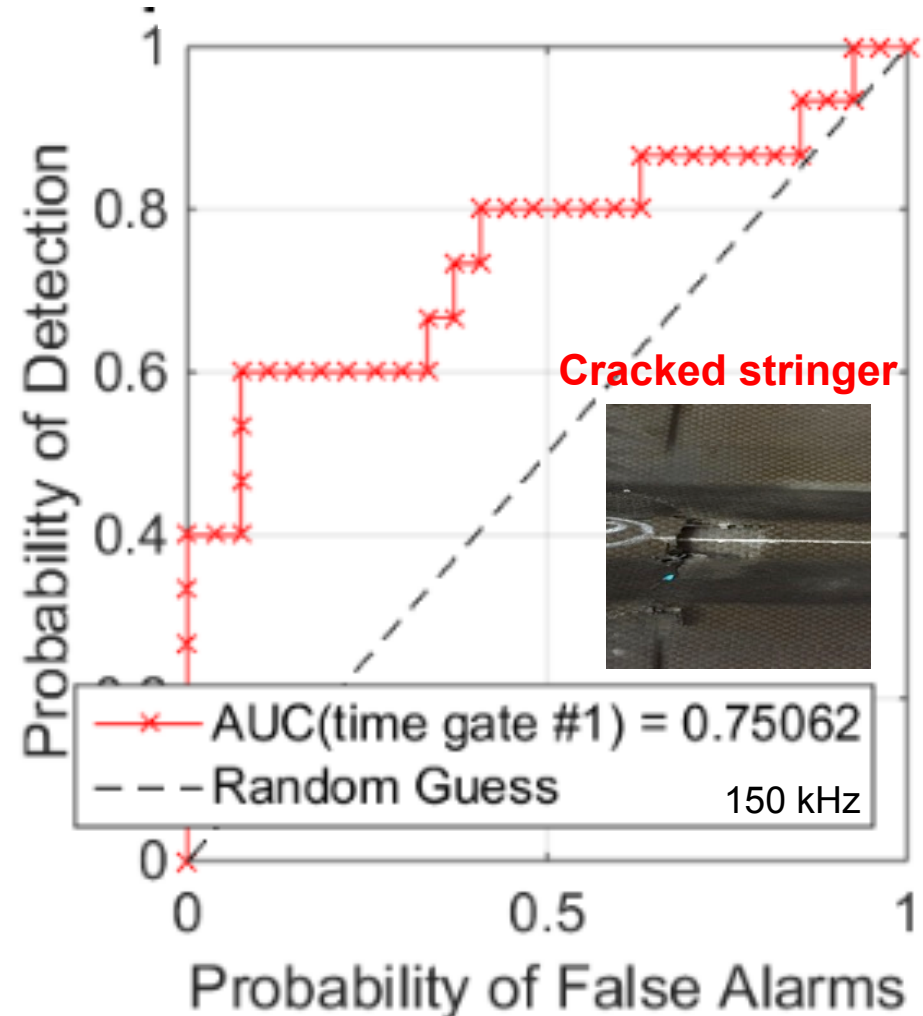
**OK detection : 60% POD with 10%
 PFA, or**

80% POD with 45% PFA

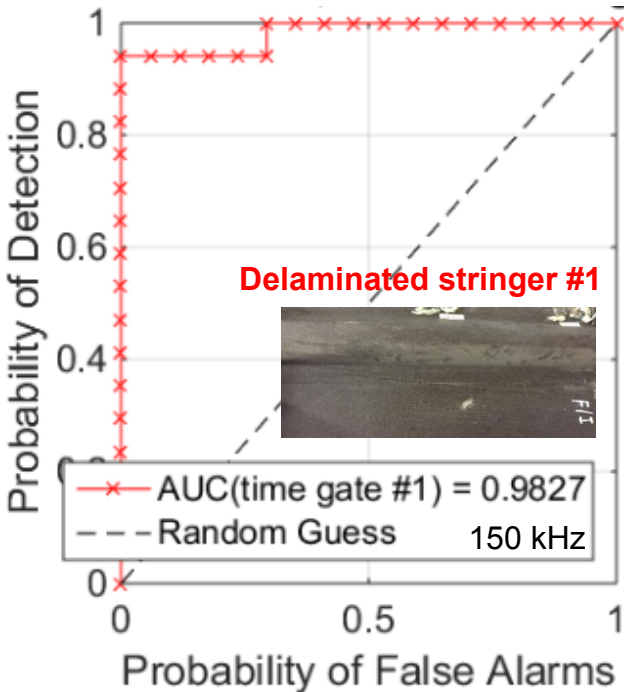
ROC Curve Results: Panel 1

Excellent detection :
95% POD with 0% PFA

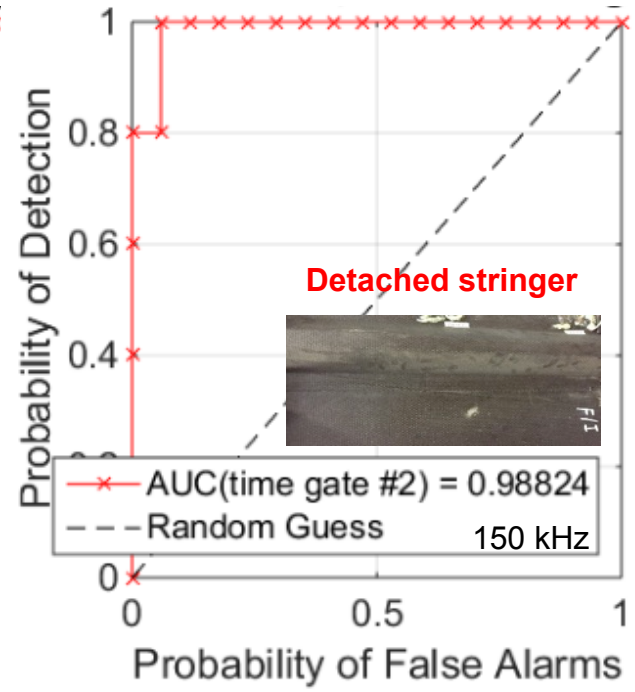
Excellent detection :
80% POD with 0% PFA, or
100% POD with 10% PFA

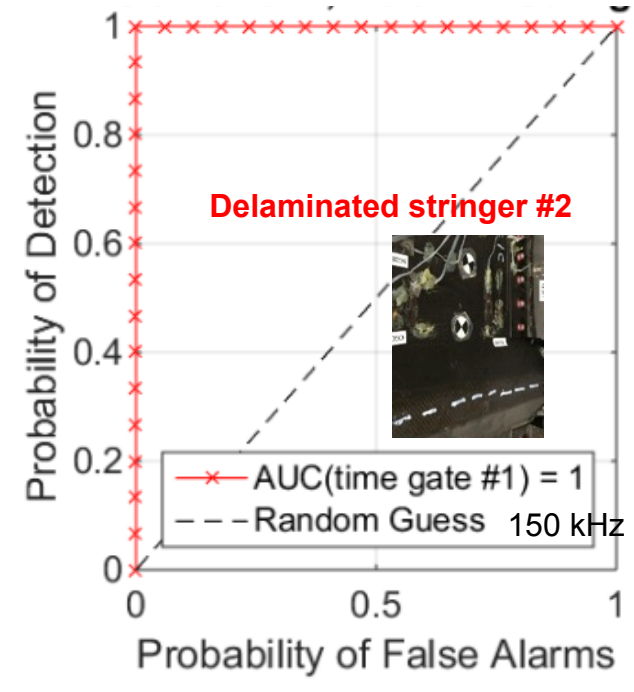
PERFECT detection :
100% POD with 0% PFA

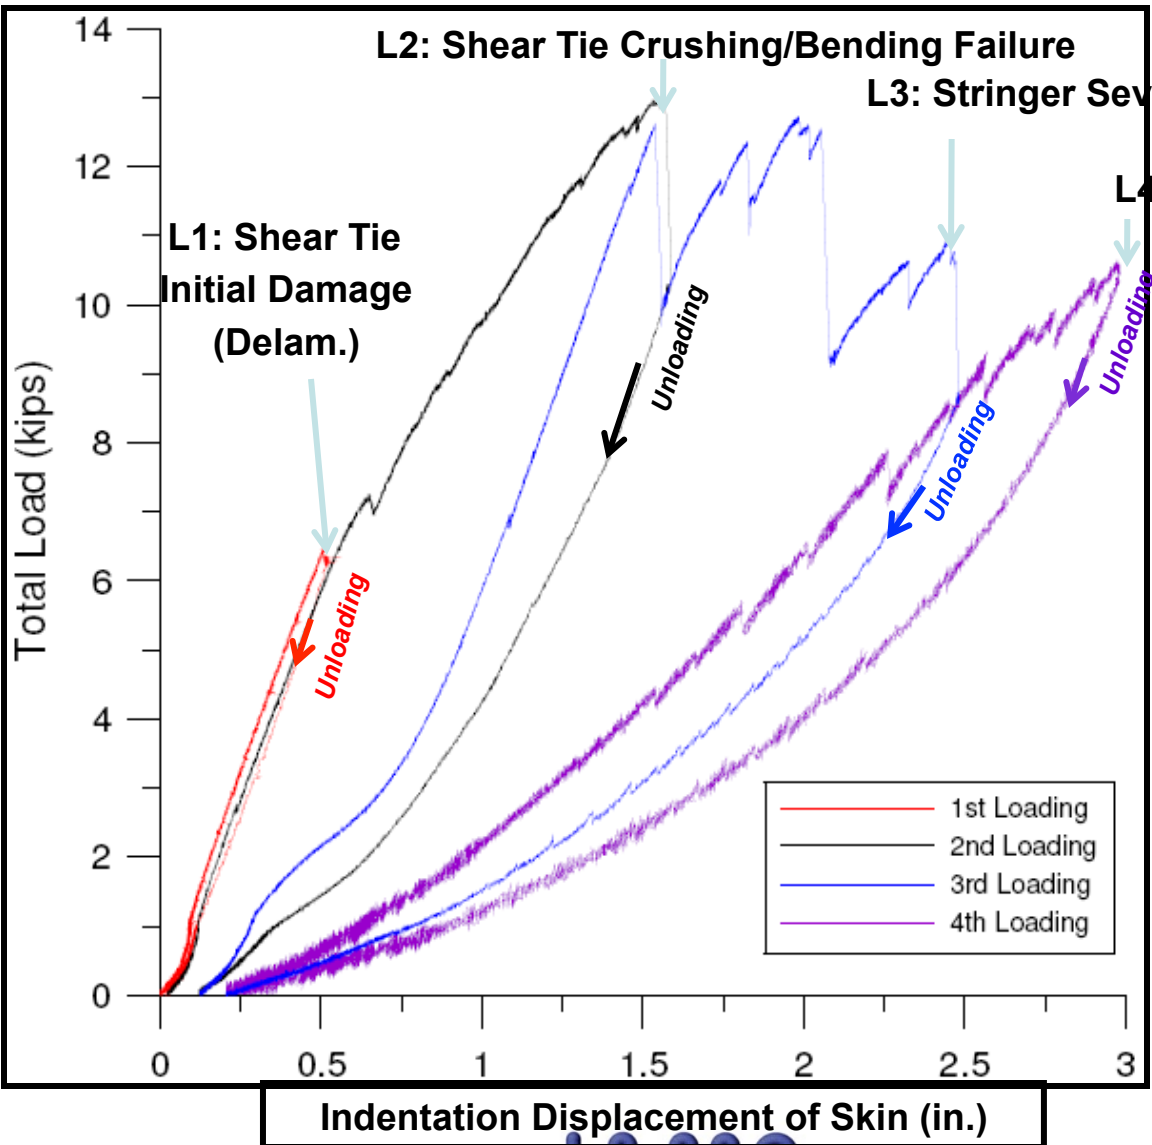
Specimen Frame01 Load vs. Indentation

L1: Shear Tie Initial Damage (Delam.)

L2: Shear Tie Crushing/Bending Failure

L3: Stringer Severed + Delam.

L4: Frame #2 Cracking

Note: all tests conducted at quasi-static speed.

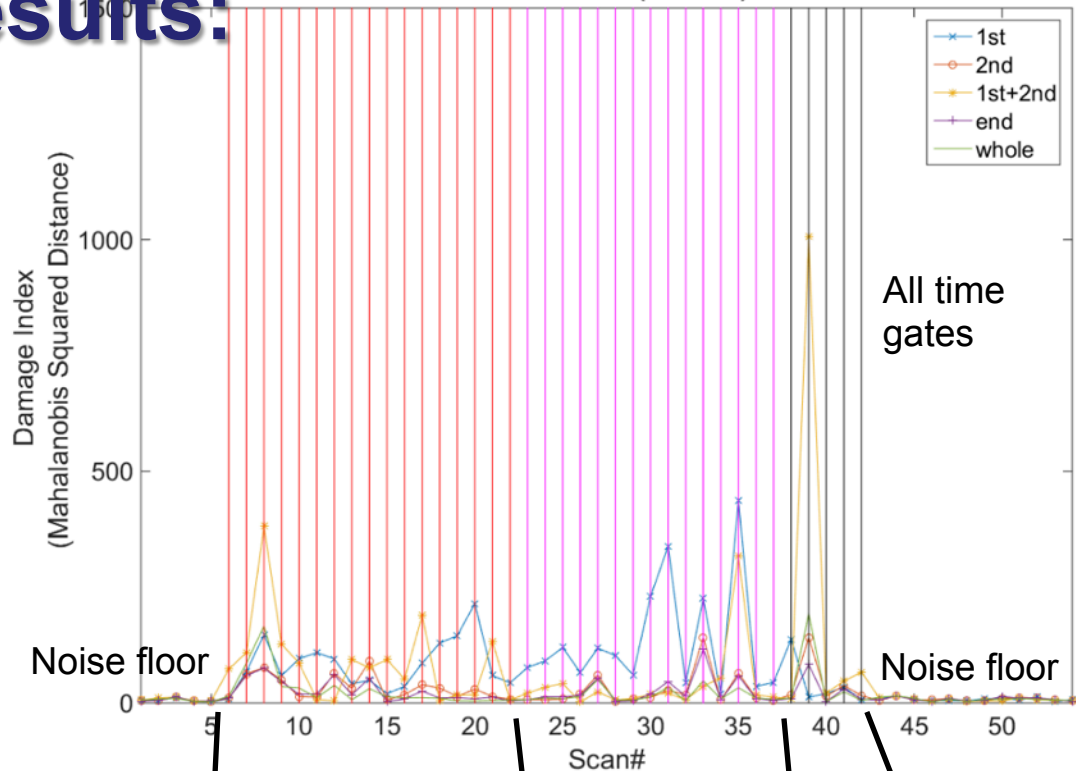
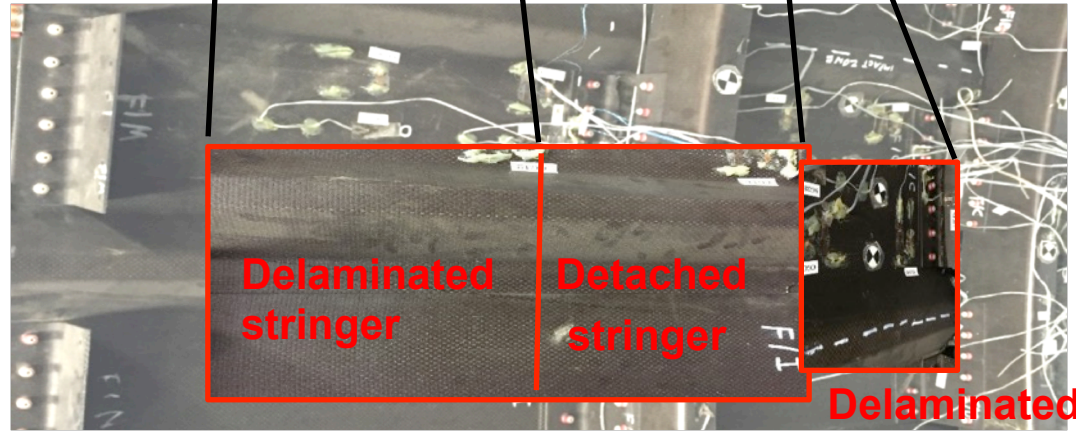
Outlier Analysis Results: Panel 1

Conclusion: all three defects clearly detected by large Damage Index values. Very low “noise” floor.
