## **AGING EFFECTS EVALUATION OF A BEECHCRAFT STARSHIP MAIN WING**

John Tomblin and Lamia Salah  
*National Institute for Aviation Research, Wichita, KS*

Curtis Davies  
*FAA William J. Hughes Technical Center, Atlantic City International Airport, NJ*

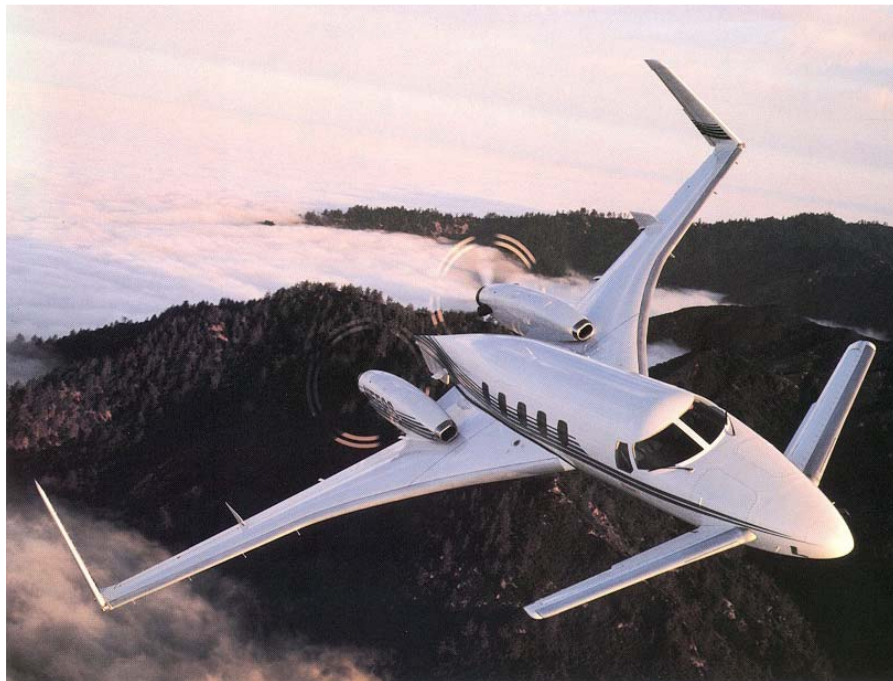
The Starship aircraft shown in figure 1 is a pressurized twin-engine turboprop constructed primarily of advanced composite materials. Approximately 70% of the airframe weight is composite structure [1]. The composite aircraft features a variable sweep forward wing, twin vertical stabilizers mounted on the tip of the main wing (aft wing) and a ventral stabilizer located in the bottom aft portion of the fuselage. Pitch control is achieved using elevators located on the forward wing, yaw control is achieved using the rudders located on the wing tip vertical stabilizers and roll control is achieved using the main wing ailerons.

Figure 1. Beechcraft Starship Airplane in Flight

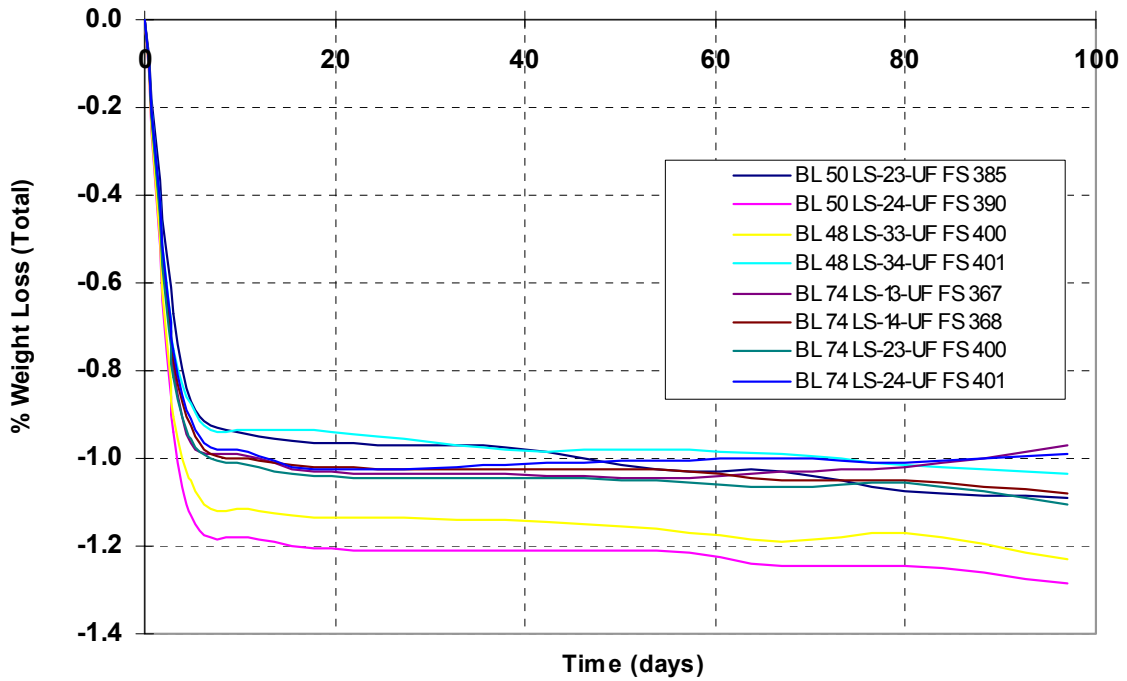
Figure 11. Moisture Loss as a Function of Time for Coupons Extracted From the Lower Skin

Moisture content in the aged structure was quantified using ASTM D 5229 using coupons extracted from both skins. Figures 11 and 12 show the moisture loss as a function of time for selected skin samples. The maximum moisture content was found to be 1.065% for the upper skin and 1.286% for the lower skin. This is very consistent with the moisture analysis data generated by the OEM and the moisture analysis data published in the NASA report [6] for the T300/5208 system, which predicted a  $1.1 \pm 0.1\%$  total weight gain expected in the structure in service due to moisture uptake.

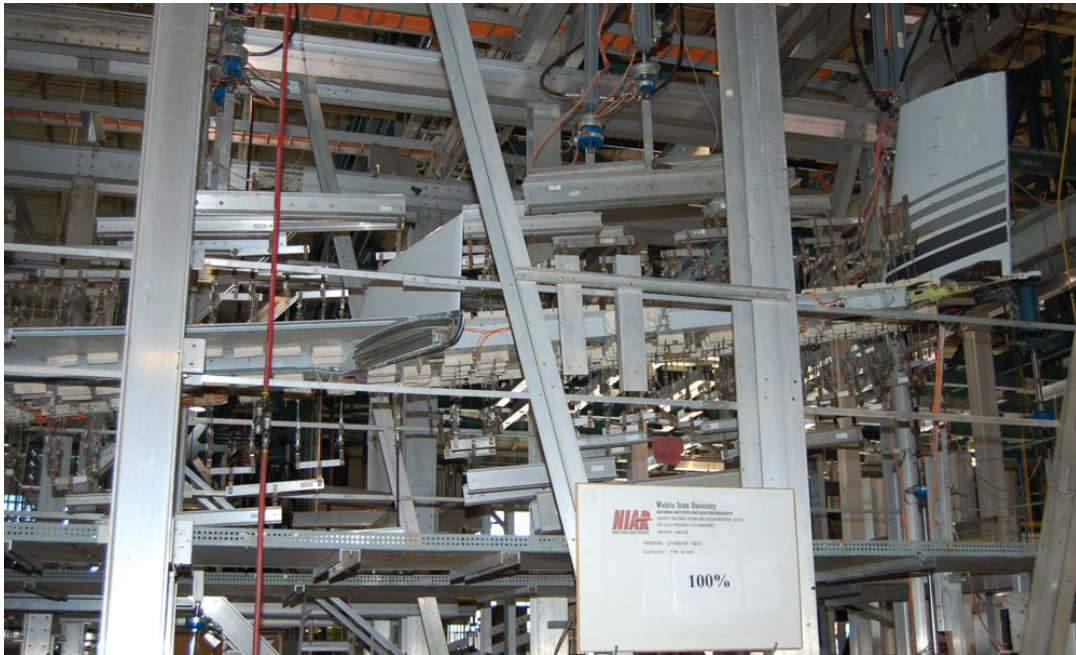
Figure 16. Deformed Wing at Limit Load

The wing was loaded to 100% limit up-bending load at 10% load increments and load, strain, and displacement data was acquired during the test. A photograph of the deformed wing at limit load is shown in figure 16.

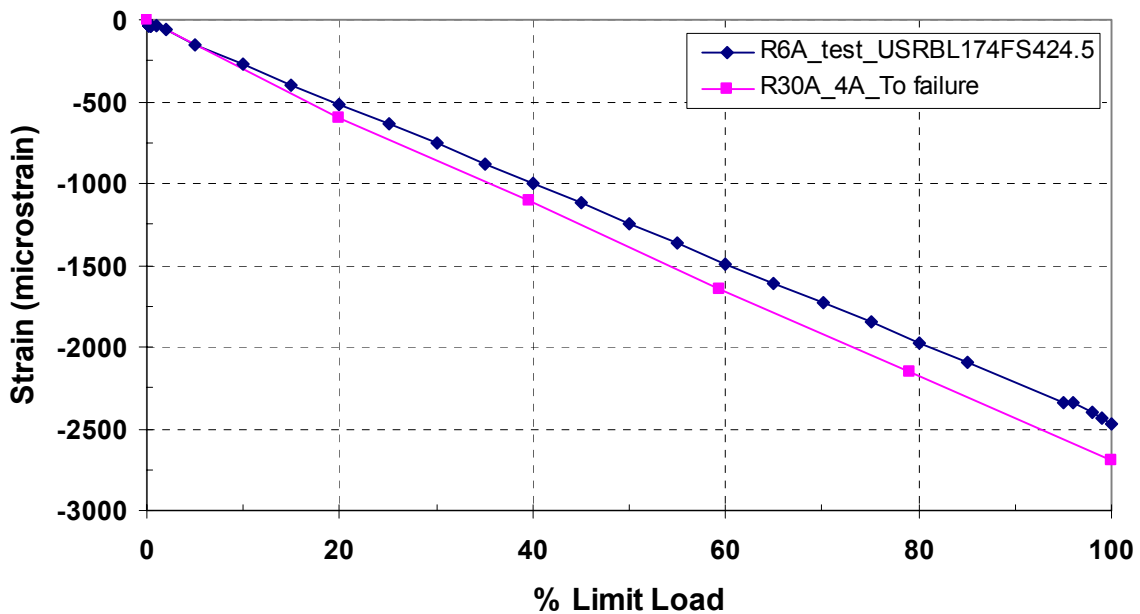
Figure 17. Strain vs % LL (Current Test vs Static Max Upbending Test to Failure)

The strain versus % LL comparison between current test and wing maximum up-bending certification test (Cond 4A) is plotted in figures 17 and 18 for strain gages R6A (compression, upper skin) and R10 (tension, lower skin) shown in figure 15. As shown in both figures, strain data from the aged test article correlates very well with strain data from the certification article subjected to the same load case. This demonstrates that there is no major change in the overall structure stiffness/compliance and structural response.
