Restoration of a Degraded Urban Forest in a Campus Setting: A Two Year Review of work at Kincaid Ravine

Dan Hintz | djhintz@uw.edu | Master of Environmental Horticulture Candidate | University of Washington - School of Environmental and Forest Sciences

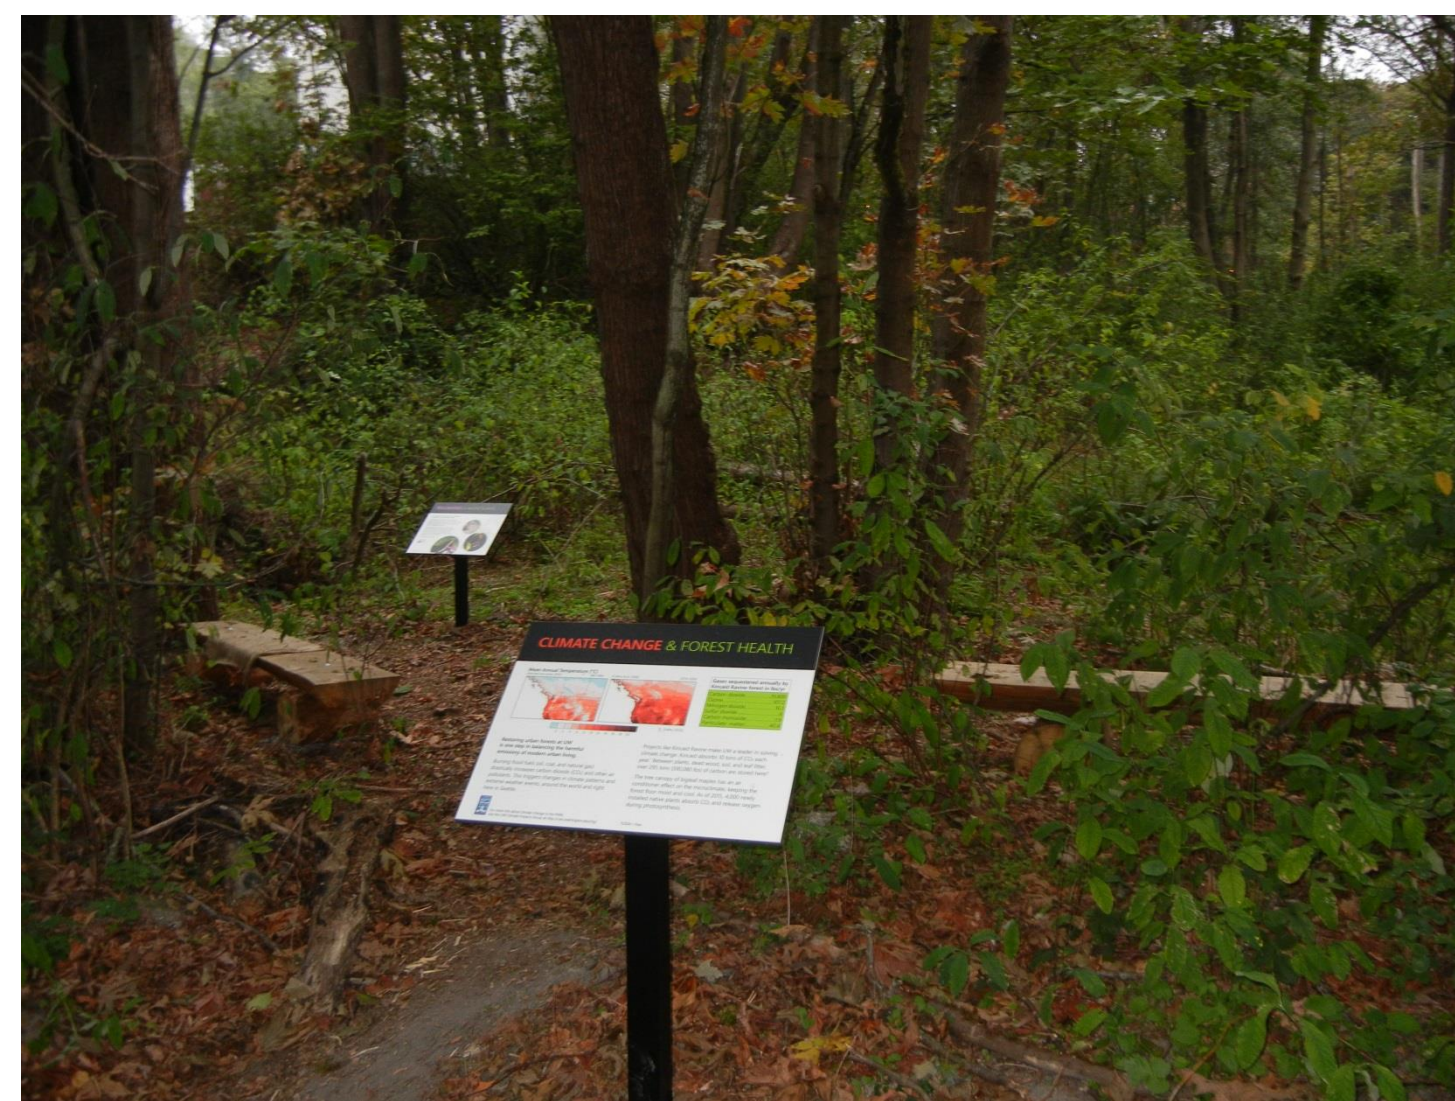
Development of "Educational Nook" that includes:

- Two cedar benches
- Interpretive signs on the importance of urban forests for pollinator habitat and climate change mitigation
- Small trail with mini native plant identification signs

Kincaid Ravine's proximity to the Burke-Gilman Trail gives the project excellent visibility which has attracted many visitors.

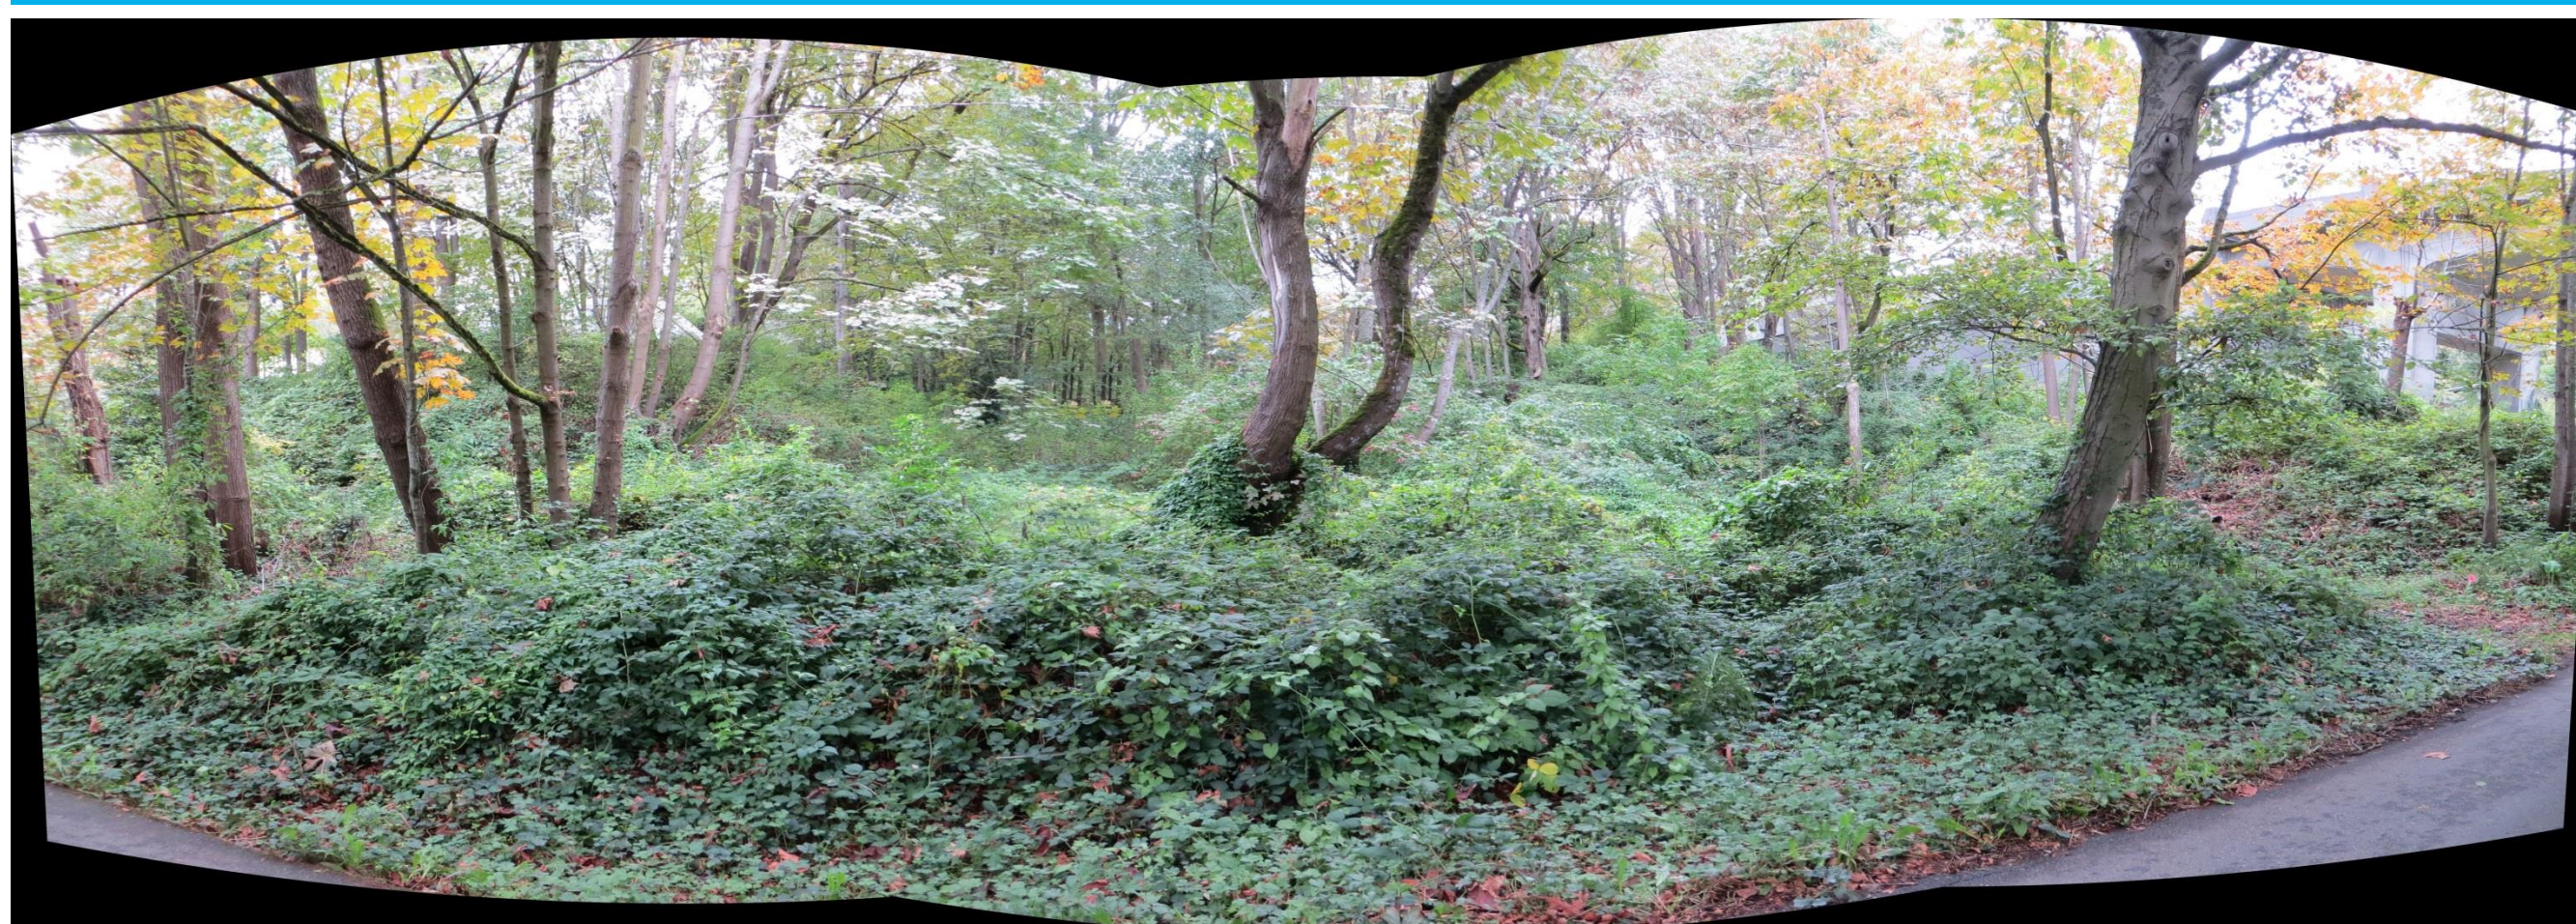
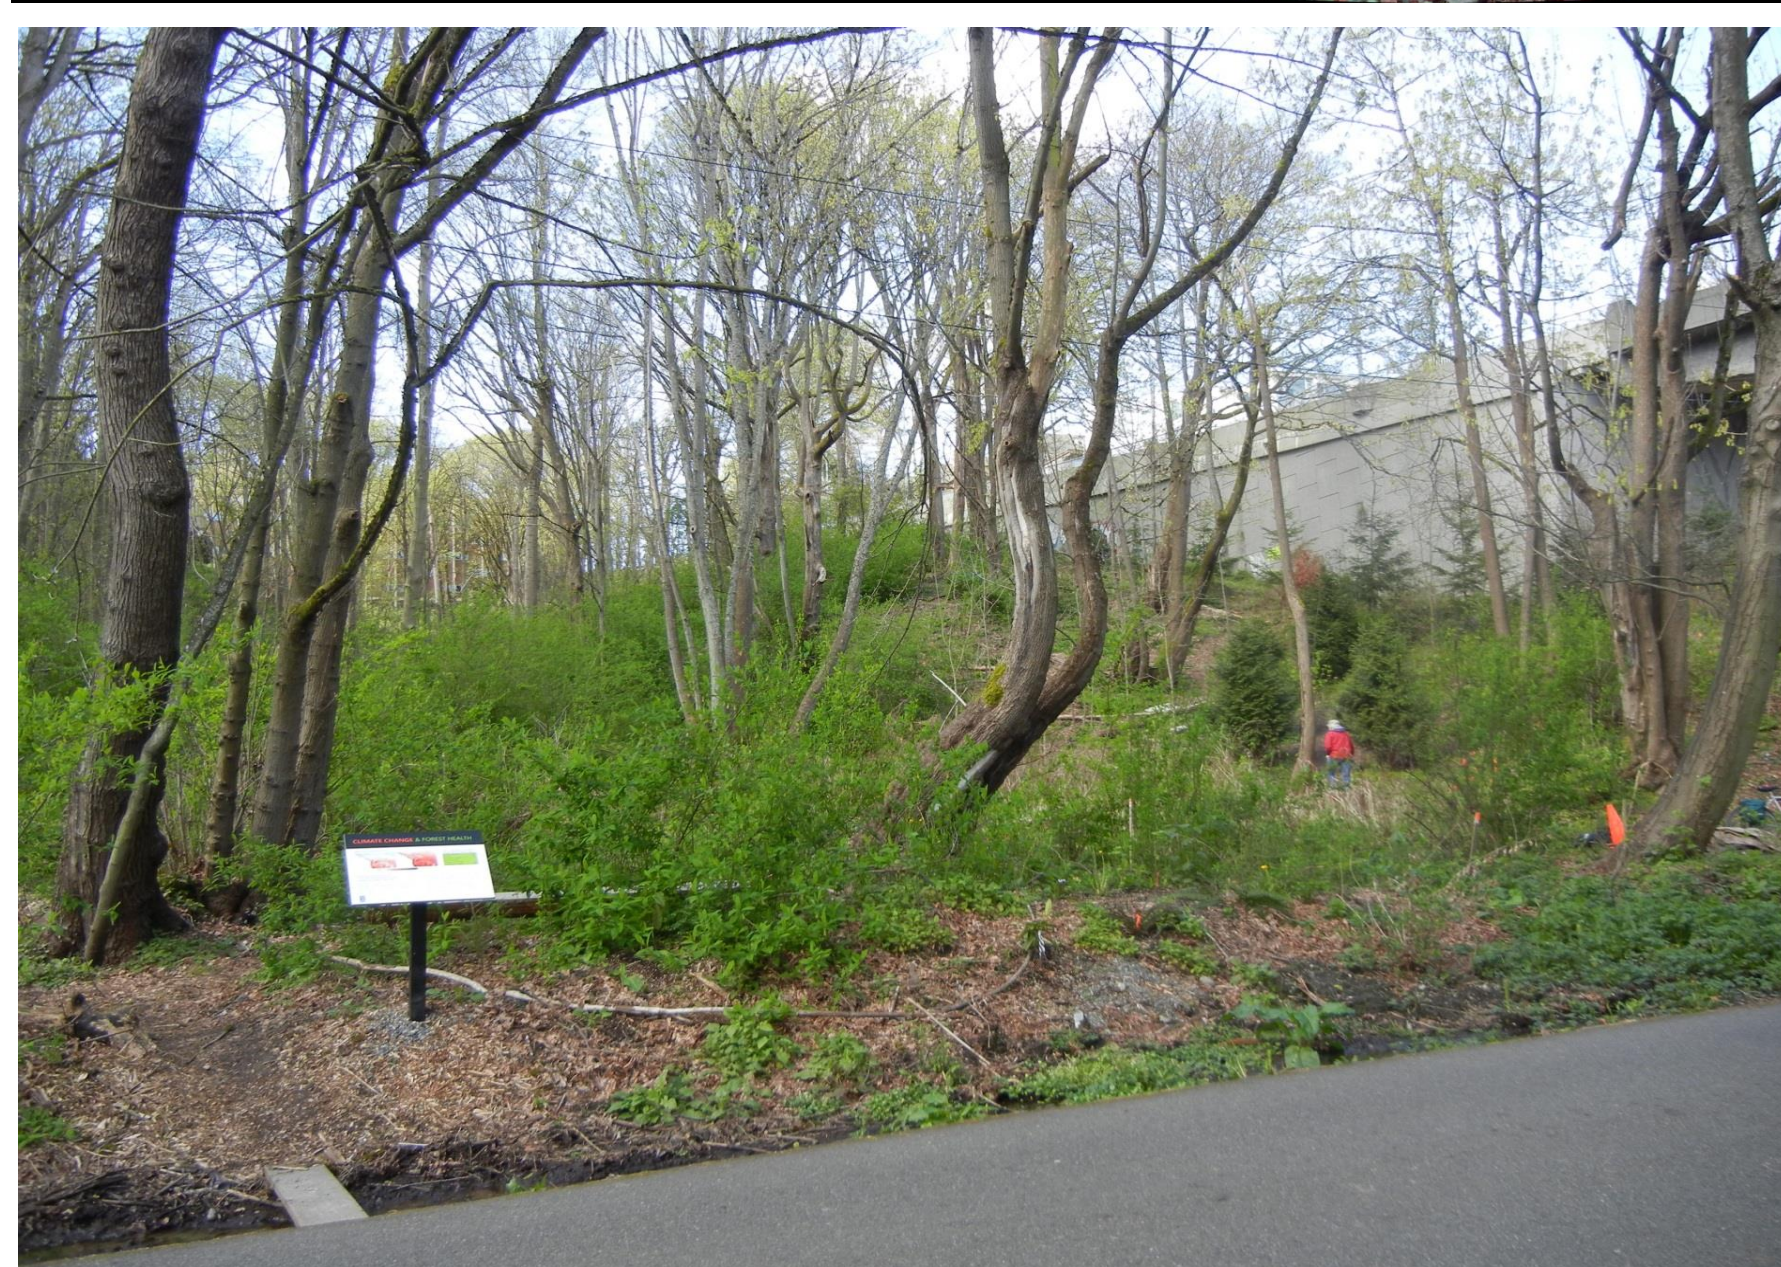
Photo Point Monitoring

Photo Point pictures taken in October, 2013 (above) at entrance to Kincaid Ravine before restoration work began and again in March of 2016 (left) two years into active restoration.

- Invasive removal and planting at monitoring plot occurred in Feb. of 2014 with one maintenance crew day in 2015.
- 83% tree planting survival (71% for PISI and 90% for THPL)
- Only dominant species listed in above table. Other species present (< 5% cover) PHCA, RILA, COSE, OPHO, POMU, DREX, TEGR and invasive species CASE and LAMU.
- Timing of monitoring may have skewed % cover estimates.
- Large ALRU in plot uprooted in Dec. 2014 which broadened the flow of water, possibly favoring wetland species.
- Invasive species regrowth concentrated around brush piles.

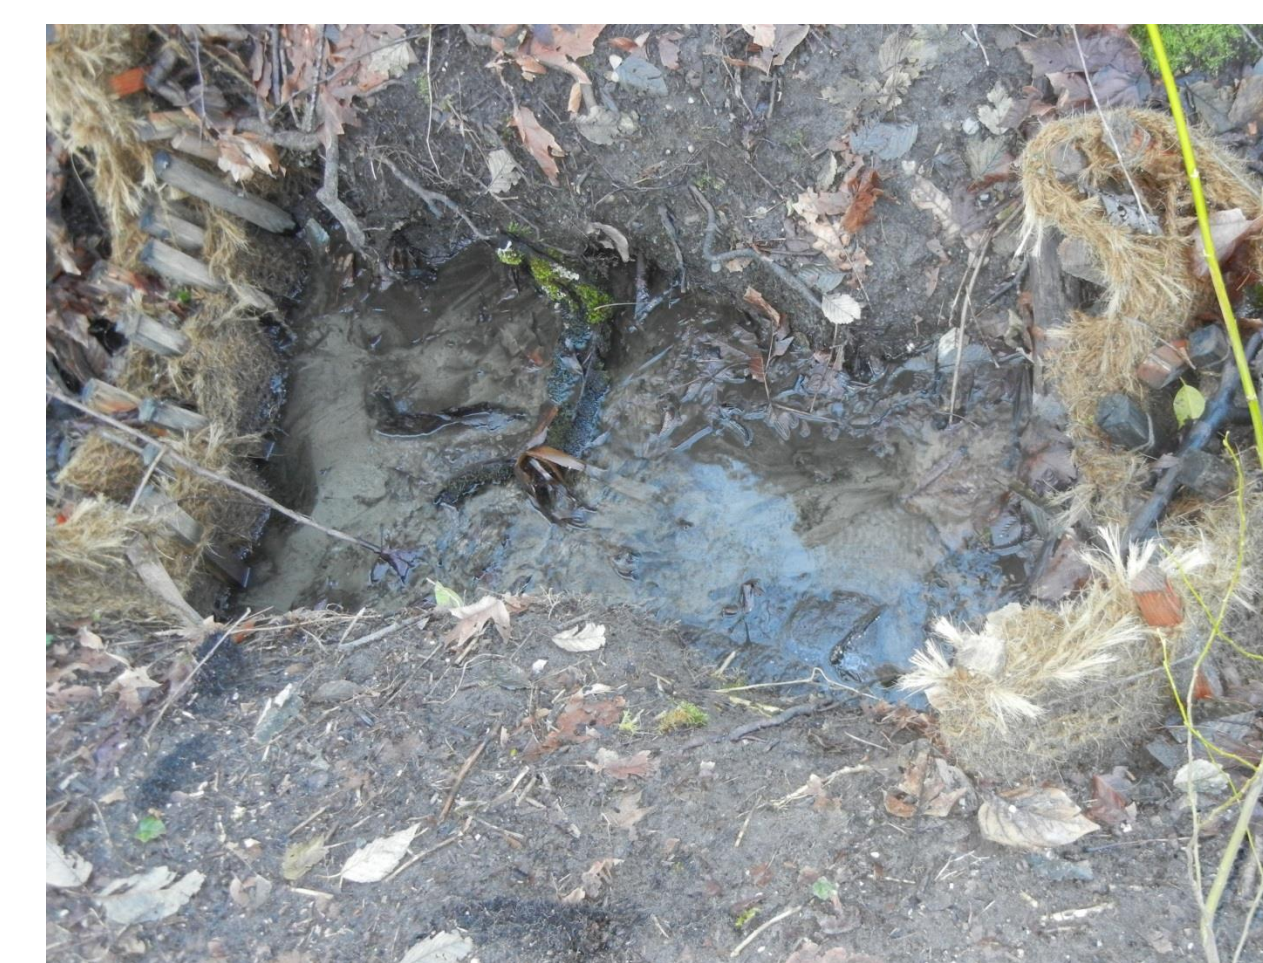
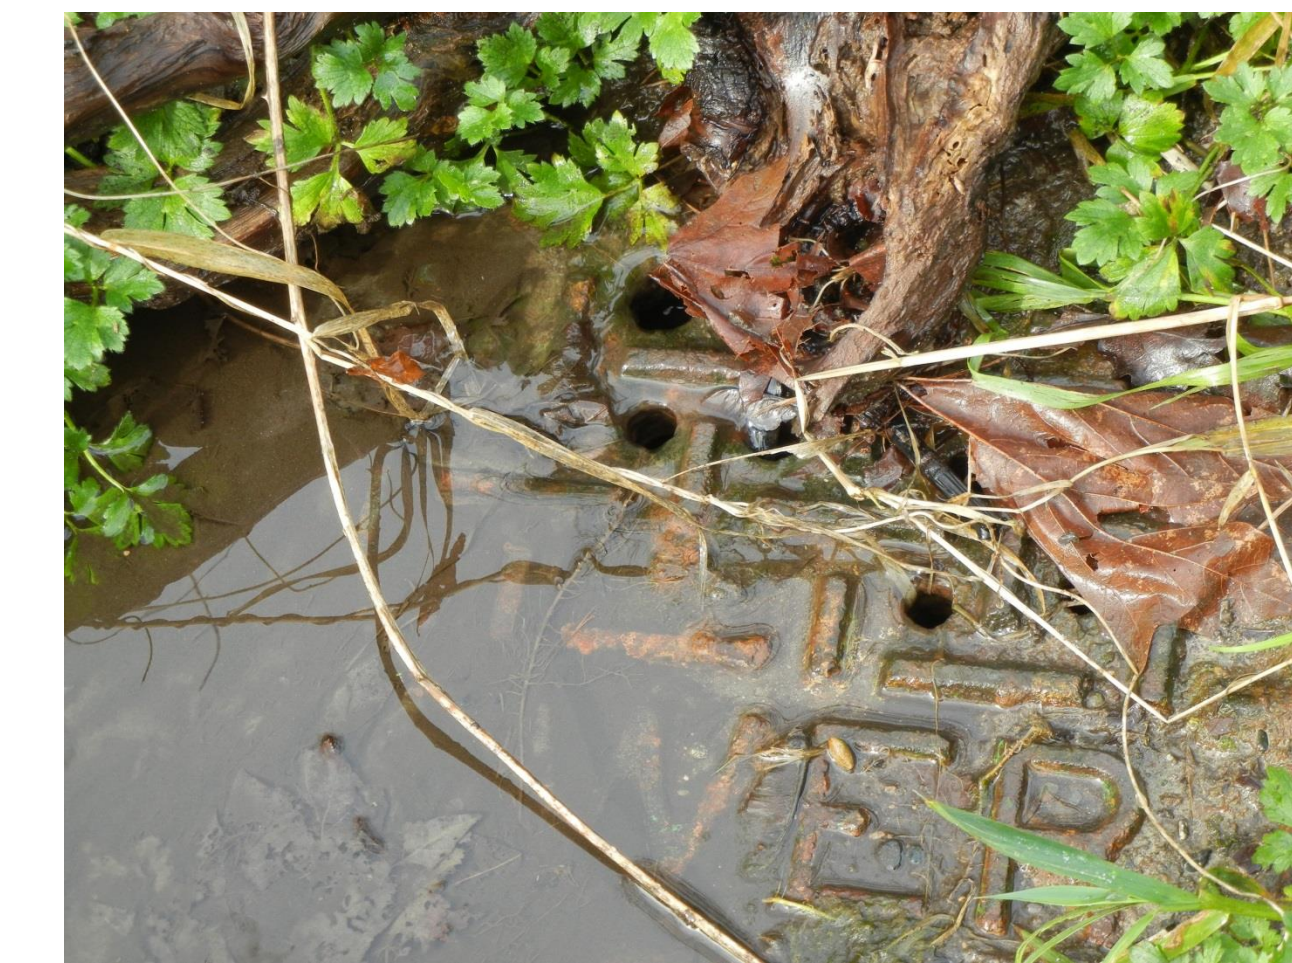
- Development of Kincaid Ravine Hydrological Assessment report documenting the groundwater seeps and channels in the ravine with a goal of improving wetland habitat and limiting flooding on the Burke-Gilman Trail.
- Use of trail side ditch for infiltration gallery which has greatly reduced the frequency of trail flooding this past winter and limited amount of water entering storm sewers (below right).
- Installation of "Picket Fence" check dams (below left) to limit channel incision and slow down transport of water and sediments.
- Planting of willow and dogwood live stakes treated with natural "willow water" rooting hormone.
- Reduction of reed canarygrass cover when cut and covered with 2-3 layers of burlap sacks as compared to just mowing.
