OPTIMIZING ASPHALT PAVEMENT PERFORMANCE FOR CLIMATE ZONES WITHIN WASHINGTON STATE

FINAL PROJECT REPORT

Haifang Wen, Associate Professor
P Skyler L. Chaney, Research Assistant
Washington State University

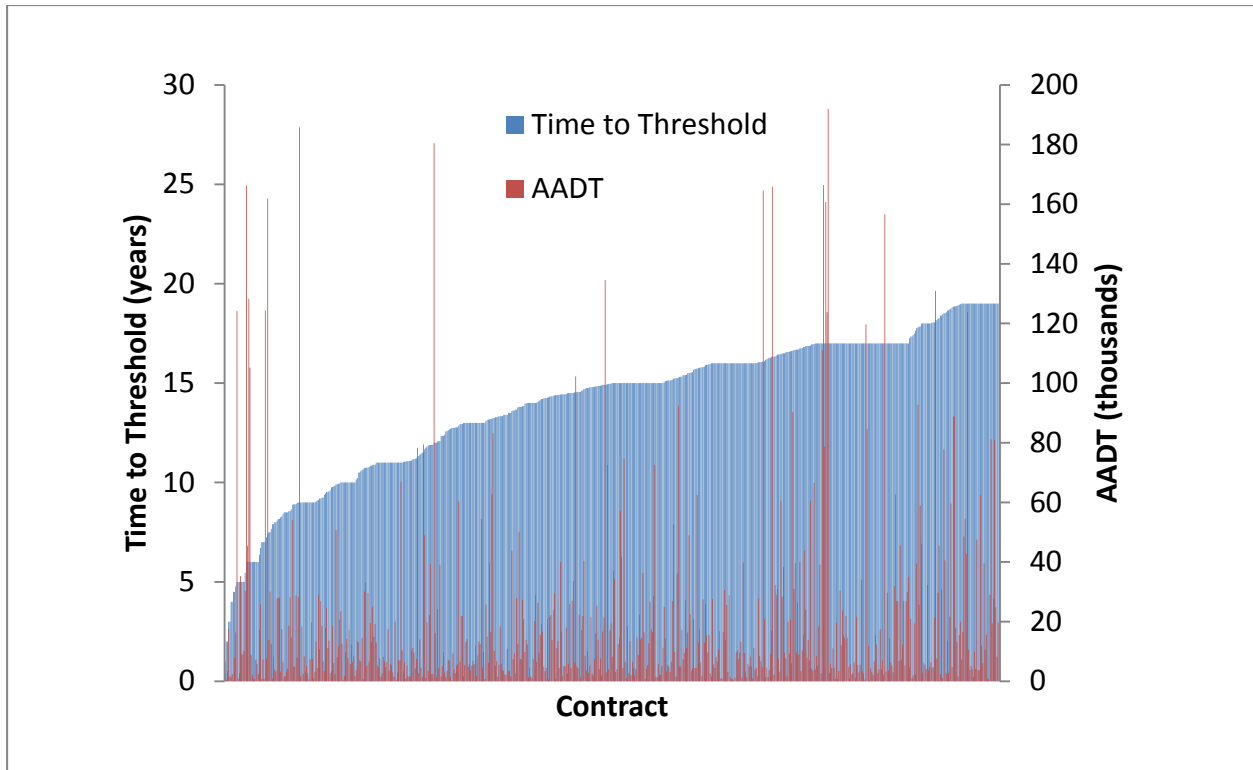
Figure 1.1 Superpave HMA Projects in Washington State

When a pavement reaches a designated level of PSC, PRC, or PPC, the pavement is considered to have reached the end of its service life. Due to the fact that some pavements are kept in service for several years after reaching a designated failure threshold, for this study the time to reach the failure threshold was considered a more reliable indication of the length of pavement life than the total time between activities. Superpave HMA projects that have reached a failure threshold in Washington levels are shown by contract with annual average daily traffic (AADT) levels in Figure 1.1. Pavements that exceeded the average 11 year life in Eastern Washington are shown by contract with annual average daily traffic levels in Figure 1.2.

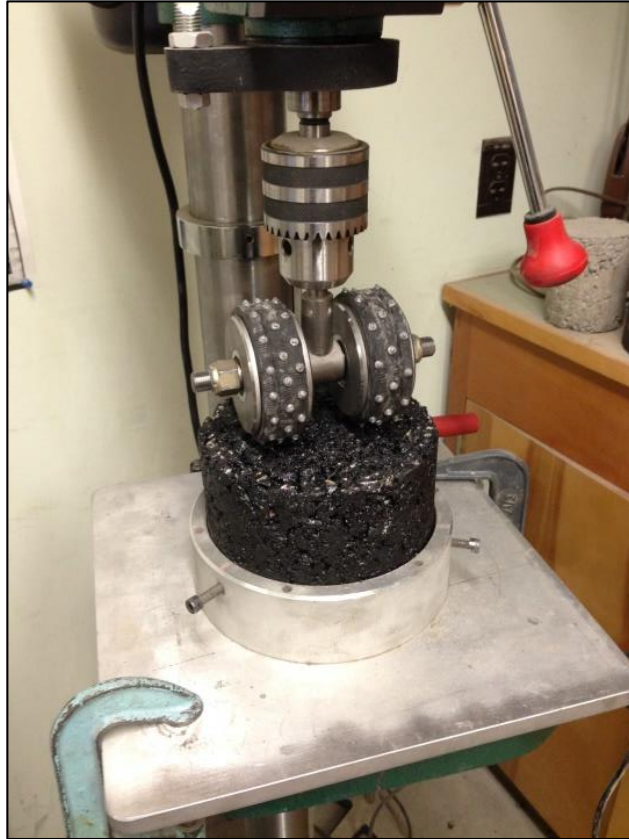
Figure B.15 Studded Tire Wear Simulator with Gyratory Sample

The studded tire wear simulator/tester developed at Washington State University is shown in Figure B.1. The wear simulator consists of a modified drill press with two free-rolling rubber tires with studs. The tires are contacted with the asphalt sample surface at 100 psi and torque is applied to the wheels at a speed of 140 revolutions per minute (RPM). Friction causes the two wheels to roll and the asphalt sample is worn in a similar way to conditions in the field.

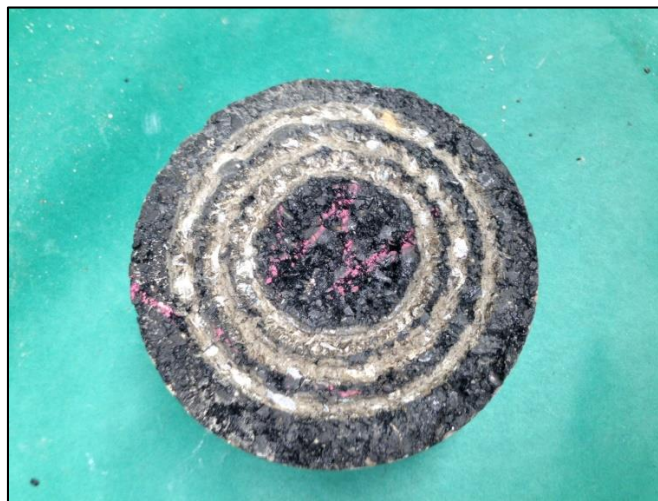
Figure B.2 Field Core Sample after Studded Tire Simulation

The resulting wear on a field core is shown in Figure B.2. The studded tire wear simulation tests were performed at a temperature of 69.8°F.

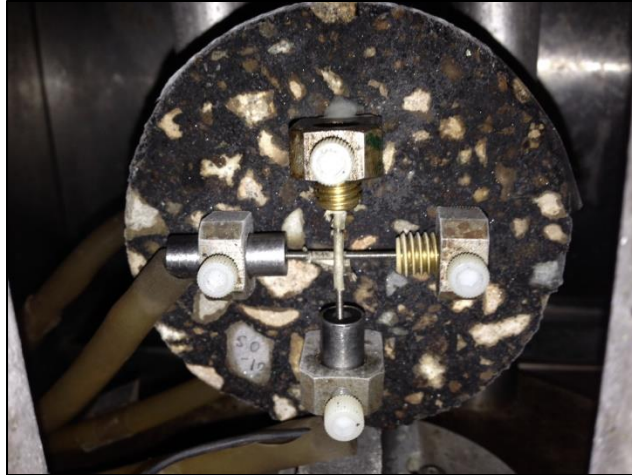
Figure B.3 Asphalt Mixture Sample Mounted with LVDTs

A servo-hydraulic Geotechnical Consulting Testing System (GCTS) with an environmental chamber was used to test the field cores and gyratory compacted specimens. The setup consists of four linear variable differential transformers (LVDTs) that are mounted to each sample, with two in the front and two in the back, as shown in Figure B.3. The distance between the mounts, known as the gauge length, is two inches. The sample with mounted LVDTs is placed in the loading apparatus and is only contacted vertically, on the top and bottom. Plates with curved loading strips are guided by four steel columns to apply a uniform load along the vertical plane. When a load is applied to the sample, the LVDTs measure the horizontal and vertical deformations, which are used to determine various parameters such as dynamic modulus and creep compliance values. The IDT test setup is shown in Figure B.4.

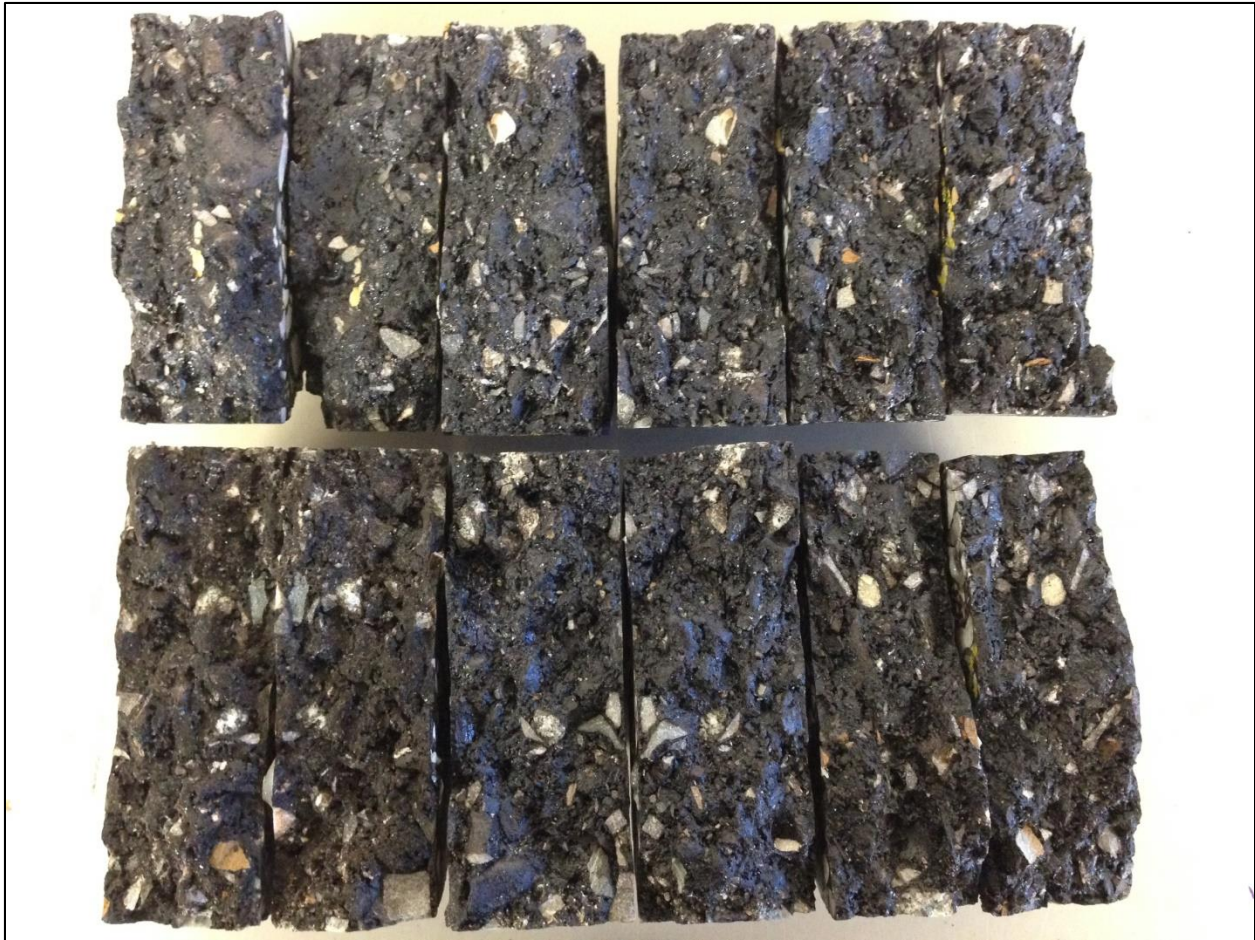
Figure B1.10 1/2" (Top Row) and 3/8" (Bottom Row) Mixes after IDT Thermal Cracking Tests

The fractured field core samples after the IDT thermal cracking test are shown in Figure B1.10. Results of IDT thermal cracking tests are shown in Figures B1.11 through B1.12. Results of the IDT thermal cracking tests are summarized in Table B1.7. The 3/8" mix has statistically significantly higher IDT strength than the 1/2" mix and based on fracture work density, is more resistant to thermal cracking than the 1/2" mix. It is noted that broken aggregates are pronounced at the fracture plane.

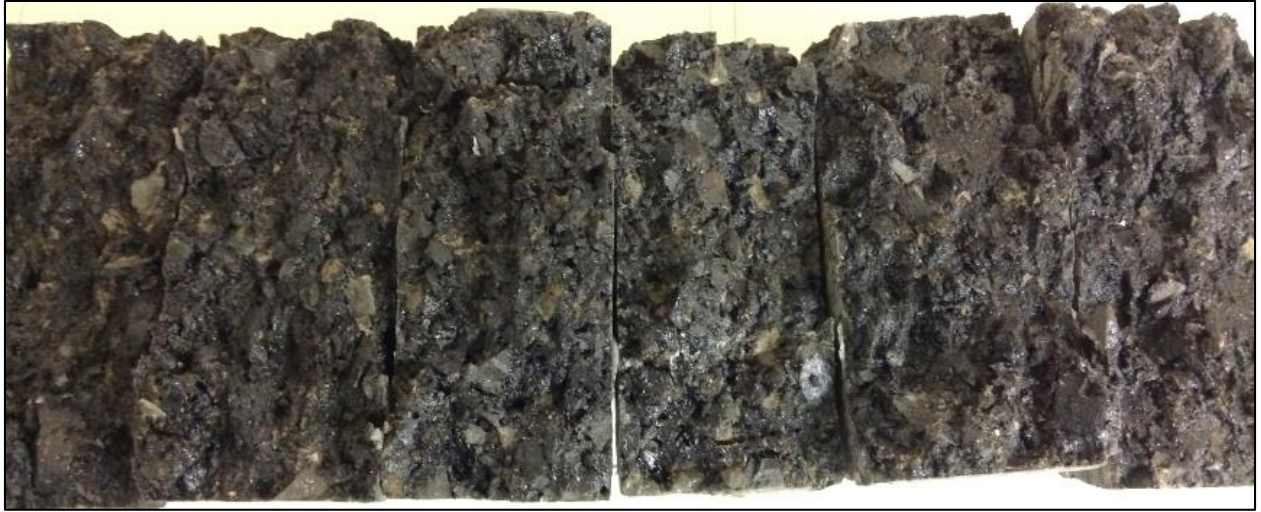
Figure B2.4 HMA Samples after IDT Fatigue Test

The fractured HMA and SMA samples after the IDT fatigue test are shown in Figures B2.4 and B2.5. From visual inspection, the samples often failed by the aggregate fracturing. Because the cores are taken between the wheel path, the fractured aggregates indicate that the pavements were over-compacted during construction, causing the aggregate to break. Graphical results for IDT strength, fracture work density, and horizontal failure strain of the HMA and SMA sections are shown in Figures B2.6 through B2.8. Results of the IDT fatigue tests are summarized in Table B2.3. Based on the fracture work density and the horizontal failure strain, the SMA is better than the HMA for bottom-up and top-down cracking resistance, respectively.

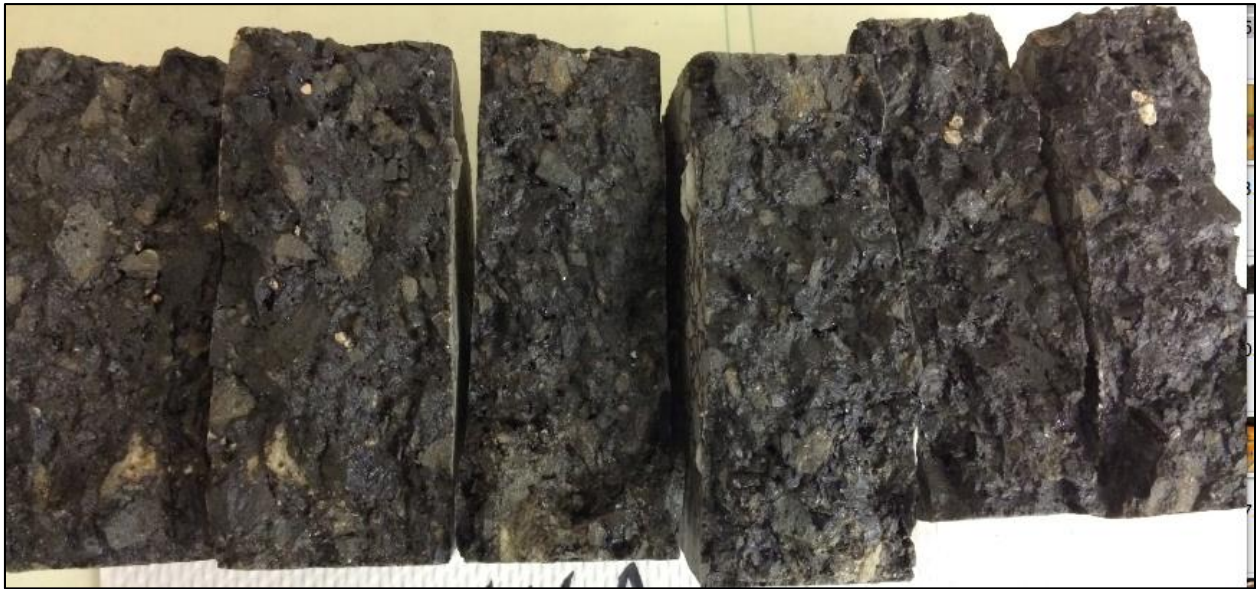
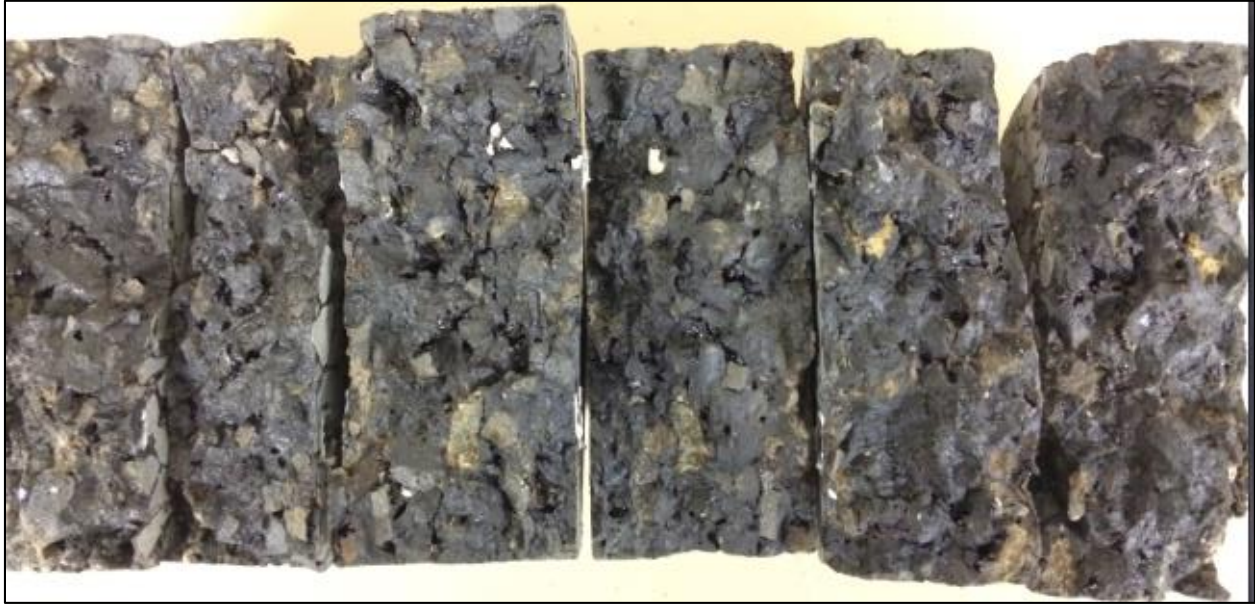
B2.12. Results of the IDT thermal cracking tests are summarized in Table B2.4. There was no statistically significant difference between the HMA and SMA for IDT strength. Based on results of the IDT test performed at a low temperature, the SMA mix performed better than the HMA mix for thermal cracking resistance.
