Thin Overlay

SR 5 OC Bridge 900/12W

SR 5 OC Bridge 900/13W

WA-RD 234.1
Post Construction Report
June 1991

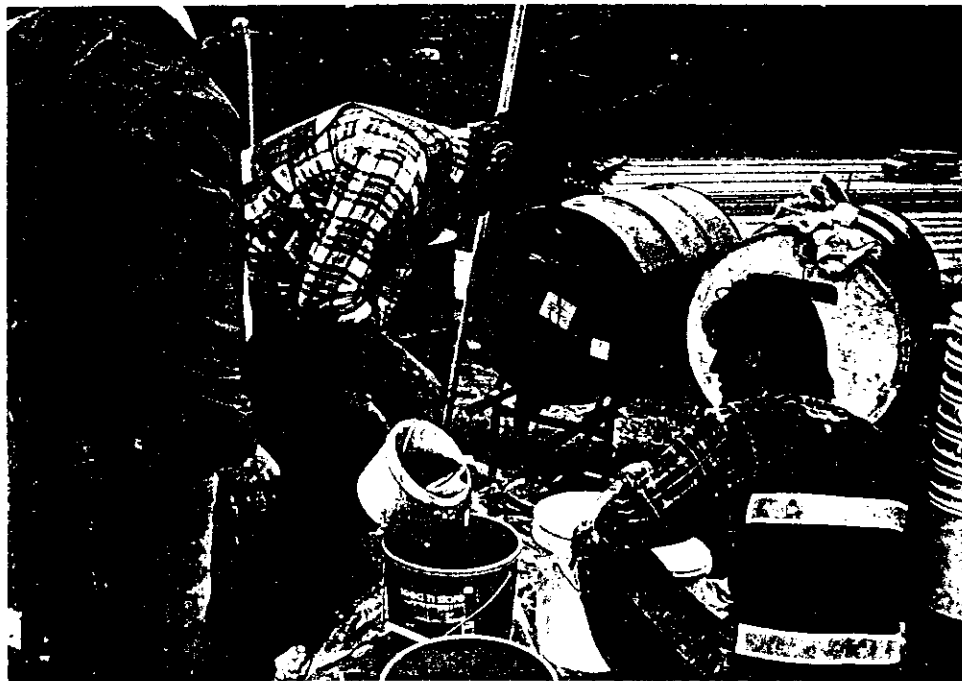
Proportioning epoxy.

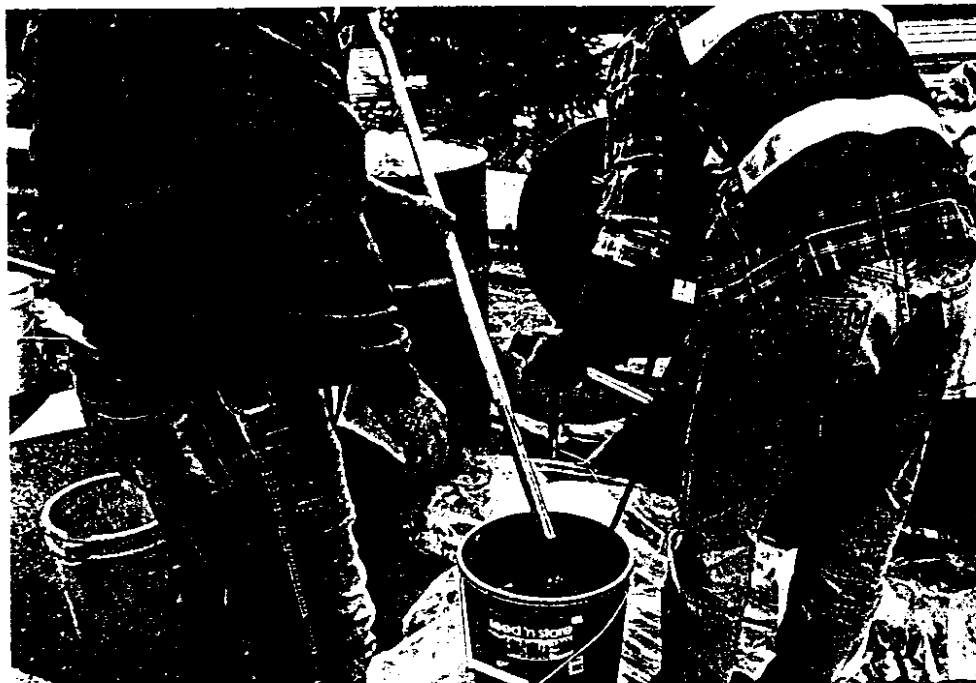
Mixing epoxy.

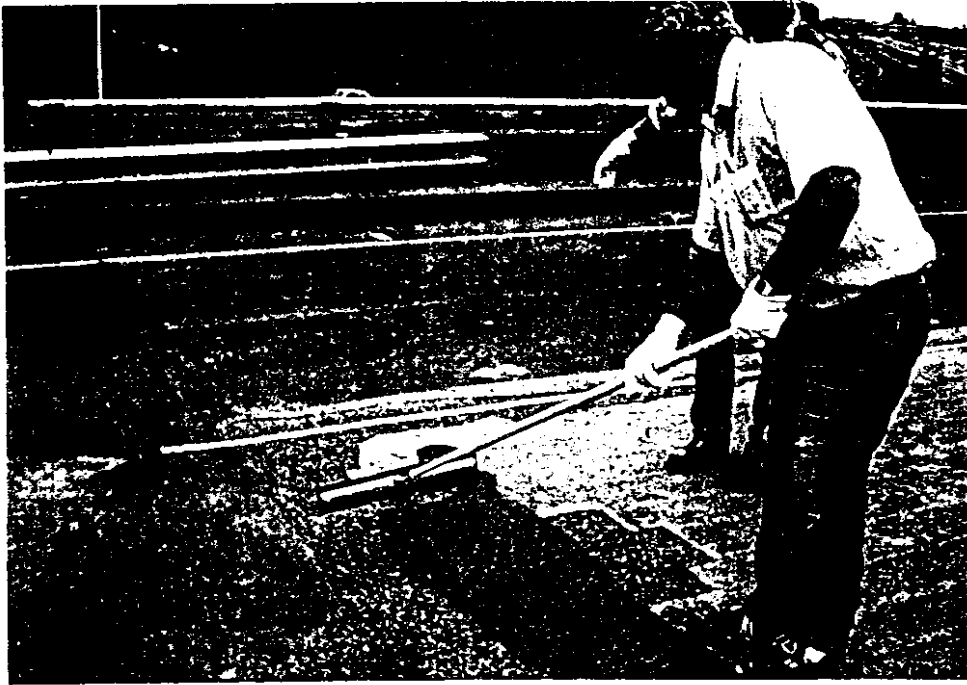
Spreading epoxy on deck.

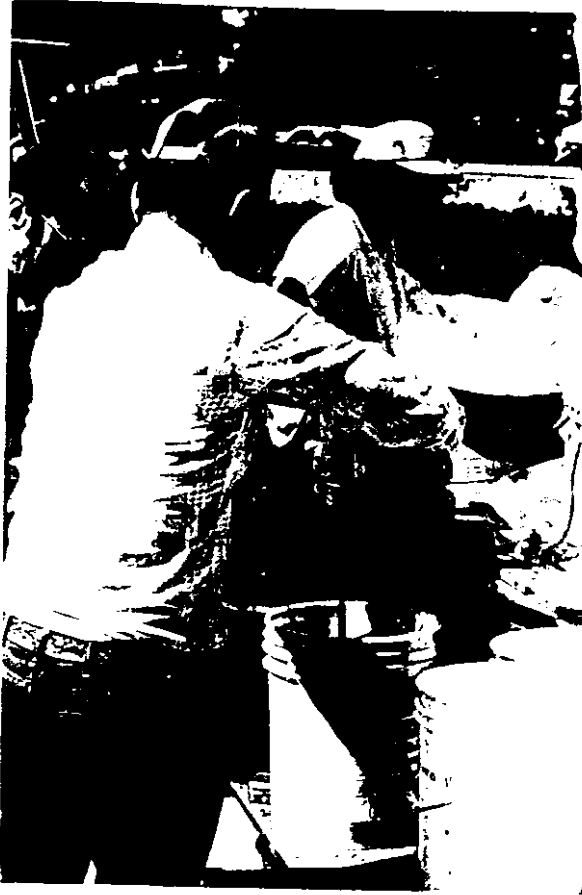
Mixing primer.

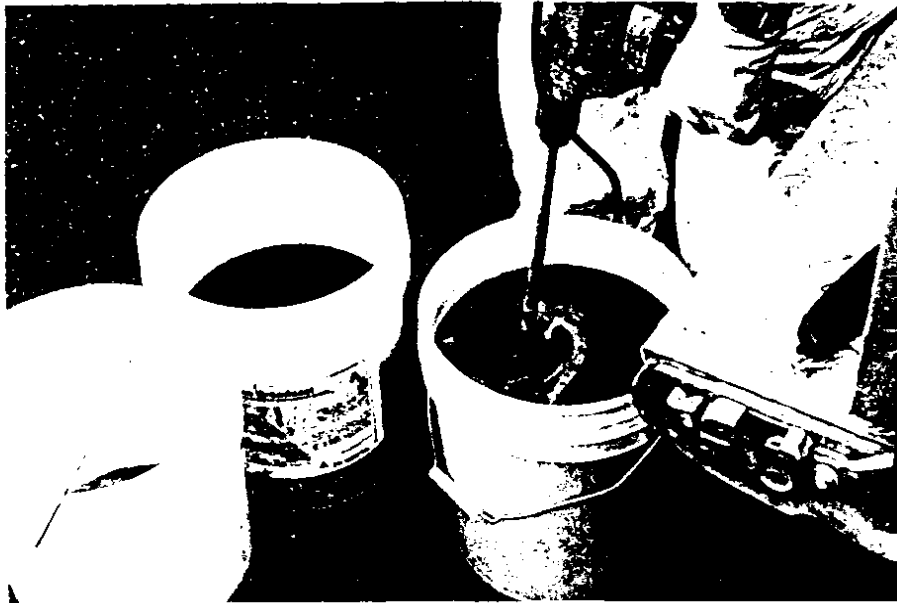
Mixing MMA resin.

The Sika Pronto 19 was mixed in five gallon batches with an electric drill mixer. The mixing was done on the bridge deck. The manufacturer's representative adjusted the amount of hardener as the temperature rose. There were problems throughout the day with the material pot-life. The Special Provisions called for a two lift application. The manufacturer's representative claimed the required depth could be attained with a single lift. It was decided to use a single lift. After brooming off excess aggregate, there were bare spots on the deck due to the resin setting up before the aggregate was applied. These areas were repaired using the original procedure.

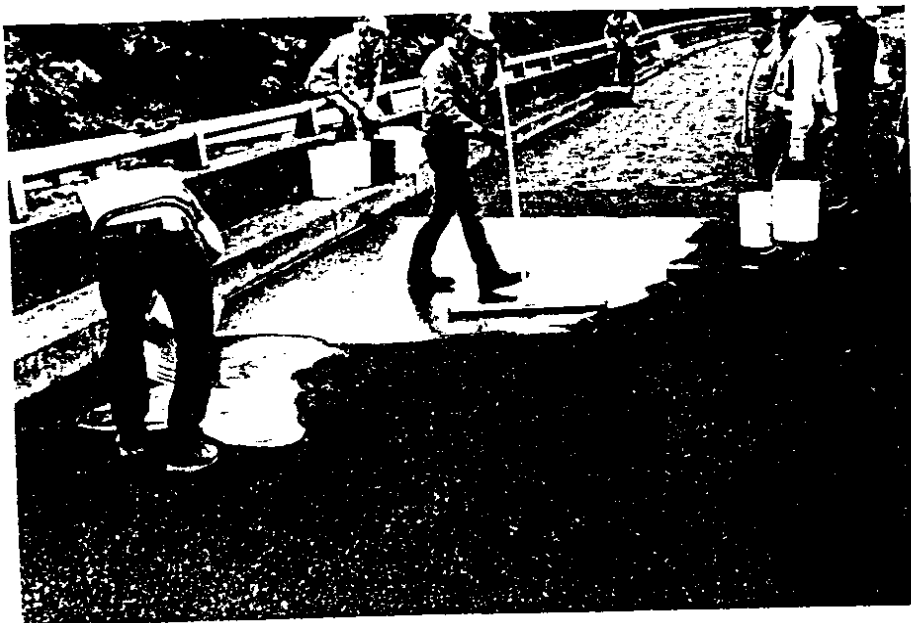
Applying MMA resin to deck.

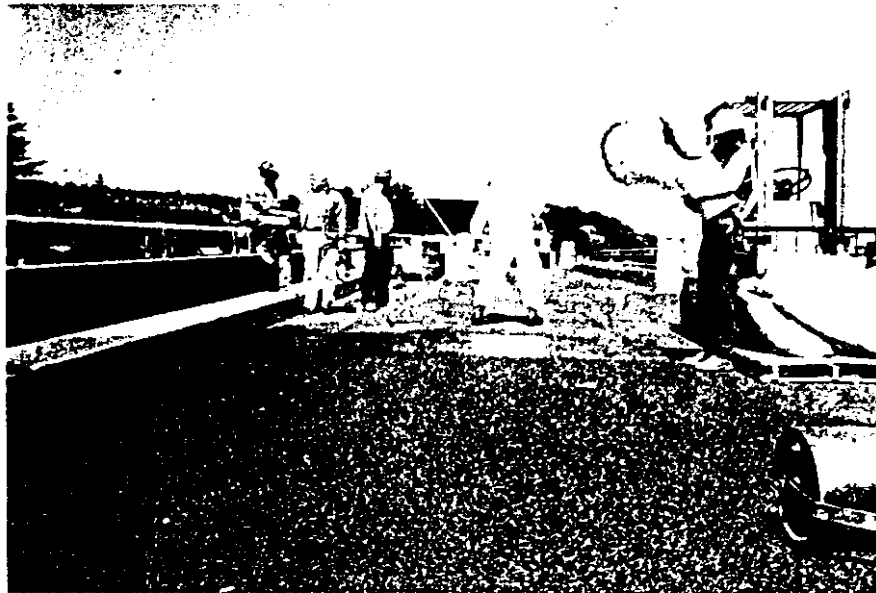
Spreading aggregate.
