# Design and Construction of a Field Test Site to Evaluate the Effectiveness of a Compost Amended Bioswale for Removing Metals from Highway Stormwater Runoff

WA-RD 724.1

WSDOT Research Report

A thesis  
submitted in partial fulfillment of the  
requirements for the degree of

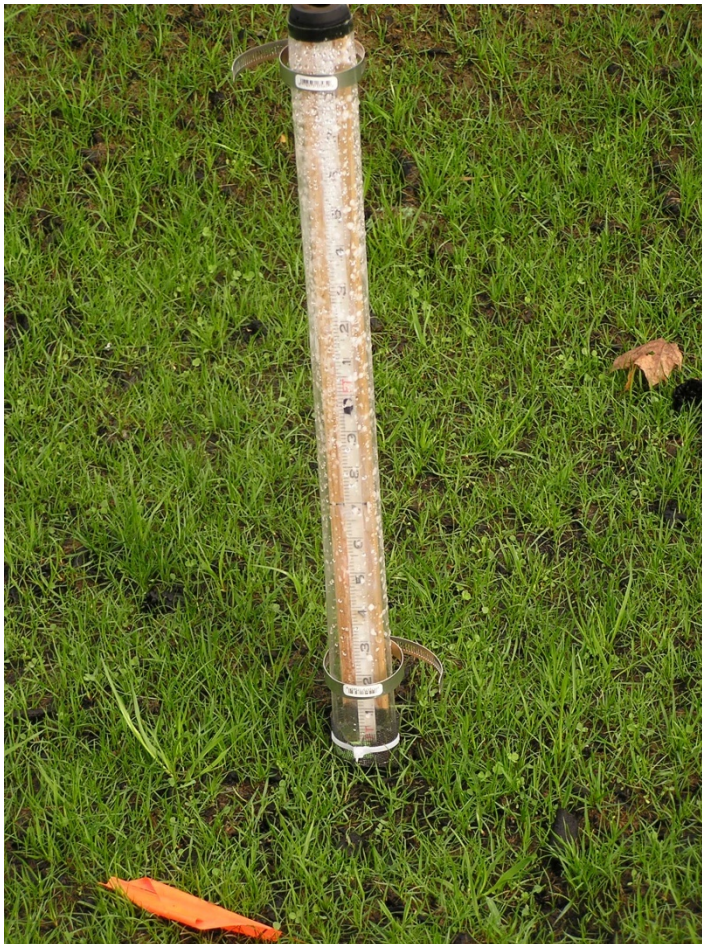
**Figure 4. Crest gauge**

Three water level “crest gauges” per swale are used to determine the maximum depth of flow in the swale per storm and to determine if the maximum depth is consistent along the length of the swale. The crest gauges are tubes with cork dust and an inlet in the bottom. As the water rises in the gauge the cork dust floats on top and leaves a ring on the inside at the maximum depth. After each storm the gauges will be read and the peak water level noted. A small amount of water is used to wash the dust down to reset the gauge (See Figure 4).

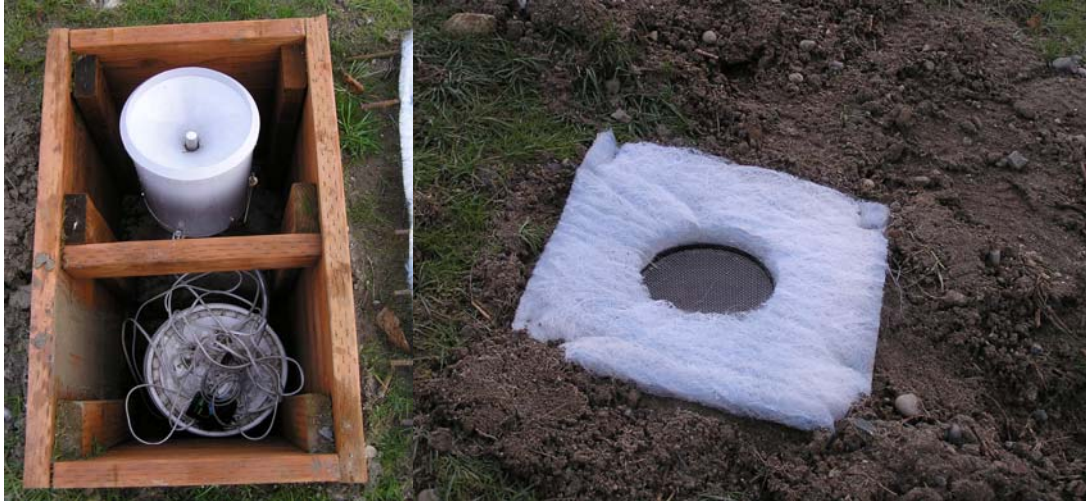
**Figure 5. TB3 (left) and ISCO (right) rain gauges installed in housing in pits**

The TB3 rain gauge is housed in a treated lumber box that allows room for the rain gauge and an accumulating bucket that is used to check the volume of water that passes through the tipping bucket gauge (Figure 5). The ISCO rain gauge is housed in a well-drained plastic 5 gallon bucket. Both rain gauges have leveling bubbles incorporated into the instrument bodies. The TB3 is mounted on 3 stainless steel rods set in concrete and the ISCO rain gauge is bolted to the bottom of the bucket. The bucket sits on a concrete pad at the bottom of the pit. Native soil is used to backfill around both housing units. A frame covered with home heating furnace air filter fabric is used to prevent water from splashing into the rain gauges. Both pits have a drain pipe leading from the bottom of the pit to a down gradient French drain to facilitate drainage.

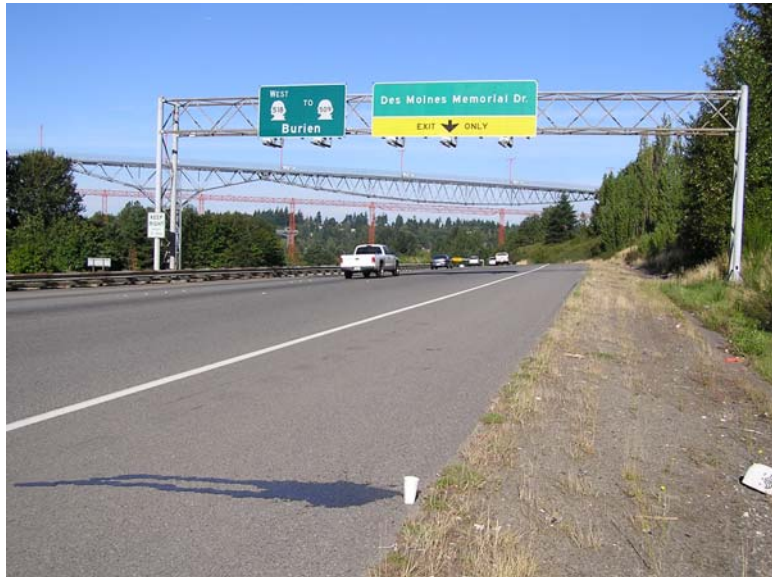
**Figure 7. Water poured on the shoulder of SR 518 to determine the contributing area**

A simple test was undertaken to determine which way the water flowed on the road. Water was poured on the shoulder to see which way it would flow. (Figure 7) It immediately flowed south

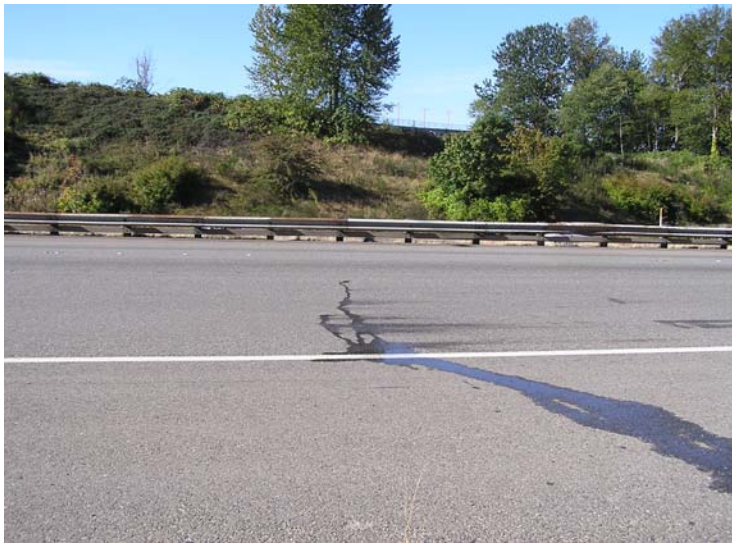
**Figure 8. Water flow across the travel lanes from north to south towards curb**

across the shoulder and toward the travel lanes. Water was slowly added to the stream and it continued to flow across the travel lanes toward the curb on the south side of the highway. (Figure 8) This test was repeated at the beginning and the end of each contributing area with the same results in each case.

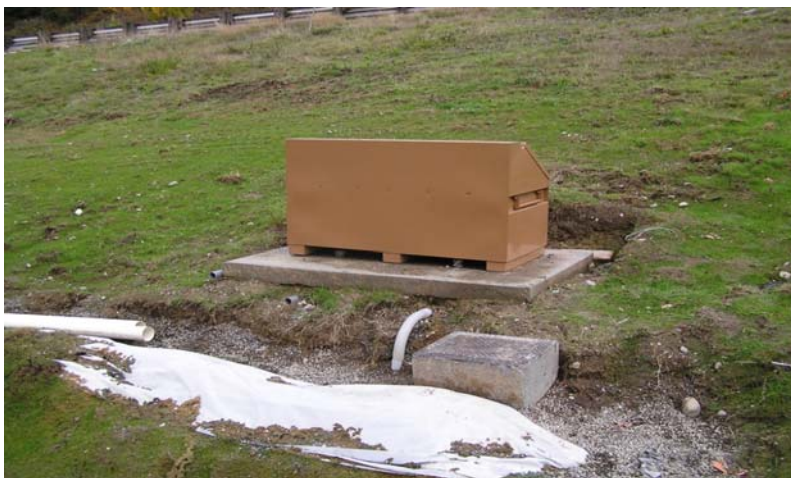
**Figure 9. Instrument box on pad**

Each monitoring station is equipped with an ISCO automated sampler that is housed in a vandal-resistant and waterproof metal enclosure (Figure 9). Flow rates are measured by routing the water through flumes at the inflow and outflow of each bioswale. Water depth is measured with pressure transducers located in stilling wells at each flume.

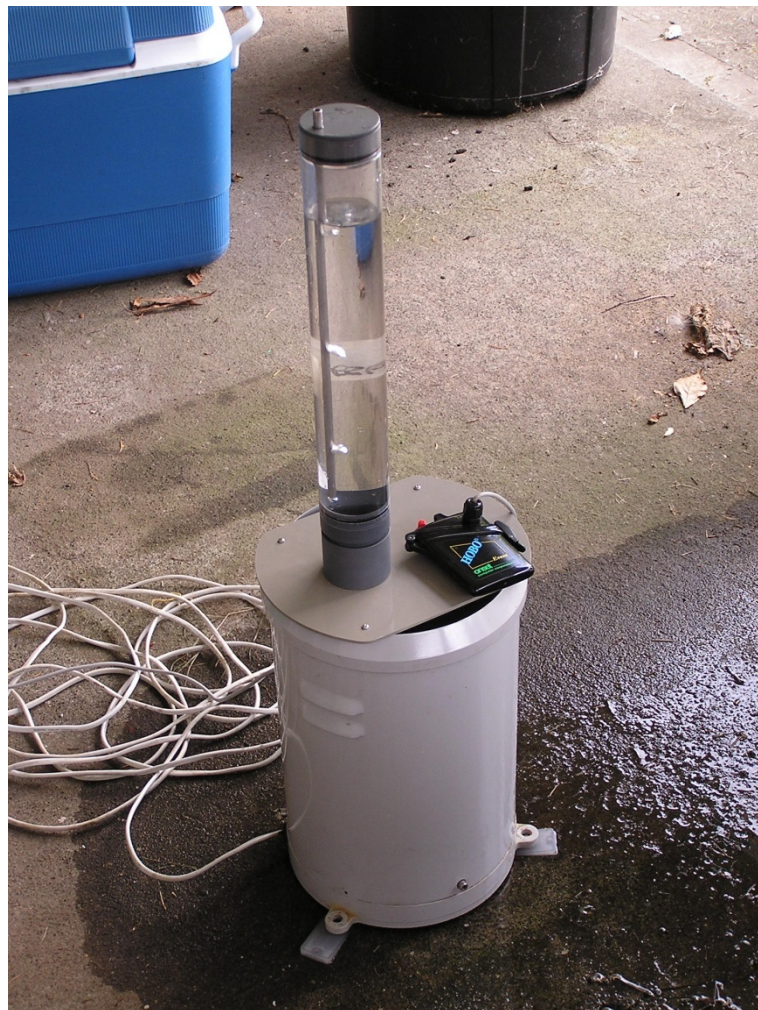
**Figure 10. TB3 “tipping bucket” rain gauge calibration with a Hydrological Services TB320 Field Calibration device and a Hobo event recorder**

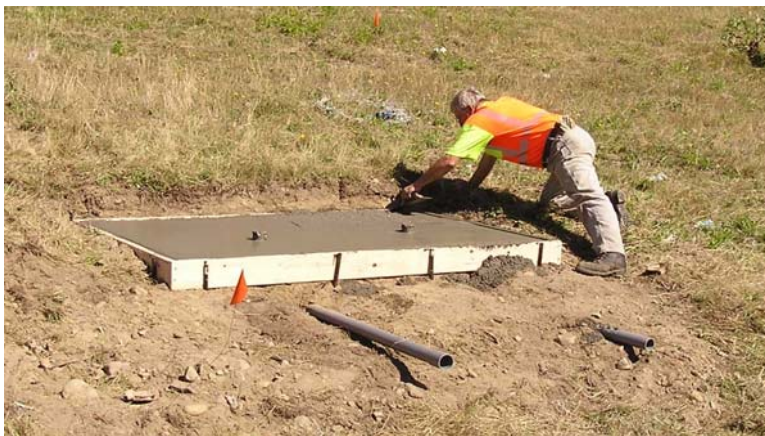
**Figure 12. WSDOT employee finishing concrete pad for instrument box**

Portland cement concrete pads were installed for the equipment boxes. Two inch conduit was installed in the pads to allow electrical wiring, cables, and tubing to enter through the bottom of the equipment boxes. (Figure 12) Two conduits were installed per box.

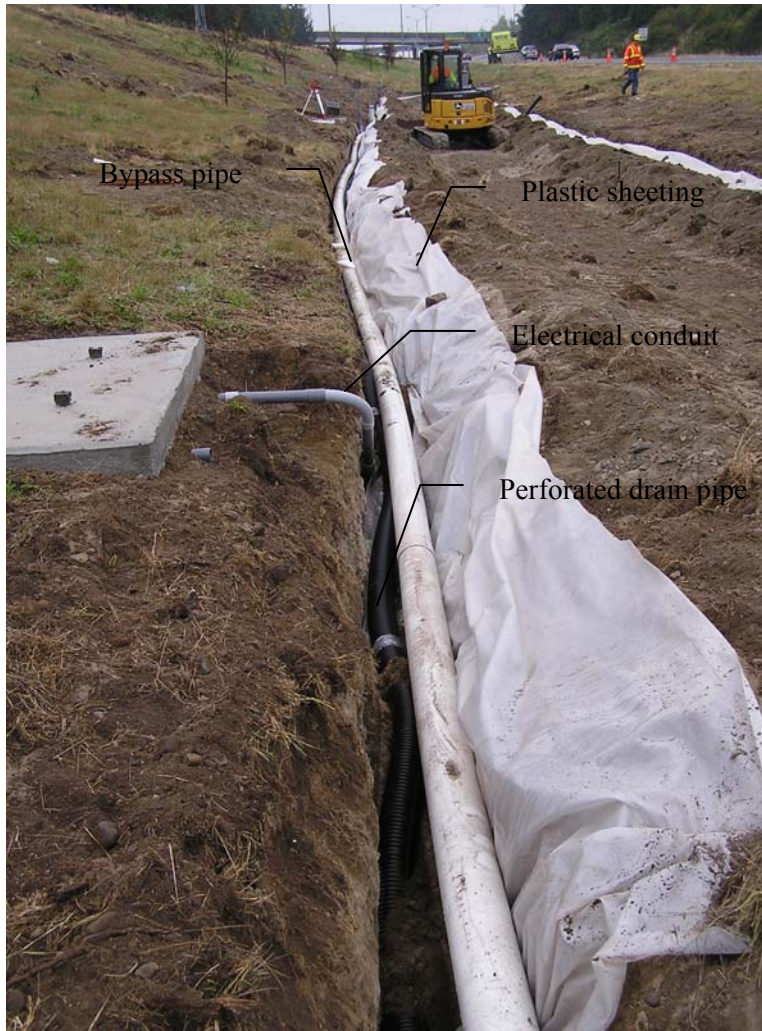
**Figure 13. French drain trench with plastic sheet lining, perforated (black) and solid pipe (light), and electrical conduit installed**

The trenches for the French drain and pipes from the curb cuts to the bioswales were made with the excavator using a narrow bucket. The trenches for the French drain were dug, at a minimum, to the top of the basal till layer, or two feet, whichever was deeper. The trenches for the pipes and electrical conduit were a minimum of 2 feet deep to meet local building codes for minimum cover for electrical conduit. (Figure 13)

The trenches for the French drains were lined with plastic on the bottom and bioswale (inside) sides. The top of the plastic was draped over the mounded soil from the trench excavation on the bioswale side of the trench and covered with additional soil to hold it in place (Figure 13). Conduit for electrical pipe, a 4 inch diameter perforated pipe, and a 6 inch diameter solid drain pipe was placed in the trenches on the instrument side of the bioswale and a 4 inch diameter perforated pipe and a 6 inch diameter solid drain pipe were placed on the opposite side of the bioswales (Figure 13).

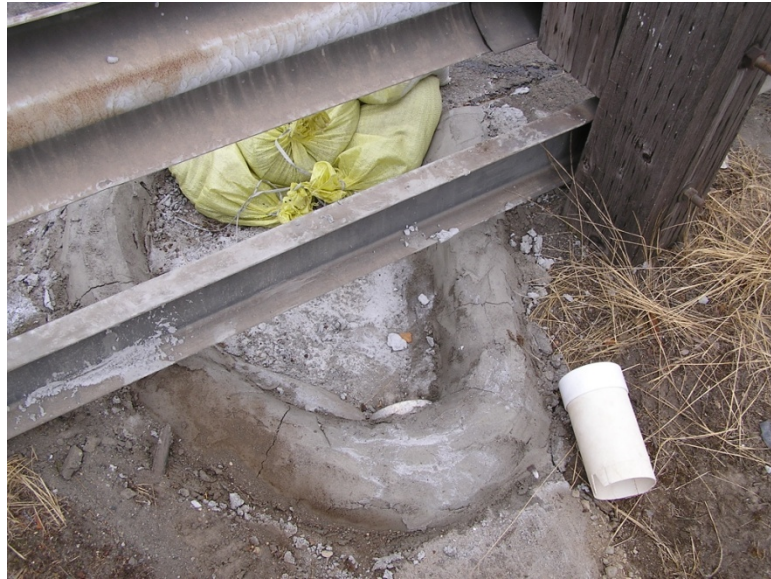
**Figure 16. Curb cut and inlet pipe with temporary cap removed and flow blocking sandbags in place**

The curb on the south side of SR 518 was cut in two places to create an inlet for the water to flow into each of the two pipes that feed the bioswales. A concrete pad was made behind the curb cut and a 4 inch diameter solid “schedule40” PVC pipe was embedded flush with the bottom of the pad. A concrete curb was built on the pad to funnel water to the pipe. Each pipe

was fitted with a removable cap and sandbags placed in front of the inlet to prevent water from flowing into the pipe until the site was ready to receive the stormwater flows. The existing catch basins were covered and the sandbags and cap removed on March 15, 2009 when the bioswales were ready to receive water (Figure 16).

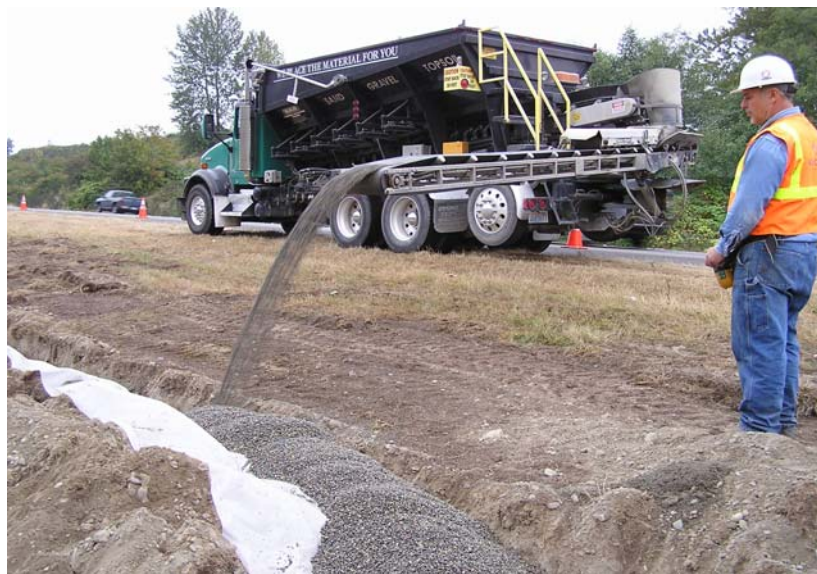
**Figure 17. Pea gravel being placed in French drain by an aggregate delivery truck**

Permeable “pea gravel” fill was supplied to the trenches using an aggregate delivery truck with a conveyor belt to place the gravel (Figure 17). An alternative option was to bring the gravel in with dump trucks and place the gravel with a front end loader. This truck placed the pea gravel

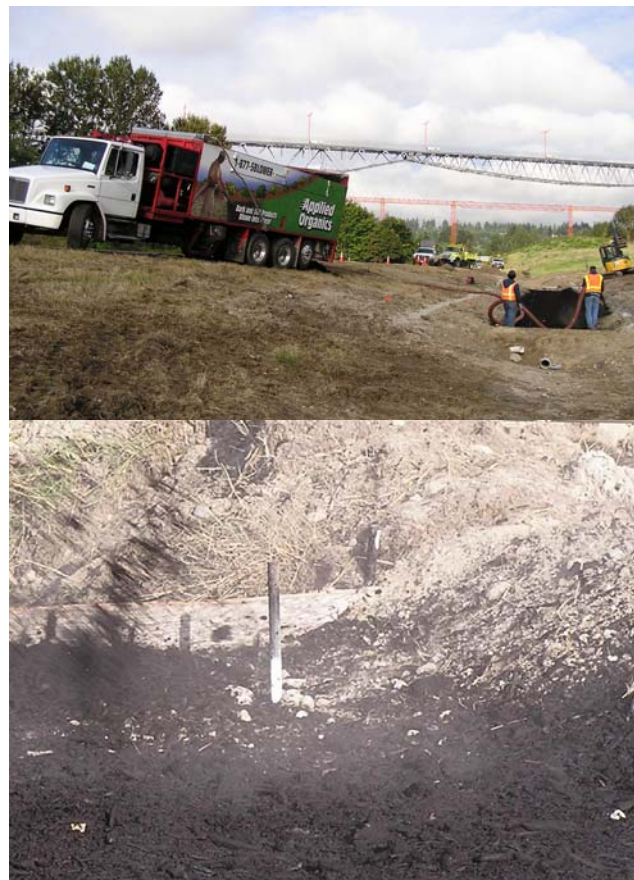
**Figure 18. Compost blower truck (top) and steel pin showing final compost depth**

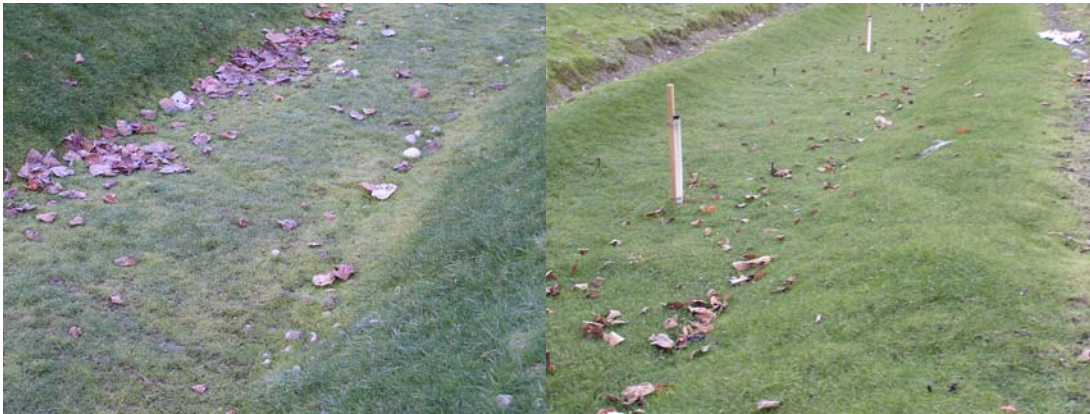
**Figure 19. Bioswale 2 (left) and bioswale 1 (right)**

The vegetation establishment on the two bioswales is noticeably different. Figure 19 shows the control bioswale and the composted bioswale side by side. The vegetation on the composted bioswale is denser and taller than the control (Figure 20). It is clear from these photos that the vegetation establishment has been enhanced by the addition of compost.

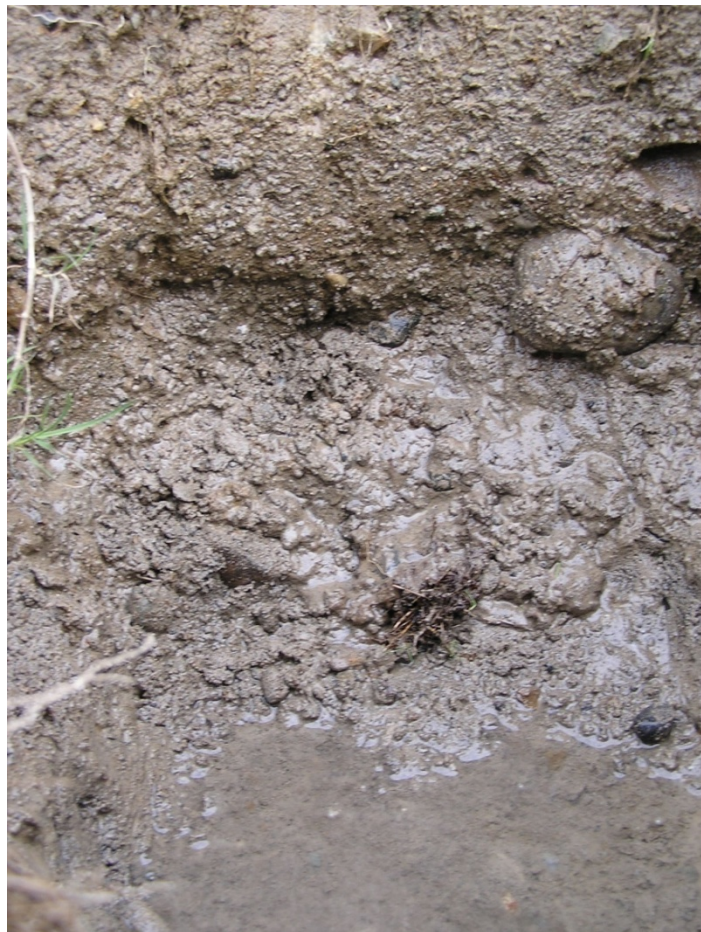
**Figure 21. Water seeping from sides of ISCO pit**

While digging the hole for one of the pit rain gauges water was observed seeping from the sidewalls of the hole and collecting on the bottom of the pit. The seepage is evident Figure 21.

This seepage is instructive in two ways. First it shows the need to place a drain in the pit to avoid water build up that could back into the rain gauge, but more importantly, it shows why the French drain is important around the bioswale to keep the water

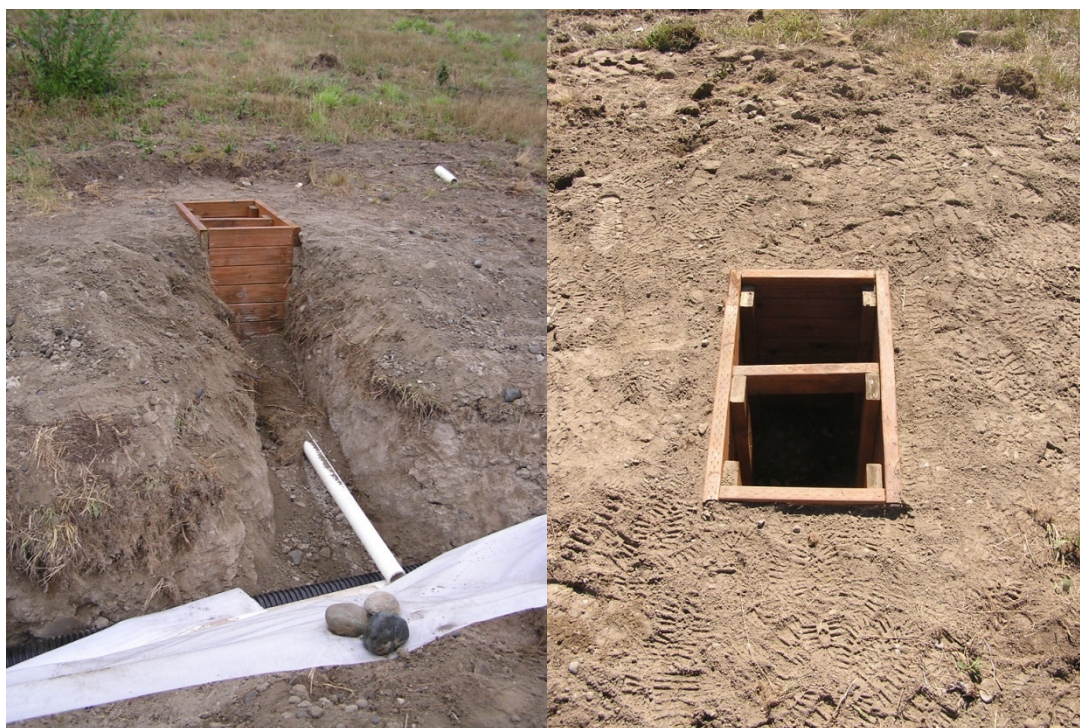
**Figure 25. Wood box for TB3 pit rain gauge showing drain to French drain (left) and fully installed**

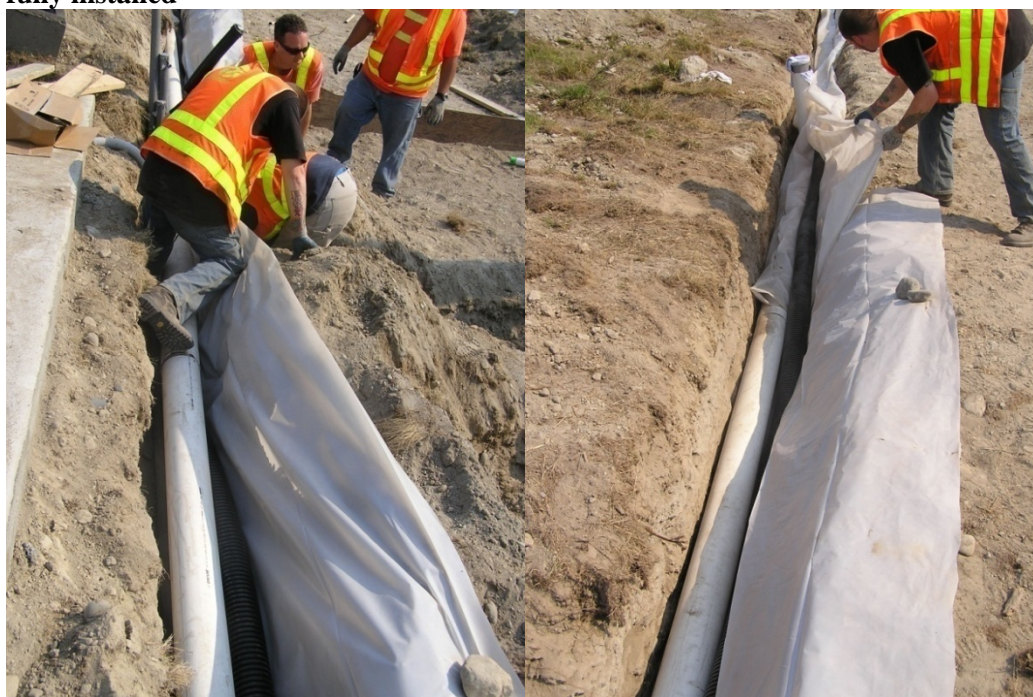
**Figure 26. WSDOT workers installing pipe and plastic sheeting in French drain**

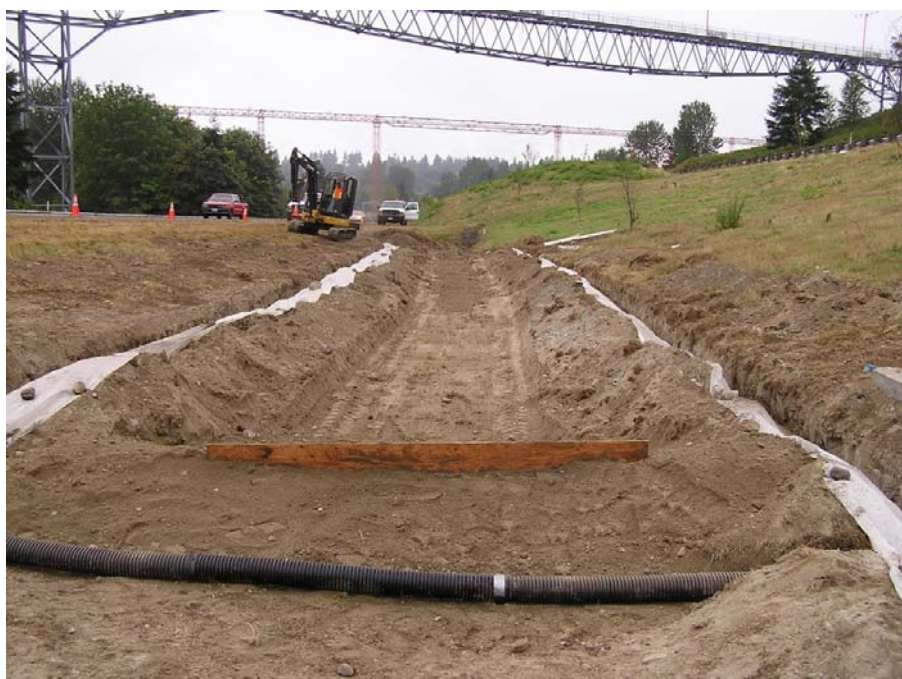
**Figure 27. Bioswale 1 with dam at bottom end and French drains**

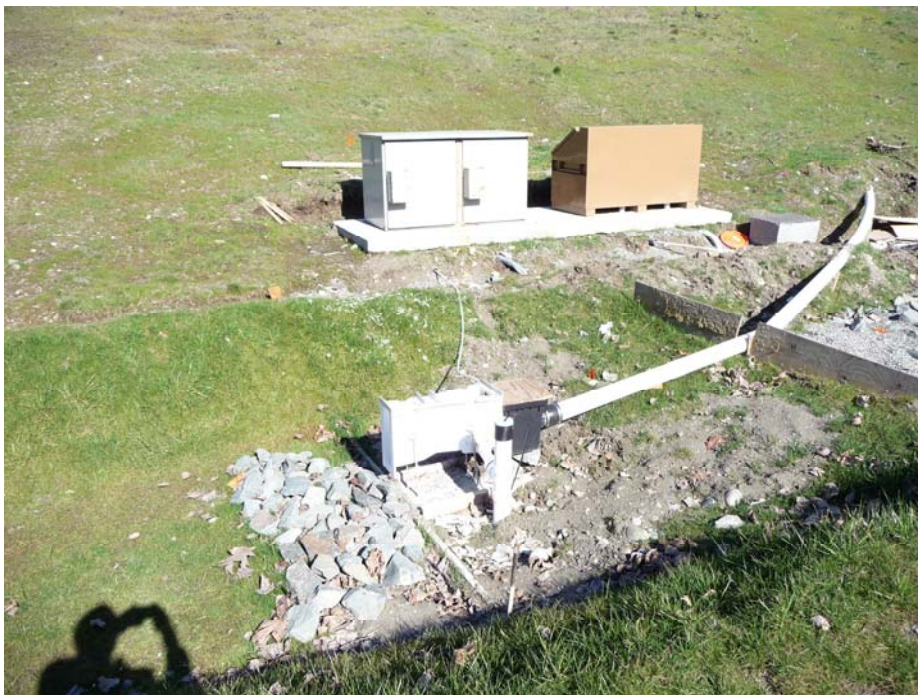
**Figure 34. Parshall flume at inlet to bioswale 2**

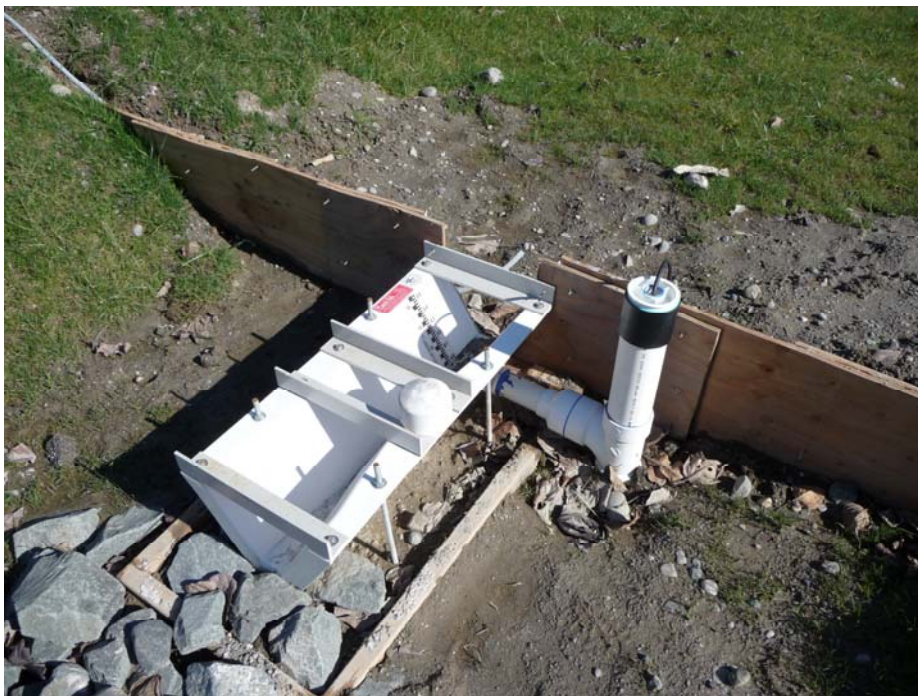
**Figure 35. Parshall flume at outlet of bioswale 1**
