INDEPENDENT FORENSIC TEAM REPORT
OROVILLE DAM SPILLWAY INCIDENT

JANUARY 5, 2018

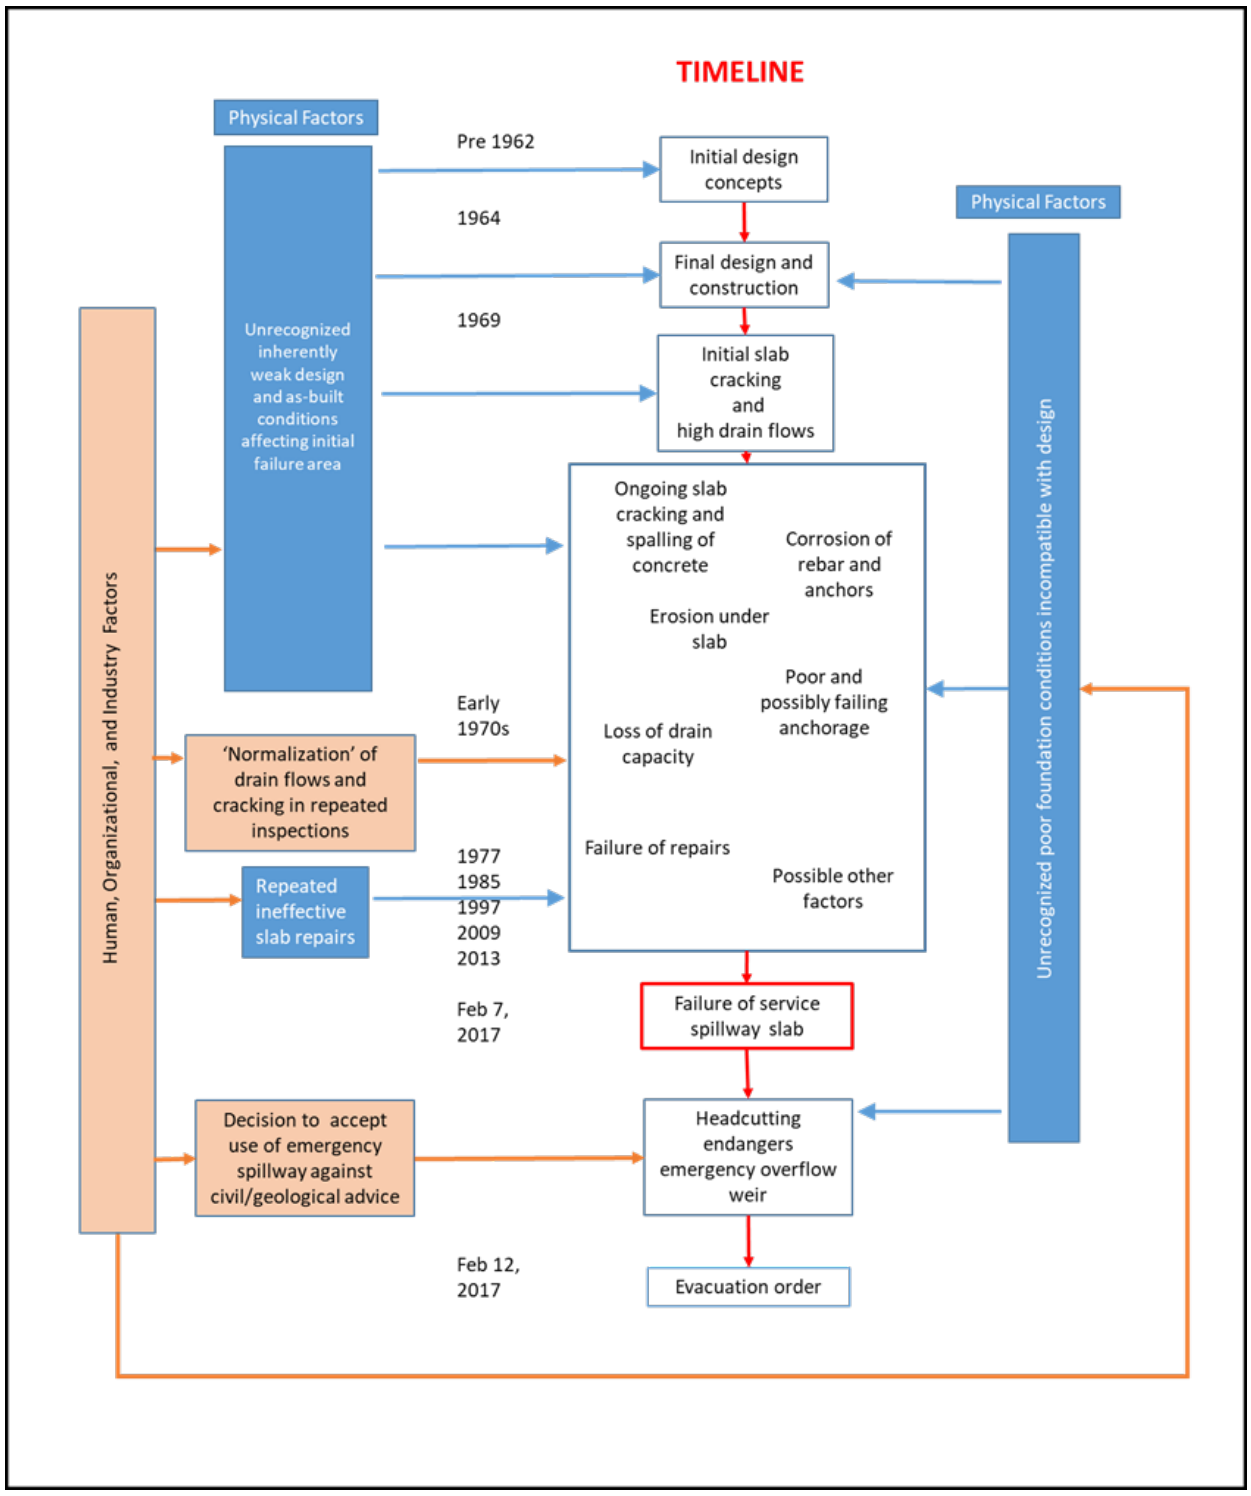
Figure S-1: Overview of interacting factors leading to the Oroville Dam spillway incident

A simplified overview of how human, organizational, and industry factors interacted with these two general categories of physical factors is given in Figure S-1, and is broadly outlined below.

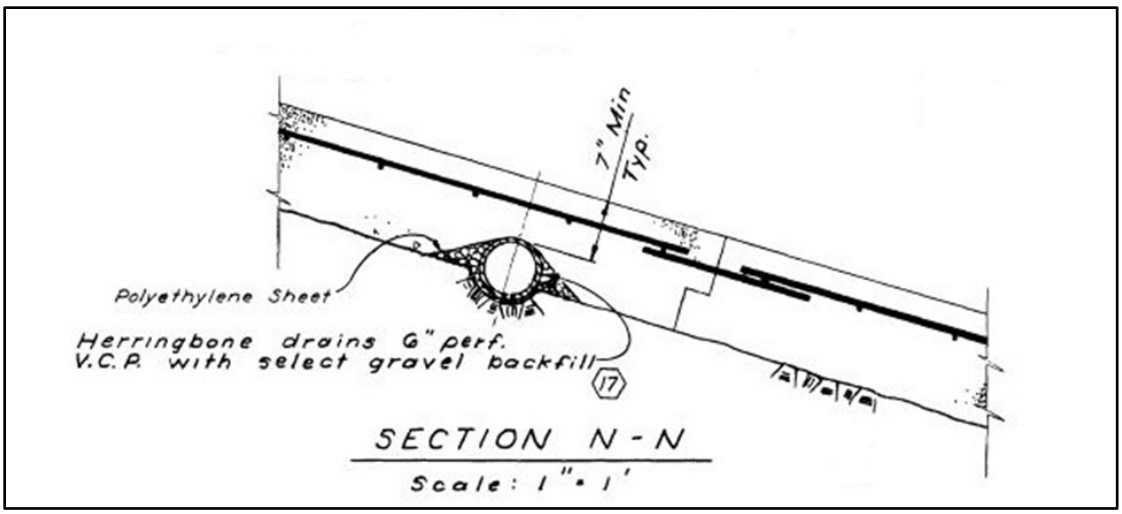
Figure 3-5: Herringbone drain VCP pipe protruding into slab section [5]

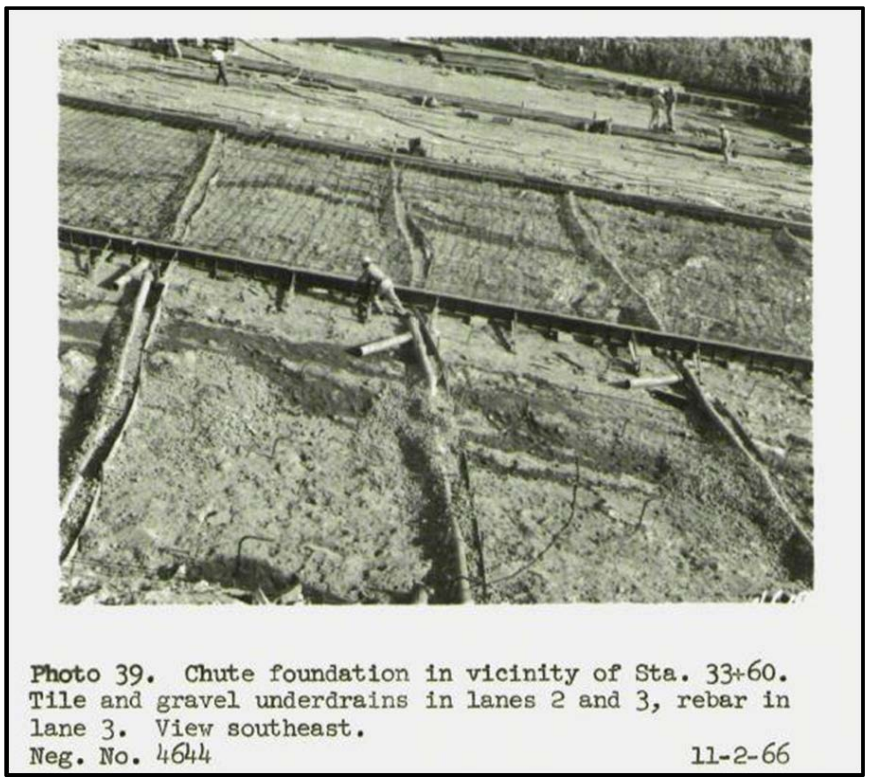
Figure 3-11: Lane 3 downstream from Sta. 33+00 being prepared for placement. [9] Note what appears to be extensive areas of soil-like materials in the foundation.

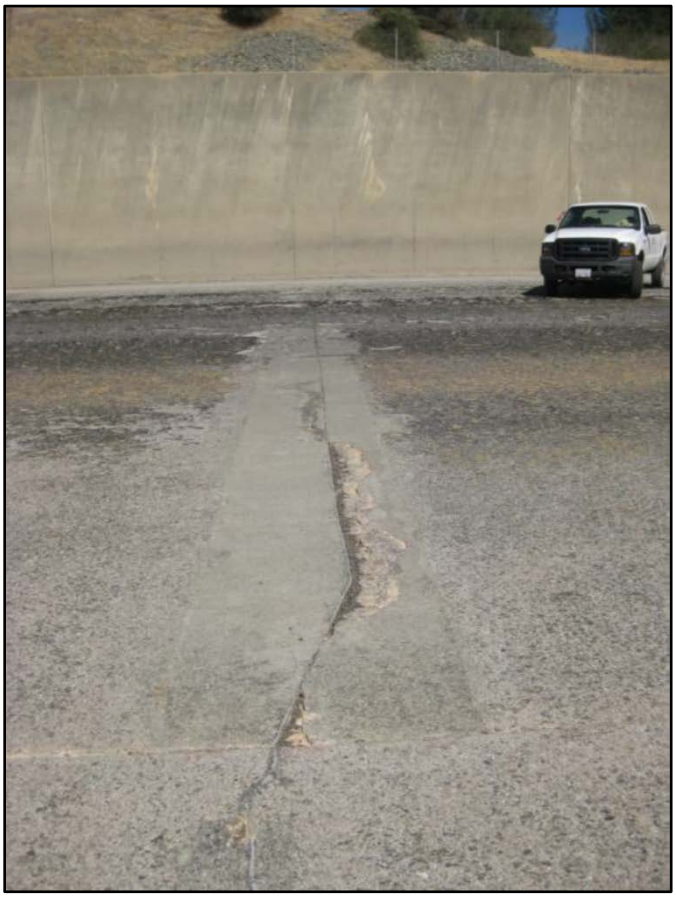
Spalling occurred almost entirely in delaminated concrete at joints and cracks and at patches from previous repairs, generally in the concrete above the level of the reinforcing steel and dowels (see Figures 3-14 and 3-15). Delamination led to spalling of the slabs near the joints and cracks. The spalling exposed reinforcing steel in the chute slabs and dowel bars at the joints to corrosion, leading to bar failure (see Figure 3-13) when subjected to tension during the winter contraction cycle. Depending on the magnitude and orientation of the spalls, vertical faces that create stagnation pressures[7] could have been created.

Figure 3-14: Spalling of previous patch [11]

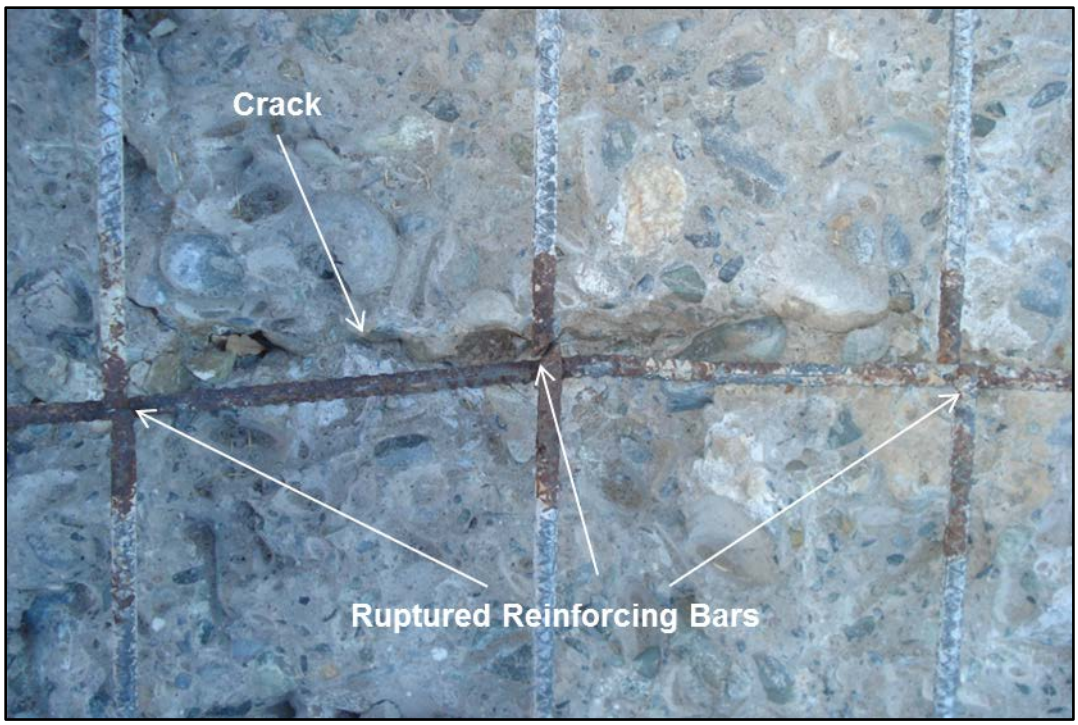
Figure 3-15: Corroded and ruptured steel reinforcing bars at a slab crack [11]

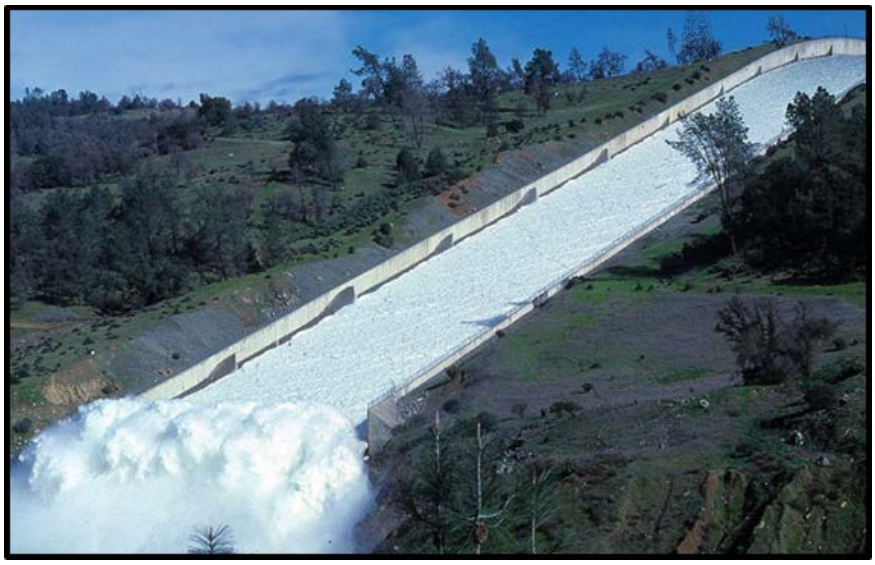
The IFT concurs. The amount of water that discharged from the drains when there was flow in service spillway is unprecedented in the IFT's experience (see Figure 3-16).

Figure 3-16: Service spillway drain flows, February 3, 2006 (photo provided by DWR)

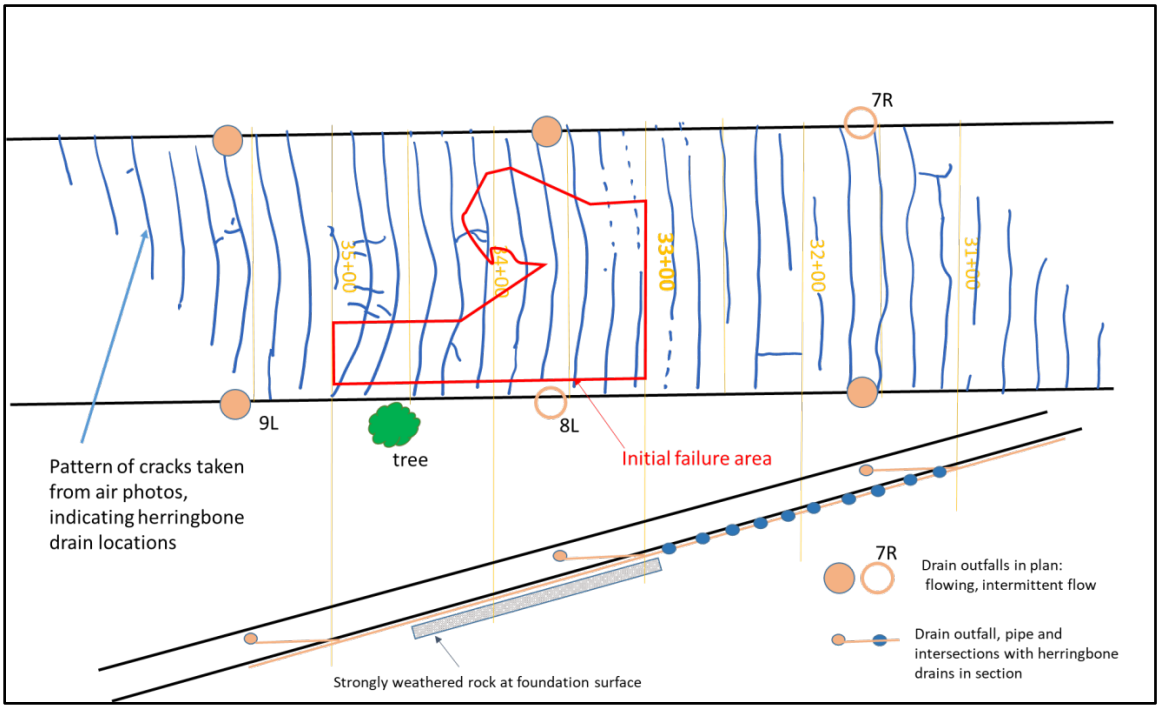
In evaluating the drain outfall flows, it is important to recognize that, because of the design of the drain system, each outfall collects drainage from a series of herringbone drains located no closer than about 60 feet upstream of the outfall, as shown in Figure 3-17.

Figure 3-17: Drain outfalls and herringbone drains in the vicinity of the initial chute failure

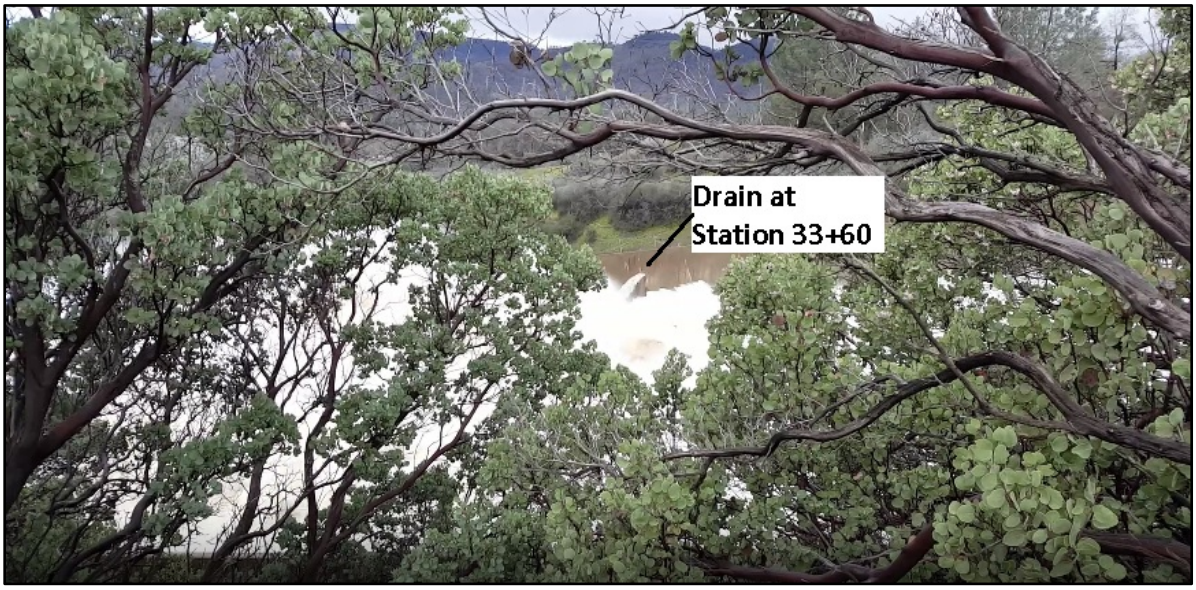
The DWR personnel arrived at the siren location at about 10:00 am on February 7. At about 10:10 am, they heard what they said sounded like an explosion or a loud bang, and they saw spray coming from the spillway chute. They turned to see a significant disturbance in the spillway flow. At 10:23 am one of them began to record video and take photographs of the disturbed flow in the chute, as shown in Figure 4-2. They stated that the flow disturbance subsequently moved upstream and toward them (toward the left side of the chute).

Figure 4-2: Flow in the chute at 10:23 am (from DWR)

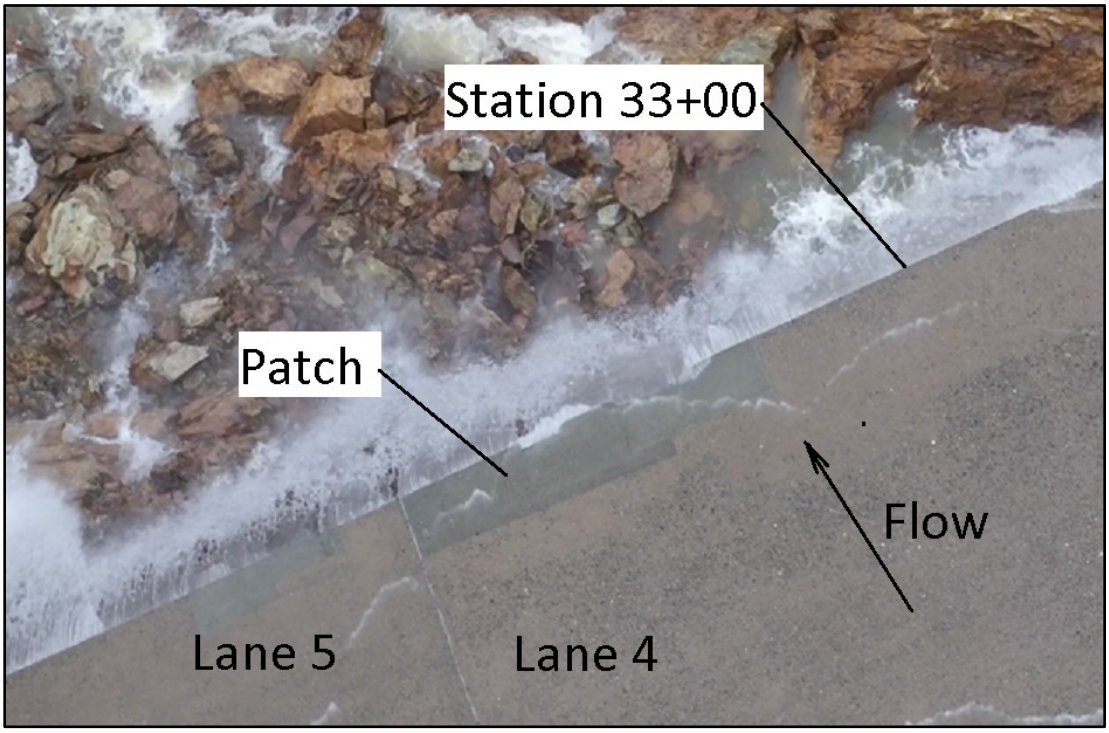
slab initiated at Sta. 33+00, in part because of a disturbance in the flow pattern on the spillway seen in a photograph reportedly taken on January 27, 2017 (see Appendix I for more discussion). However, the IFT has concluded that, although there may have been water injection along the Sta. 33+00 joint, this was almost certainly not the location of the initial failure. The slab section downstream of the joint at that location could not have lifted without shearing the concrete key in the upstream slab section, and this condition was not observed in the photos taken by a climb team or in drone videos taken on February 8, which were carefully reviewed by the IFT. The intact, overlapping key element upstream of Sta. 33+00 can be seen in a drone video image in Figure 4-5. In addition, the photographic evidence and eyewitness accounts suggest that the initial damage occurred downstream of Sta. 33+00, and subsequently progressed upstream. The conditions at the Sta. 33+00 are discussed further in Appendix I.

Figure 4-5: Joint at Sta. 33+00 on February 8 (from DWR)

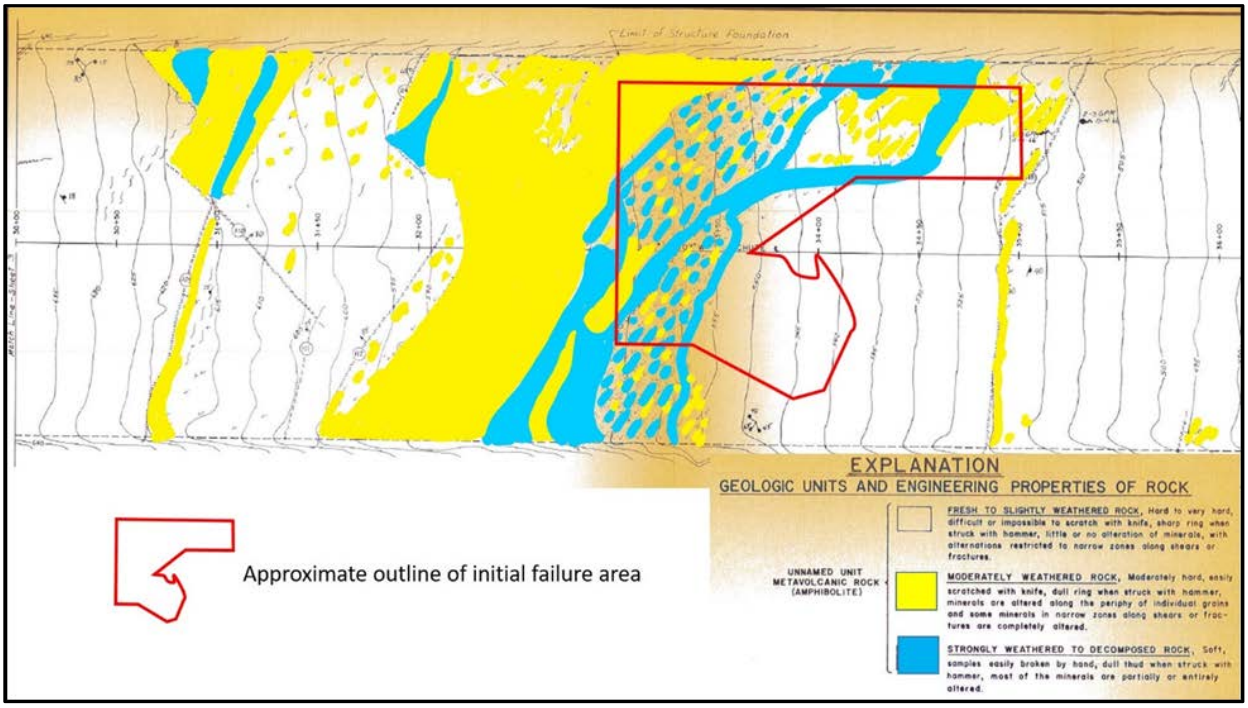
prevalent in the area of the chute slab failure. With the large amount of water that has been observed flowing through the underdrain system and the lack of filter compatibility between the drain system gravel and the erodible materials, it is conceivable that voids beneath the slab could have been created by piping (internal erosion) of the underlying materials by water flowing under the slab. As noted in Section 4.1.1, the IFT believes that any voids that would have formed would have been shallow (perhaps a few inches at most), rather than deep. With extended periods of underdrain flows, areas of voids could expand laterally beneath the chute. This would increase the size of areas of uplift pressure beneath the slab and also more readily transmit stagnation pressures over greater distances, resulting in an increase in the net uplift force on the slab. With the thickness of the chute slab and the anchors which would support the chute slab, voids beneath the slab would be difficult to detect.

Figure 4-6: Extents of moderately and strongly weathered rock.
Geologic mapping from Final Geologic Report [9]

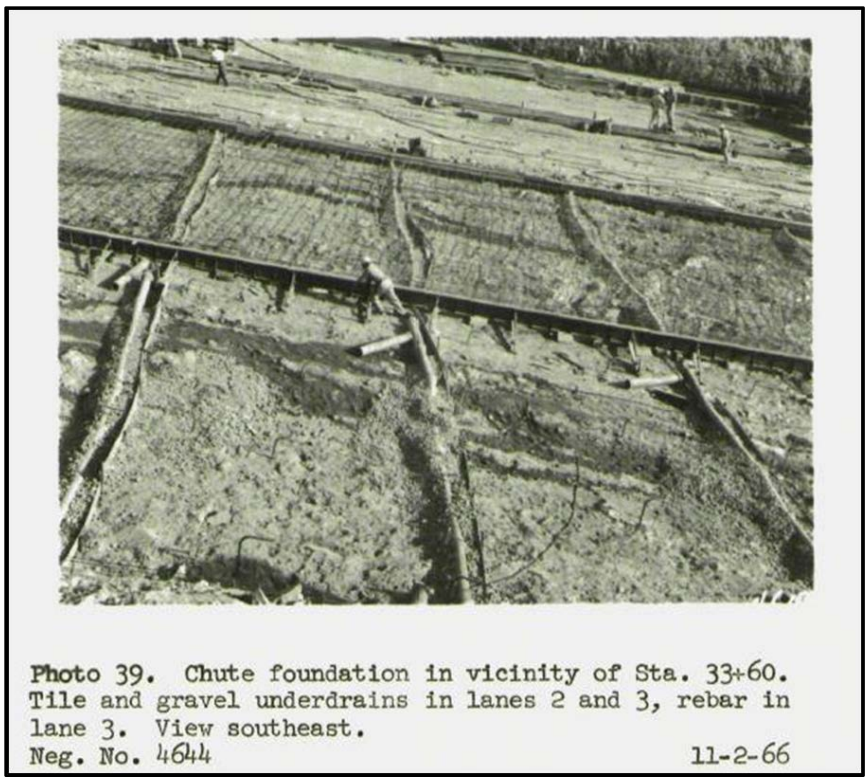
Expansion of relatively shallow void(s) under the slab: During construction, erodible materials were left in place in the foundation beneath the chute slab to varying extents and depths. Beneath the chute slab sections that were removed during post-incident forensic investigations, the erodible materials were found on top of and around areas of less erodible rock and are believed to be material left from incomplete cleaning and preparation of the rock foundation. In construction records, these materials were called “compacted clayey fines.” Only one void of limited extent was found beneath the remaining slabs in the post-incident forensic investigations, despite investigation locations being targeted in part at areas with “compacted clayey fines.” However, based on original geologic mapping of the chute foundation and limited available construction photos (see Figures 4-6 and 4-7), the IFT believes that erodible materials were much more

Figure 4-7: Lane 3 downstream from Sta. 33+00 being prepared for placement. [9] Note what appears to be extensive areas of soil-like materials in the foundation.

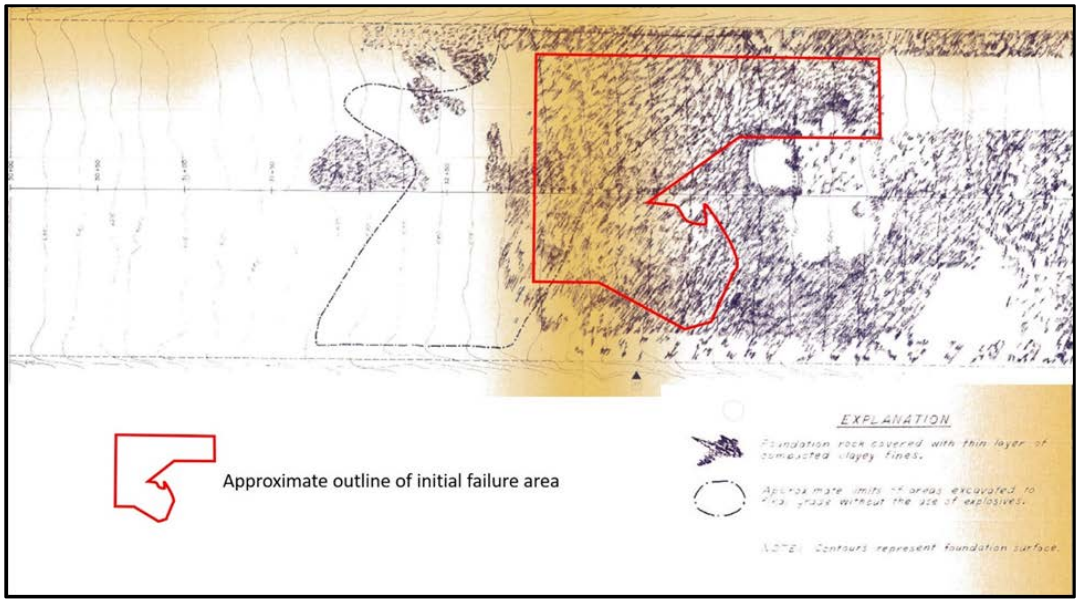
The foundation material beneath the chute slab in the area of the slab failure also plays a significant role in two of the four factors noted above. Based on the chute slab foundation geology maps and construction photographs (see Figures 4-6 through 4-8), as discussed in Sections 3.3.5 and Appendices A and C, the IFT believes that moderately to strongly weathered rock and soil-like

foundation conditions existed beneath the slab in the area of the initial chute failure. These conditions reduced effectiveness of slab anchorage, allowed for at least some underslab erosion, and certainly dictated the extent of the ensuing damage after the chute failure initiated. Areas immediately downstream from the initial damage area have much less weathered foundation rock conditions, where both bonding of the concrete slab and bonding of the anchor bars to the foundation rock offered significantly greater resistance to uplift, and some sections of these slabs remained in place when the gates were closed after the initial chute failure.

Figure 4-8: Extents of compacted clayey fines. Geologic mapping from Final Geologic Report [9]

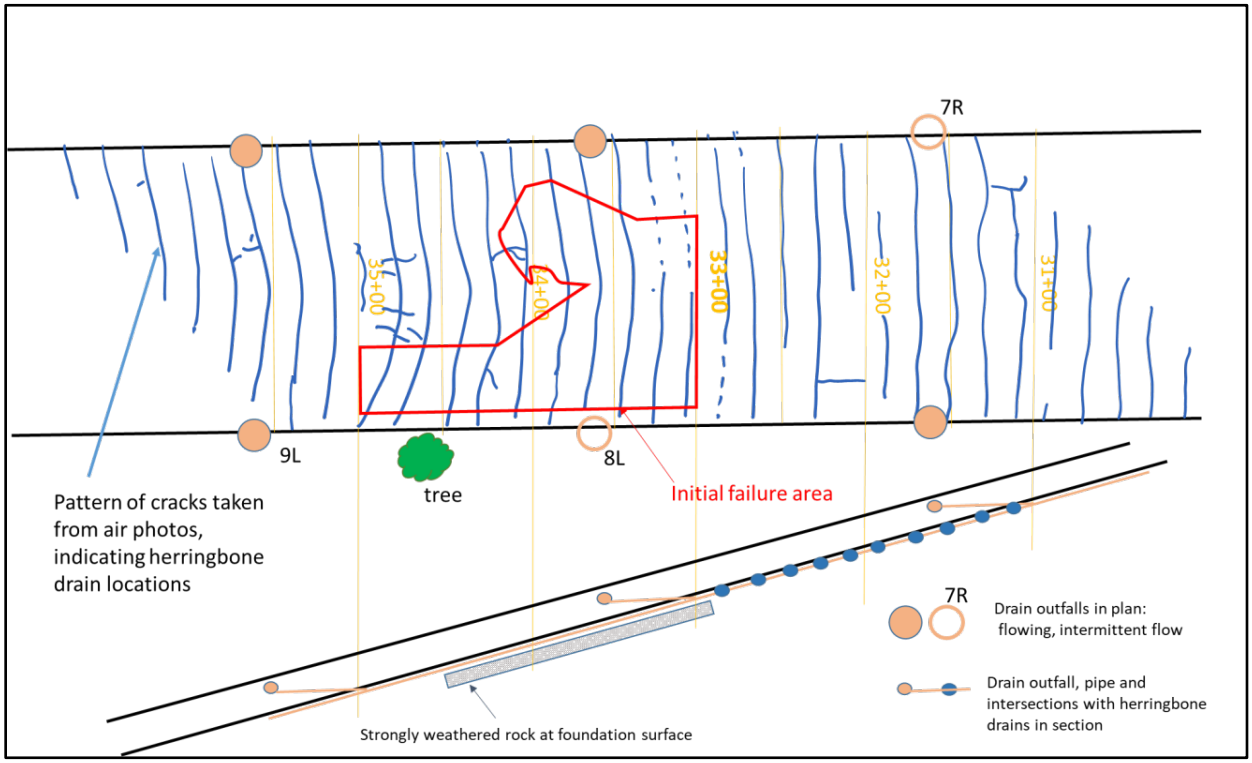
A report issued by others [20] suggested that roots from a single tree located on the left side of the spillway plugged Drain Outfall 8L (See Figure 4-12), which was observed to not be flowing just prior to the chute failure. The IFT believes that this is not plausible because of the physical arrangement of the drain system.

The particular tree in question was located very close to the left side of the spillway about 100 feet downstream from the initial chute failure area and Drain Outfall 8L. The layout of the drain system is illustrated in Figures 4-12 and 4-13. As illustrated in the figures, roots from this tree could not reasonably have blocked the collector pipe connected to Outfall 8L, which was the outfall observed to not be flowing. If roots from this tree blocked any outfall, it would have been Outfall 9L, which was observed to be flowing.

Figure 4-12: Schematics of service spillway chute near initial failure area

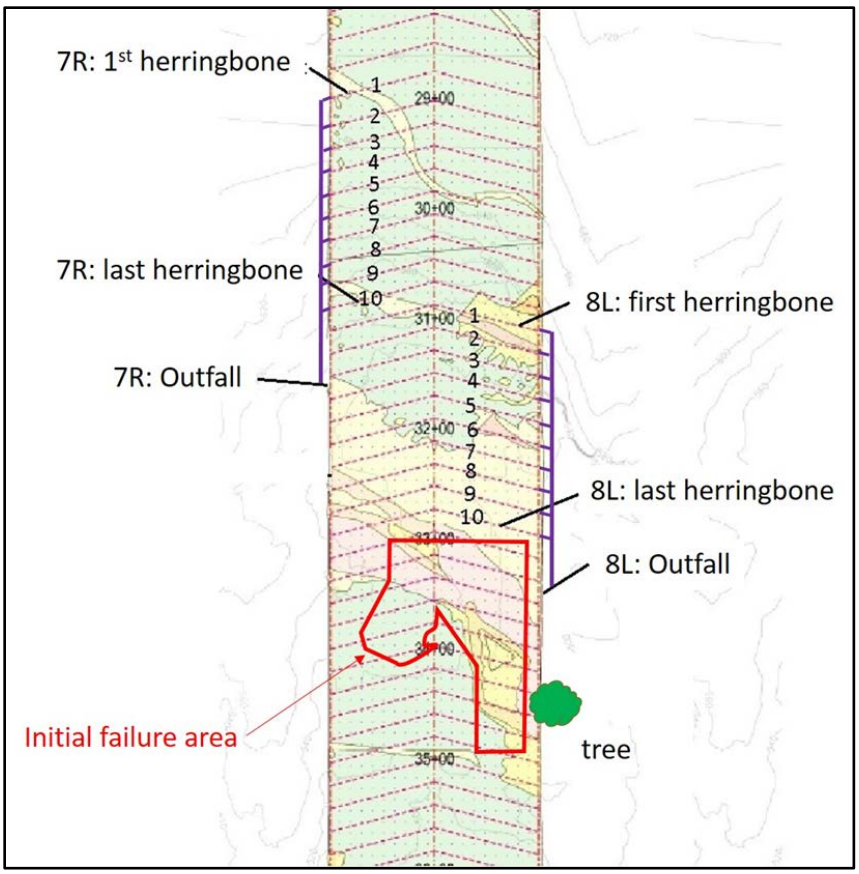
Figure 4-13: Idealized layout of spillway chute underdrains upstream of initial failure area (underlay of chute geology provided by DWR)

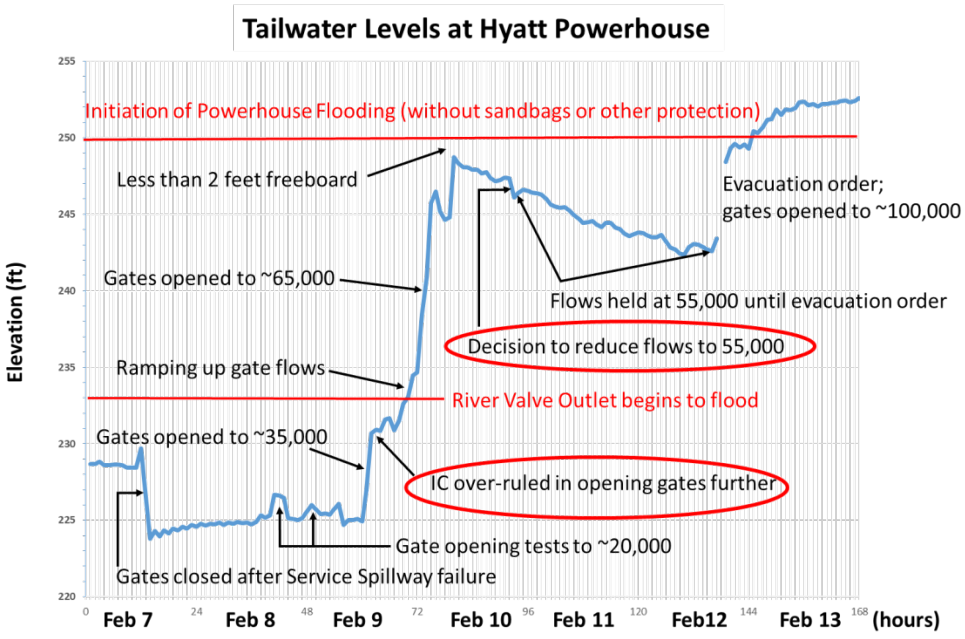
In reviewing data provided by DWR (see Figure 5-1), the IFT found that, at the times these decisions were being made, there was no immediate threat of powerhouse flooding. In fact, when service spillway flows were reduced at about 7:00 pm on February 10, the tailwater level was actually falling and the threat to the powerplant was diminishing, even with the 65,000 cfs discharge. When the IFT asked a number of DWR personnel who were involved in the incident about the dropping tailwater level, they were surprised to hear this information. By their accounts, after the decision had been made to reduce discharge to 55,000 cfs, there was apparently little to no further discussion regarding whether service spillway discharges could be increased to reduce the risk of overtopping the emergency weir – this risk had been accepted. Further, the IFT learned that technical personnel had opined that the transmission tower was stable, and, due to better upstream rock quality, headcutting extending up to the service spillway headworks was no longer considered a major concern, based on their engineering judgment.

Figure 5-1: Tailwater levels during the Oroville Dam spillway incident

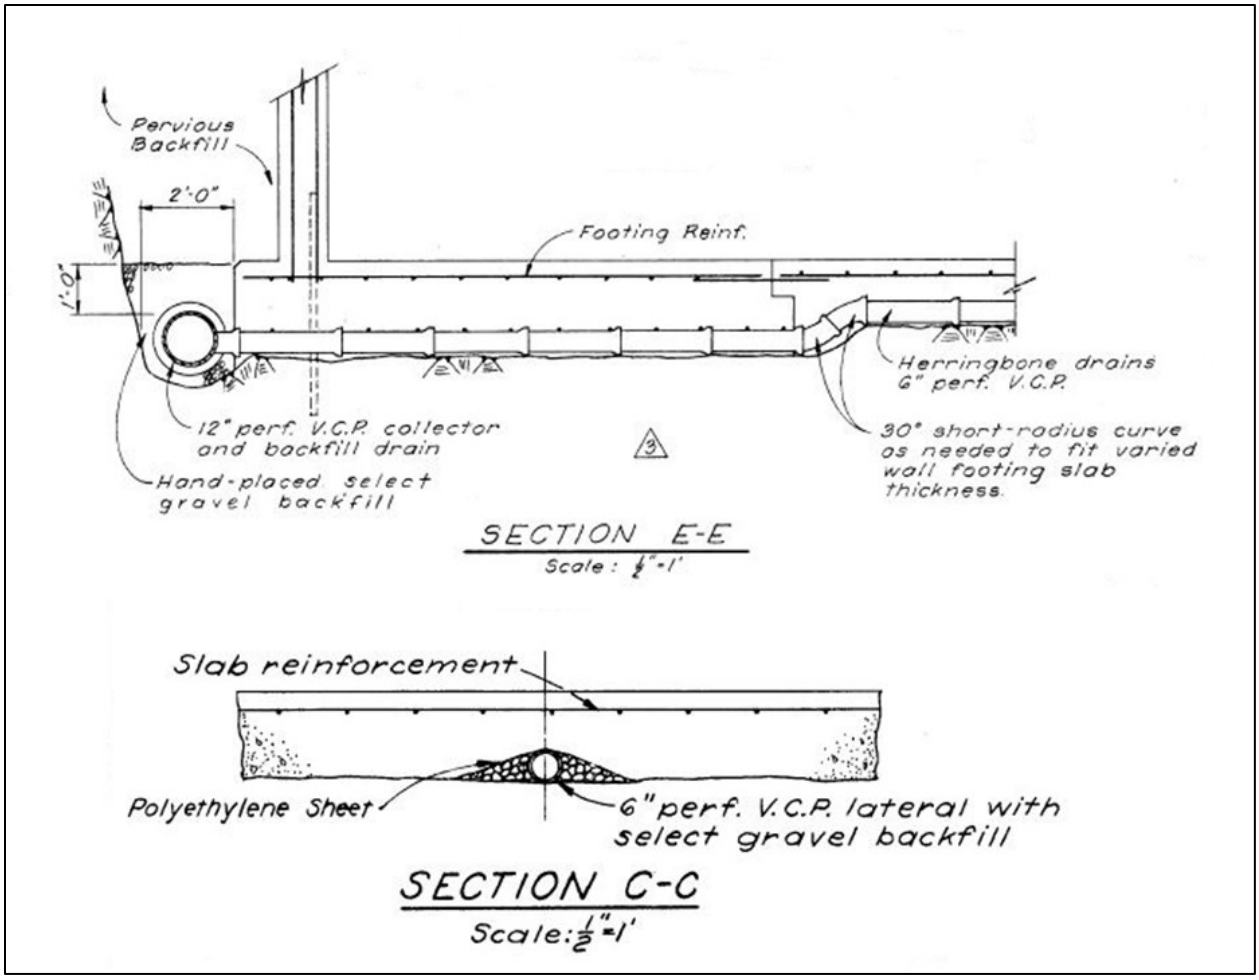
Figure A-4: Upper Spillway Chute Drains Showing Herringbone and Collector Drainage (top) and Herringbone Installation Beneath the Chute Slab (bottom) from As-built Drawing A-3B5-3

With the as-built changes, the collector pipes begin as 12-inch perforated pipes, replacing the separate 8-inch perforated backfill drains, then extend downstream as non-perforated VCPs, set at a flatter angle than the chute slope, and eventually discharge into the chute through outfalls that penetrate the walls (Figure A-6). Rather than having a single, common collector pipe on each side of the chute, there are many independent collector pipes on each side of the chute, each draining a section of the chute and wall. In each the upper and lower chute (upstream from Station 27+00), there are six separate pairs (one on each side in a pair) of collector pipes. The underdrain system can collect water from different sources including:

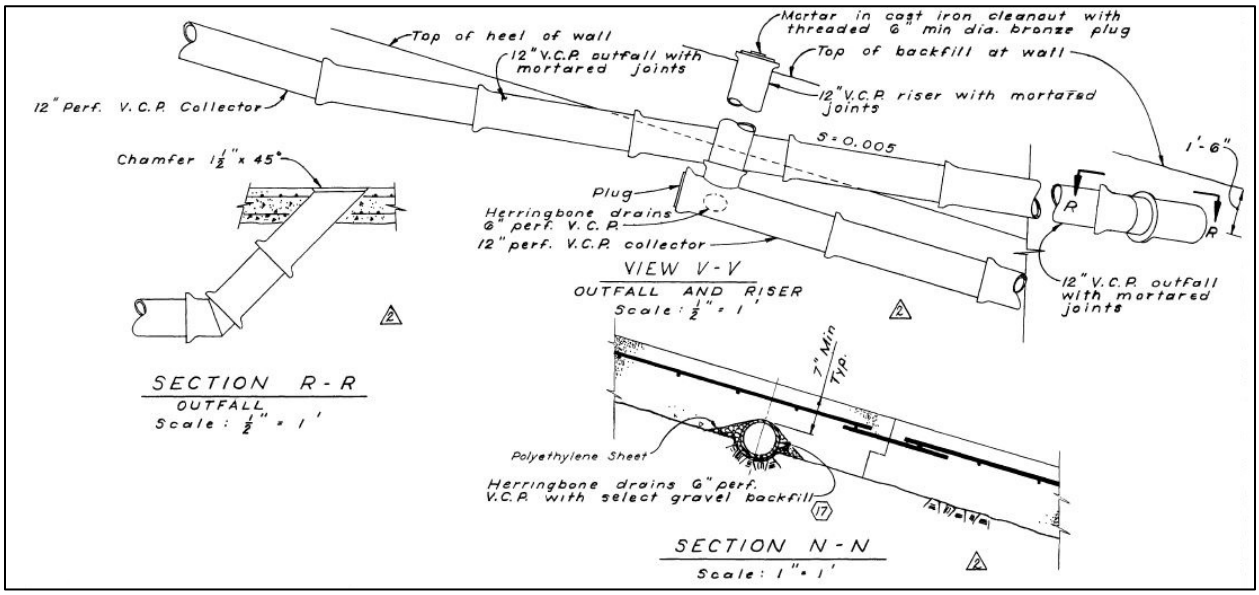
Figure A-6: Herringbone (bottom) and Collector Drain Details (from Drawing A-3B9-1)

Following the as-built design changes, the perforated lateral drains were to be placed within the bottom half of the spillway chute slab. After the drain size was increased to 6 inches, the minimum concrete cover over the drains was reduced to 7 inches above the pipe (Figure A-6). The perforated pipe was to be laid within an envelope of select gravel that was to be mounded over the top of the pipe. Perforations were to be oriented to face the foundation surface. Polyethylene sheeting was to

The herringbone drain design places the drains within the 15-inch concrete slab, such that there is only 7 inches of concrete cover above the drains (not including the bell at the connections), see Figure A-6. While this creates a problem in terms of concrete cracking above the drains, it also places the drains well above the foundation should overexcavation occur. Since the drains were intended to relieve pressure from groundwater in the foundation, it would seem that a better design would have been to place the drains on the foundation or in a foundation trench, as was being done at other dams at the time Oroville Dam was being designed (see Appendix E). There apparently was no consideration that the drains placed within the concrete slab would lead to concrete cracking and additional drainage requirements. Also, with polyethylene sheeting being placed over the top of the drain to prevent concrete contamination of the drains and gravel envelope, flow into the cracks occurring above the drains would be diverted away from the drain immediately below. Apparently, the designers, design reviewers, and staff making as-built changes to the drawings did not understand the concern related to water from the flow surface passing through cracks and joints into the foundation that other spillway designers at the time seemed to have addressed with alternative design details. Typical designs from that period included drains being associated with control joints placed above concrete keys, trenched into the foundation. The individual associated with the original design (interviewed by the IFT) recalled the design of this type of keys (which never made it into the bid specifications), but did not recall details related to placing drains beneath the chute slab.

The as-built changes resulted in the herringbone drains embedded 7 inches below the flow surface. This results in a reduced cross section at the drain locations. This reduced cross section can be expected to be a stress concentration point, and designers typically would have provided additional reinforcement in this area to prevent excessive cracking and crack opening. However, this provision was not part of the design, and there was no room for an additional mat of reinforcement to be placed over the drains. Therefore, the bar spacing would have needed to be reduced to provide

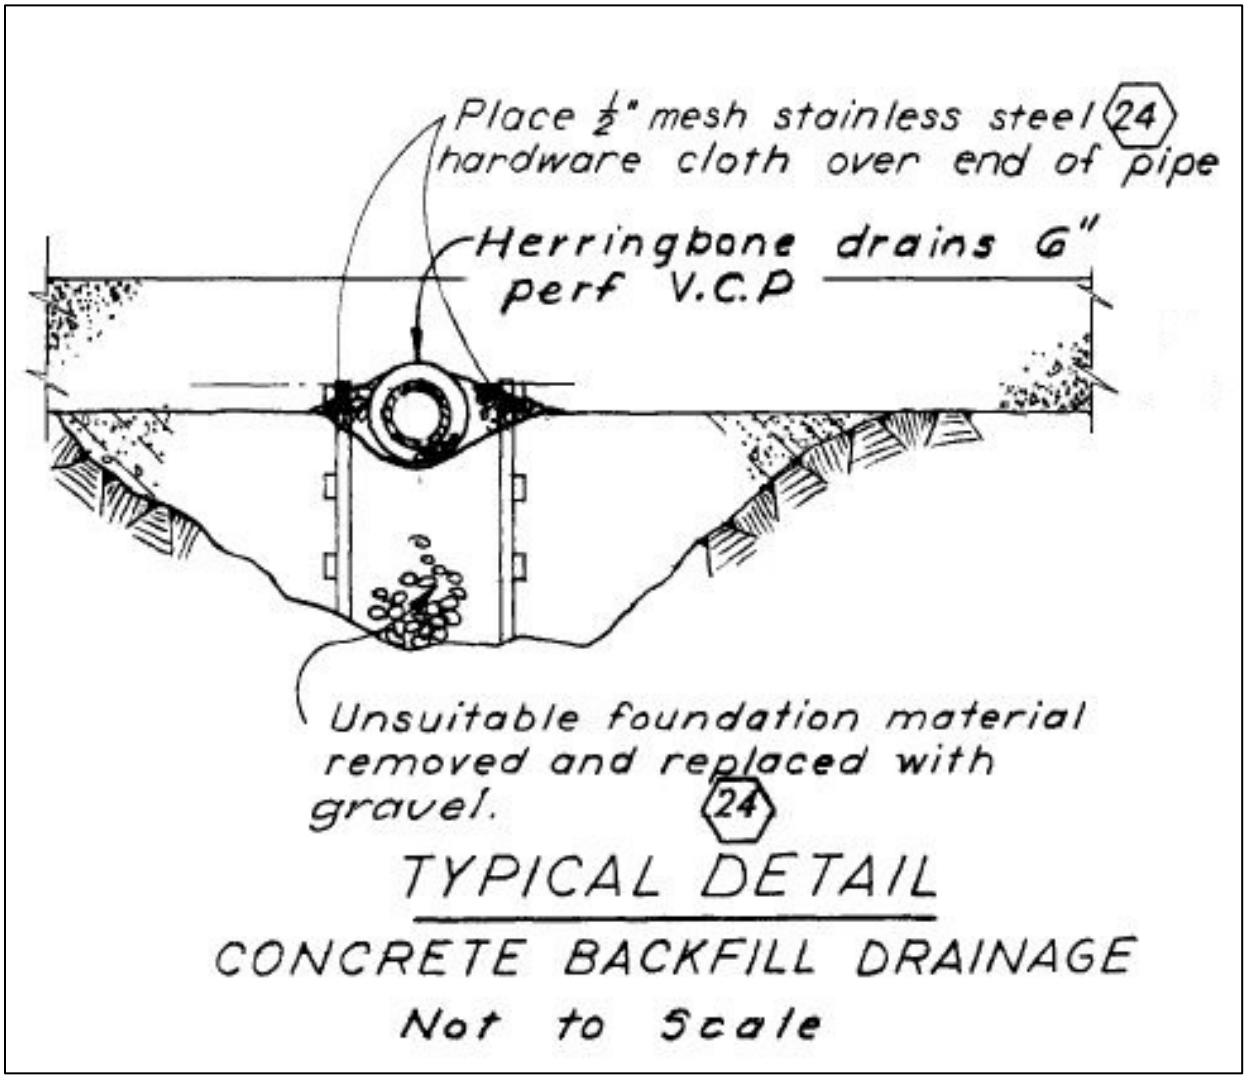
be placed over the pipe and gravel envelope. Where foundation overexcavation was required, gravel contained by wooden formwork was to be placed between the foundation and the pipe (Figure A-8). Pipe laid within the limits of the concrete was to have caulked joints. The drains were to be field adjusted to have a 1 to 4 percent slope for drainage, as discussed above. However, from cracking patterns, it appears that the drains were placed uniformly and parallel to each other in a herringbone pattern. Construction photographs show that in areas of deep overexcavations, the drains were connected to the foundation through gravel columns that were constructed by placing gravel in sonotubes, see Figure A-9 (Photo 40 of the Final Geologic Report [A-5]), or in wooden formwork.

Figure A-8: Herringbone Treatment Where Overexcavation Occurs (from Drawing A-3B9-1)

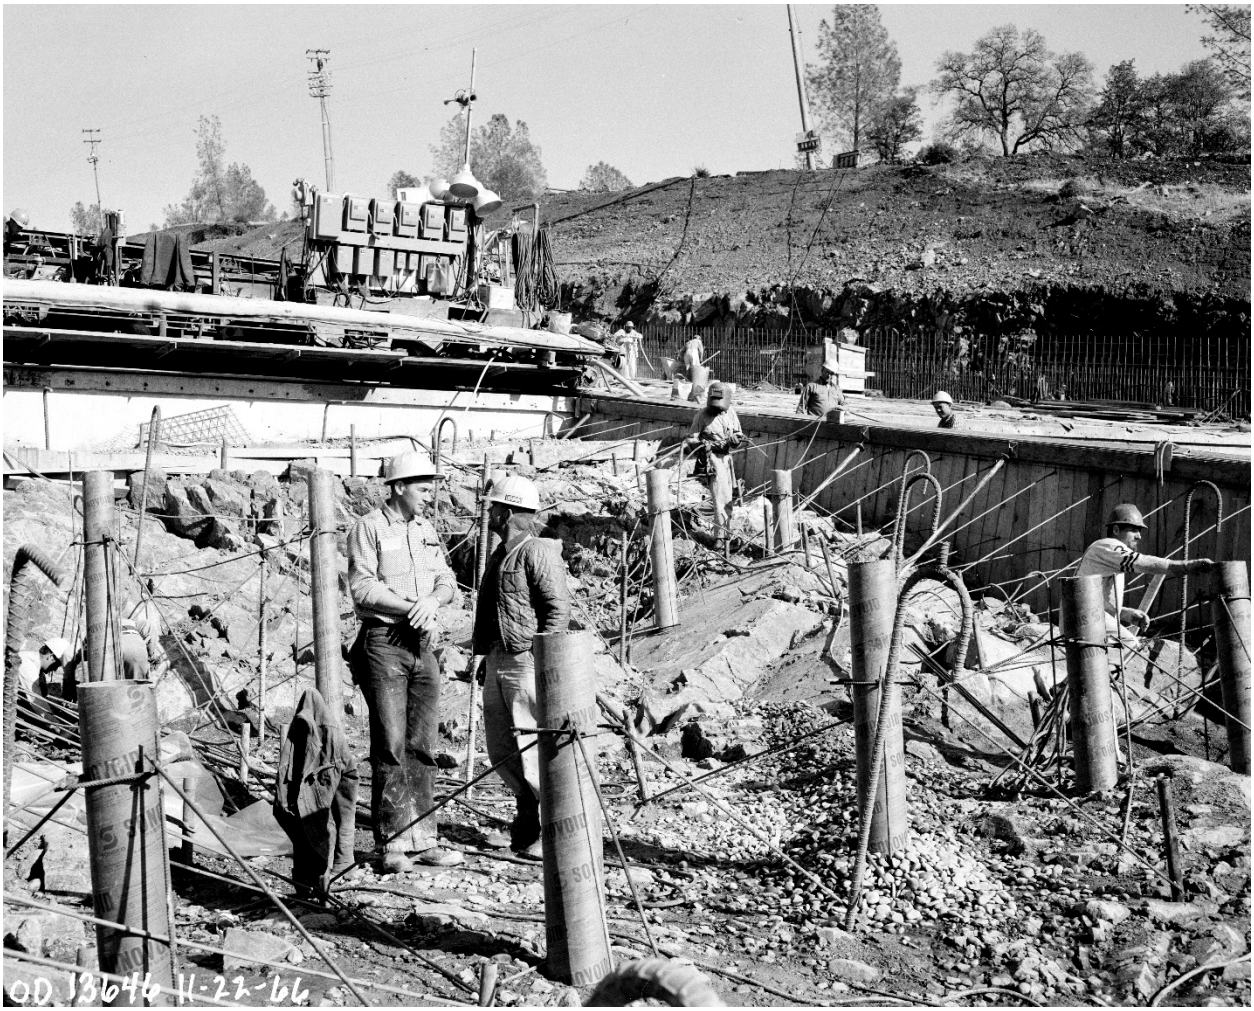
Figure A-9: Gravel-filled Sonotubes Being Installed to Connect Herringbone Drains to the Foundation through the Backfill Concrete

There were no specification provisions for overexcavation with respect to anchor bar installation. Based on Figures A-12 and A-13, it is not clear whether the bars were lengthened to maintain 5-foot foundation embedment, the foundation embedment was reduced to keep the top of the anchor bar hook at its design location just below the rebar mat, or if the bars were all adjusted to maintain the specified embedments in both the slab and foundation while keeping the bar lengths constant. It is also not clear what rock would have been considered “sound rock” for the referenced 5-foot embedment into such rock. Two observations from the construction photos would tend to indicate that the required embedments in the foundation were either not always maintained, or that longer bars were sometimes used to compensate for overexcavation. Many photos show the tops of the bars just below the rebar mat as designed, even with a varying foundation surface (Figure A-13). Photos of the downstream area near the end of the chute show bars that appear to be longer and that have 180-degree hooks (see Figure A-9).

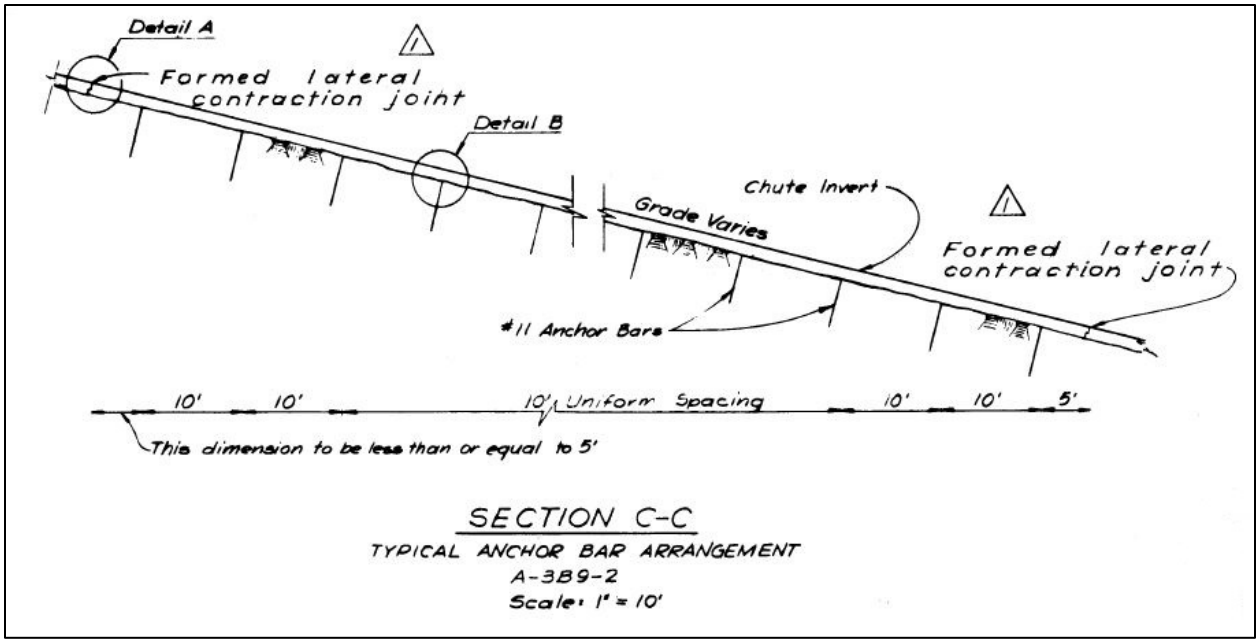
There has been considerable confusion about the types of joints used in the spillway chute slab. Expansion joints were shown in the bid specification drawings, and contraction joints were shown in the as-built drawings. Both types of joint have no bond or bonded reinforcement across the joint. The difference is that expansion joints have a compressible filler material in the joint that allows the joint to close under high temperature stress, while the contraction joint has a painted or sprayed on bond breaker to prevent bonding of adjacent concrete placements. The bid specifications and the as-built drawings were ambiguous and unclear about the location of these joints. The Plan and Profile views on as-built Drawing A-3B9-2 do not clearly state that the joints being shown are the expansion joints for the wall stem and base only, and do not apply to the chute slab. However, Section C-C, cut on the plan view of that drawing and shown on as-built Drawing A-3B9-4, shows that the chute invert has a contraction joint at the same location that the walls have expansion joints. It is not clear if the contraction joint detail shown in Section C-C for the joints at Sta. 33+00 and Sta. 37+00 are intended to be applied to all lateral chute slab joints, or to some of the lateral joints, but no other lateral joint details are provided for the spillway chute (Figure A-10). Part of this confusion may be due to the bid specifications drawings (Figure A-2) having expansion joints in the chute slab. There is no indication why the expansion joints were removed, but as discussed in Appendix E, expansion joints on high velocity flow surfaces were not considered good practice at the time (and still are not today).

Figure A-10: Spillway Chute Anchor Bar Arrangement Showing Transverse Invert Contraction Joints (from Drawing A-3B9-4)
