INDEPENDENT FORENSIC TEAM REPORT
OROVILLE DAM SPILLWAY INCIDENT

JANUARY 5, 2018

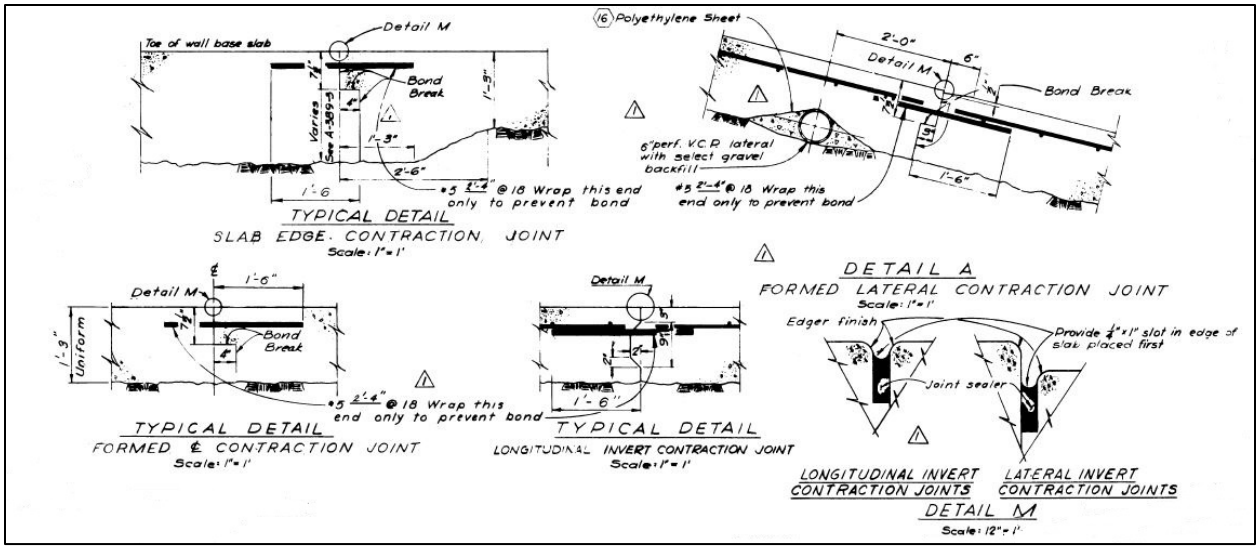
At some locations on the drawings, the lateral contraction joints were depicted without these offsets. Construction records and photographs indicate that much of the chute slab was constructed using slip-form methods. It is believed that the slip-forming used to construct the chute concrete allowed the contractor to place more than one 50-foot long concrete chute panel at a time. It is further believed that the contractor "cut" shallow grooves in the freshly placed concrete to initiate a crack at intermediate (50-foot) locations within the slip-form length, rather than stopping the slip-forming operation to construct a formed contraction joint (see Spillway Chute Construction Timeline in this Appendix). All contraction joints were to be treated with 1-inch deep by ¼-inch wide filler material, placed in a groove formed at the top of the joint. Corners of the joint were to be tooled to a round edge (see Figure A-11 for joint details).

Figure A-11: Chute Slab Joint Details (from as-built Drawing A-3B9-4)

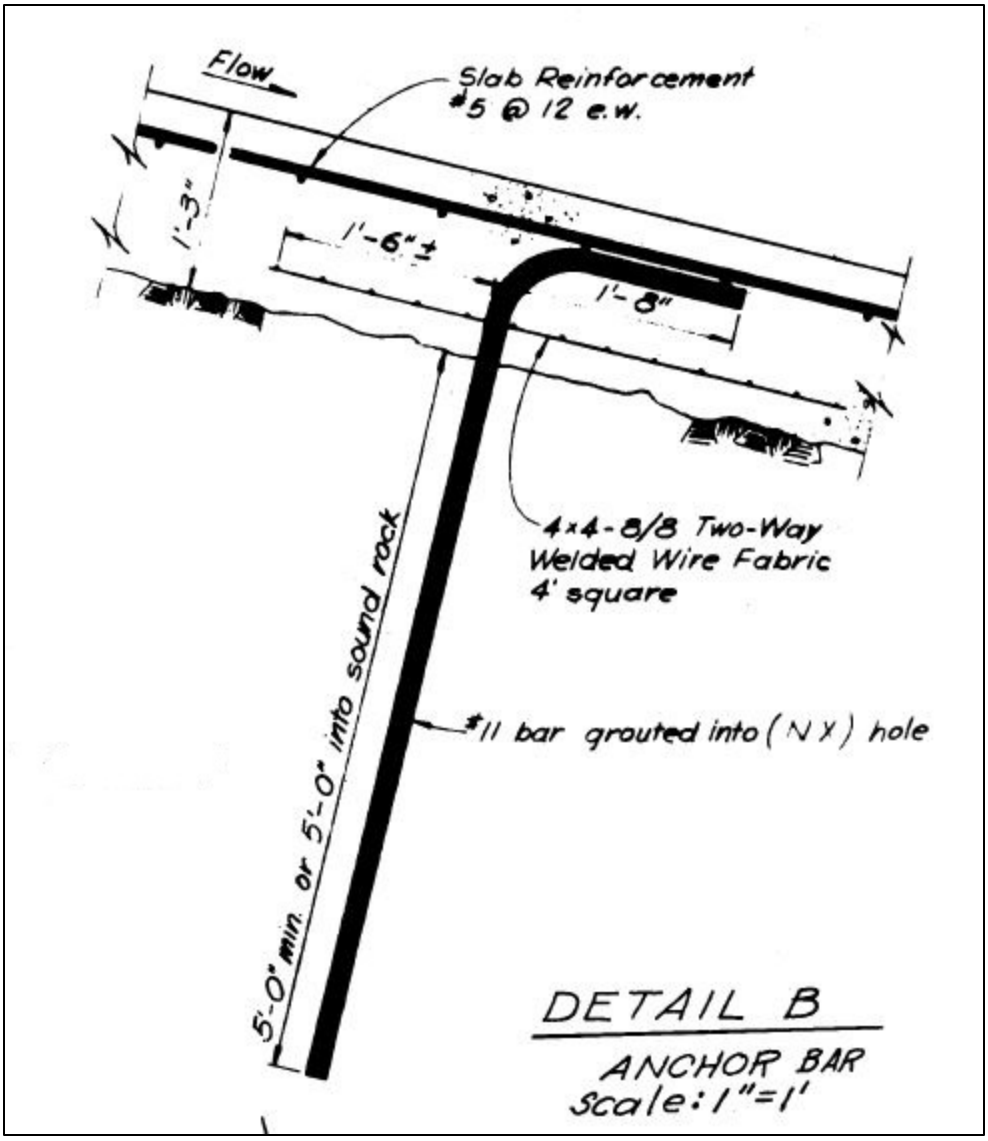
The service spillway chute slab design included No. 11 anchor bars spaced at 10 feet each way along the foundation surface (see Figures A-12 and -13). The anchor bars were intended to resist 5 feet of uplift [A-8]. The designed embedment lengths were likely insufficient to develop the full design tensile strength of these bars based on the assumed foundation conditions. The design embedment of the standard 90-degree hooks into the concrete slab is only 10¾ inches. The ACI-318 Code from that period would have required about a 21-inch embedment. While it is understandable that the designers would not have wanted to make the slab 10 inches thicker to accommodate the No. 11 hook embedment, a typical design might call for smaller bars more closely spaced to achieve the desired pull-out strength. For example, the designers could have used No. 8 bars spaced at 6 feet each way. However, even with No. 8 hooked bars, embedments could not fully develop the hook strength in the concrete, so it is possible that the anchors were oversized to provide sacrificial steel to accommodate possible corrosion. A 4-foot square piece of welded wire fabric was to be placed at the base of the concrete slab where the anchor bars were installed. Presumably this was to help prevent pull-out of the bar from the concrete.

There were no specification provisions for overexcavation with respect to anchor bar installation. Based on Figures A-12 and A-13, it is not clear whether the bars were lengthened to maintain 5-foot foundation embedment, the foundation embedment was reduced to keep the top of the anchor bar hook at its design location just below the rebar mat, or if the bars were all adjusted to maintain the specified embedments in both the slab and foundation while keeping the bar lengths constant. It is also not clear what rock would have been considered “sound rock” for the referenced 5-foot embedment into such rock. Two observations from the construction photos would tend to indicate that the required embedments in the foundation were either not always maintained, or that longer bars were sometimes used to compensate for overexcavation. Many photos show the tops of the bars just below the rebar mat as designed, even with a varying foundation surface (Figure A-13). Photos of the downstream area near the end of the chute show bars that appear to be longer and that have 180-degree hooks (see Figure A-9).

Figure A-12: Anchor Bar Detail (from Drawing A-3B9-4)

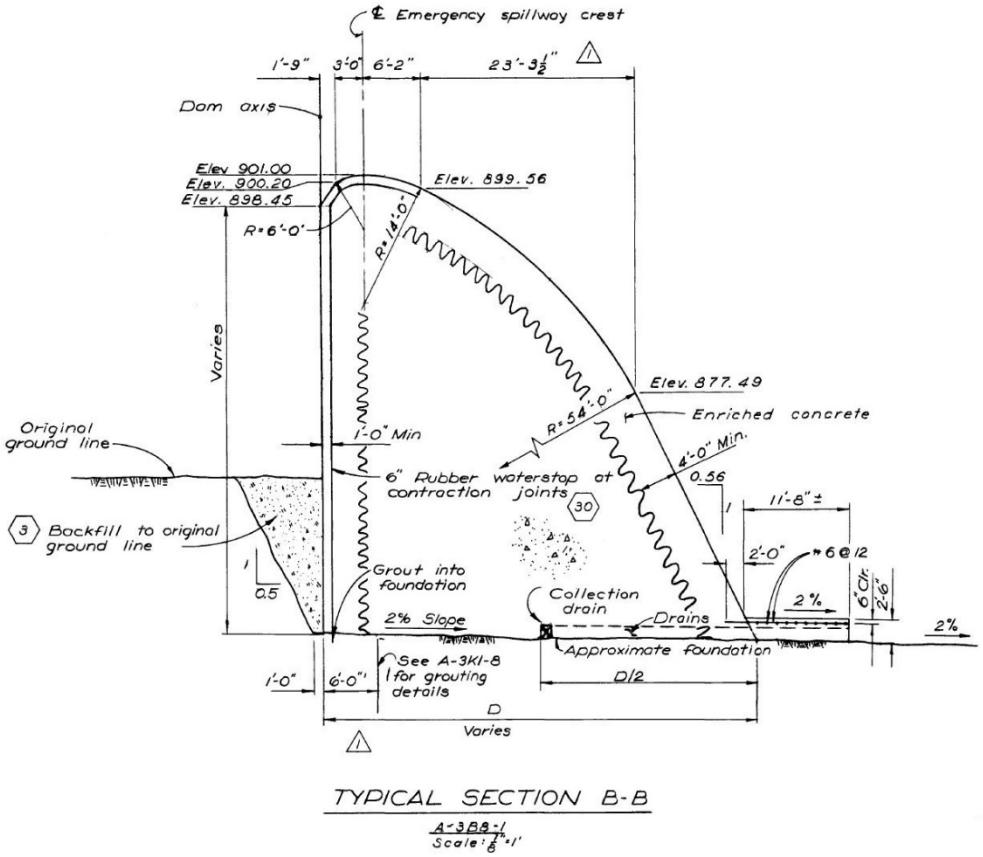
The overflow weir was designed with an 11.67-foot long downstream apron to protect against erosion as flows over the ogee weir reach the foundation elevation (see Figure a-14). While this apron will absorb some of the impact of direct flow onto the foundation, it does not protect against downstream erosion and headcutting. Spillways with this configuration have experienced significant erosion holes downstream of the apron, which could also undermine and fail the apron, if foundation conditions are unfavorable. Additionally, a large erosion hole could remove all passive resistance to sliding of the gravity structure, if any foundation features daylight into the erosion hole.

Figure A-14: Ogee section of the emergency spillway showing the downstream apron

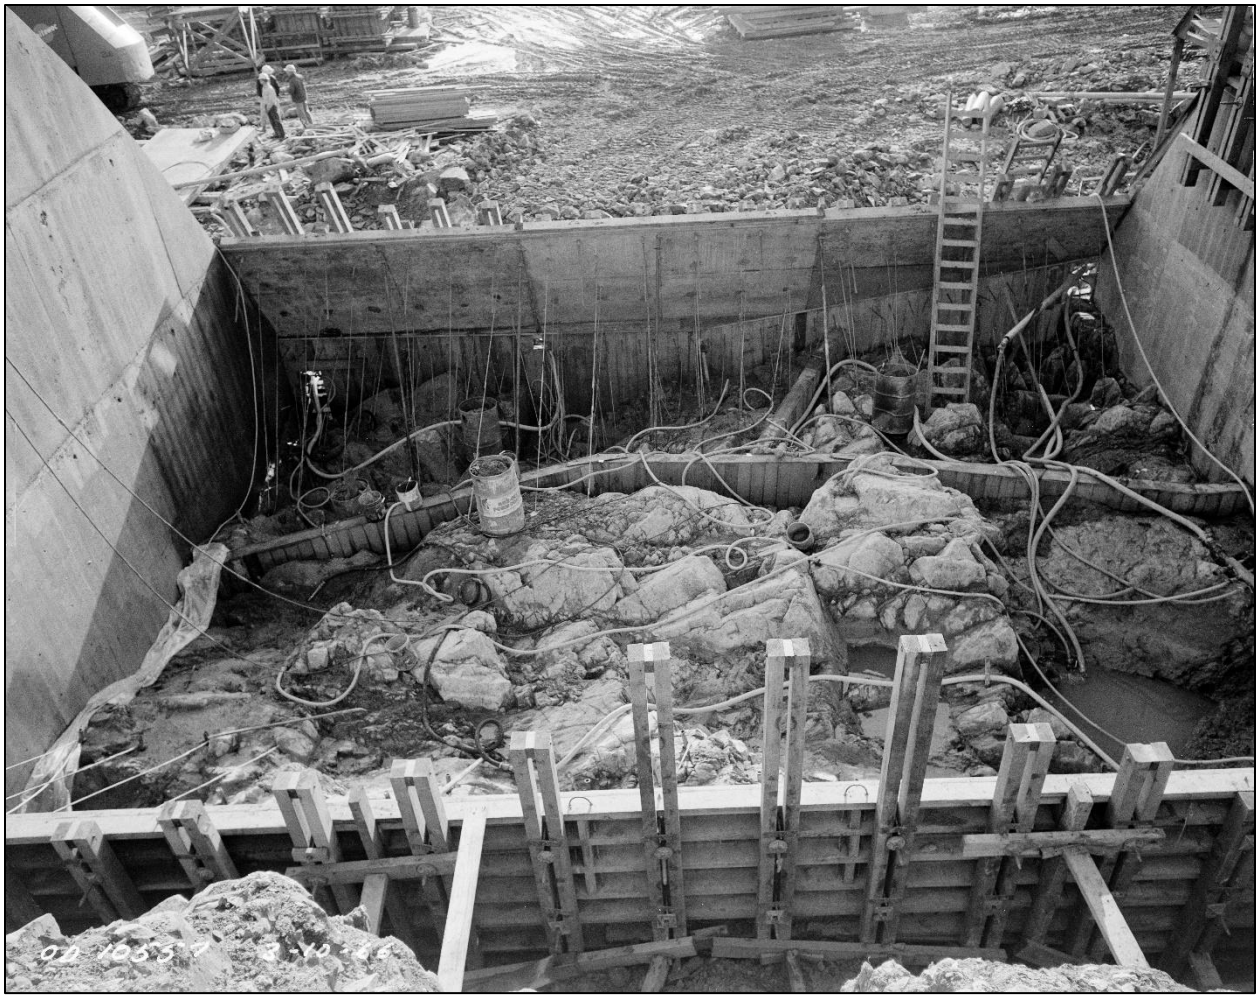
Figure A-15: Clean-up effort for the emergency spillway gravity crest structure just prior to placement. Note that all mud, debris, and loose or unsound rock fragments have been removed and the rock has been pressure washed. (Photo OD_10557_03_10_1966)

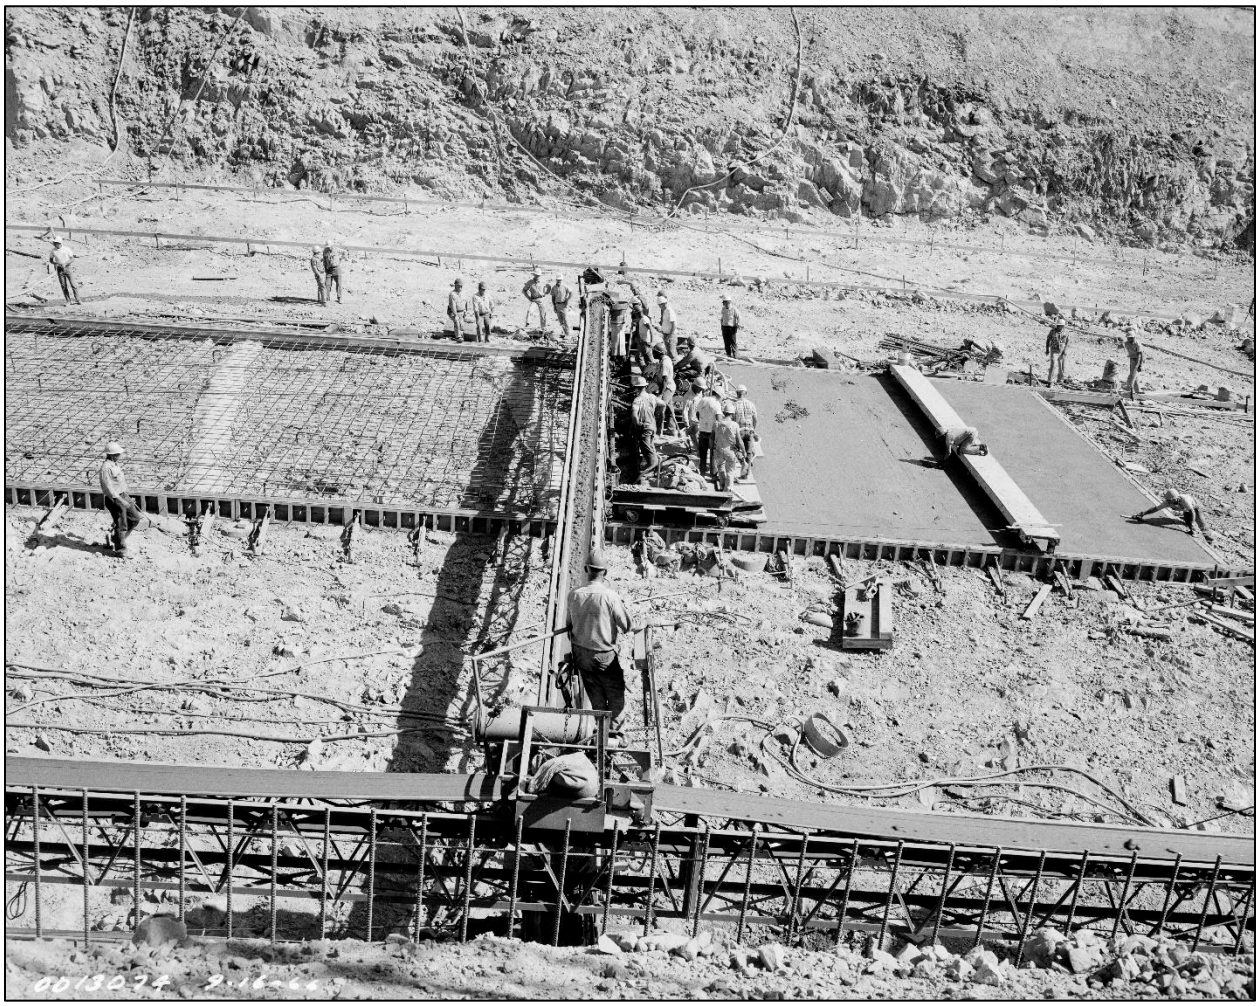
assumed that the bars were oversized, possibly to add greater bar area to counteract minor erosion. Figure A-18 is believed to show the area near where the anchor bar pull tests were performed (10 days after the pull tests), based on the date of the photo compared to the construction activities as reported in the daily reports from construction. Note that in Figure A-18 it would be difficult to determine where there were worst case conditions having clay seams, unless there was a special cleanup for the anchor bar pull tests.

Figure A-18: Typical concrete placement in the spillway chute (believed to be Lane 3, Sta. 26+00 to 27+00) using slip-forming. Note that the foundation ahead of the slip-form shows very few distinct rocky outcrops. (Photo OD_13074_09_16_1966)

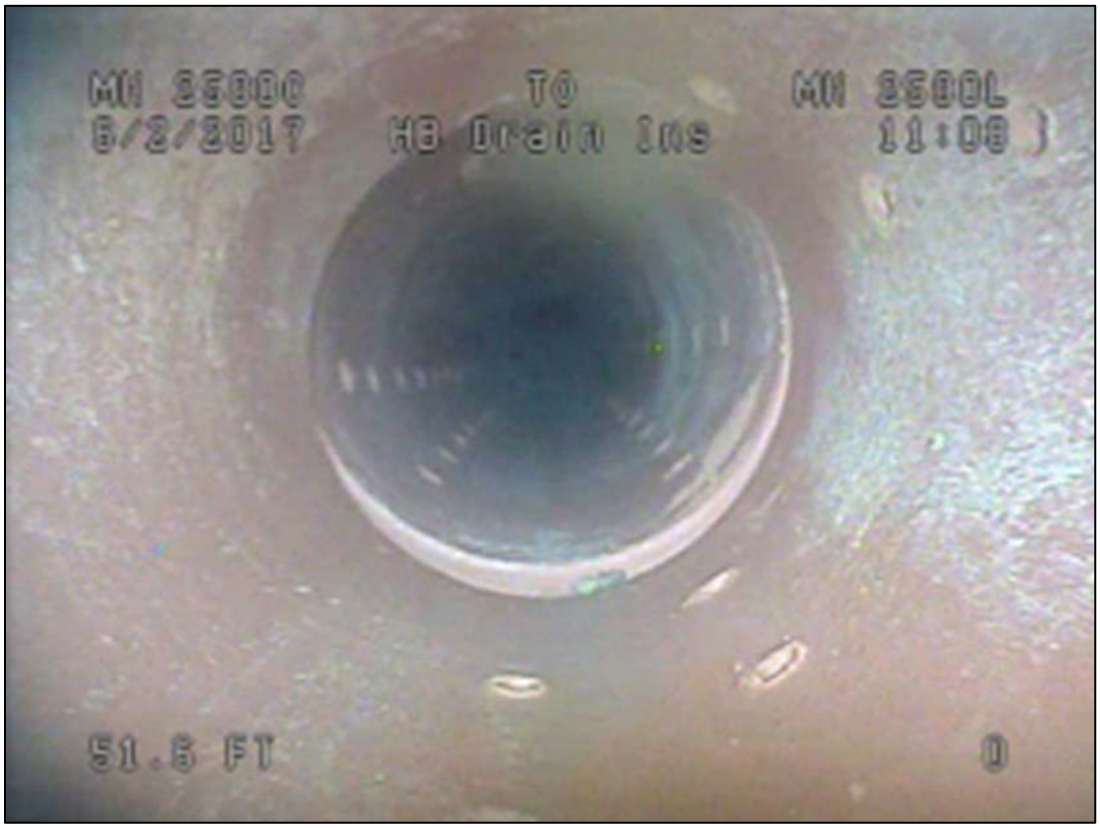
A common issue with the herringbone drains is that the drains were not placed directly on the foundation, but rather were placed well above the foundation when overexcavation occurred. The drains were intended to be placed in a gravel envelope that includes gravel below the drain pipe as well as over the top of the pipe. There was no filter material placed around the gravel to prevent fine foundation material or concrete from contaminating the gravel during construction. Polyethylene sheeting was to be placed over the pipe and gravel to protect it from the fresh concrete, which tended to isolate the drains from the cracks that formed above the drains. Fine-grained materials left on the foundation surface after cleanup could easily move through the gravel and into the drains due to lack of filtering. The gravel placement over the top of the pipe seems unnecessary, since the perforations were intended to be on the bottom of the pipe where they are less likely to be contaminated with concrete.

Figure A-24: Herringbone drain inspection. Note that the perforations are rotated at the joint. (from HDR investigation)

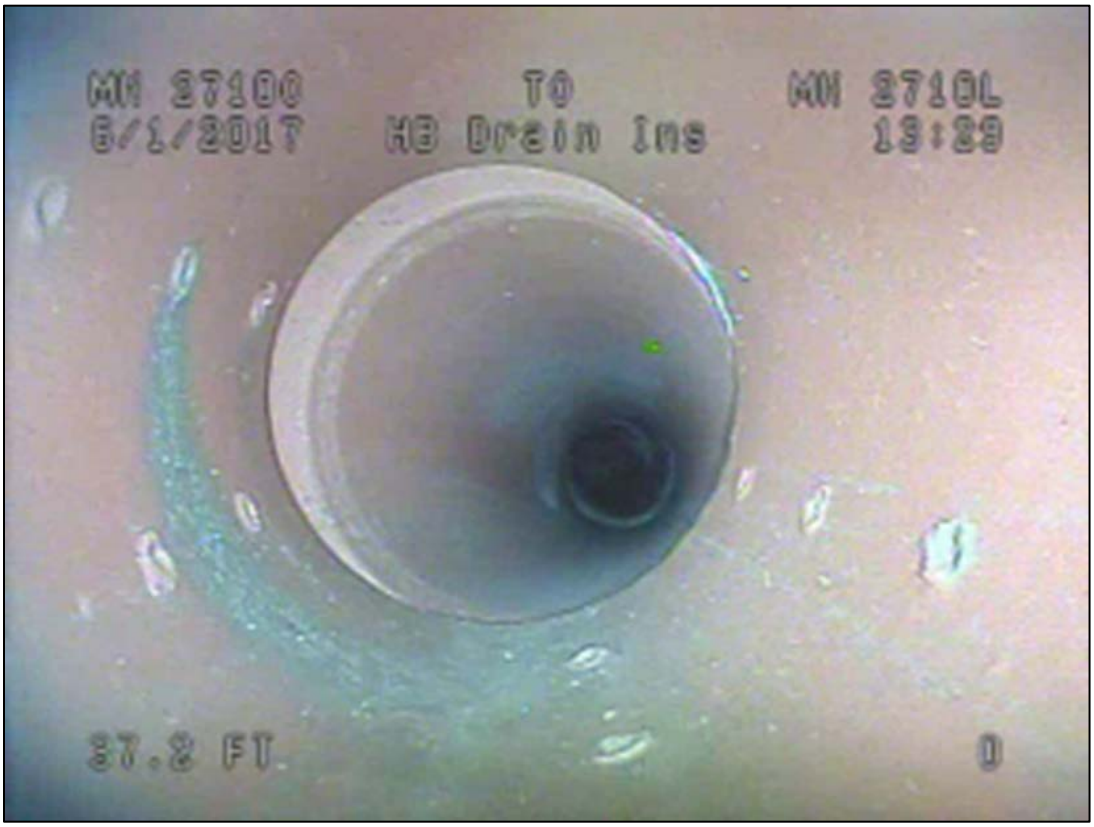
overexcavation of more than several inches occurred, the gravel beneath the pipe was built up using wooden forms to contain the gravel. In other places where overexcavation was more than a couple of feet, the pipes were connected to the foundation below by placing gravel-filled sonotube risers between the herringbone drains and the foundation. The result of these adjustments for overexcavation is that the drains were placed within the concrete slab a foot or more above the foundation surface (Appendix D). These drains would have little chance of collecting surface flows at the foundation contact until the ground water backs up enough to enter the drains. Figures A-13 and A-26 show details of drain construction where there was significant overexcavation.

Figure A-25: Herringbone drain inspection. Note that the section beyond the joint has no perforations. (from HDR investigation)

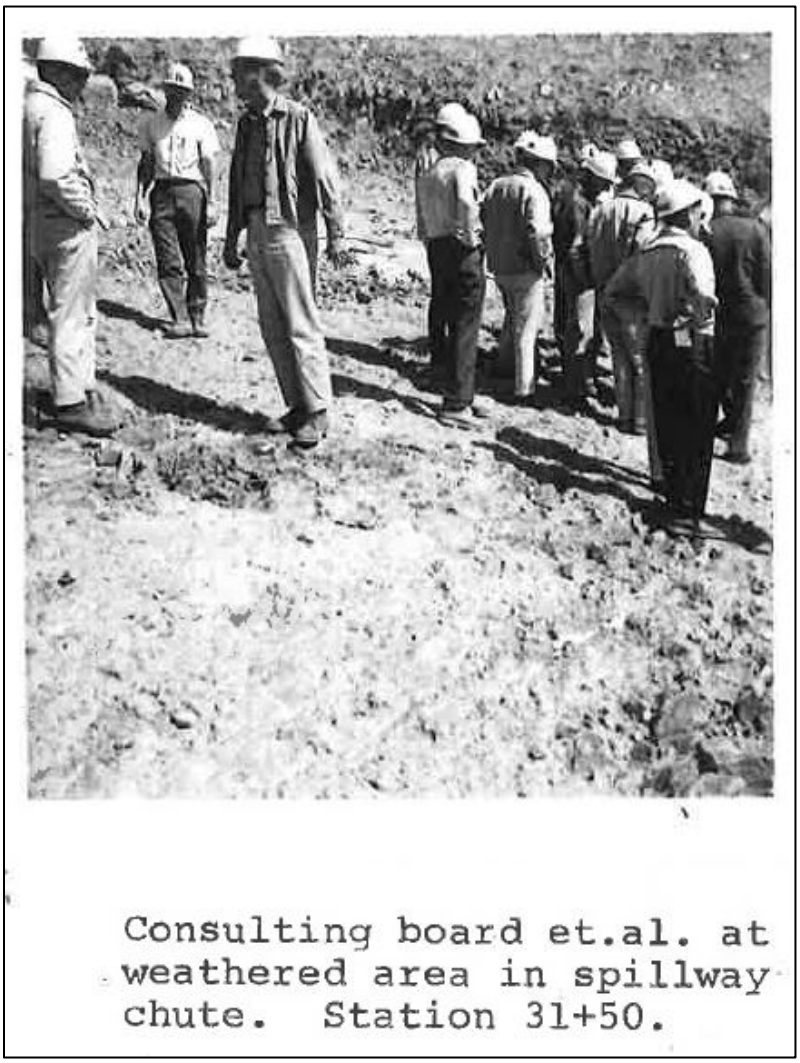
04/19/1966 The IFT had access to the agenda prepared for the April 19-20, 1966 Consulting Board meeting. A photo showing the Consulting Board at spillway chute Sta. 31+50 was included with the DSOD reports (Figure 31). (No Consulting Board report of this visit could be found by DWR).

Figure A-31: Photo from the February 12, 1966 DSOD Inspection Report

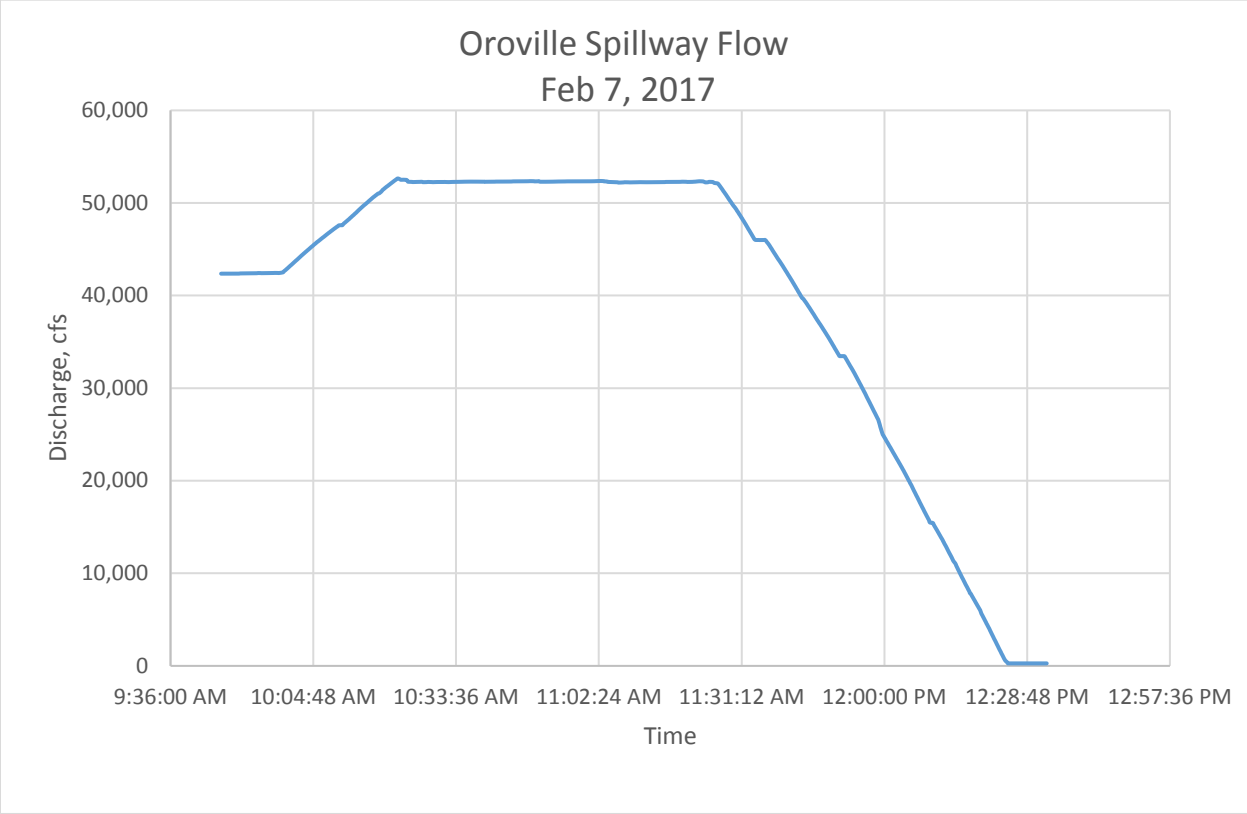
Figure B-7: Time History at Time of the Chute Failure

cavitation would not occur around Station 33+00. The flow was shut off around 11:30 AM and was essentially stopped around 12:20 PM.

Drone inspections of the sections of the chute remaining in place downstream of the chute failure area did not indicate evidence of cavitation damage. In addition, a careful onsite examination of the remaining lower chute sections by a member of the Independent Forensics Team (IFT) could not find any evidence of cavitation damage at supposed locations of damage. Therefore, we can conclude that cavitation was not a contributor to the failure that was observed on February 7th, 2017.

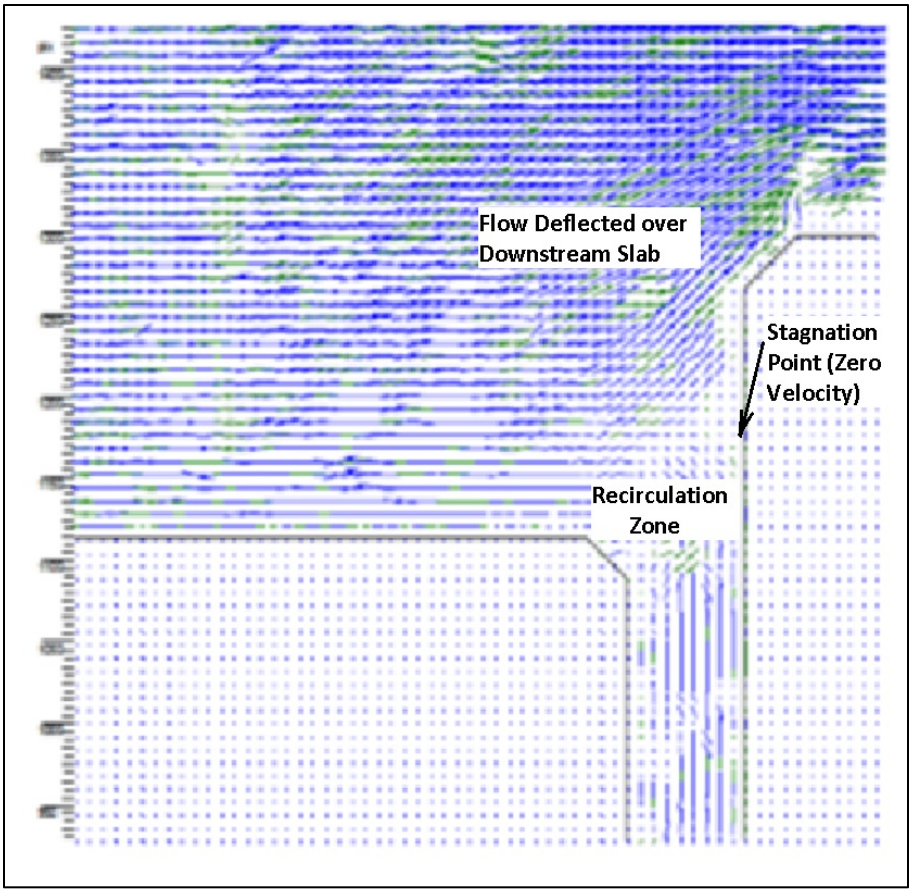
Figure B-12: 1/8-inch Gap with a 1/2-inch Offset and a Vented Cavity, Reference [B-3]

A two-dimensional particle imagery in Reference B-3 by Frizell shows that the stagnation pressure occurs at approximately ½ of the offset height as shown in Figure B-12. The blue vectors in the figure represent the flow velocity. The green vectors are the flow velocity at locations where the data were incomplete. The space covered with dots represents the concrete slabs. The stagnation point can be seen about half way up the vertical face of the downstream slab. Above the stagnation point, all the flow is deflected over the downstream slab. Below the stagnation point, the flow is in a recirculation zone. The recirculation patterns even develop within the gap between the slabs.

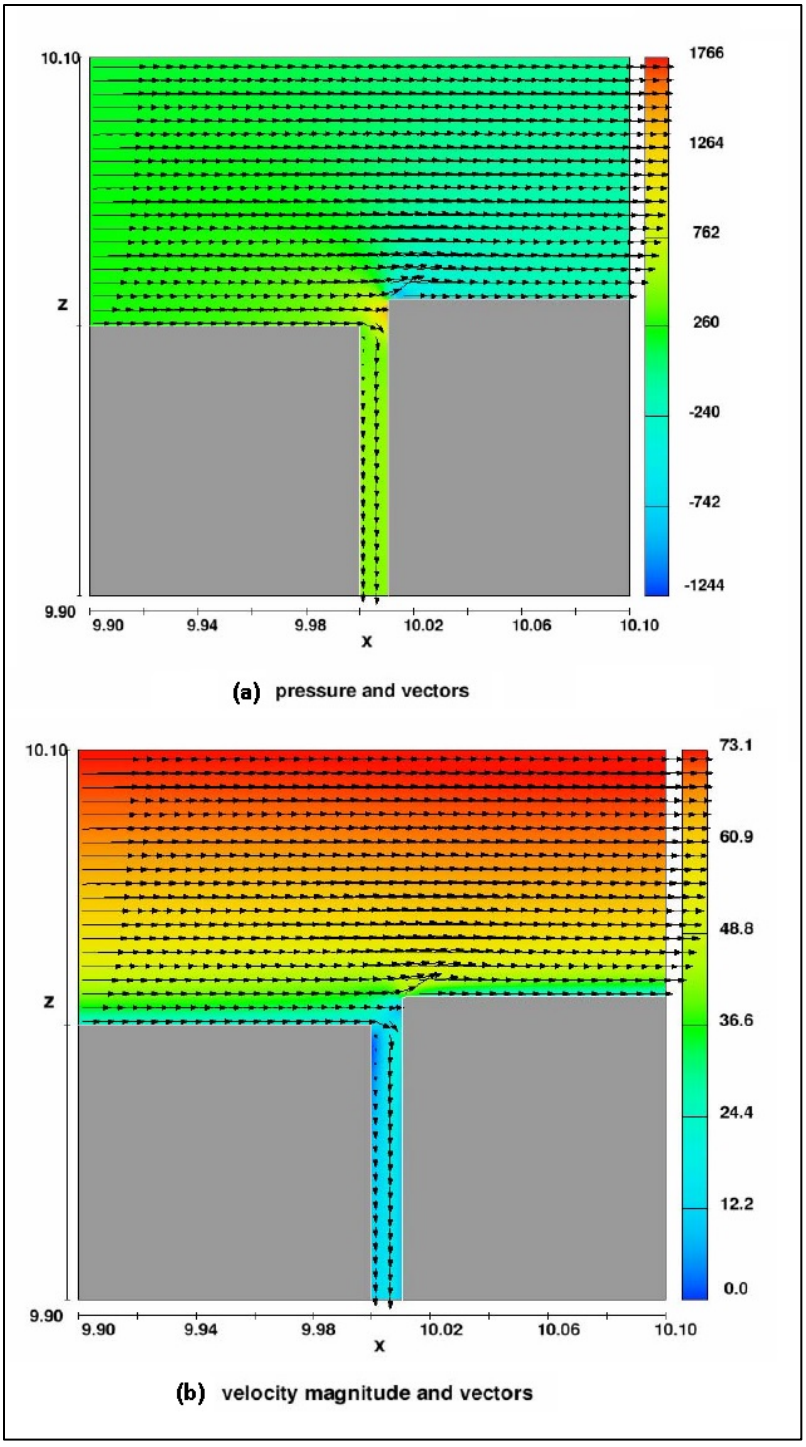
Figure B-13: Free Flow 1/8th Inch Offset 1/8th Inch Gap, 12-inch Flow Depth, 90-ft/sec Velocity, Reference [B-3]

The computational fluid dynamics (CFD) studies in Reference B-3 by Frizell show that when the cracks are open to the atmosphere the stagnation pressure is concentrated to a small area around the impact point as shown in Figure B-13a. Note that the stagnation pressure will be equivalent to the velocities on the stream line that approaches the downstream slab. The velocity distribution can be seen by the location where the velocity vectors are shown to begin and end on each side of the figure.

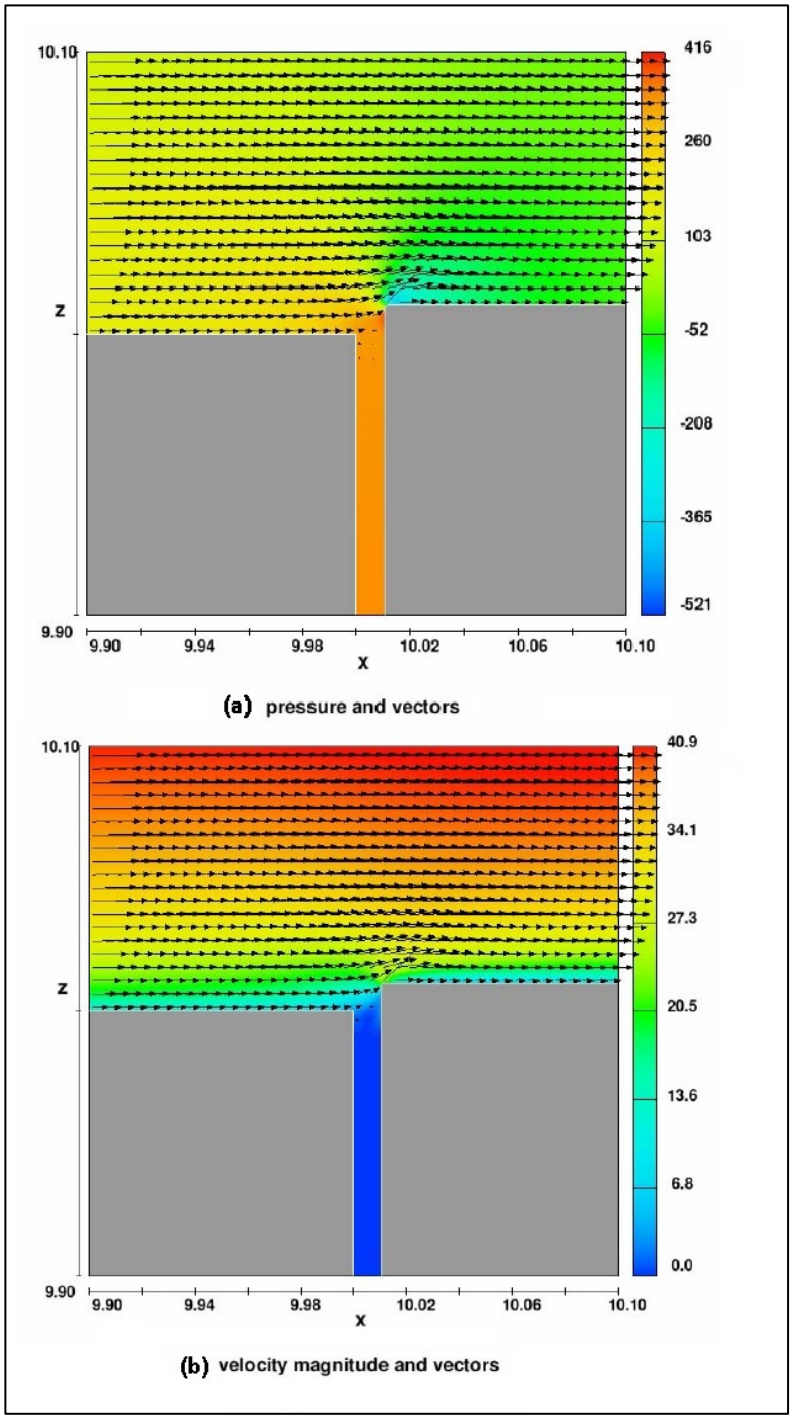
Figure B-14: Sealed Cavity 1/8th Inch Offset 1/8th Inch Gap, 12-inch Flow Depth, 50-ft/sec Velocity, Reference [B-3]

However, with a sealed cavity that would simulate conditions with a saturated foundation under the slab, the pressure in the slot is only slightly less than the stagnation pressure as shown in Figure B-14(a).

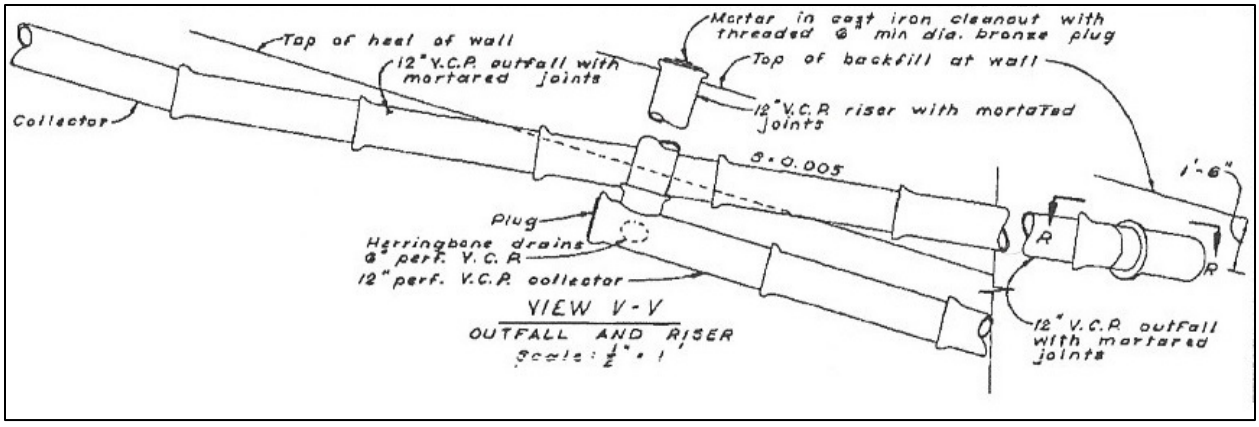
Figure B-15: Collector Drain and Outfall, Reference [B-8]

The collector drains exit into an outfall line as shown in Figure B-15. This line has a maximum capacity before it flows full that is determined by its diameter, friction factor, and invert slope. If the capacity of this outfall line is exceeded, the collector drains will begin to fill and discharge water into the backfill material behind the wall through perforations on the top of the collector pipes. For even higher inflow discharges, the flow in the herringbone drains will begin to fill and pressurize the area under the floor slabs on the chute.

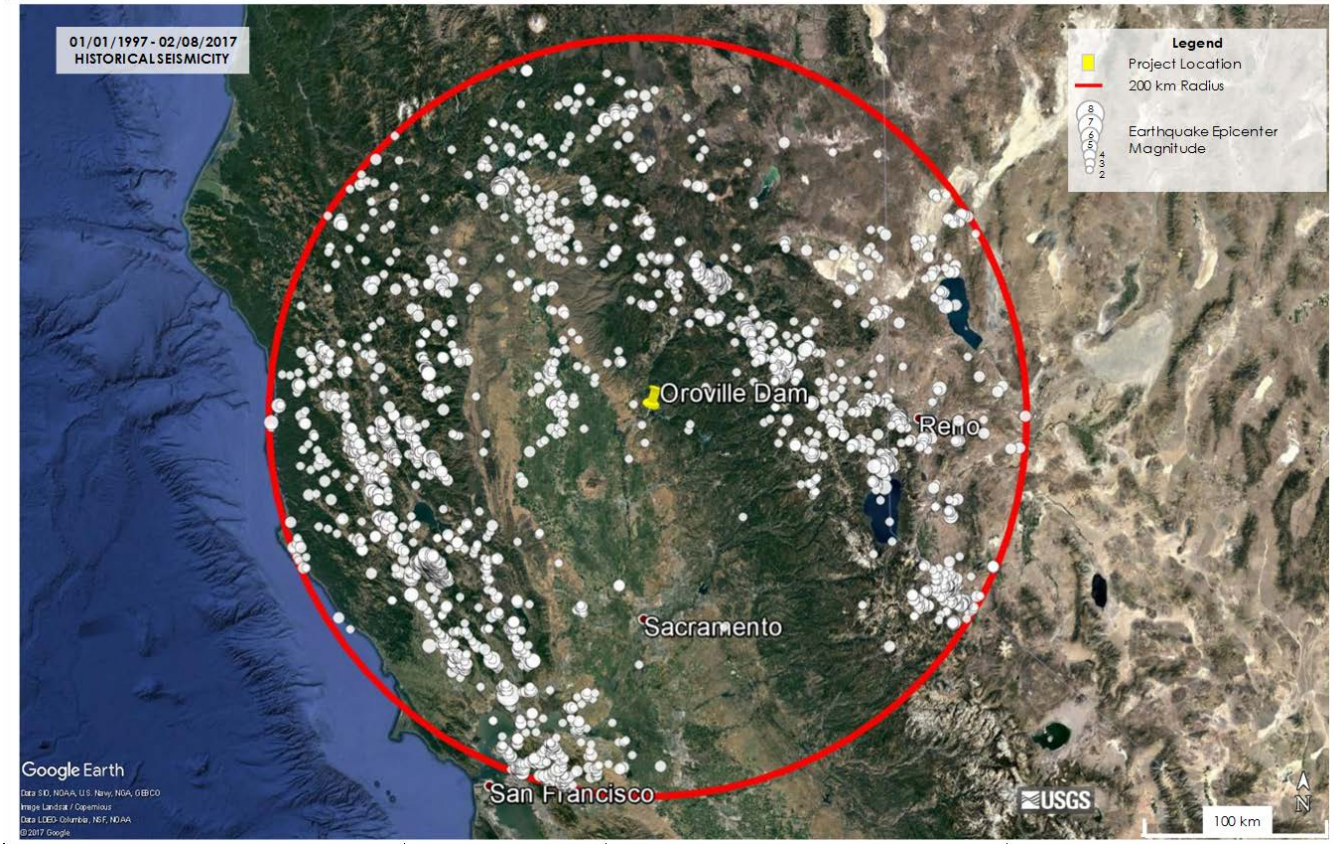
Figure C-4: Plot of earthquakes (>M=2.5) recorded in the last 20 years and within 125 miles (200 km) of Oroville Dam. Data from USGS Search Earthquake Catalog [C-12].

4. A plot of earthquakes (>M=2.5) recorded in the last 20 years and within 125 miles (200 km) of the project is provided in Figure C-4. The data set includes seven events M 4.0 to M5.7 but each was located more than 100 miles from Oroville Dam. The remainder are all

<M4.0. These earthquakes occurred during the timeframe when previous historical major flows had taken place over the spillway. In other words, no new potential damage caused by seismicity had taken place in the time between previous major spillway releases and the February 2017 spillway flows.

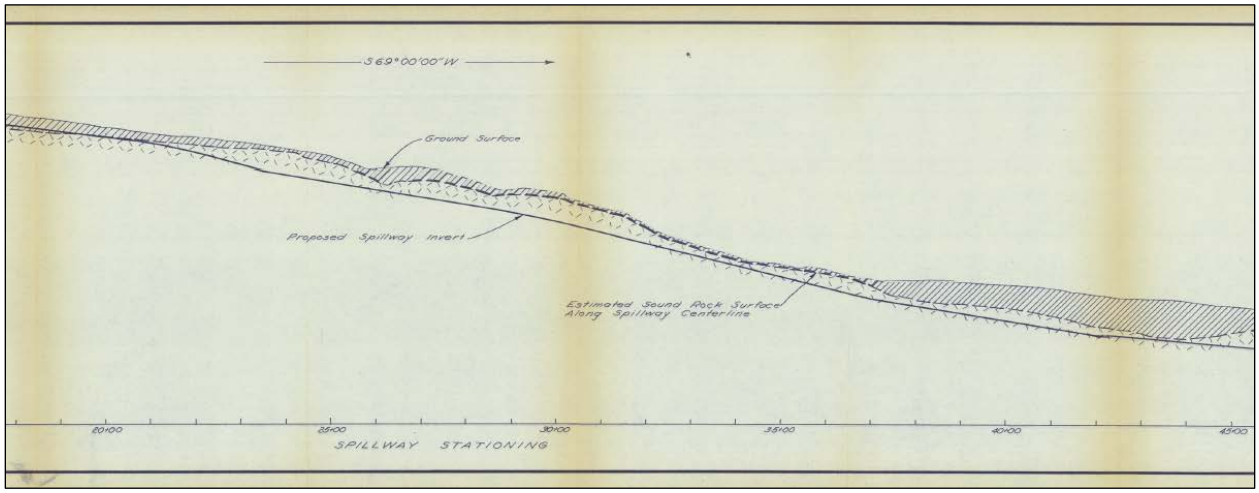
Figure C-5: Portion of a longitudinal section along original spillway alignment, based on 1961 investigations. Now downstream from current emergency spillway.

"Depth to sound rock," defined similarly to that in the first report, was shown in a longitudinal section along what is now an alignment within the emergency spillway discharge channel. The proposed invert of the spillway on the profile was shown to be excavated down into "sound rock," or at the top of "sound rock" for its entirety, except for a small portion adjacent to the Feather River. A portion of the profile is shown below in Figure C-5.

This foundation rock had been thought of as acceptable for riprap, and the IFT believes that this is the basis of not having a concrete liner in the original design, as noted later in this appendix.

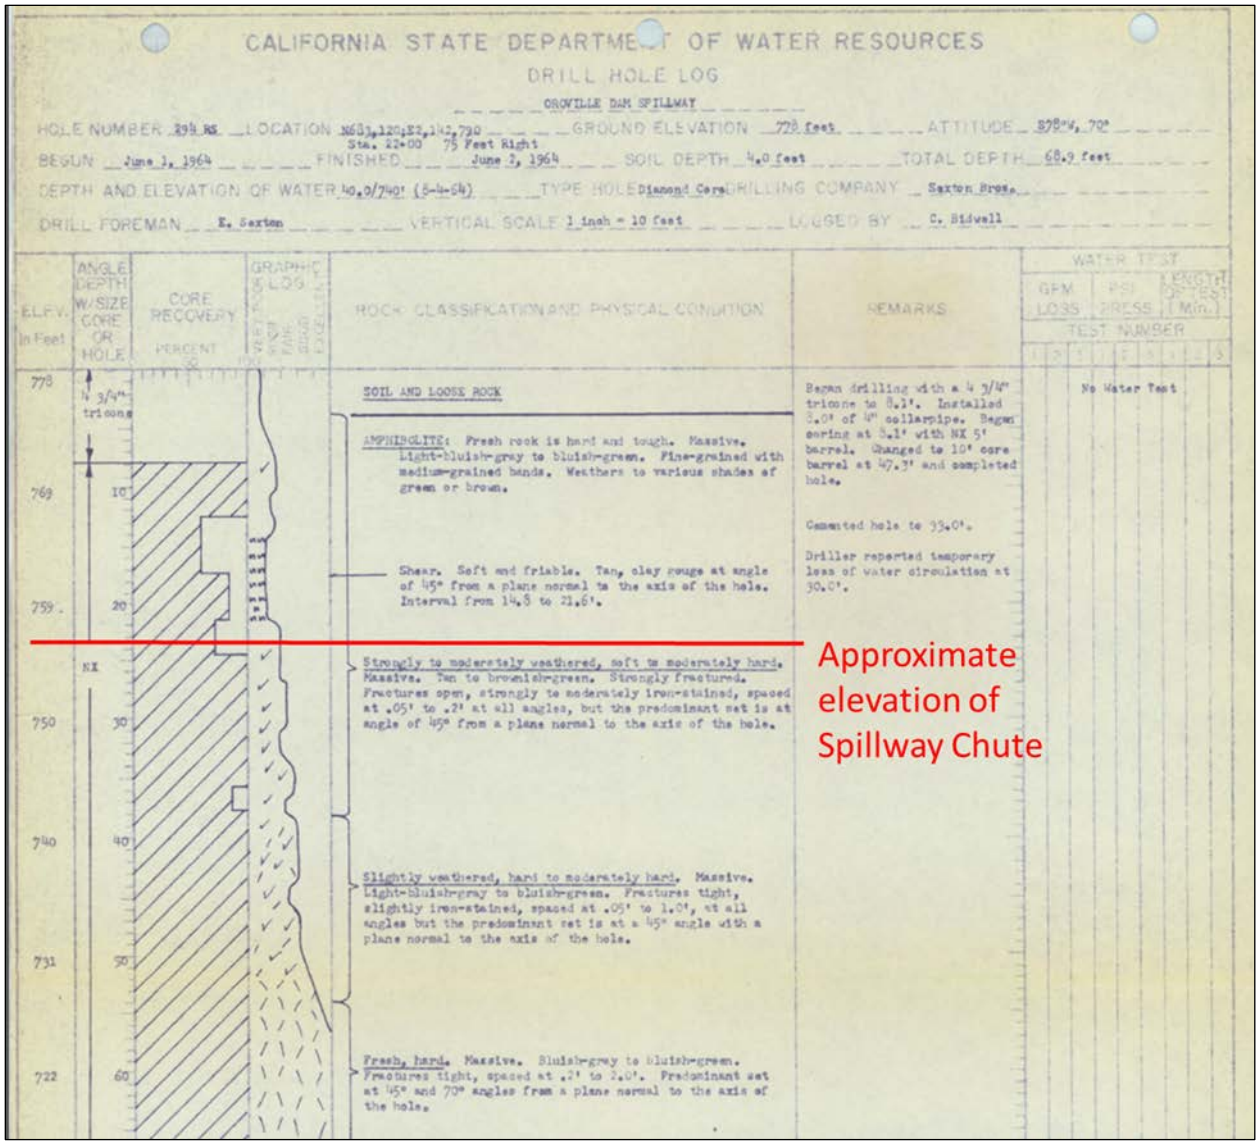
Figure C-9: Borehole 294RS, approximately Sta. 22+00 along Service Spillway, offset 75 feet

> "Rippable material at and below invert grade should be anticipated in the chute between Stations 19+00 and 23+00."

Although rippable conditions were called out in the report, apparently associated with strongly to moderately weathered rock of poor to fair quality (as per Figure C9), apparently no special treatment for such fully rippable foundations was considered, and the following general statement was given:

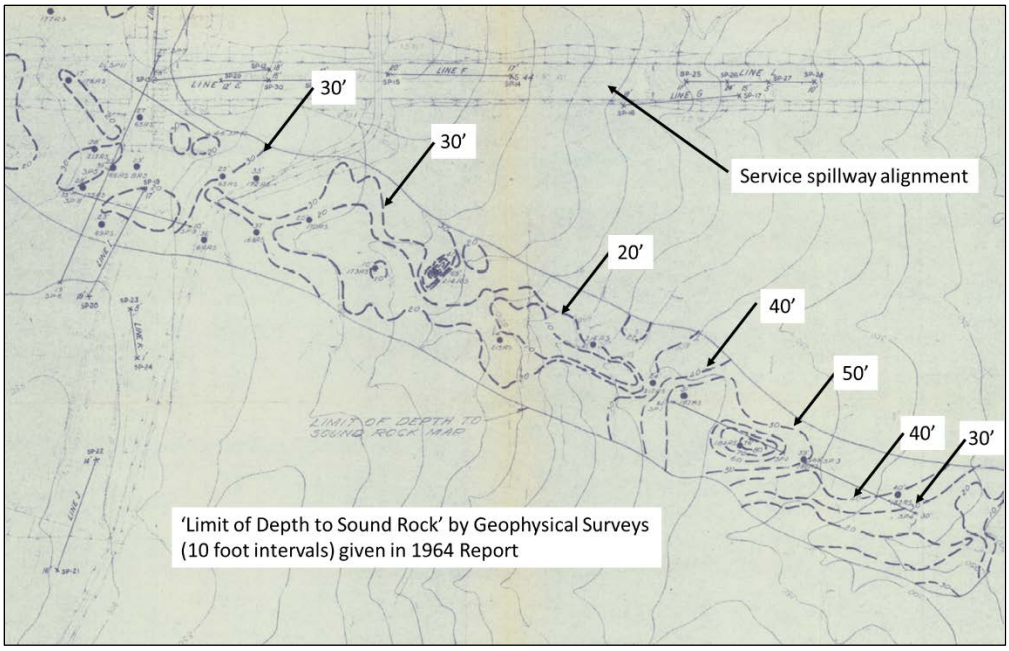
Figure C-10: Summary of 1961 Geophysical Results downstream from current emergency spillway weir

Geophysical Information: The 1964 report also includes a summary of both the 1961 and 1963 geophysical investigations. A summary plot of the earlier investigations along the alignment of the emergency spillway is given in Figure C-10.

This summary shows large depths to sound rock, as defined for the purpose of riprap exploitation. The relevance to the current discussion is that the report indicates that there was no discernable difference in velocity from the surficial soil and decomposed rock layer until the "sound" rock layer was reached in most surveys, i.e. the measured velocities of the moderately to strongly weathered rock were not different enough from the measured velocities of the soil and decomposed rock to be interpreted as a separate layer. This would be yet another indication that significant depths of erodible material could be expected downstream from the emergency weir.

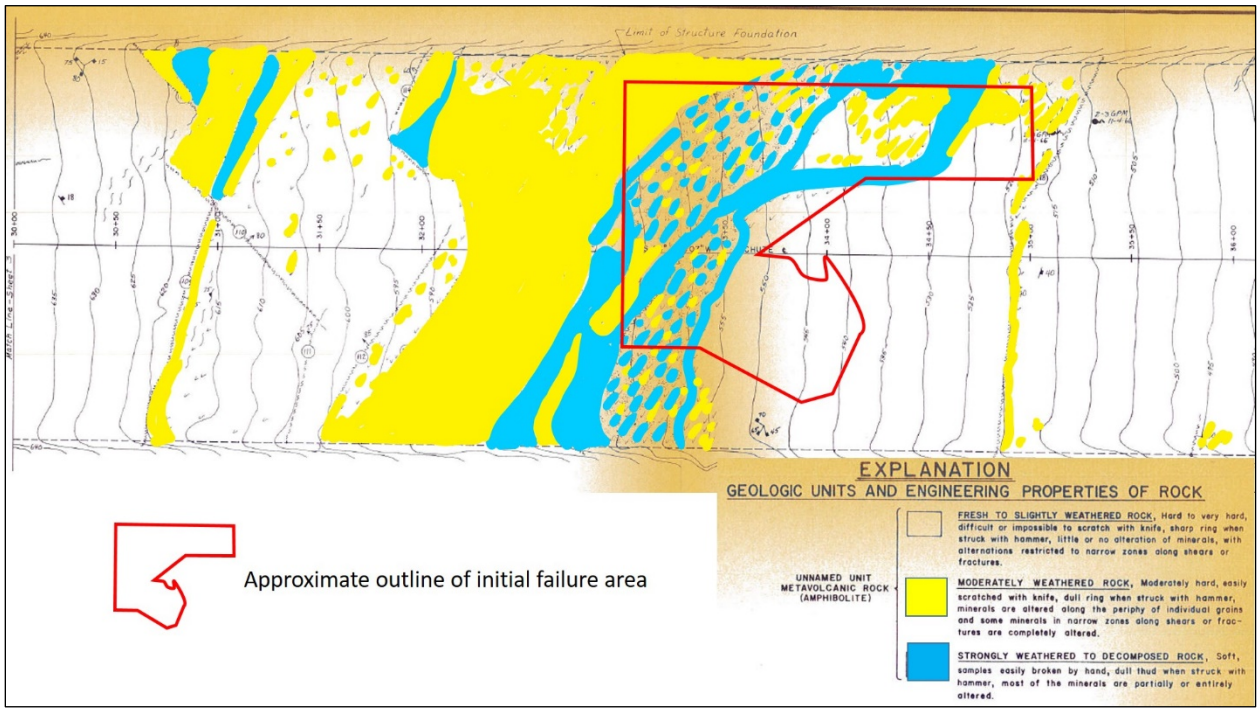
Figure C-11: Extents of Moderately and Strongly Weathered Rock. Geologic mapping from Final Geologic Report [C-1]

There is no moderately or strongly weathered rock noted in the foundation for the first 600 feet downstream from the headworks structure. The most upstream locations where such conditions were found are documented on the right side of the chute near Sta. 19+00 to 20+50, followed by an area on the left side at Sta. 27+00, with the largest areal extents from Sta. 31+00 to 38+00, in the area of the initial failure in February 2017. Figures C-11 and C-12 are excerpts from drawings in the Final Geologic Report showing the large extents of the moderately and strongly weathered rock, and the degree of compacted clayey fines left upon foundation cleanup in the vicinity of the initial spillway slab failure (colorized by the IFT). These aspects are discussed further in Appendix I.

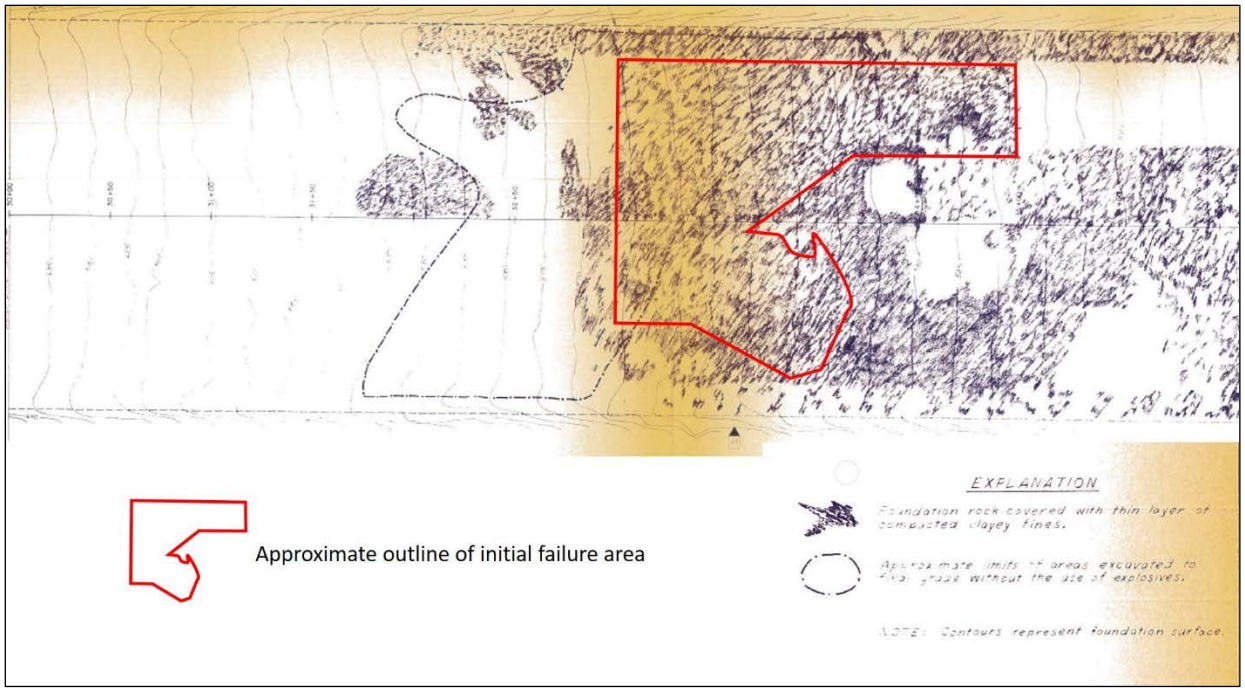
Figure C-12: Extents of Compacted Clayey Fines. Geologic mapping from Final Geologic Reportm [C-1]

Encountering strongly weathered rock was clearly never expected at the time of the 1964 Interim Geological Report. Although there are references in this report back to the early reports, there is no apparent connection made to the fact that these obvious changed foundation conditions were not covered under the project specifications.
