INDEPENDENT FORENSIC TEAM REPORT
OROVILLE DAM SPILLWAY INCIDENT

JANUARY 5, 2018

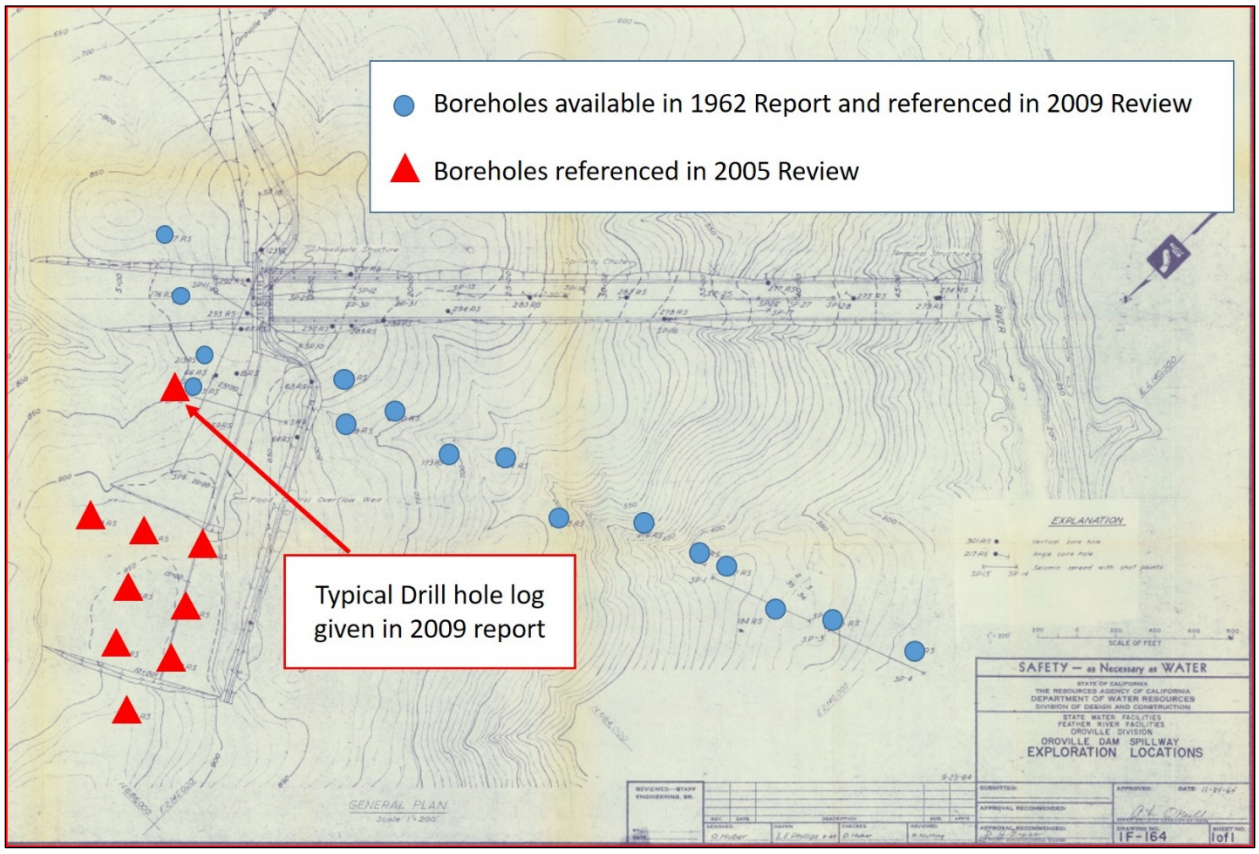
Thus, the detailed geological descriptions that would have given critical information on strength and jointing (which would have indicated the likelihood of erodibility) downstream from the emergency weir were not accessed. However, the nine borehole logs that were accessed provided ample evidence of poor to very poor rock conditions. Even if one assumed that moderately weathered rock was non-erodable, six of the nine logs show worse than moderately weathered rock conditions. Two logs show strongly weathered rock to depths of 12 feet and 17 feet, and all six logs indicate moderately to strongly weathered, moderately weathered to soft, poor to fair conditions to depths ranging from 22 Feet to 44 feet.

Figure C-13: Borehole Logs Available for Review

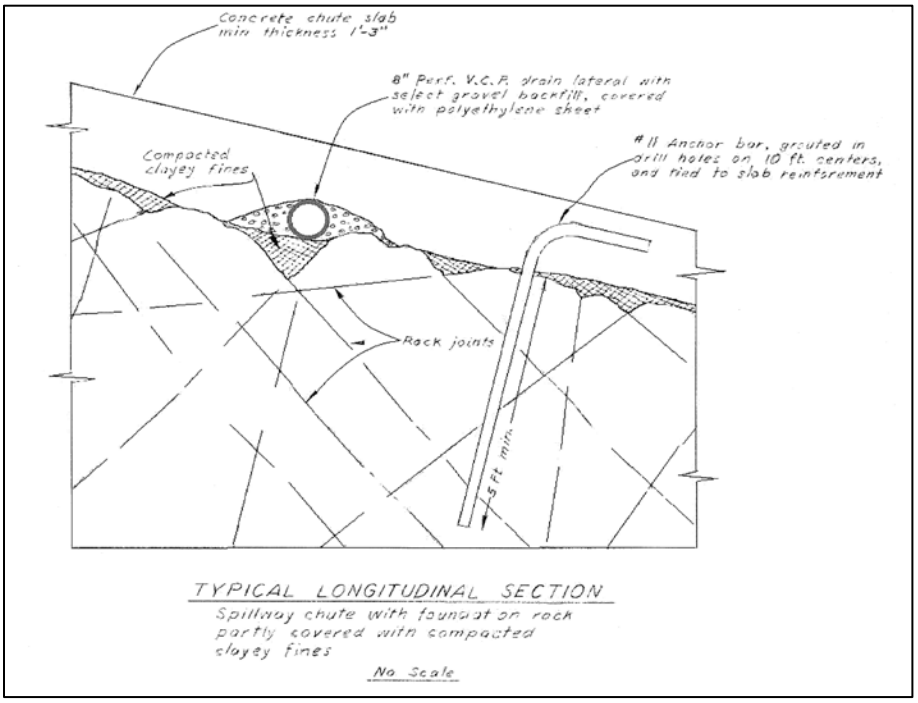
The construction geology report [D-4] includes foundation geological mapping sheets showing Geologic Units and Engineering Properties, including 124 specific shear zones tabulated along the chute. It also includes detailed drawings showing cleanup of the chute foundation, where the foundation rock was left partly covered with a layer of "compacted clayey fines" (Figure D-3). One objective of the IFT investigation program was to achieve a better understanding and definition of the phrase "compacted clayey fines."

Figure D-3: Sketch from Construction Geology Report Showing "Compacted Clayey Fines"

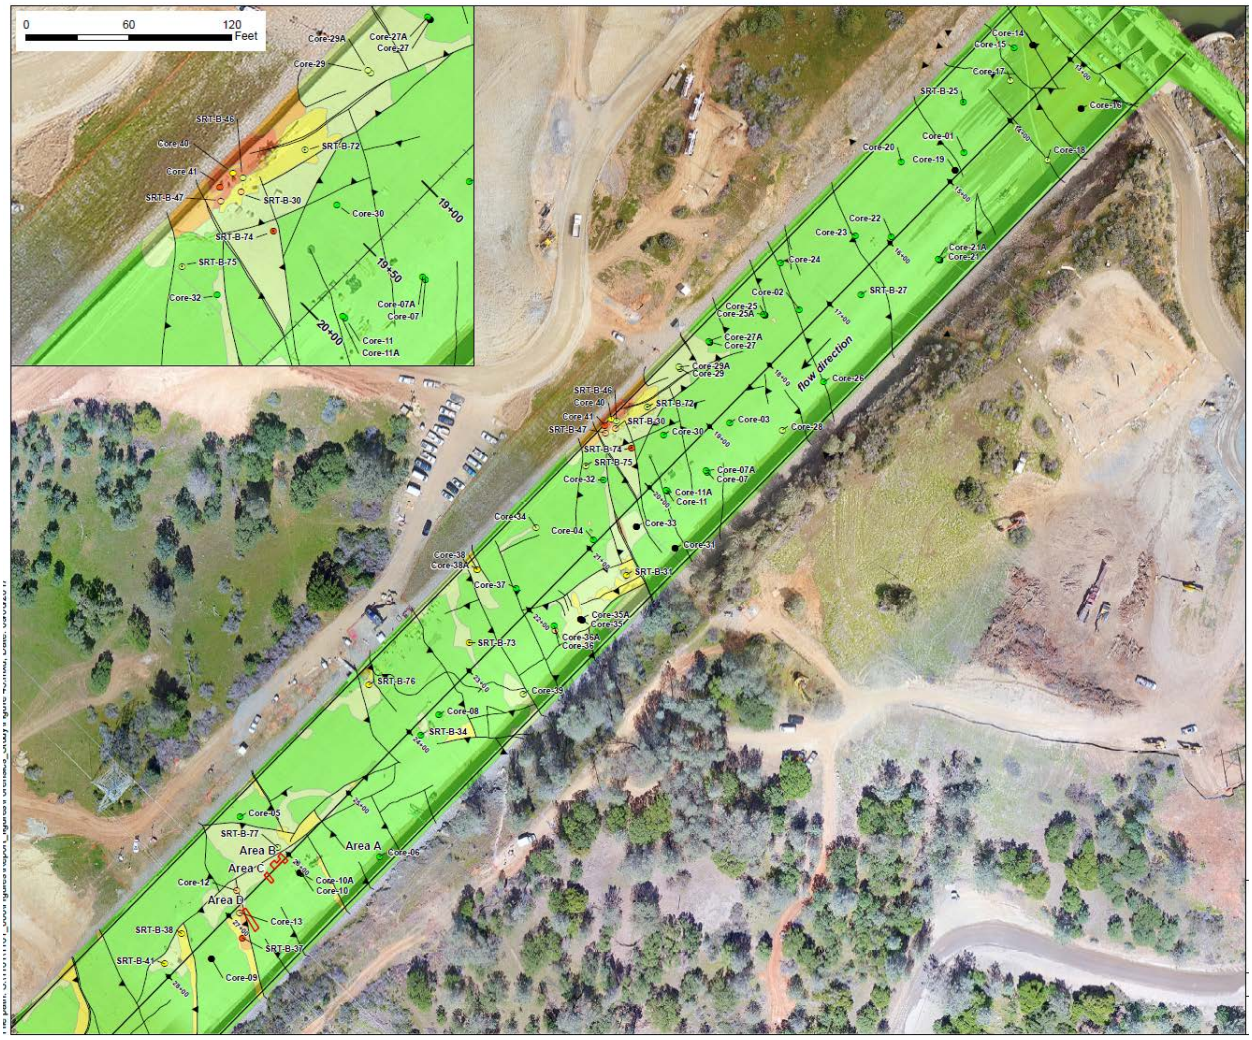
The most upstream locations where such conditions were found are documented on the right side of the chute near Sta. 19+00 to 20+50, followed by an area on the left side at Sta. 27+00, with the largest areal extent from Sta. 31+00 to 38+00.

Since the February 2017 incident, DWR geologists have prepared new geologic drawings based on and depicting the original geologic mapping prepared during construction and presented in the Final Geologic Report [D-4]. An extract from the new DWR drawings is presented in Figure D-4. This clearly depicts the locations of some of the weathered conditions in the foundation described in the previous paragraph.

Figure D-4: Geologic Map of Foundation in Upper Chute Area

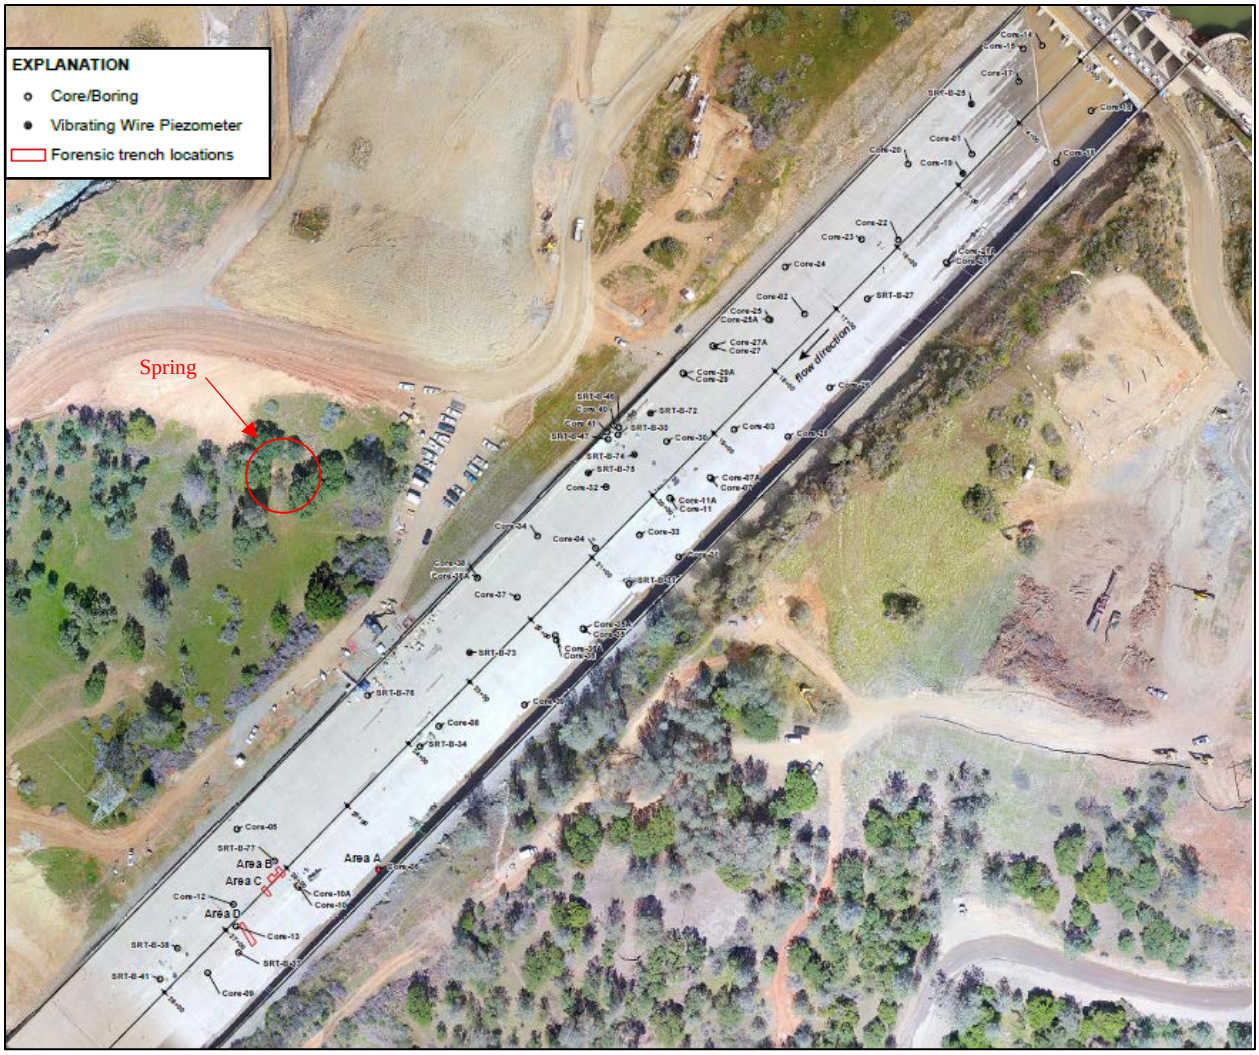
In only three core holes of the 56 locations evaluated in the upper chute area (Figure D-6) were conditions found to be more highly weathered rock than as documented during original spillway construction. Most of the core holes (39 of 68) were drilled to evaluate foundation rock weathering and to help validate or corroborate the historic geologic mapping conducted during construction [D-4]. In their recent program of investigations, DWR geologists compared results of mapping and sampling conducted as part of 2017 studies with mapping completed during original construction, focusing on characterizations of rock weathering. In general, the rock weathering characteristics observed as part of recent studies correlate well with the historic construction mapping. Similarly, foundation bedrock exposed in the forensic trenches was found to be generally consistent with the original construction geology foundation mapping conducted in those areas.

Figure D-6: Location of DWR Core Holes in Upper Chute Area

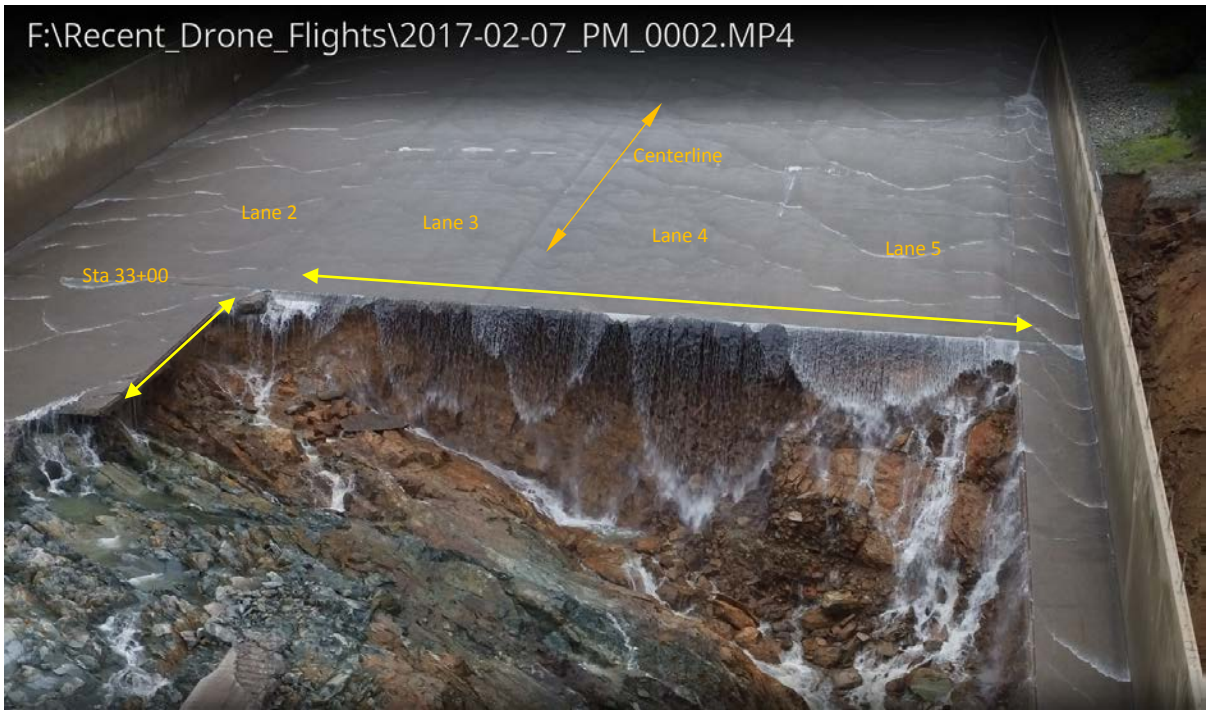
Figure D-11: Image from Drone Flight Showing Location of Initial Chute Failure Downstream from Sta. 33+00

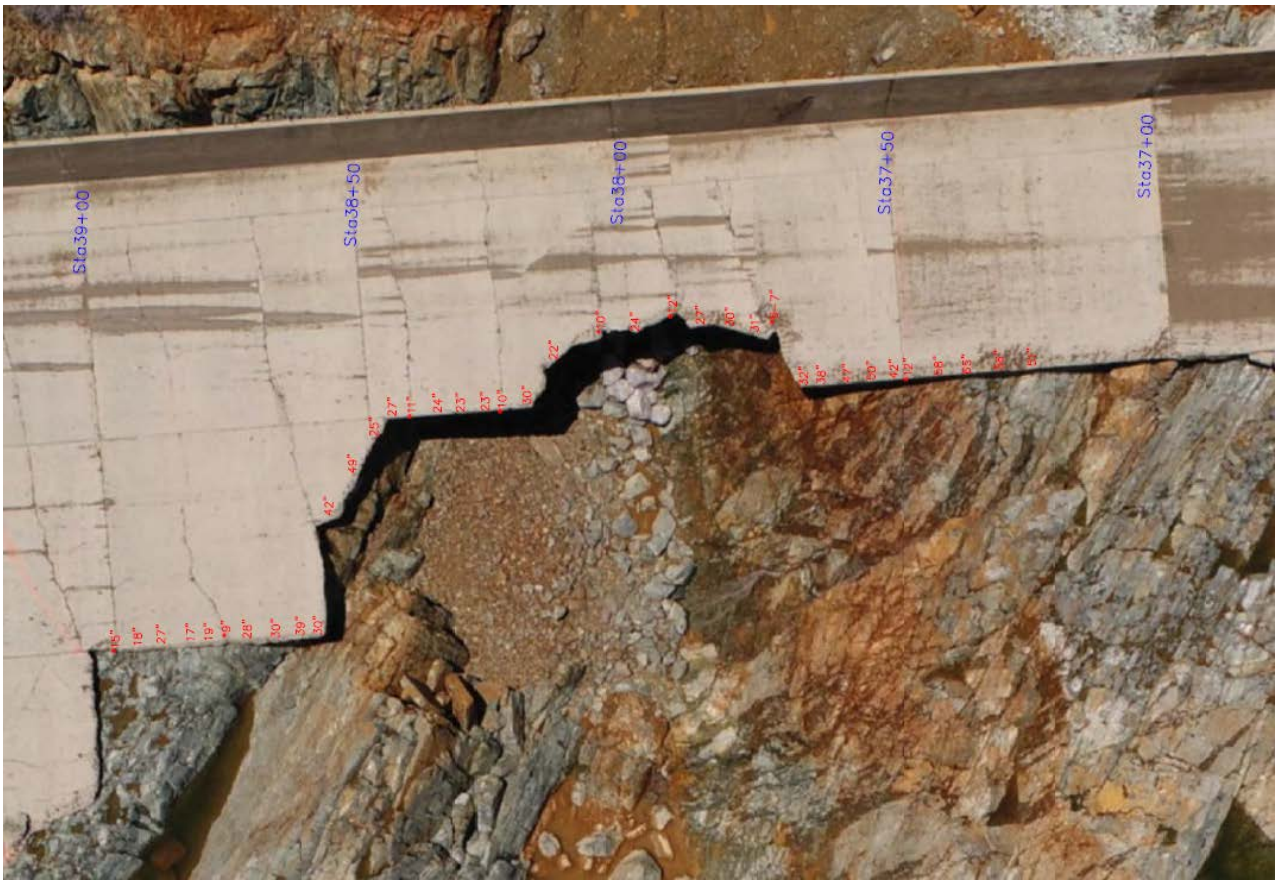
Figure D-13: Plan of Erosional Feature Between Sta. 37+00 and Sta. 39+00 Showing Observed Concrete Thickness Values (in inches)

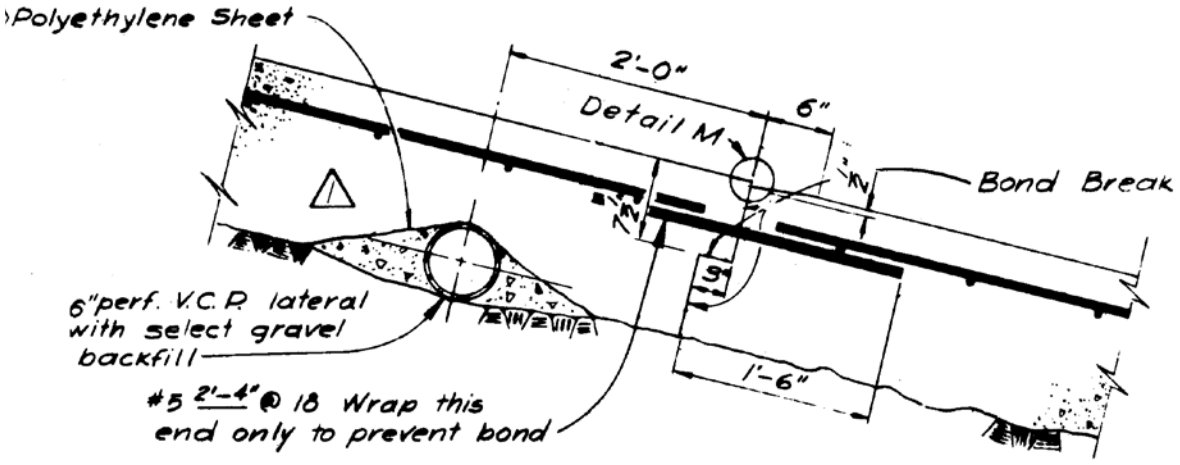
Figure D-19: Formed Lateral Contraction Joint

Formed offsets, as indicated on the drawings and Figure D-19, were not observed as consistent or uniform features at lateral contraction joints. The large majority of lateral joints observed during forensic investigations had no obvious evidence of offset. Offsets were observed at some lateral contraction joints at 400-ft-spacing, some of which possibly could have been installed during post-construction repair programs though there is no mention of such in repair documentation.

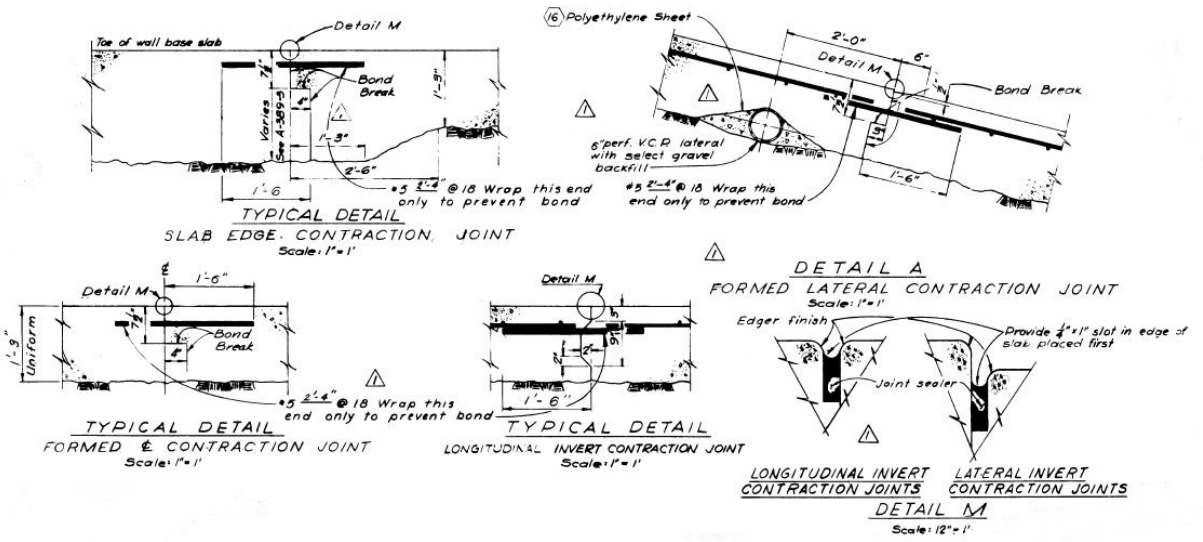
The as-built construction drawings indicate that all lateral contraction joints would be installed with a "joint sealer" to fill the top inch of the joint between the abutting slabs, see Detail M shown in Figure D-22 below. No evidence of the original sealing material was seen during the forensic investigations. Various types of elastomeric materials were used to seal the joints in subsequent maintenance and repair programs but most of this material was found to be no longer present.

Figure D-22: Contraction Joint Details [D-4]

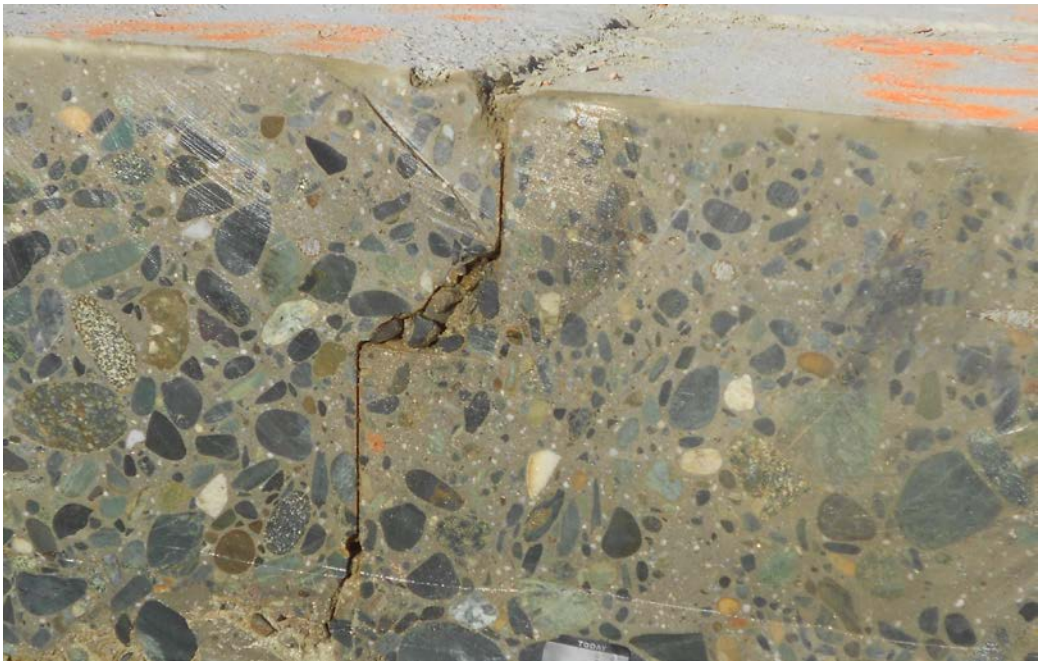
Figure D-24: Typical Cracking at Shear Key

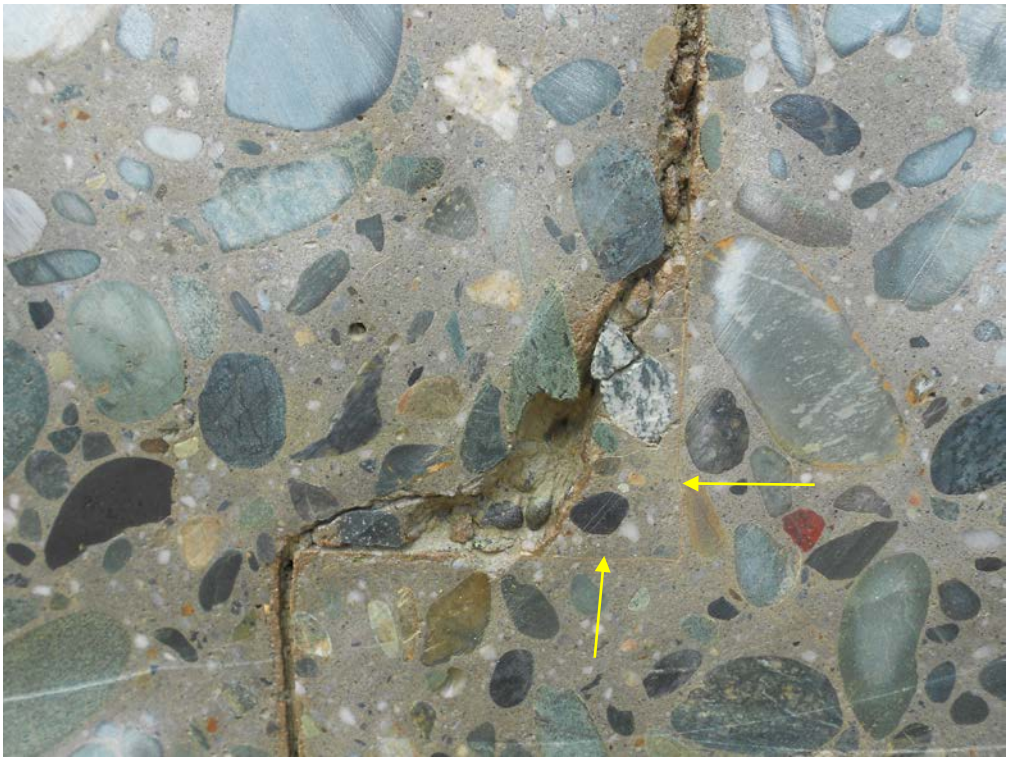
Figure D-25: Shear Key with Tight Bond (Arrows) and Typical Cracking

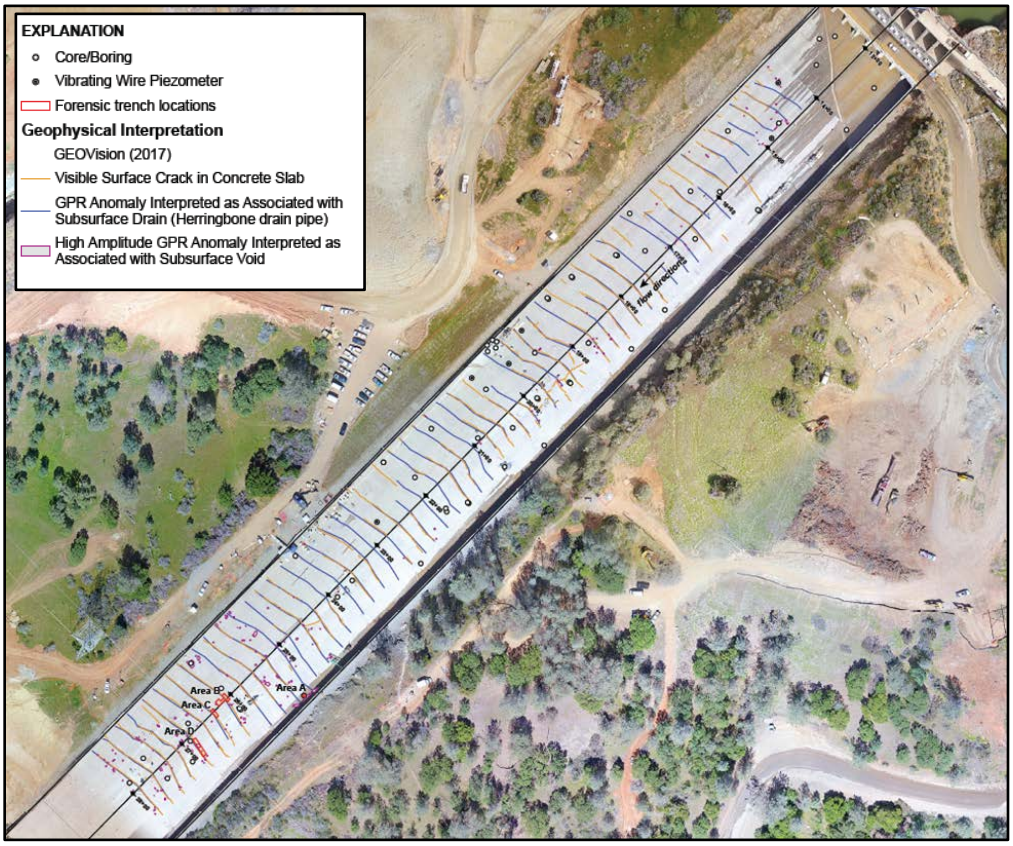
Figure D-31: Crack Mapping in Upper Chute Area

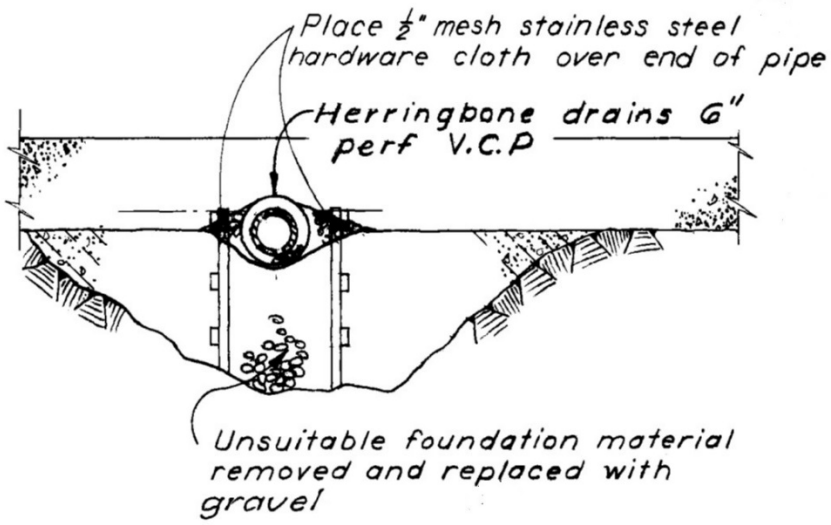
Figure D-35: Concrete Backfill Drainage Detail

Both the types of concrete backfill drainage detail were observed at numerous locations during the forensic investigations and demolition. It was noted by the IFT that these details were probably difficult to construct, and several deviations or defects were observed during forensic investigations, including:

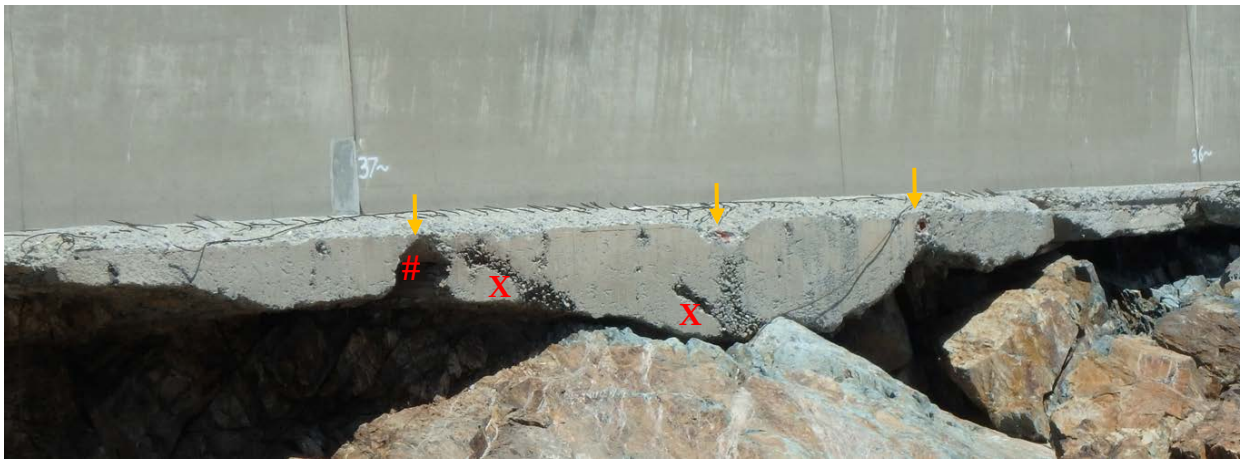
- Collapsed gravel formwork or sonotube, resulting in a locally ineffective drain and/or uncontrolled hydraulic pathways through concrete or over the foundation. Figure D-36 illustrates drain construction defects at a longitudinal contraction joint, between lanes 2 and 3, at approx. Sta. 37+00 – Sta. 37+70 in the lower chute area. Underdrain locations are shown by yellow arrows, collapsed formwork and gravel spillage are shown by X symbols, and a suspect installation is marked by # symbol where gravel formwork was apparently 3-4 feet in width.
- Noted absence at several locations, over distances of 10 to 20 ft., of gravel formwork or sonotubes needed to connect drains to the foundation through thick concrete backfill.
- Frequent spillage of gravel from formwork or sonotubes.

Figure D-36: Typical Drain Construction Defects (explanation in text)

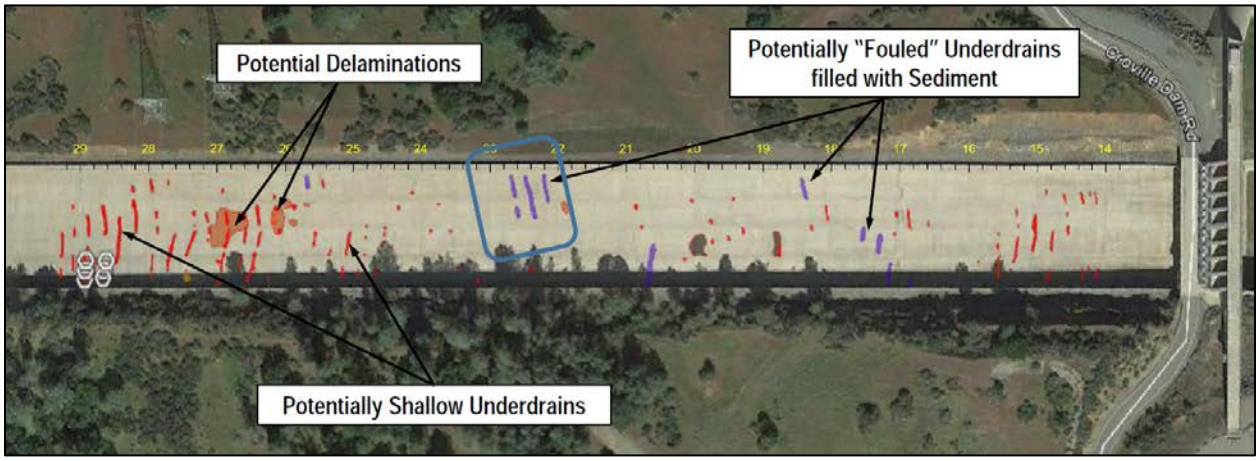
Soil Infilling (Settled Deposits), Debris, Encrustation and Scale: The only area where significant deposits were found resulting in total blockage was in one herringbone drain in the upper chute area, see Figures D-37 and D-38 [both from reference D-14]. This was discovered during a follow-up video inspection to investigate potentially "fouled" underdrains that could have been filled with sediment and originally identified in a Caltrans GPR survey [D-14]. A 15-ft-long section of a herringbone drain at Sta. 22+50 was found to be completely filled with a lean clay deposit. This infill was sampled and analyzed but its origin has not yet been determined, though it could

conceivably have originated from erosion of highly weathered foundation or from re-working of the known deposits of construction debris left on the foundation ("compacted clayey fines").

Figure D-37: Location of Potentially Blocked Underdrains and Potentially Shallow Underdrains

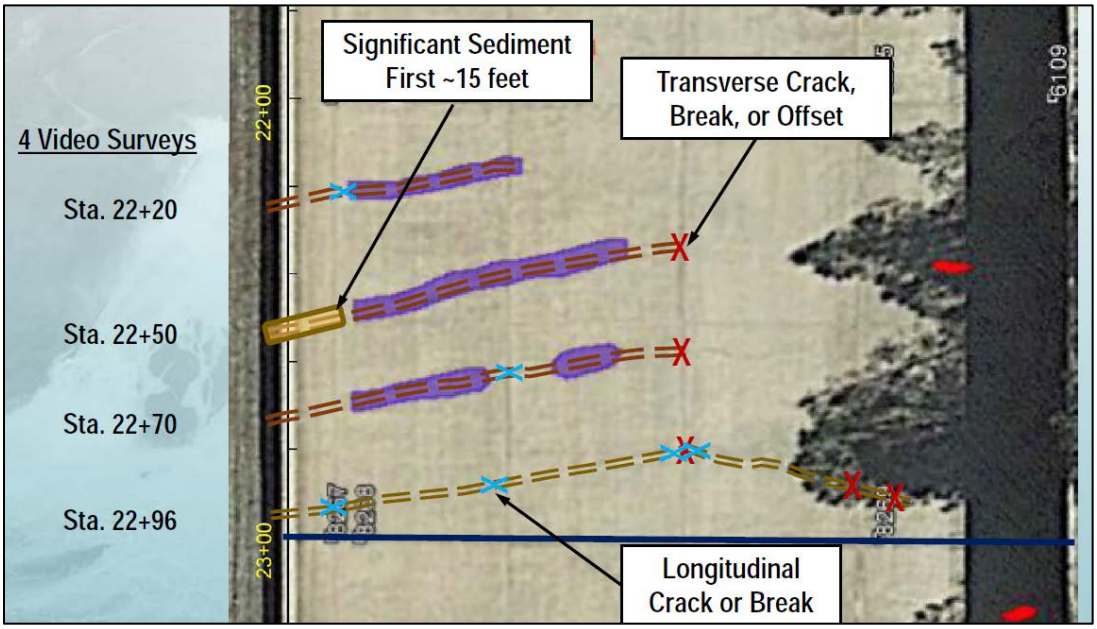
Figure D-38: Follow-up Video Surveys of Herringbone Drains Sta. 22+00 to Sta. 23+00

Elsewhere, only minor soil deposits were found, typically at separated joints. The small quantities involved would not have had any significant hydraulic effects in performance of the drains. Gravel and cobbles were intermittently present in the system. Gravel was found at offset joints and was assumed to have originated from surrounding gravel fill. Cobbles were present only below the collector pipe cleanouts and were presumed to have been dropped in. Other minor debris, soil deposits, encrustation, and scale were observed at several locations.

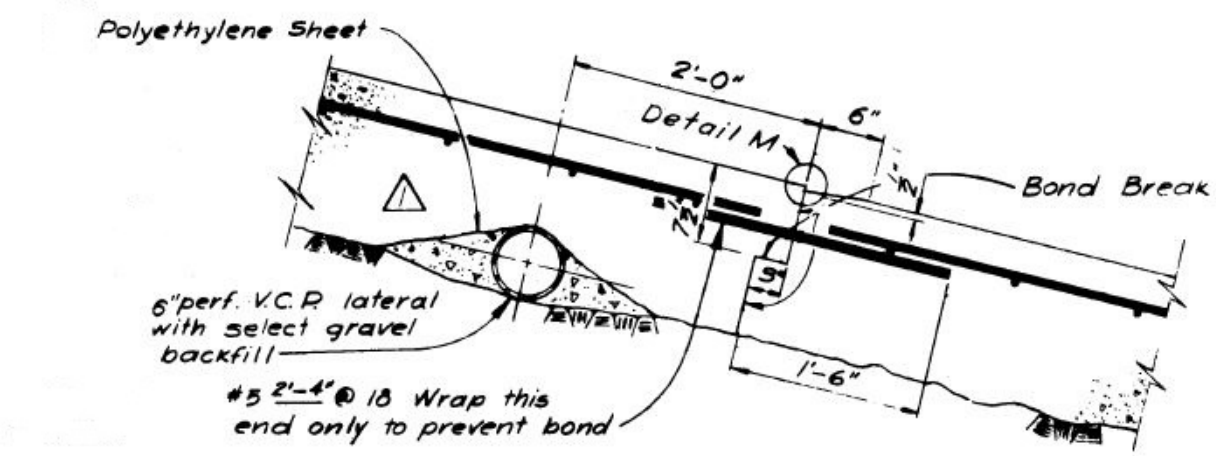
Figure E-2: Oroville Dam Spillway – Transverse Joint Detail

Keys are used at joints to prevent differential movement between individual slab panels. Keyed joints were provided in 83% of the spillways surveyed for this study. Reclamation and others typically provided a key that is integrated with a cutoff design, as shown in Figure E-1 from the Best Practices document [E-3]. This "key" prevents upward movement of the downstream slab panel relative to the upstream panel. Keys at transverse joints for the Oroville Dam service spillway chute provide an offset at a depth of 7.5 inches that prevents the downstream slab from moving upward (Figure E2). This key is not as robust as the key in Figure E-1 because it is not the full depth of the slab. Differential movements could more easily cause spalling of the upstream slab panel above the key for the Oroville detail.

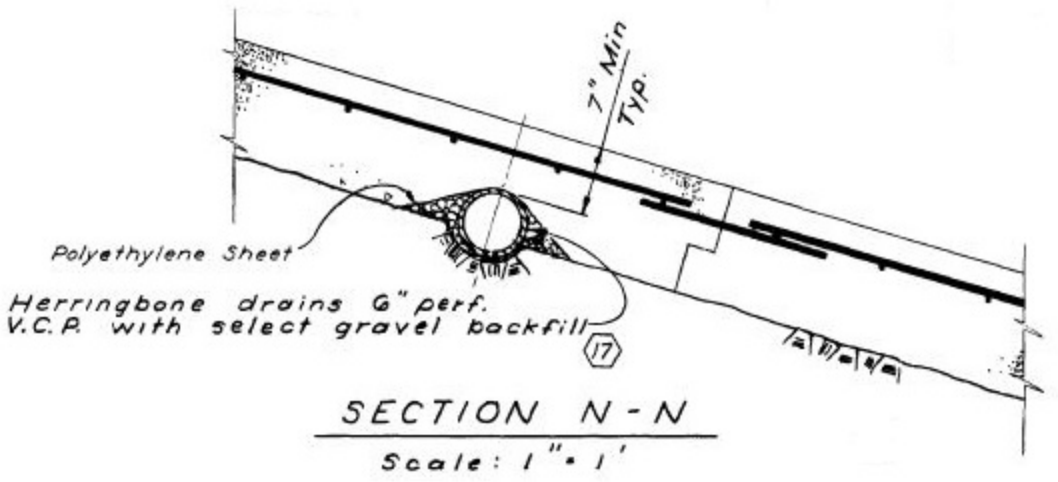
Figure E-3: Oroville Dam Service Spillway Slab and Drain Detail

During the period when Oroville spillway was designed, the potential flowing water in the chute to produce uplift beneath the chute slab through hydraulic jacking was not well understood. The design of offset joints (as discussed above) was based on the concern that flowing water could enter the foundation, increasing uplift. However, the potential for high uplift and foundation inflows caused by stagnation pressures at joints and cracks was not quantified. Nevertheless, the Oroville Dam spillway chute drainage system was originally designed to remove ground water, and the entire piping system was increased in size after the contract was awarded to increase capacity. The survey of spillways for this study showed that 95% of the spillways had a drainage system for the foundation. However, only 9% had drains that were placed within the bottom of the slab, as was done at Oroville (Figure E-2). Of the spillways with drains within the chute slab, the drain pipes were a smaller percentage of the total slab thickness, than was the case for the Oroville Dam service spillway chute. For example, the one DSOD spillway with drains placed in the slab had a 6-inch half round pipe in a 21-inch thick slab (approximately 3 inches projecting into the slab, or 12.5% of the slab thickness) More than 50% of the 15-inch slab thickness was reduced at the drain locations for Oroville (see Figure E-3). This reduction in thickness lead to cracking over the drains. In most cases, when drains are placed within the slab there is enough room for a bottom layer of reinforcement to be placed above the drains. There was not enough room for this to be done at Oroville.

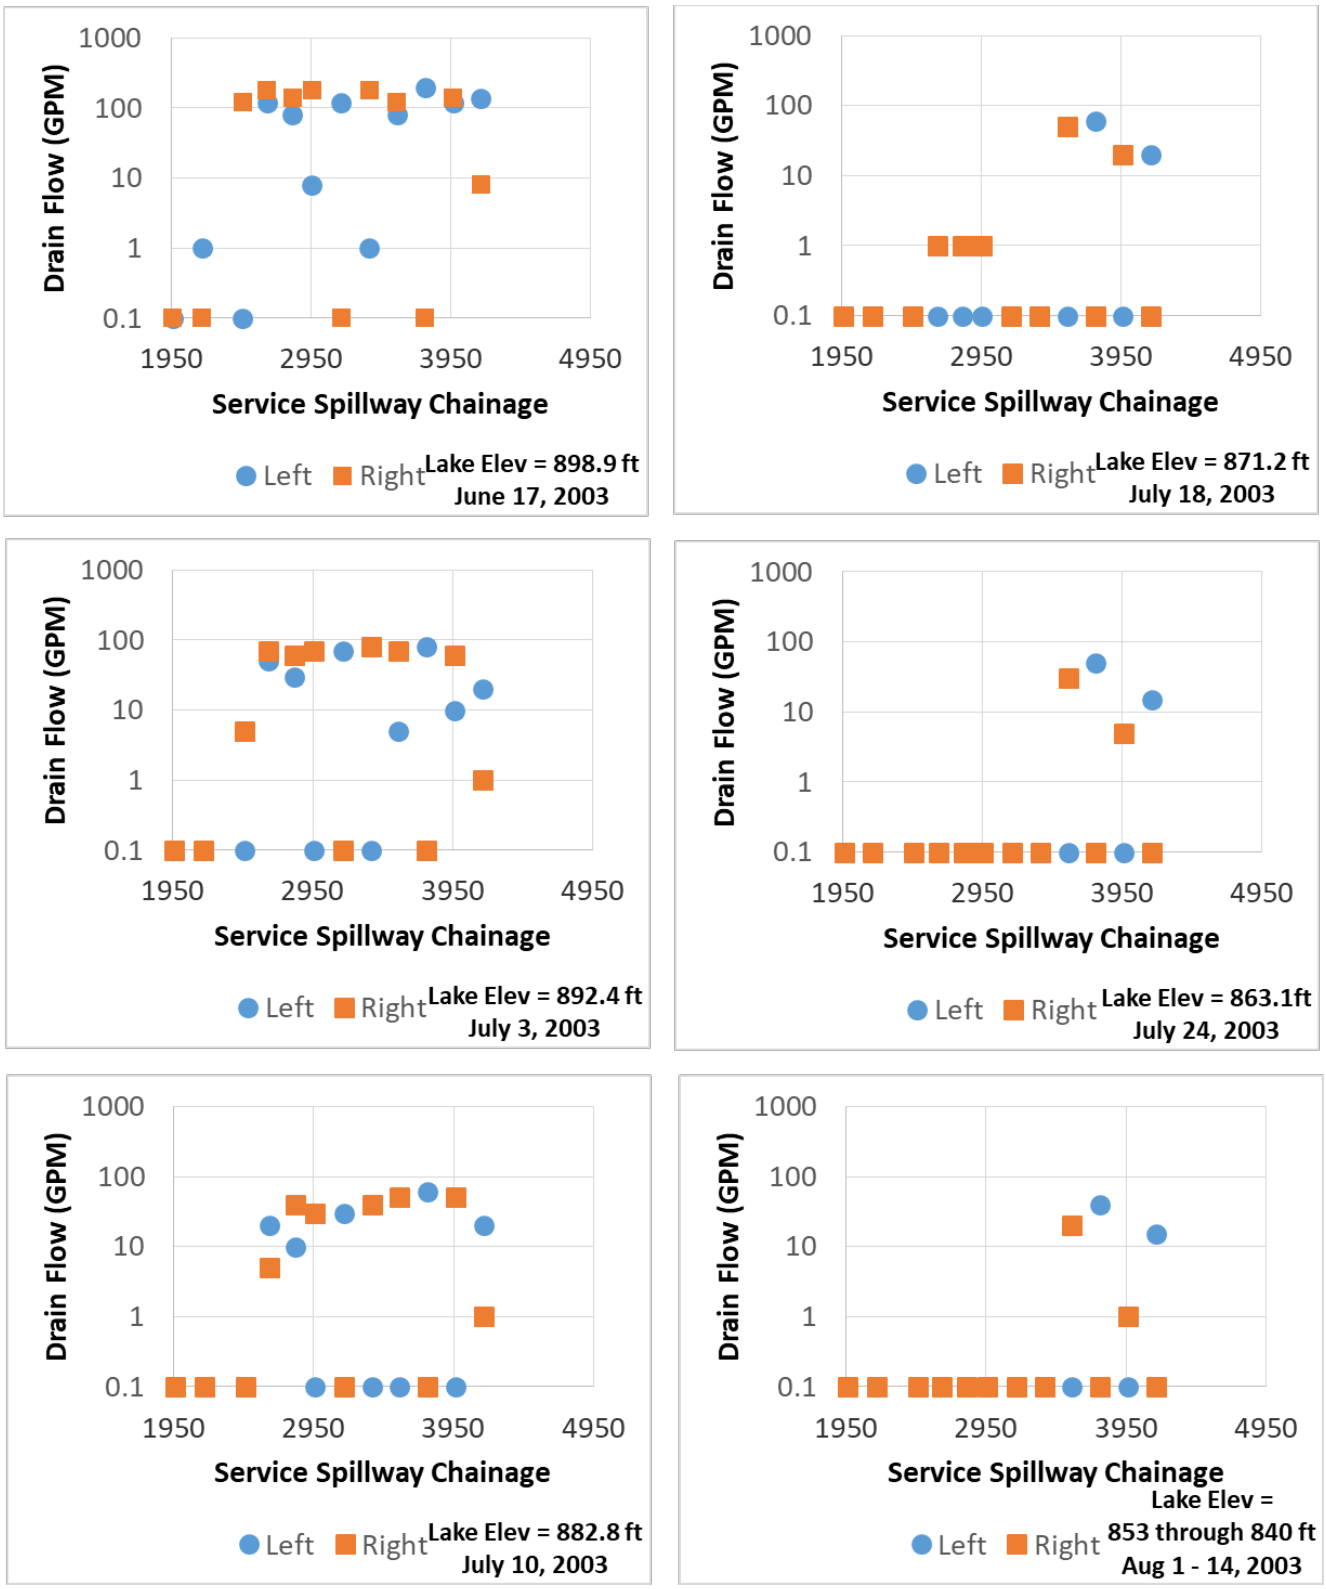
- By the time the reservoir is lowered another 10 ft. to about elevation 870, there are only four of the 24 outfalls still flowing, all at the furthest four downstream locations 8 through 12.

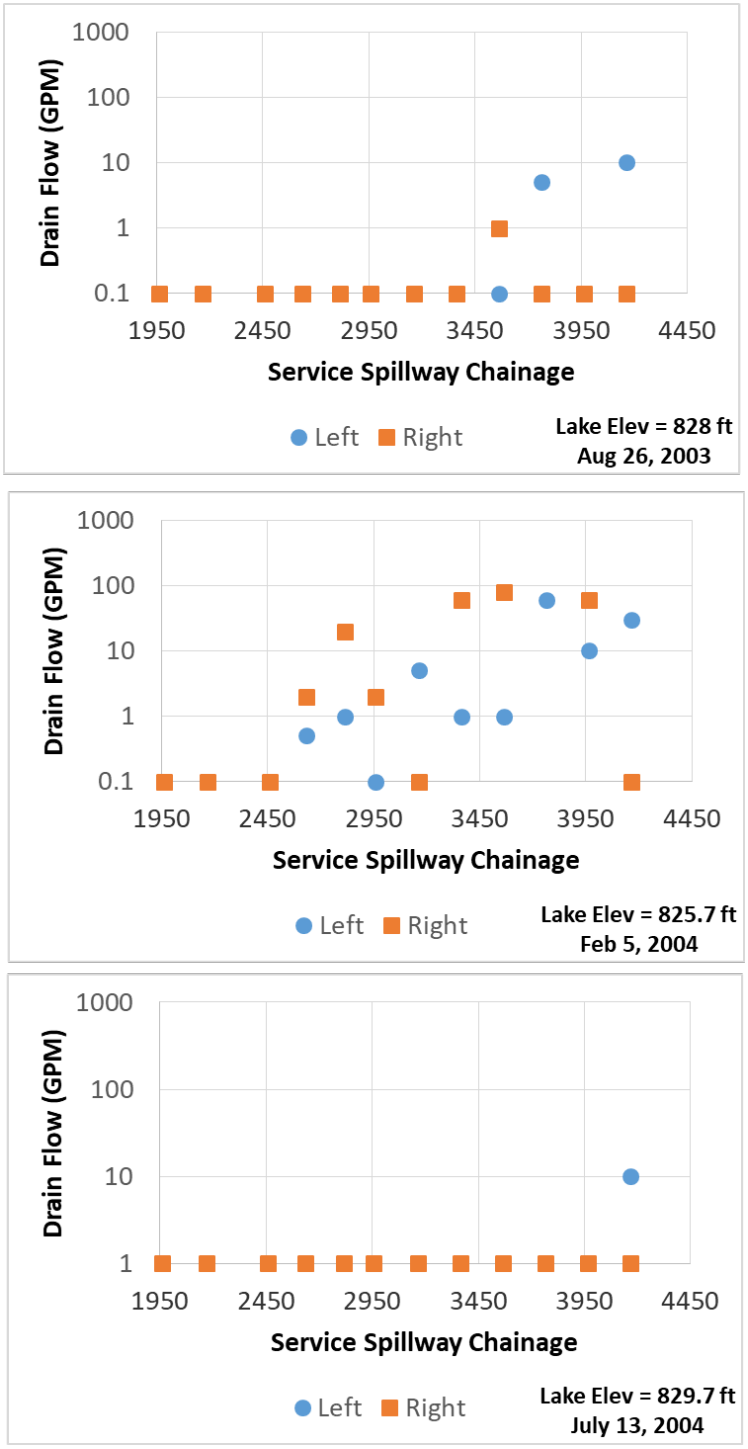
Figure F1-3: Plot 2 of 2003 DWR Unreferenced Data

Figure F1-3 shows the major effect of seasonal factors that could include thermal opening/closing of cracks, rainfall and runoff, etc. A series of three plots are shown over a period of a year, while at about the same reservoir elevation of 825 ft.: summer flows are negligible from all outfalls, while in winter, 18 of the outfalls are flowing, seven of these between 10 and 100 GPM each.

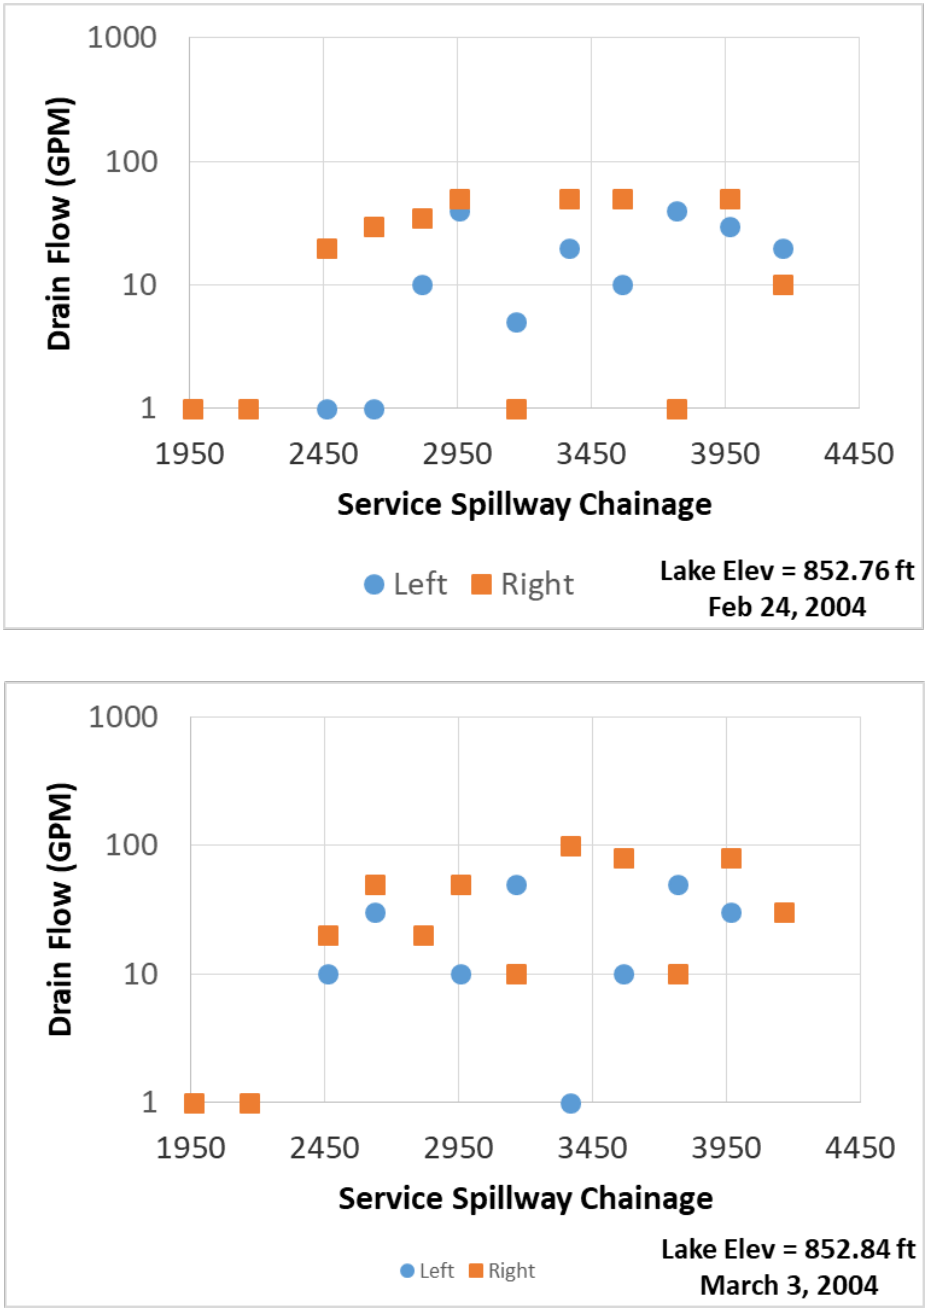
Figure F1-4: Plot 3 of 2003 DWR Unreferenced Data

Figure F1-4 illustrates the variable nature of the flows by comparing two plots separated in time by one week at the end of February 2003, with essentially no change in reservoir elevation. In this short timeframe the changes in flow are significant, and include:

- Outfalls 3L and 4L and 7R and 10R, start flowing up to > 10 GPM from being originally dry, while at the same time:
- Outfall 8L goes dry after originally flowing up to 100 GPM.

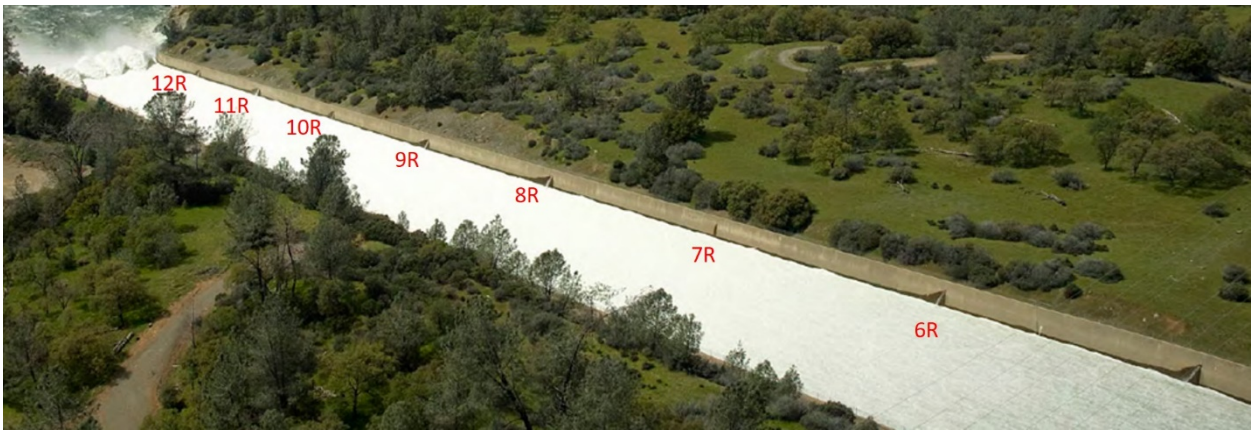
Figure F1-5: February 3, 2006 (Photo provided by DWR): Spillway in use - all right side drains apparently flowing well. No photos available for left side.

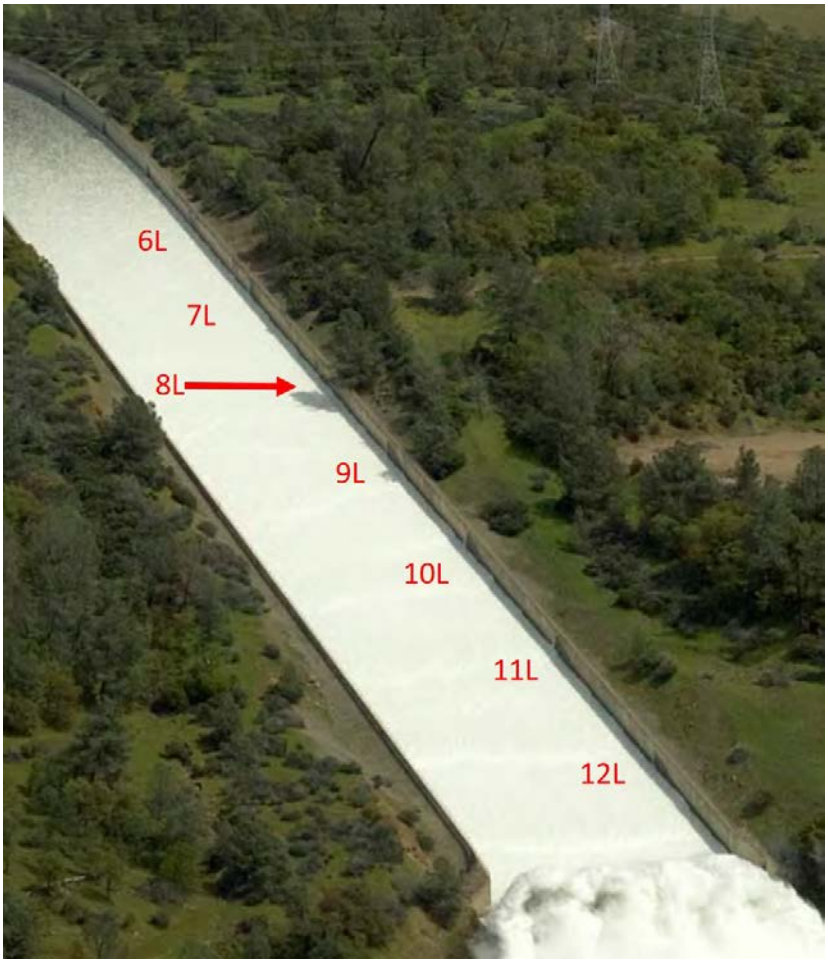
Figure F1-6: May 17, 2006 - Spillway in use (photo provided by DWR): obscured view, but possibly little to no flow in outfalls 9L and 8L and possibly 10R.

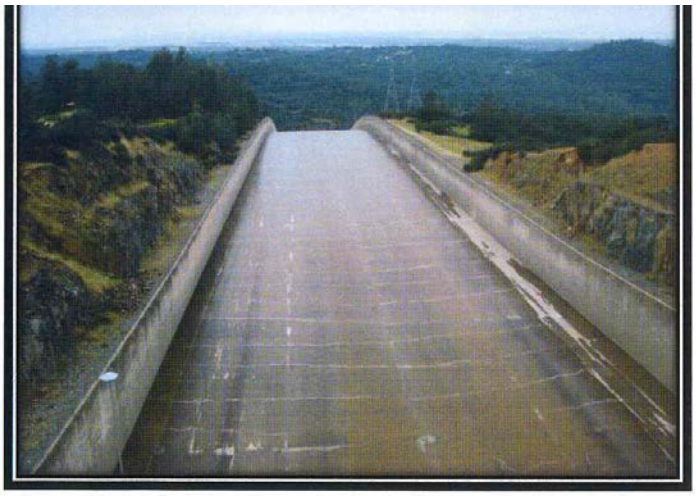
> "We observed some chevron cracking in the floor that is coincident with the underlying floor drains."

12. The concrete along the spillway chute has been repaired. The repaired herringbone crack pattern is said to reflect the underlying drain system. "
