INDEPENDENT FORENSIC TEAM REPORT
OROVILLE DAM SPILLWAY INCIDENT

JANUARY 5, 2018

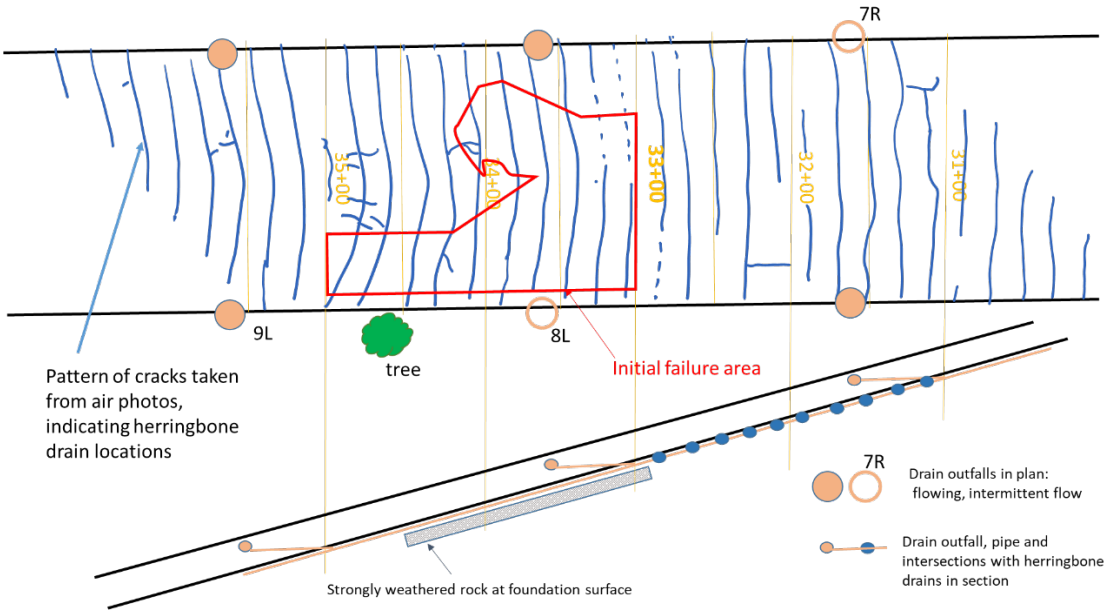
Figure F1-12: Schematics of Spillway Chute near Initial Failure Area

The particular tree in question was closest to the left side of the spillway at about station 34+50. The IFT considered whether roots from this particular tree, only about 100 ft. or so from the initial failure area, could have been a contributing factor. The IFT believes that this hypothesis is unlikely, due to the layout of the drain system as illustrated in Figures F1-12 and F1-13:

As shown in the plan views, the tree was located close to the left spillway wall, between Outfalls 8L and 9L, so that blockage by roots from this tree would affect Outfall 9L. Each outfall connects to the herringbone drains upstream of the outfall location, as shown in the profile view and lower plan view. The most downstream drain for each outfall is located about 60 to 70 ft. upstream from the outfall, and the most upstream drain is located about 260 ft. upstream of the outfall. Had roots from this particular tree entered the drainage system, they could have blocked the herringbone drains in the vicinity of the initial failure. However, the outfall for this section is at about station 35+65 (Location 9L), which in 2011 and 2017 photos is flowing freely. As such, roots from this particular tree could not have been significantly blocking the 9L outfall.

Outfall drain 8L, immediately adjacent to the initial failure area, has been observed not to flow, and thus was possibly blocked. This outfall collects flows from drains under the chute from about Station 31+00 to 33+00, upstream from the initial failure area as shown in the sketches. Blockage of 8L is a possible contributor to the failure under certain assumptions. If the slab was thick enough in this area (upstream from Sta. 33+00) that the drains were well above the foundation, and water leaking into the foundation could pass through a thick gravel layer placed beneath the drains where the foundation was overexcavated. This water could make its way to the downstream drainage set that is in the area of the initial damage. If this happened, the downstream drain set (9L), might not have had sufficient capacity to handle the combined drainage flow and caused flows to back up under the slab.

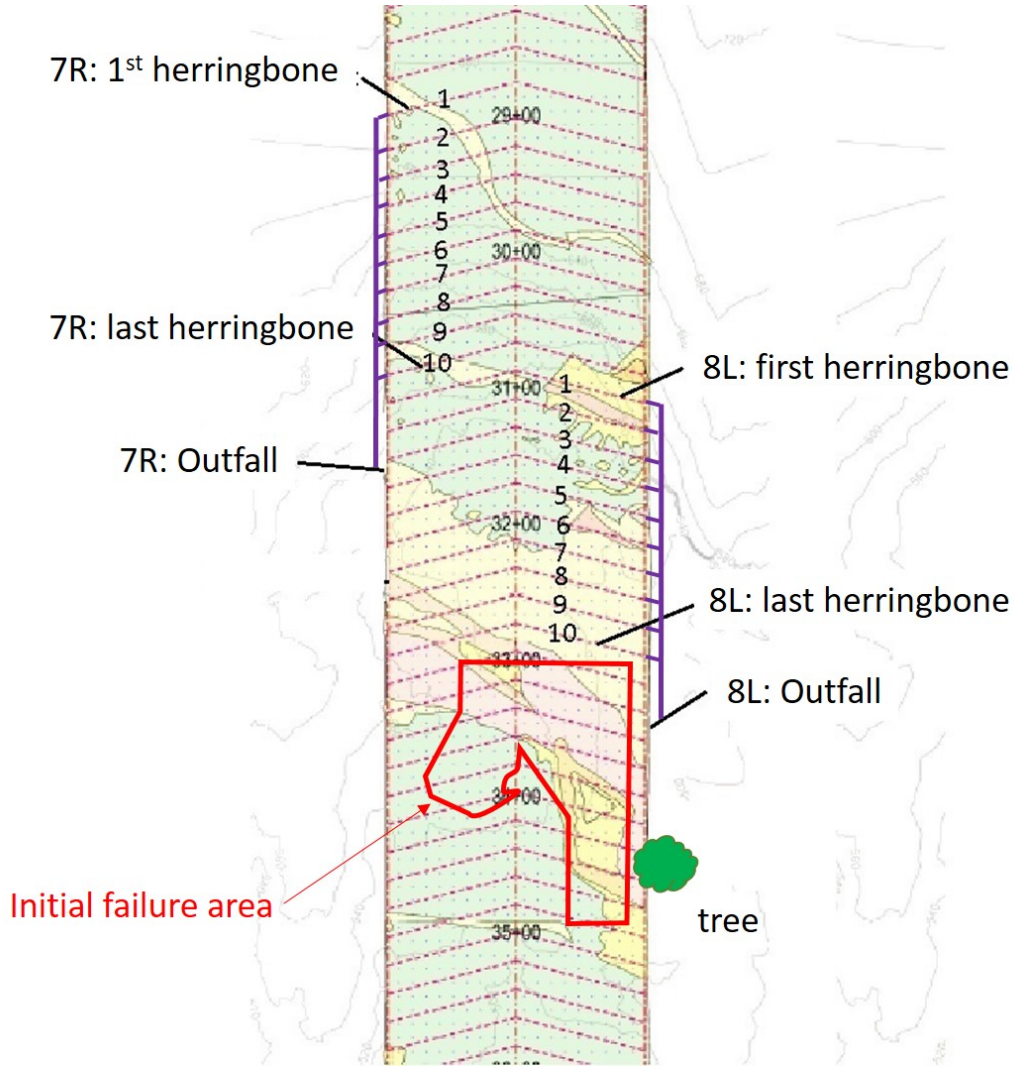
Figure F1-13: Idealized Layout of Spillway Chute Underdrains upstream of Initial Failure Area (underlay of chute geology provided by DWR)

Another possibility possible explanation for no drain flow is that the water from the chute entered the foundation, and bypassed the herringbone drains by flowing under the slab through piping internal erosion channels downstream to the next drain set.

However, it is also possible that either this drain was not connected to the outfall pipe prior to the damage, and flow from the herringbone drains discharged into the gravel outside the wall, or there was actually no inflow to the herringbone drains in that drain set because the repairs had not failed there, and no flow was entering the foundation.

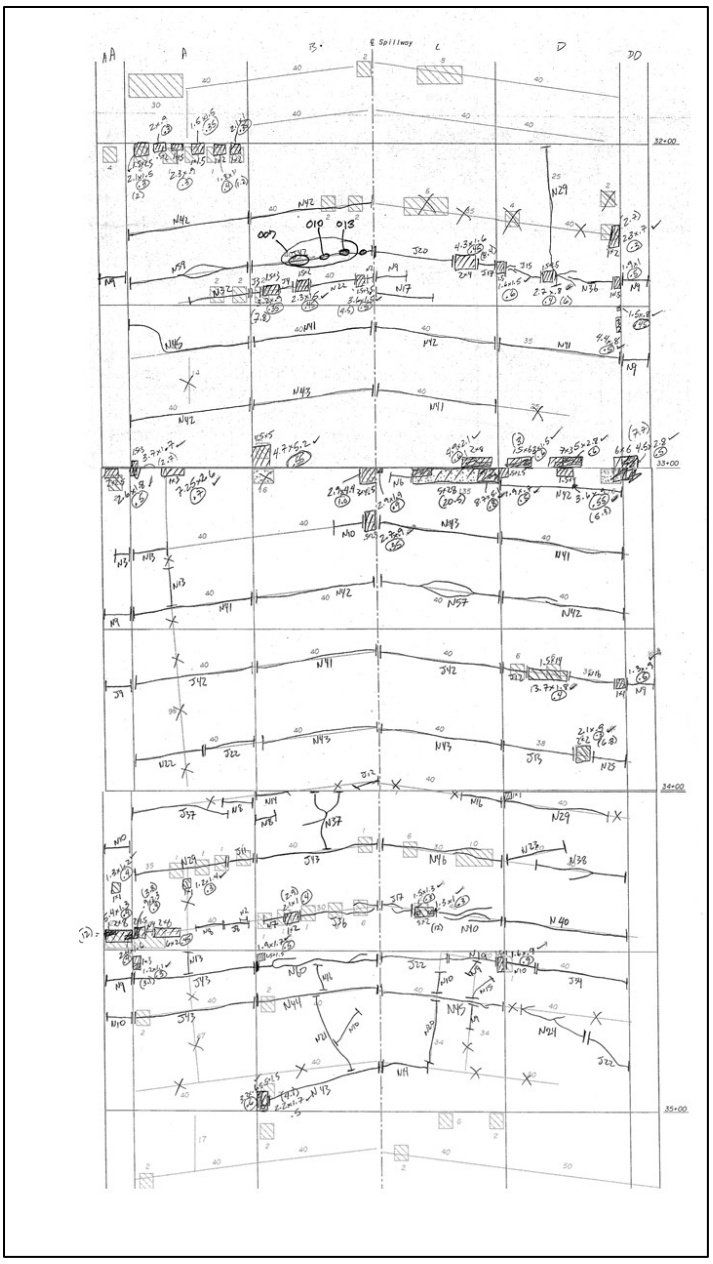
Figure G-1*:* Repairs made in 2009 (from Field Notes)

The repair effort for cracks ranged from minor crack repair (1/4-inch wide or less) to major crack repair. Where spalls and/or delaminations (labled as "voids" on the drawings) were adjacent to cracks, the repairs were more extensive. Minor repairs called for the cracks to be completely filled with a low-viscosity epoxy. The epoxy used was a Sikadur 55 SLV formulation that is specifically intended to penetrate and seal cracks, driven by gravity only. While it worked well, most cracks required three to four applications to completely fill the volume of the crack, with a few localized spots requiring six to seven applications. Major crack repair included preparing the cracks by sawcutting or routing to a neat rectangular cross-section with minimum dimensions of 3/8" wide x 1/2" deep. The contractor used hand-held grinders to cut a rectangular groove at the top of these

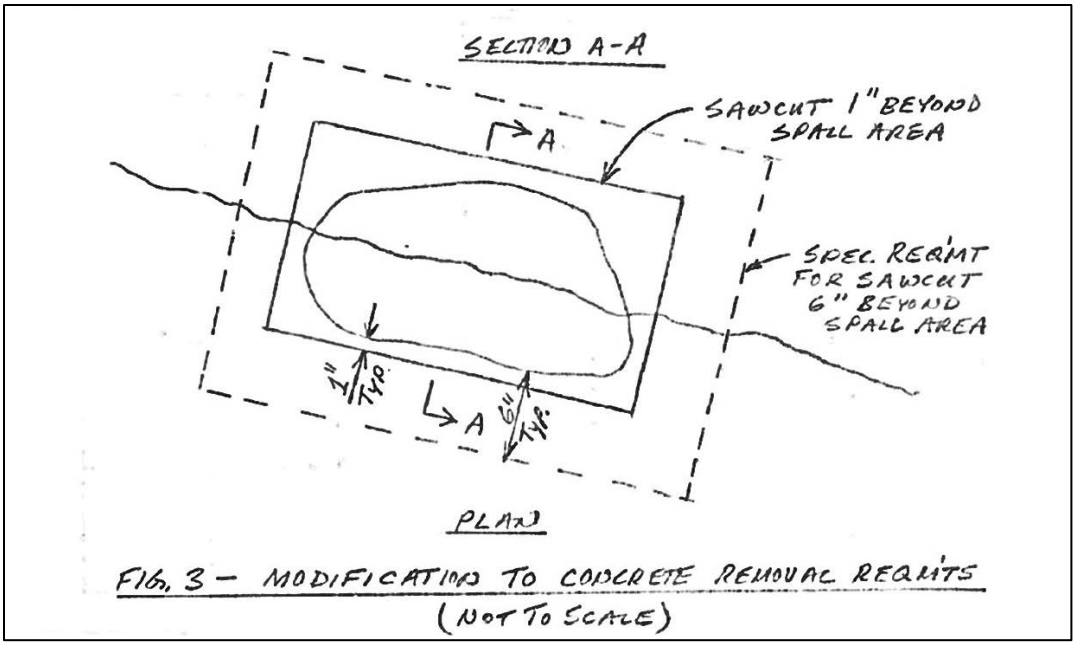
Figure G-2: Revision to 2009 Repairs to Reduce the Area of Concrete Removal Around Spalls

Some of the repairs as described above were the result of modifications made to the repair methods during the construction. These included a reduction to the area of concrete to be removed around a spalled area above the drains, a 1-1/2-inch sawcut above the crack in the new concrete, and splicing of broken rebar over the drains (see Figures G-2, G-3, and G-4). The modification to reduce the area removed around a spall (Figure G-2) was made to minimize the potential to damage the VCP pipe below as the concrete was being chipped out. This process seemed to inadvertently fracture the pipe when large concrete aggregates were present, and it was believed that by reducing the area of conctere to be excavated, the damage to the pipe would also be reduced. However, this change may have resulted in some cracked or delaminated concrete not being fully removed.

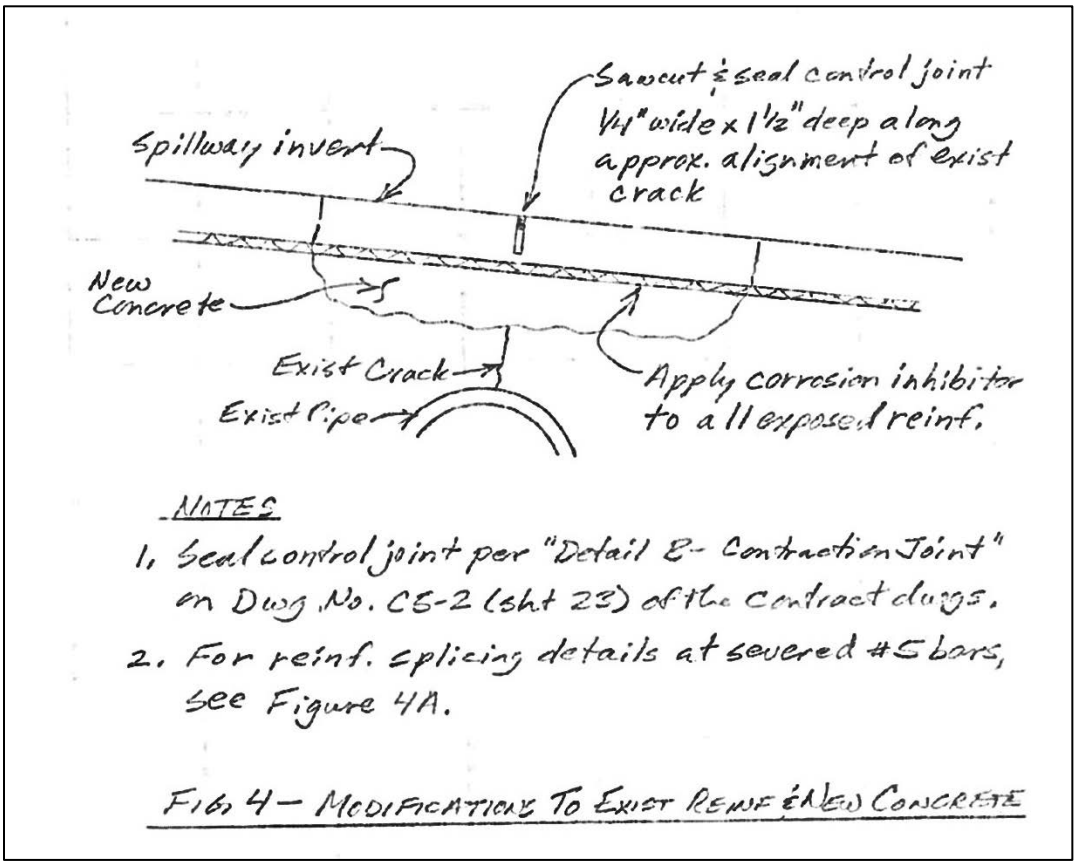
Figure G-3: Revision to 2009 Repairs to Provide Sawcuts Above Cracks Over Drains

Sawcuts above the cracks in the new concrete (Figure G-3) were done because the DOE staff believed that the cracks had become "expansion joints." The IFT believes that the cracks had opened as a result of concrete contraction, and the location above the herringbone drains corresponds to the reduced concrete thickness (from a minimum of 15 inches to 7 inches) above the drains. If the cracks below the new concrete were still open, a partial 1-1/2-inch sawcut above the crack in the new concrete would not prevent transfer of load as the concrete expanded in the summer heat. The thin section of new concrete between the sawcut and the cracked original concrete below the repair would be subjected to high compressive stresses, which could cause delamination of the repair. Rebar passing through the repair, whether spliced, or original intact bars, would go into compression during high temperature periods, possibly buckling the bars and contributing to the potential for concrete delamination and spalling. In the IFT's opinion, these repairs were mearly temporary and cosmetic, and would not be capable of resisting the temperature stresses that caused the damage in the first place. The way in which they were done may have even potentially resulted in larger damaged areas in the future.

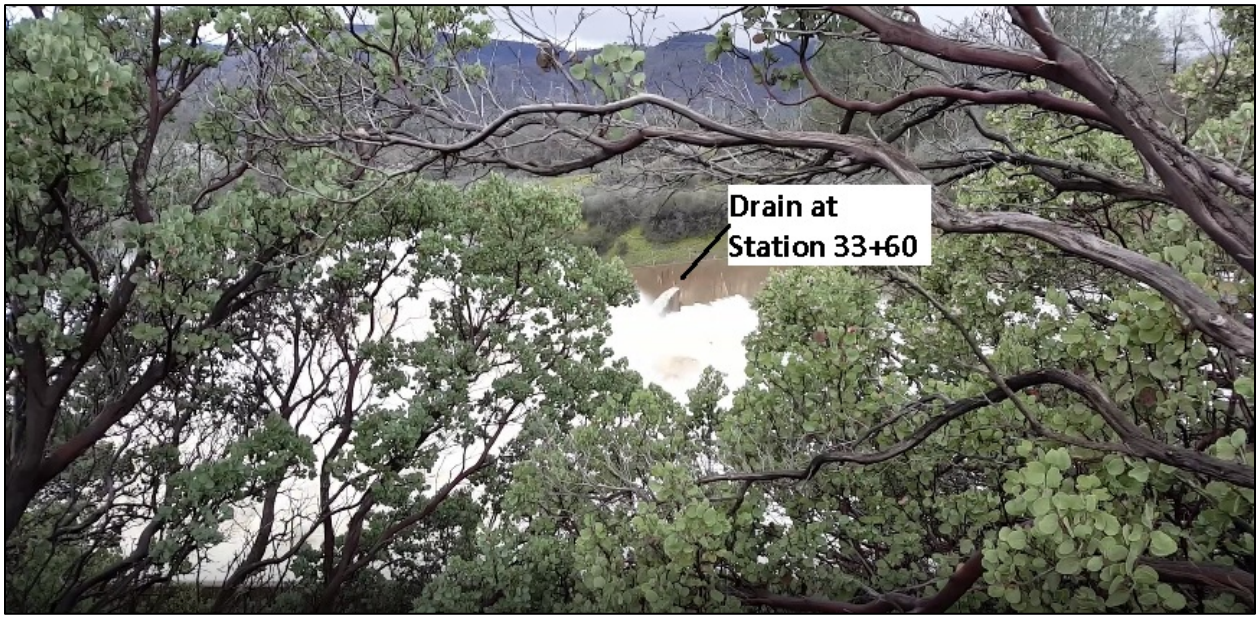
Figure I-3: Flow in Chute at 10:23 am [I-2]

On February 7th, at approximately 10:10 am, DWR maintenance staff workers, who were servicing the siren on the left side of the spillway, next to the spillway chute, heard what they said sounded like an explosion or a loud bang, and saw spray coming from the spillway chute. One of the workers began to take photos and videos [I-2]. The first video was made at 10:23 from the location noted on Figure I-2, and two still frames from that video are shown on Figures I-3 and I-4. They reported that the damage appeared to start near the center of the chute and then move toward them (the left wall.) As they watched, the area of spray also moved upstream. A photo taken at 10:32 am shows that the damage is occurring downstream of Station 33+00, Figure I-5.

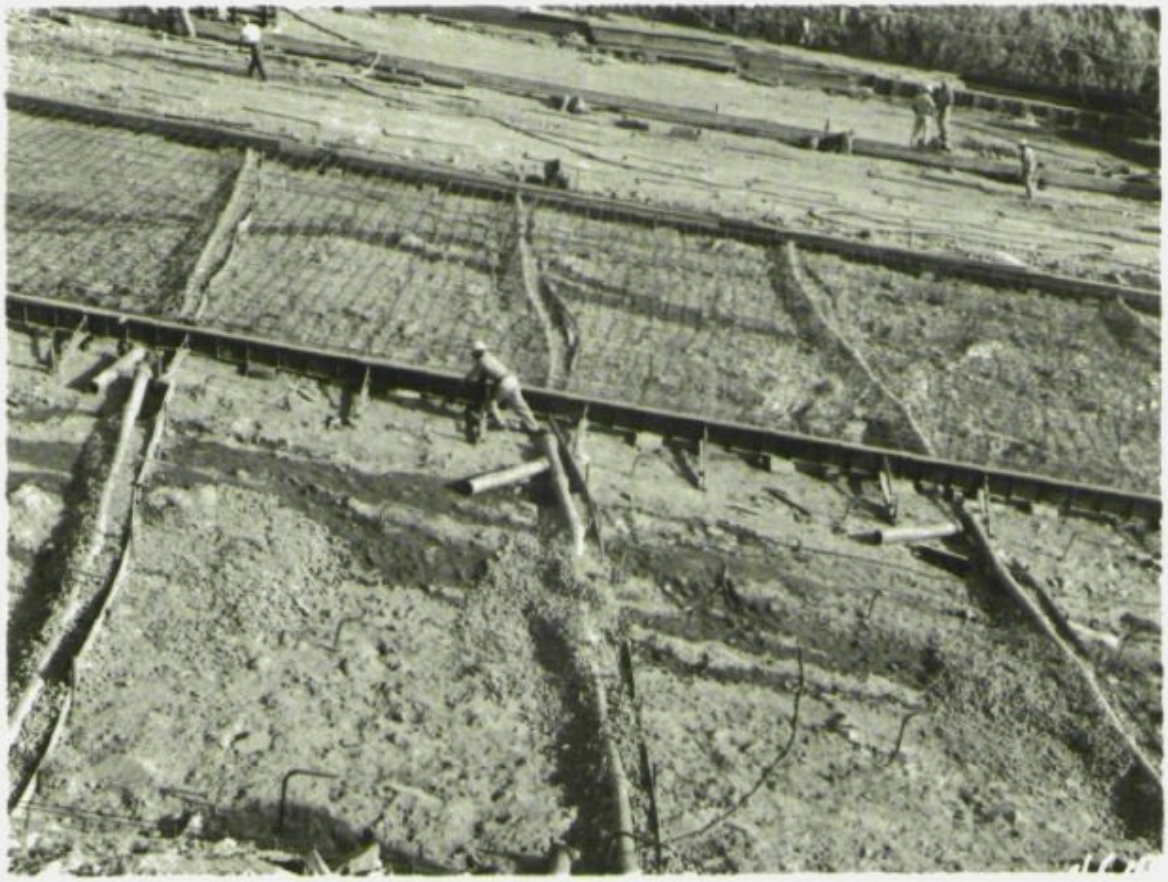
Figure I-11: Foundation in the Vicinity of the Failure [I-4]

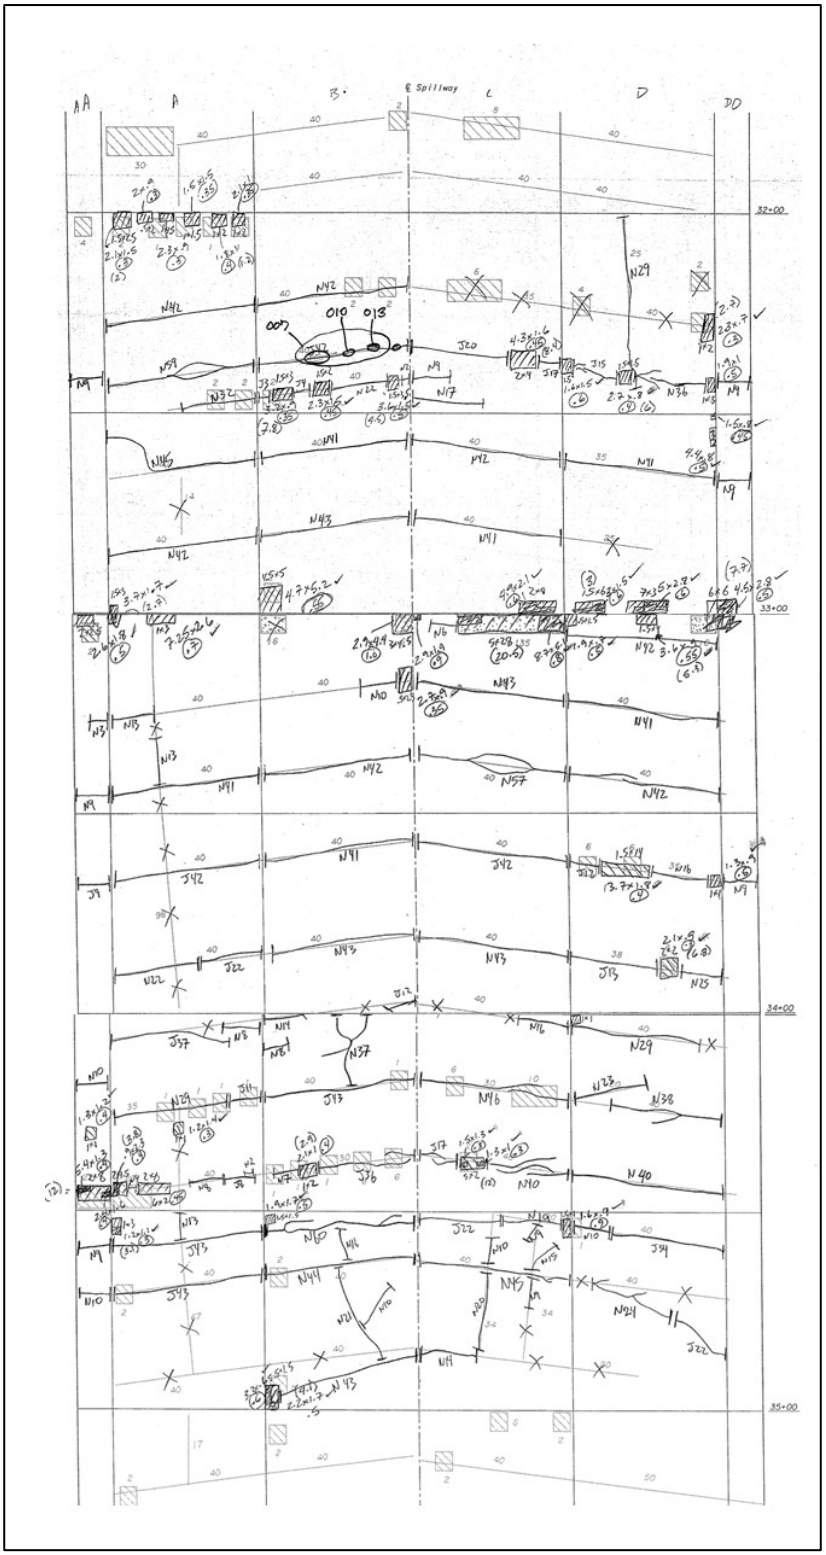
Figure I-12: 2009 Repairs [I-5], Sta. 32+00 to 34+00 from Field Notes

As discussed in Appendix G of this report, repairs to the spillway chute slab made prior to the February 7, 2017 incident were ineffective long-term solutions to an ongoing problem. It is unlikely that cracks over the herringbone drains could be prevented from opening and closing during seasonal temperature cycles, and the repairs were not robust enough to prevent occurrence of further damage within a few years of repair completion. The sealing of cracks and contraction joints was done with materials that could not withstand these seasonal cycles, and/or would not remain in place during high velocity spillway flows. While the concrete repairs patched over spalled concrete, the patches were relatively shallow, and were not capable of preventing new spalls in either the repaired concrete or concrete that had not previously spalled. Spalling at cracks and joints creates a significant potential for water to flow into the foundation and generate high uplift pressures, if the drains cannot successfully remove these inflows. Two critical design details that were never addressed by any of the repairs are the lack of waterstops at the contraction joints, and the herringbone drains being placed within the chute concrete where they create a weakened section that can easily crack and indeed had done so throughout the chute.

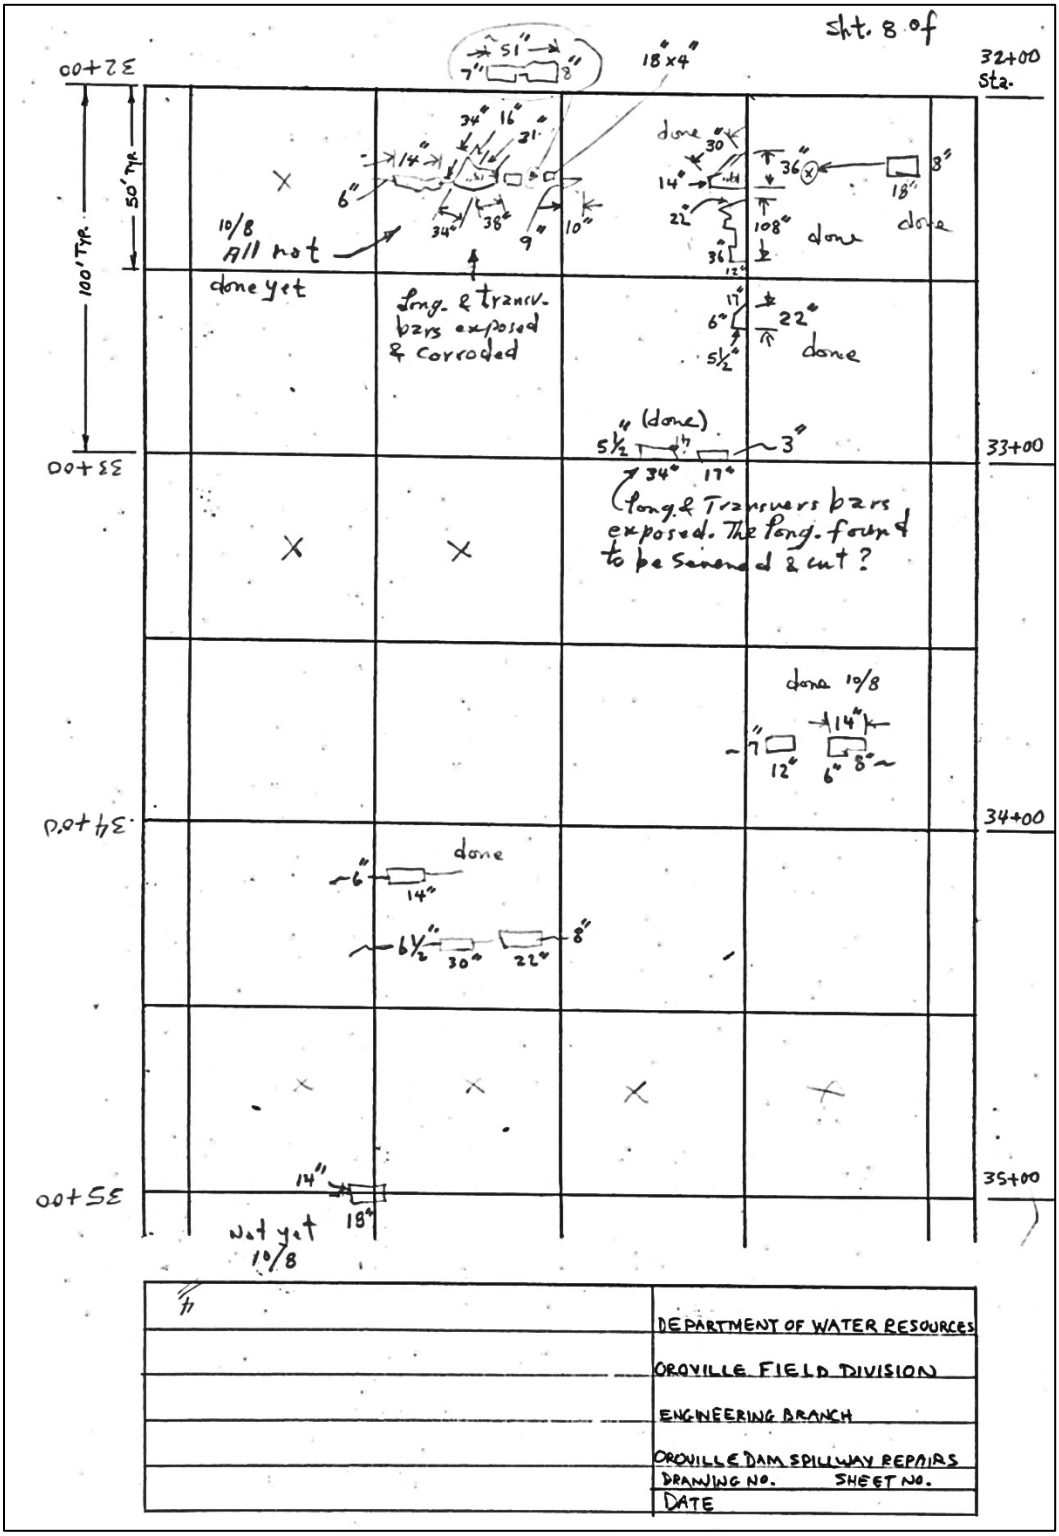
Figure I-13: 2013 Spillway Repairs from DWR Staff Field Notes from Sta. 32+00 to 35+00

Further repairs were made in 2013, as shown in Figure I-13. These repairs seem to included repairs to areas with previous repairs that had failed and new areas of damage. Repair methods were similar to the 2009 repairs [I-5], although it is believed that non-shrink grout was not used in 2013. The 2013 repairs in the failed area between Station 33+00 and 34+00 were again, mostly sealing of cracks, with few new patches. While it is assumed that there were few visible spalls between Station 33+00 and 34+00 in 2013, it is not known if there were delaminations developing in that area that were undetected at the time. A possible explanation for fewer patches in this area could be that the chute slab was partially founded on a better foundation downstream from this area, as is evident from the post-failure photos showing shallow scour depths and intact slab sections further downstream. As discussed above, the weaker foundation between Station 33+00 and 34+00

may have allowed the slab to move more freely, causing stress concentrations upstream and downstream.

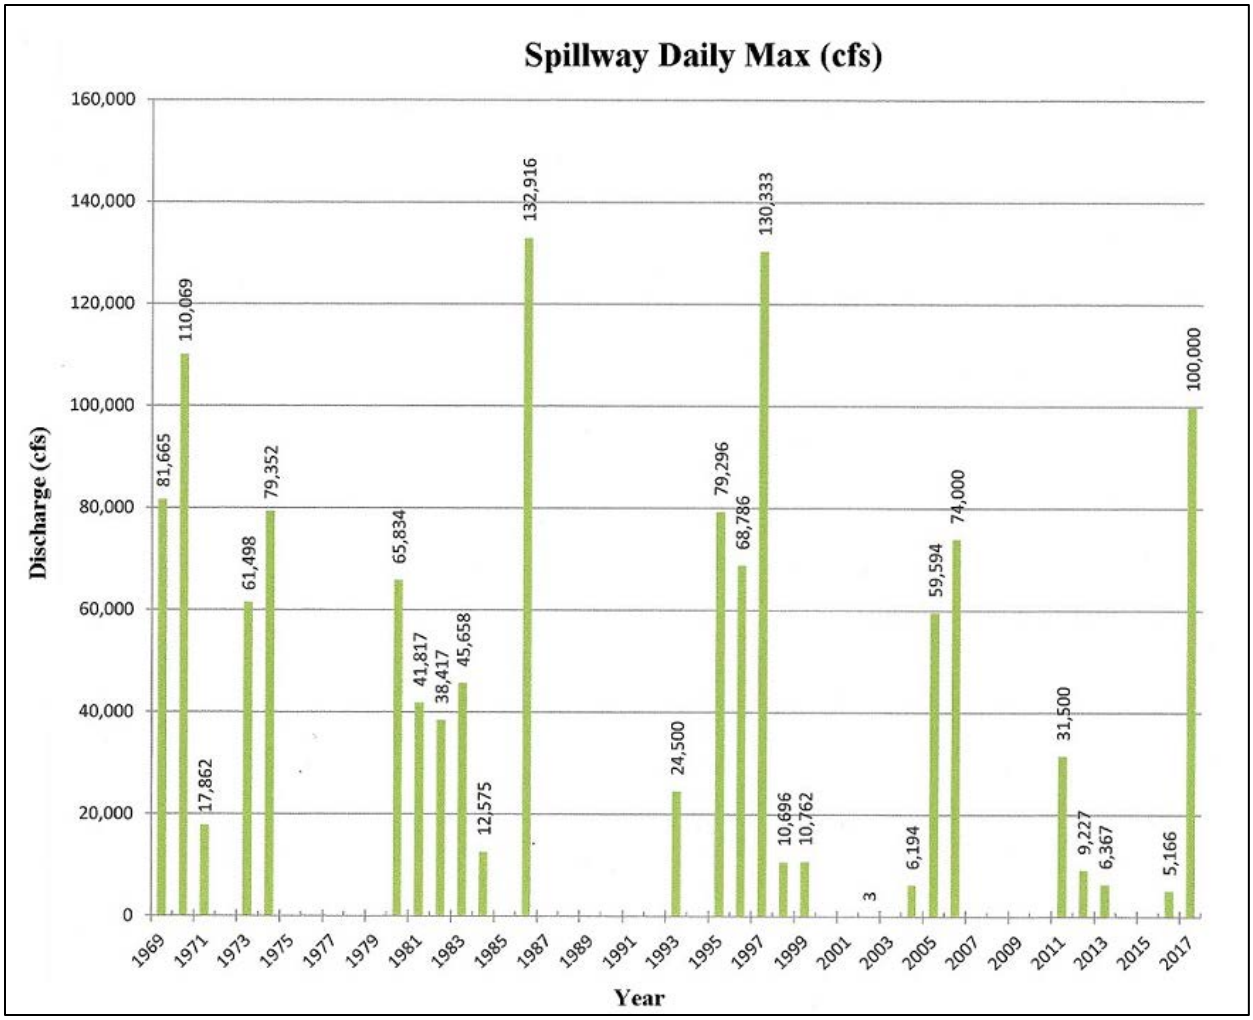
Figure I-14: Historic Daily Maximum Flows (chart provided by DWR)

Although repairs were made as recently as 2013, it is believed that significant flood releases that began in late January 2017 had damaged some of the previous repairs, and possibly caused damage to new areas of the chute that were not previously damaged. While normal seasonal temperature cycles could have compromised and/or damage the repairs, additional damage likely occurred as a result of the high velocity flows in the spillway chute during the spillway operations leading up to the chute failure incident of February 7, 2017. Photographic evidence of high collector drain flows prior to February 7 is an indication that water flowing in the spillway chute was reaching the foundation, where it was discharged through the herringbone drainage system into the collector drains. This can be seen as drain flows changed from January 13, to January 27, 2017 (Figures I-15 and I-16, respectively). Figure I-16 also shows a drain set that did not flow on the left side of the chute and another drain set that flowed intermittently on the right side of the chute.

While some minor flow in the drains can be expected to be from groundwater seeps and surface runoff into the gravel surrounding the collector drains (possibly seen as minor seepage on January 13), the increase in the observed flows on January 27 may have been caused by additional leakage from the chute into the foundation. Even though similar gate leakage is flowing down the chute in both photos, only very minor spillway flows occurred prior to the January 13, 2017 photo, while more significant flows of up to 9,700 cfs occurred between the dates of the two photos. Since both photos were taken on sunny days, surface runoff is not considered a significant contributor to the drain flows. One possible explanation for the increased flows is that the number surface features in the spillway chute allowing flow to enter the foundation has increased between the two dates because of spillway flows causing a number of previous repairs to fail, along with new damage to the chute. However, as discussed in Appendix F1, drain flows have been previously documented to significantly vary within a few days under apparently identical conditions, likely due to time lags following spill and rainfall events.

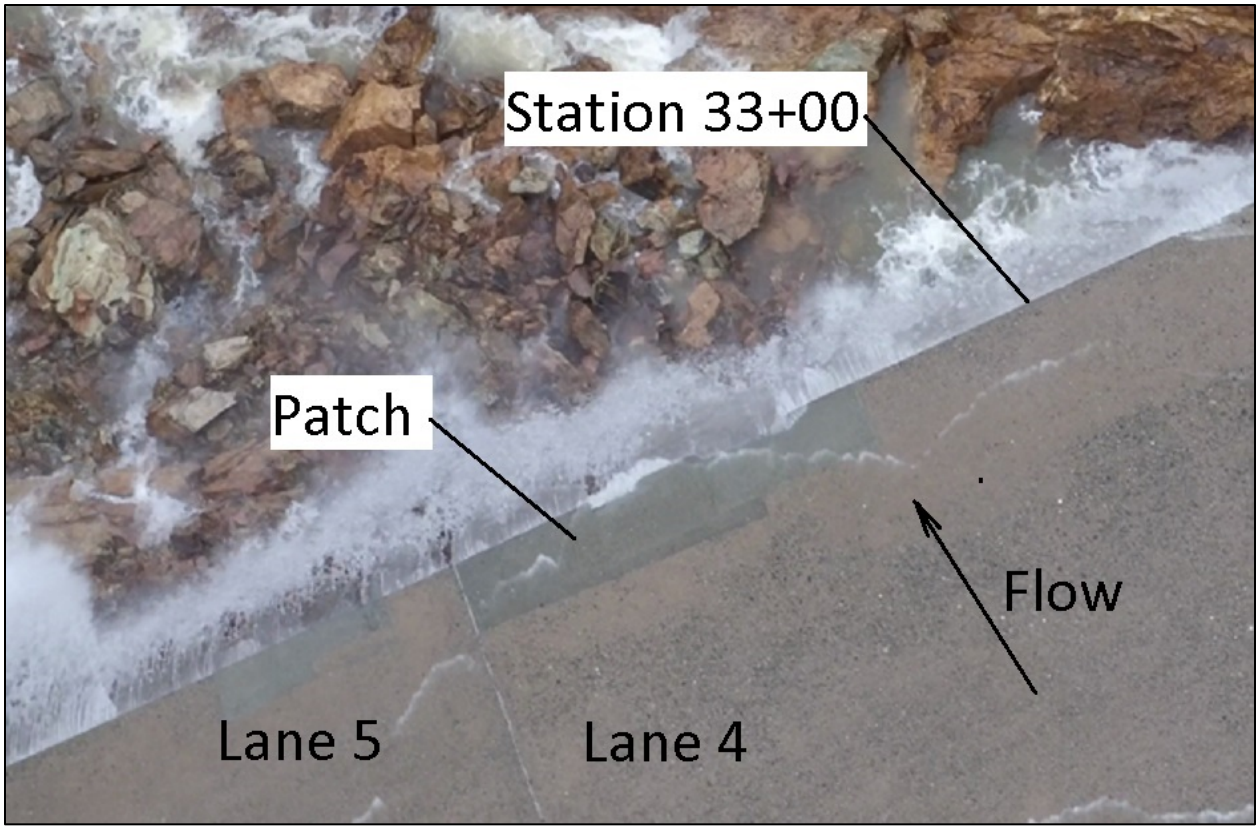
Figure I-17: Patches Upstream from Sta. 33+00 [I-2]

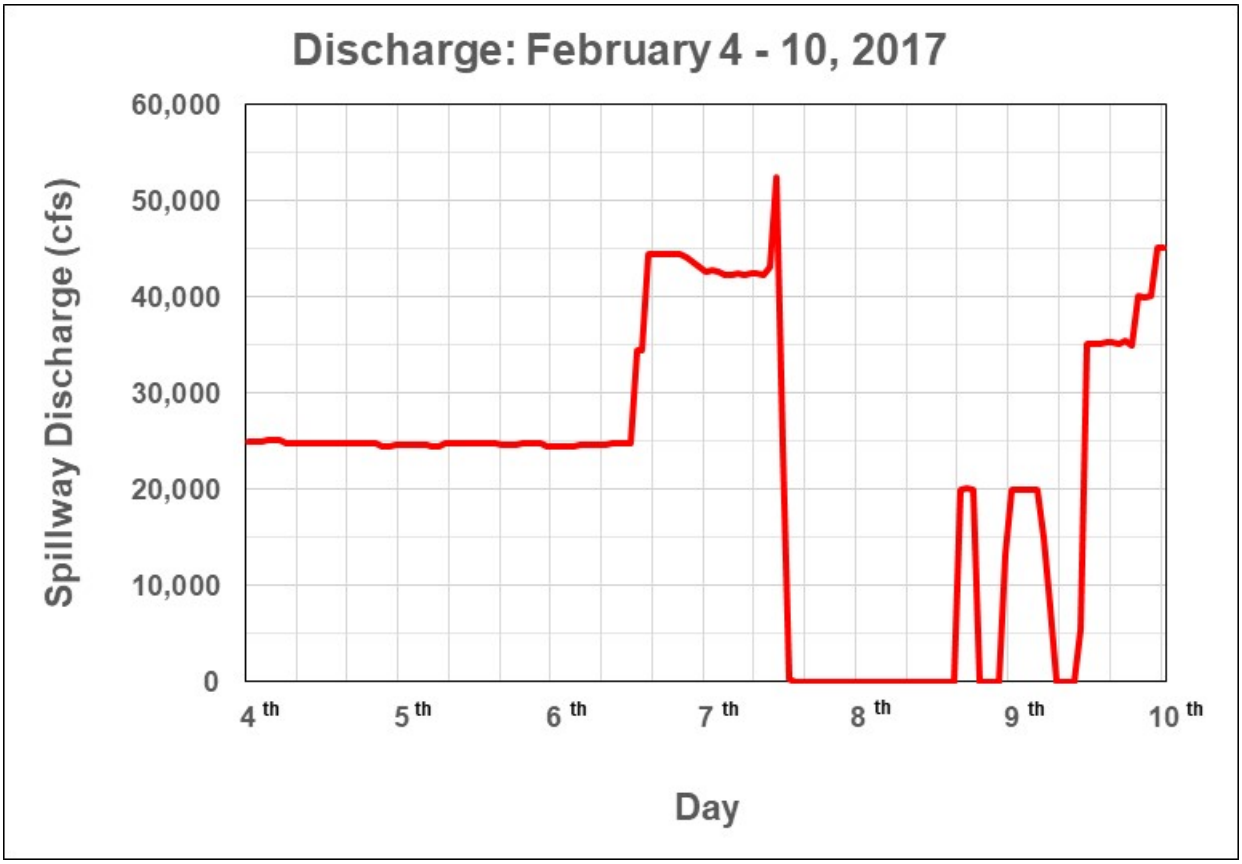
Figure I-19: Spillway Flow History, February 4 to 10, 2017 (data provided by DWR)

On February 7, 2017, extensive damage occured downstream of Station 33+00 after the flow was increased from about 42,500 cfs to 52,500 cfs at about 10:00 am that morning, as shown on Figure I-1. The point where zero flow occurs on the February 7 (Figure I-19) is the time when the spillway gates had been closed after the damage was discovered on February 7.

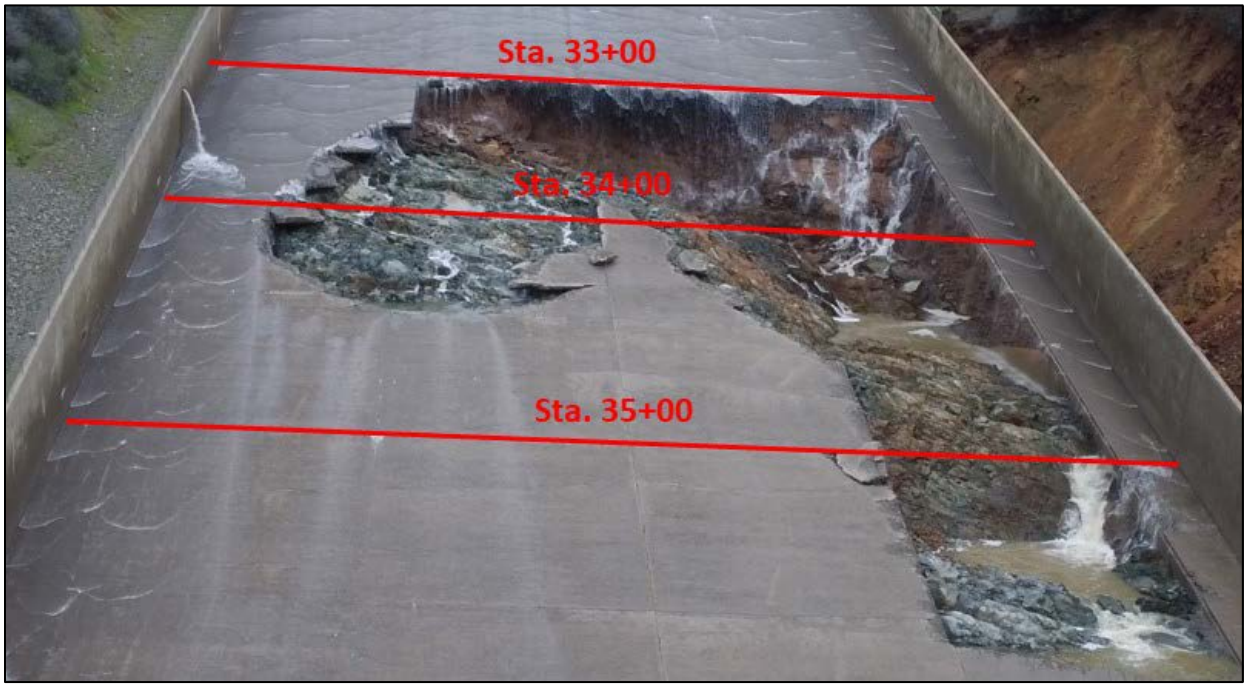
Figure I-20: Closeup of Damage on February 8, 2017 [I-2]

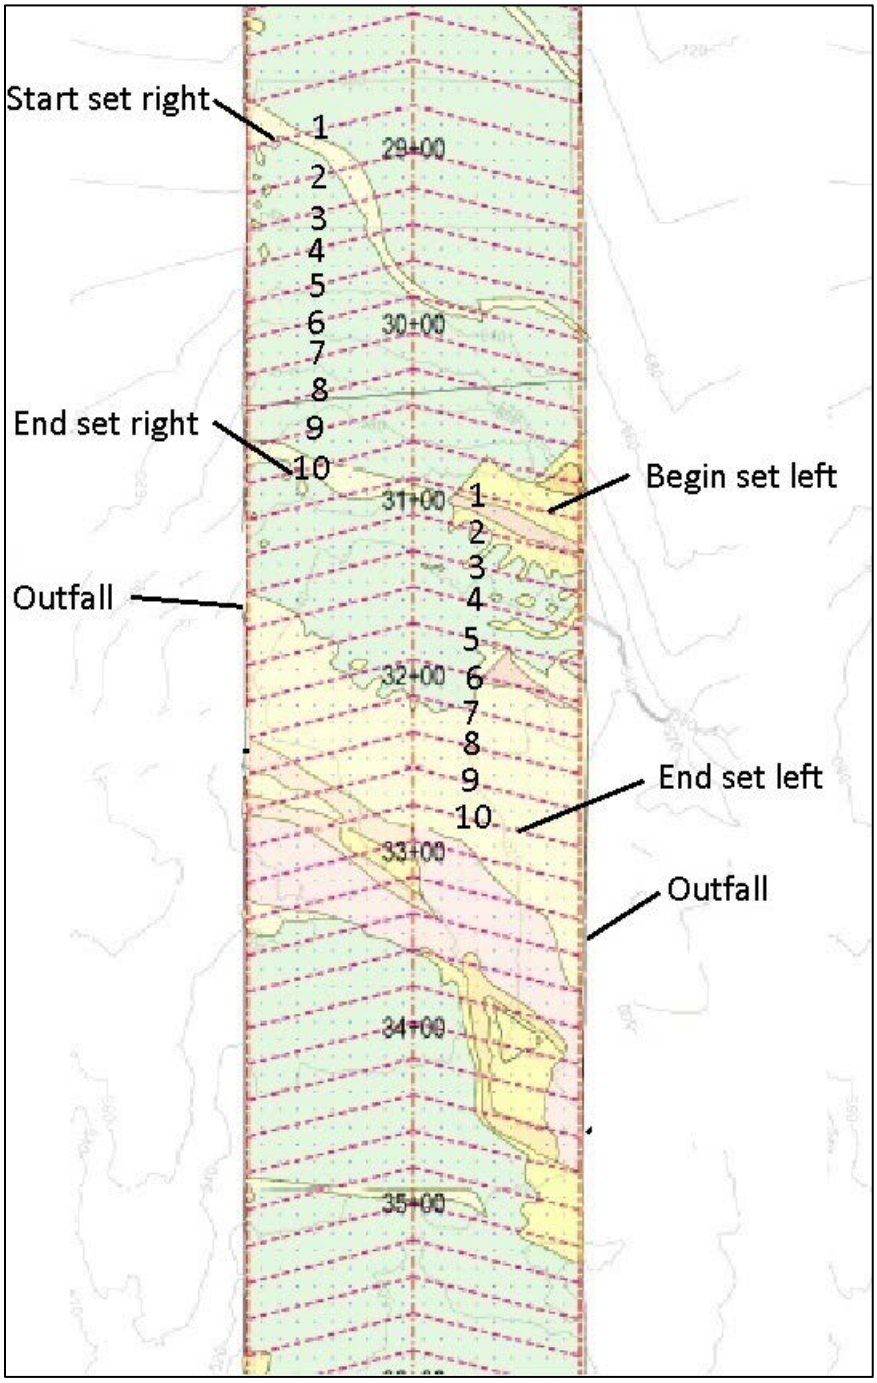
Figure I-21: Problematic Drain Sets (from DWR)

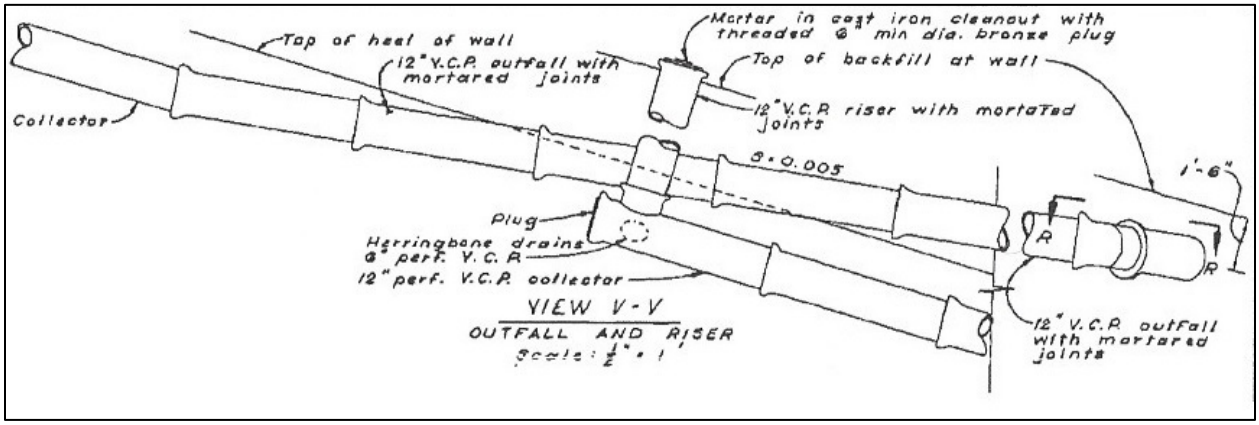
Figure I-22: Collector Drain Detail [I-7]

The capacity of the collector drain is determined by free-surface flow conditions in the portion between the collectors and the outfall, see Figure I-22.

This 12-inch VCP outfall pipe is set on a 0.005 slope. If the pipe becomes 82 percent full, it can carry the same amount of water as if it were full. With a Manning Coefficient n = 0.012, the maximum discharge when the discharge collector pipe flows full is 3.25 cfs. For higher flow rates, the collector pipe and herringbone drains will flow full. In Appendix B, the computed flow into a crack in the damaged area through a ½-inch gap is given as 0.28 cfs/foot when the spillway discharge is 54,000 cfs. At this rate, the flow through just 16.75 feet of open transverse joint matching this condition would be 4.7 cfs. Thus, flow through transverse cracks or joints, if only a small percentage of the cracks or joints were partially open, could exceed the capacity of the collector drains. With over 800 feet of herringbone drains feeding a single collector drain, the cumulative flow from all contraction joint and herringbone crack repair failures within the

collector drain set would add to the total discharge. The local drain set flows combined with possible flow passing under the slab from upstream of Station 33+00 when the failure occurred, could have easily exceeded the collector drain capacity, allowing pressure to back-up under the slab.

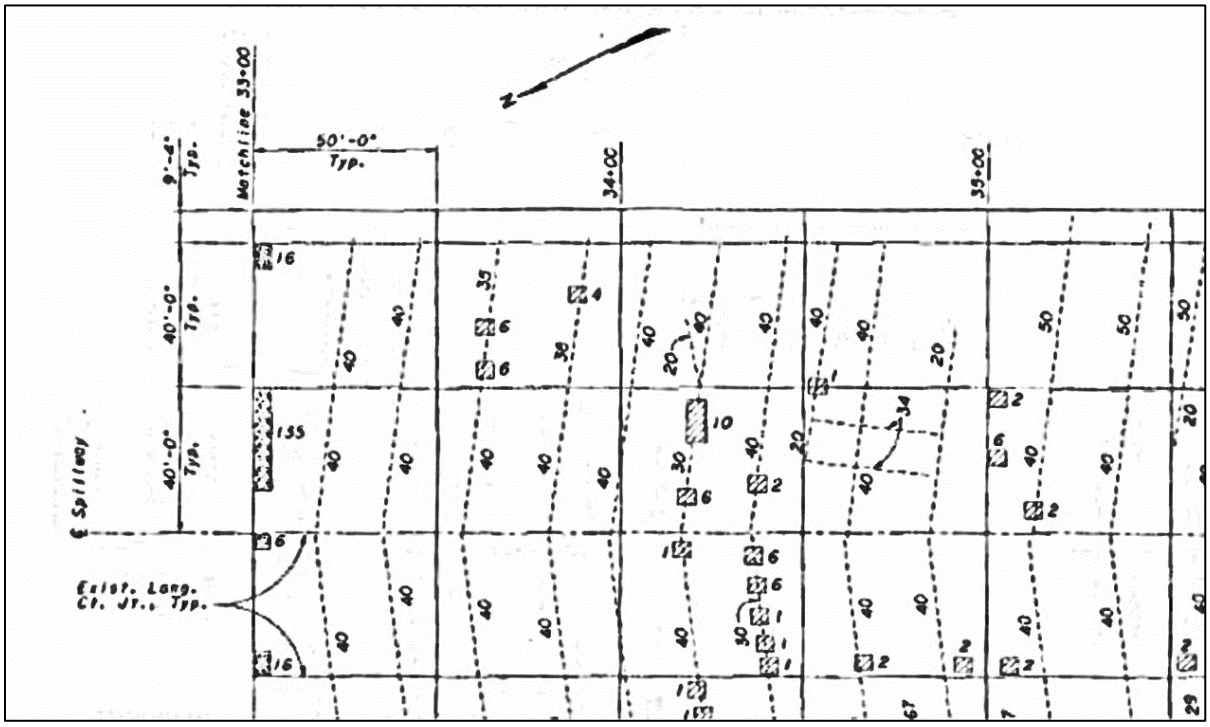
Figure I-26: Cracks in Invert of Chute in 2009 [I-5]

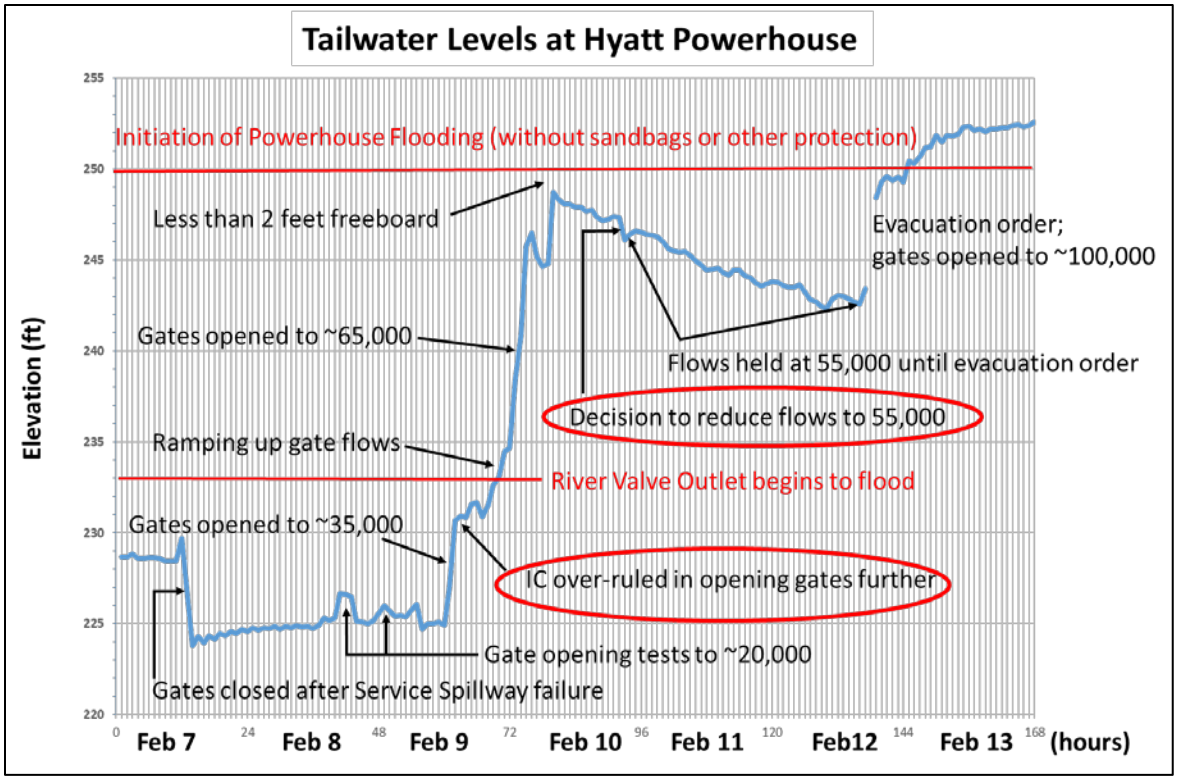
Figure L-4: Tailwater Levels During the Oroville Incident

The annotated graph shows tailwater response due to service spillway gate operations. Tailwater first drops when the gates are closed soon after the service spillway chute failure to allow inspection of the initial failed area, and then rises when the gates are re-opened for a number of trial flows. The first decision, overruling the Incident Command to increase flow beyond 35,000 cfs, was made at a time when powerhouse flooding was not a serious threat. However flooding of the River Valve Outlet System (RVOS) was imminent, and the potential for loss of the transmission tower had already been identified:
