Fluid Ingression Damage Mechanism in Composite Sandwich Structures

Allison Crockett, Wichita State University
Hal Loken, Consultant
John Tomblin, Wichita State University
July 17-19, 2008

Research Objective

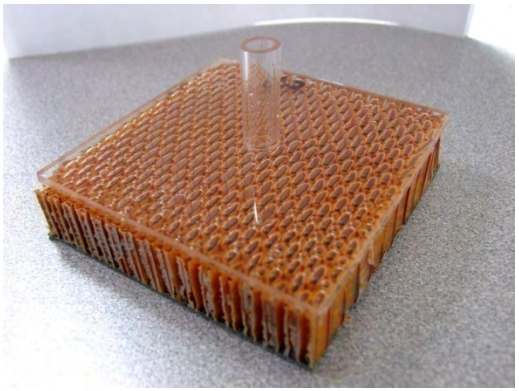
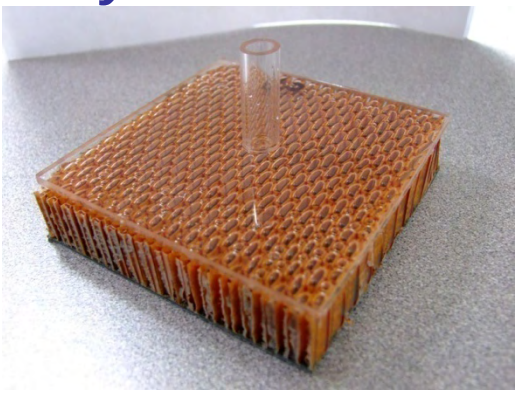
- Amount of water that is calculated as migrating cell-to-cell is negligible, due to nature of ASTM standard.
- Nomex Honeycomb cores tested from configuration 1 and 2 exhibit a water-proof cell wall.

- ASTM F1645 test results can be affected by three things:
  - the permeability of the adhesive, the adhesive thickness and the thickness uniformity of the adhesive.
  - Voids, cracks and other defects may also affect the fluid migration results.

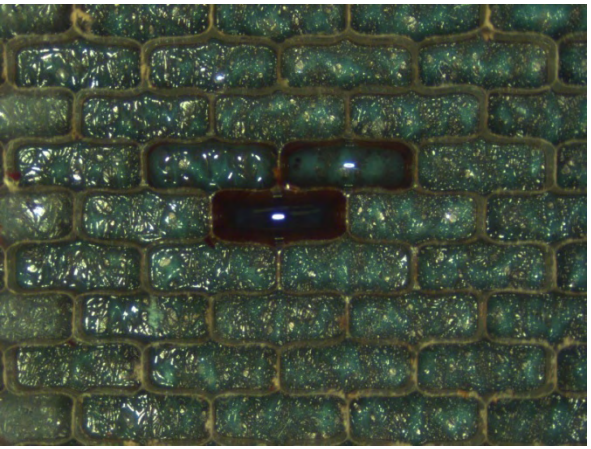
CP1B-3C TOOL SIDE

- Consequently a more robust approach was taken so visibility of the cells and quality of the cell to facesheet bond was visible. The core was sliced in half as seen above, and a similar fluid test was repeated.

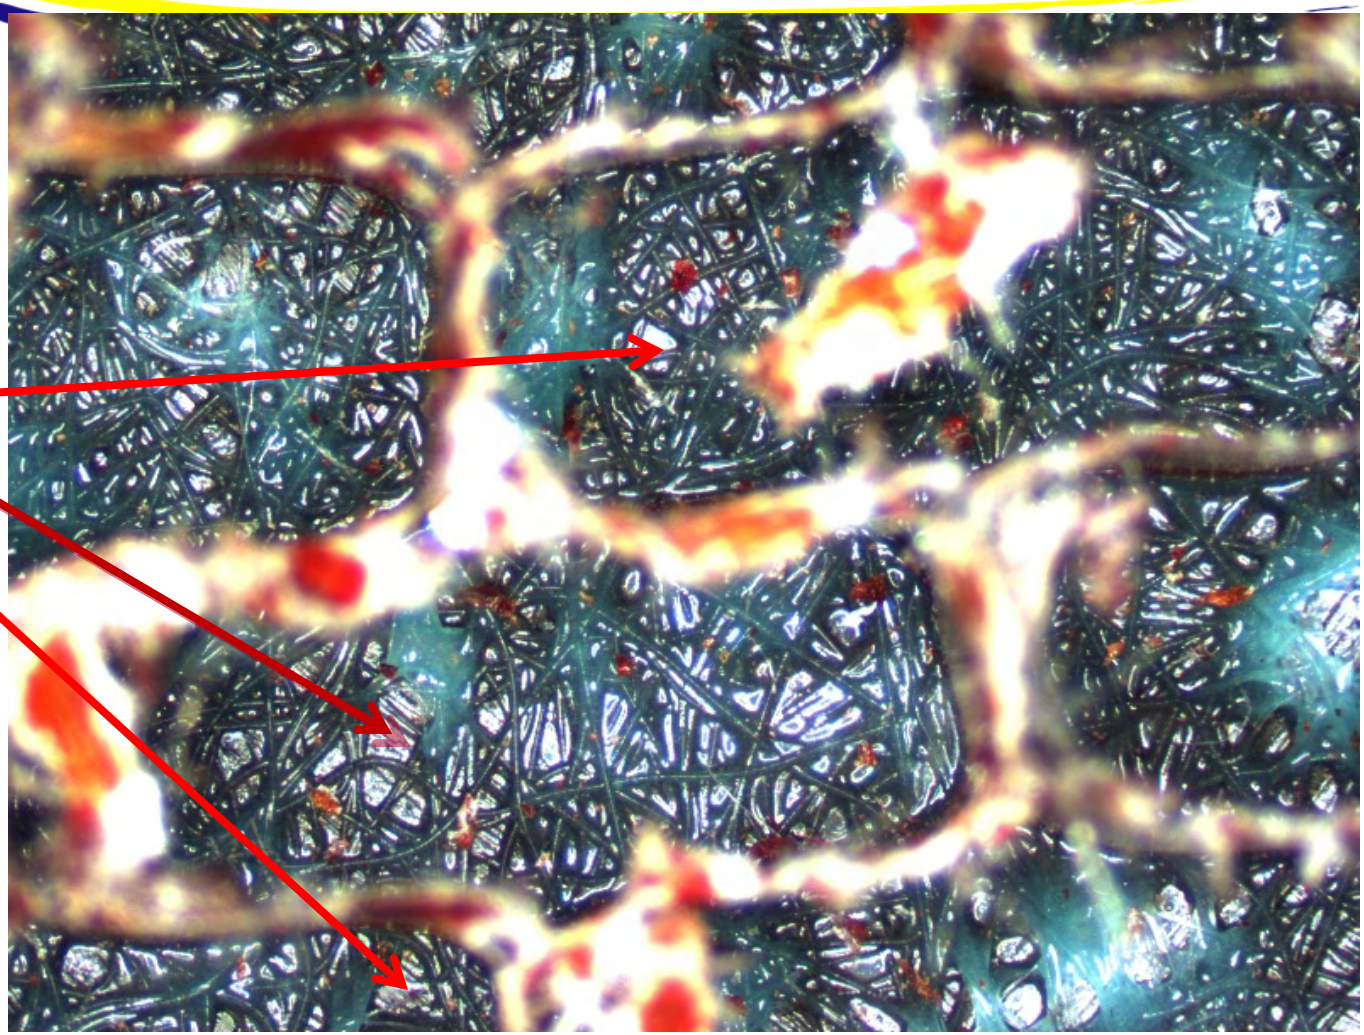
CONFIGURATION 2 PANEL

Problem between Facesheet and Core contributing to Fluid migration

- Samples taken from the same Configuration 2 panel seen previously with dry spots.
- Three different fluids were added to one single cell.
- Migration between cells occurred after fifteen minutes, in all cases three cells filled with fluid immediately.
- No Configuration 1 panels displayed dry spots and therefore showed migration, half of the Configuration 2 panels tested showed migration.

- No evidence of fluid migration was present through undamaged Nomex Honeycomb Core Cell walls.
- With an adequate bond present between the facing and the core the Nomex Honeycomb core appears to be fluid resistant to the following:
  - Deionized water, Skydrol, JP8 and Hydraulic fluid.
- Fluid will migrate through the spacing located between facesheet and the honeycomb core, a result of the facesheet not being completely filled with adhesive.
- This could be improved through manufacturing process improvements.

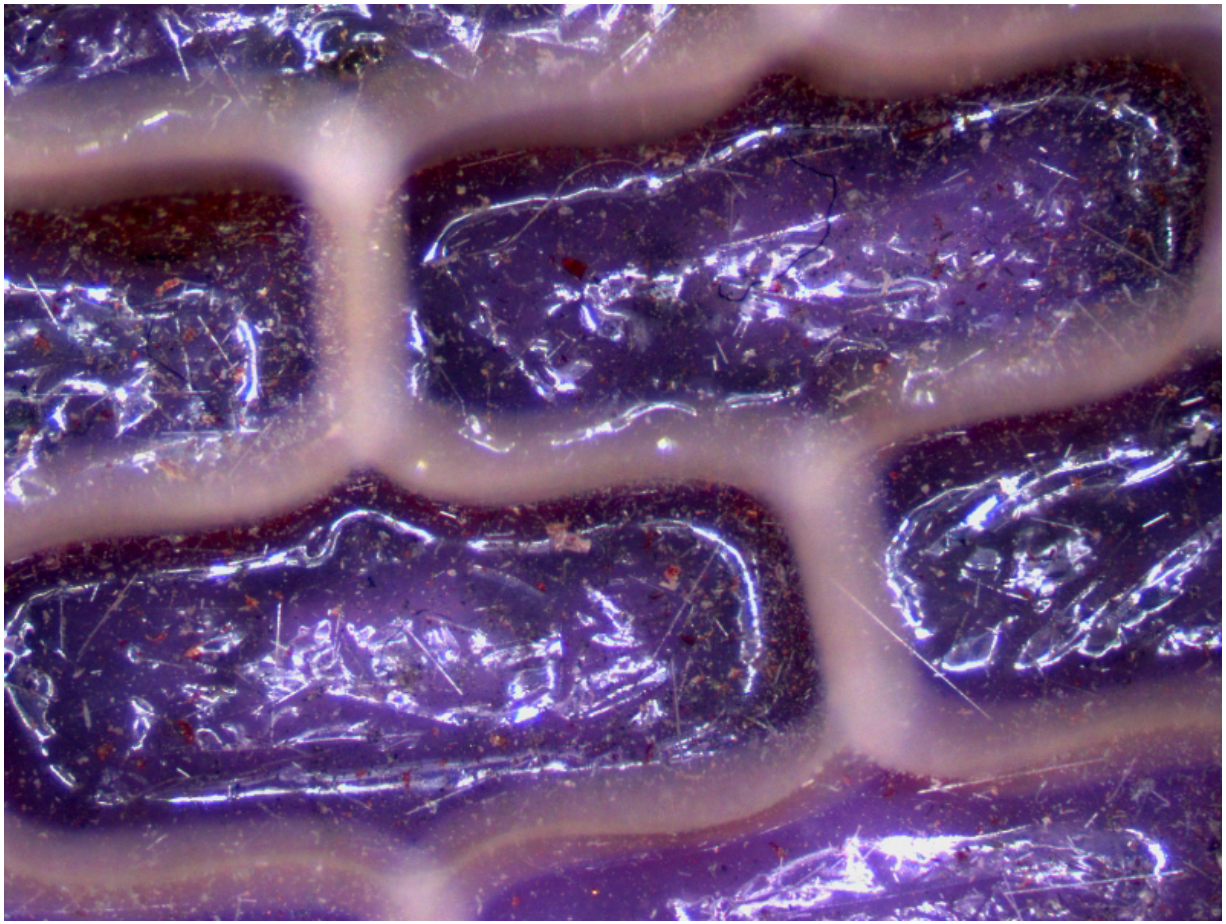
CONFIGURATION 2 PANEL

No Dry Spots between facesheet and core visible

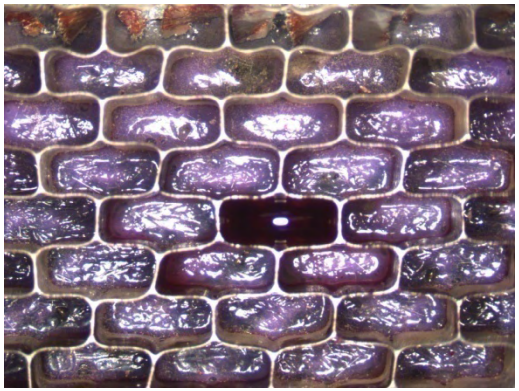
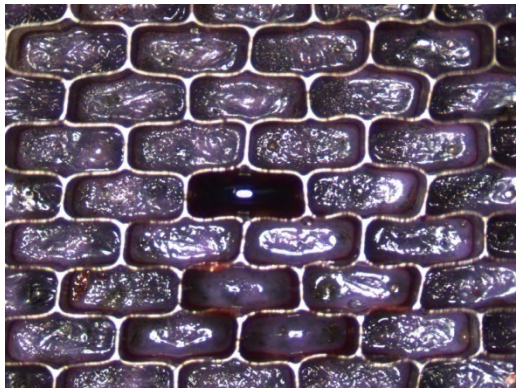
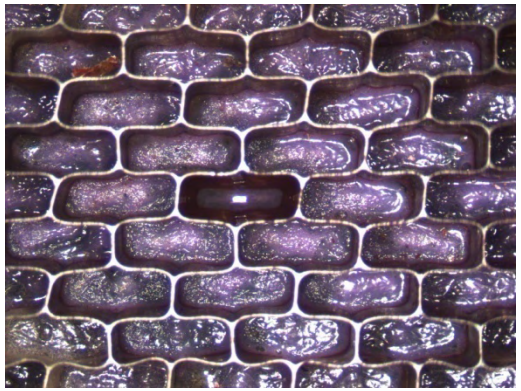
No Dry Spots-Spacing between Honeycomb core and Facesheet fully Filled

- Samples taken from same Configuration 2 panel seen previously with no dry spots.
- Three different fluids were added to one single cell.
- After fifteen Minutes-No Migration Occurred.
- All Configuration 1 panels tested had no migration present from cell-to-cell about half the configuration 2 panels had no migration.

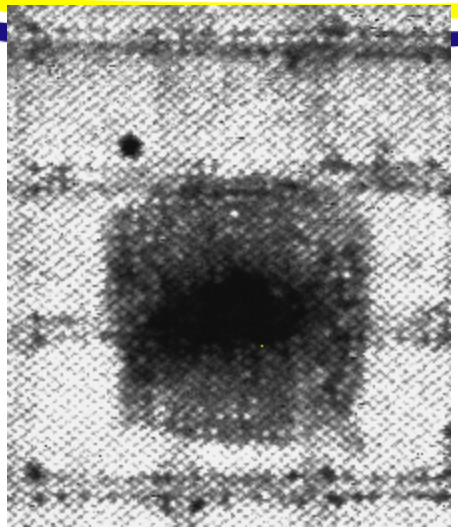
After Impact Before Thermal Cycling

- Impact Energy: 500 in-lb
- Dry Weight: 450.17 g
- Weight After Water Bath: 479.49g
- Weight After Thermal Cycle: 471.28 g

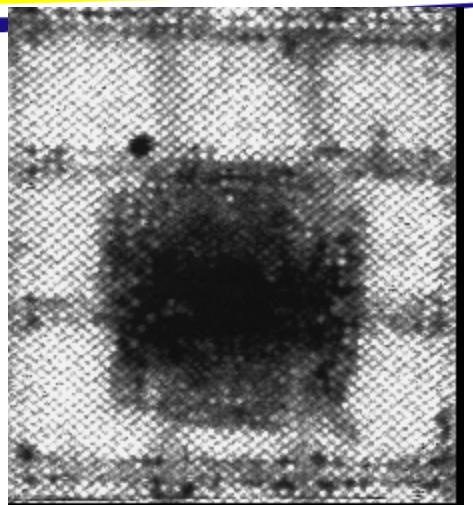
After Impact After 7 Days Thermal Cycling

- No Dramatic Growth present After 7 Days of Cycling.
- Continue Thermal Cycling

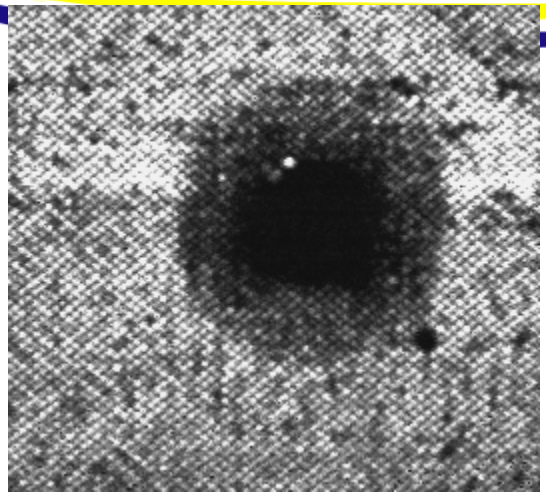
After Impact Before Thermal Cycling

- Impact Energy: 800 in-lb
- Dry Weight: 442.82 g
- Weight After Water Bath: 482.8 g
- Weight After Thermal Cycle: 435.48 g

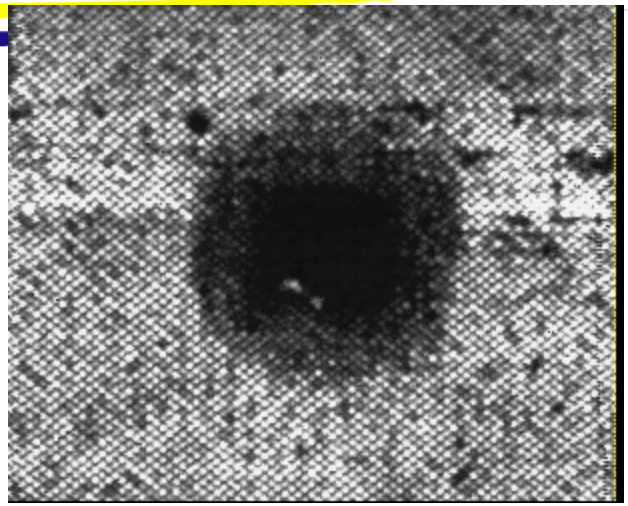
After Impact After 7 Days Thermal Cycling

- No Dramatic Growth present After 7 Days of Cycling.
- Continue Thermal Cycling

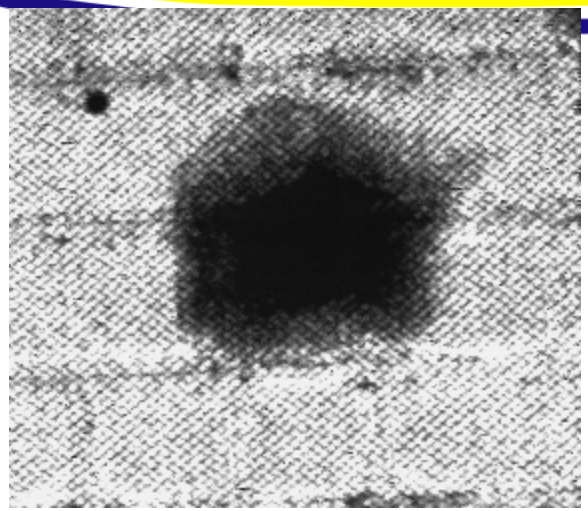
After Impact Before Thermal Cycling

- Impact Energy: 1100 in-lb
- Dry Weight: 531.61 g
- Weight After Water Bath: 577.19 g
- Weight After Thermal Cycle: 552.36 g

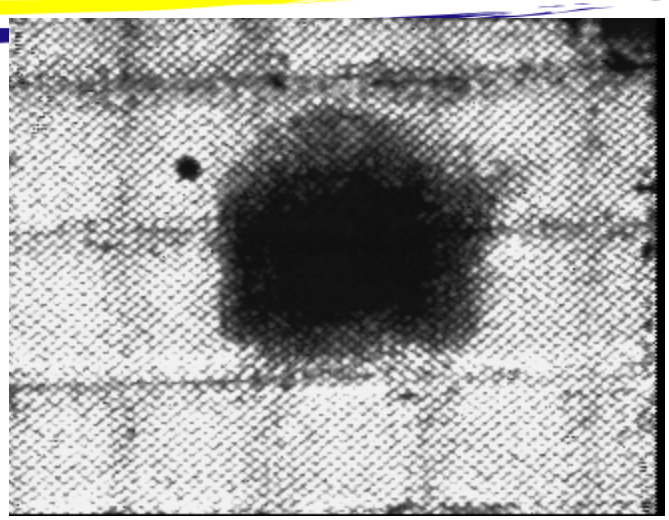
After Impact After 7 Days Thermal Cycling

- No Dramatic Growth present After 7 Days of Cycling.
- Continue Thermal Cycling

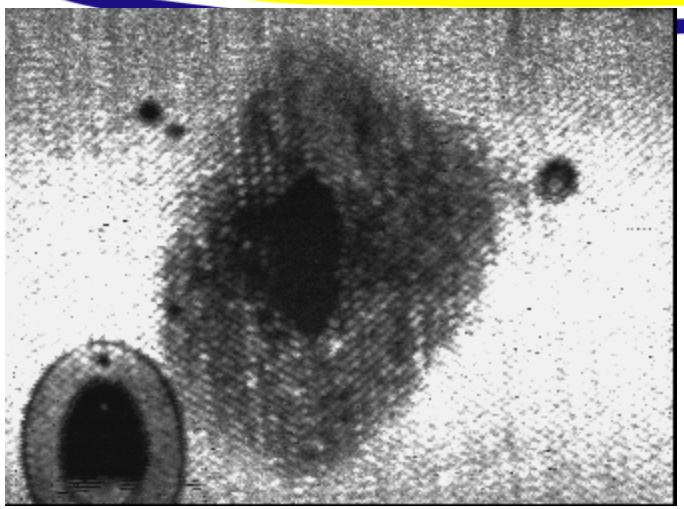
After Impact Before Thermal Cycling

- Impact Energy: 600 in-lb
- Dry Weight: 821.4 g
- Weight After Water Bath: 834.6 g
- Weight After Thermal Cycle: 822 g

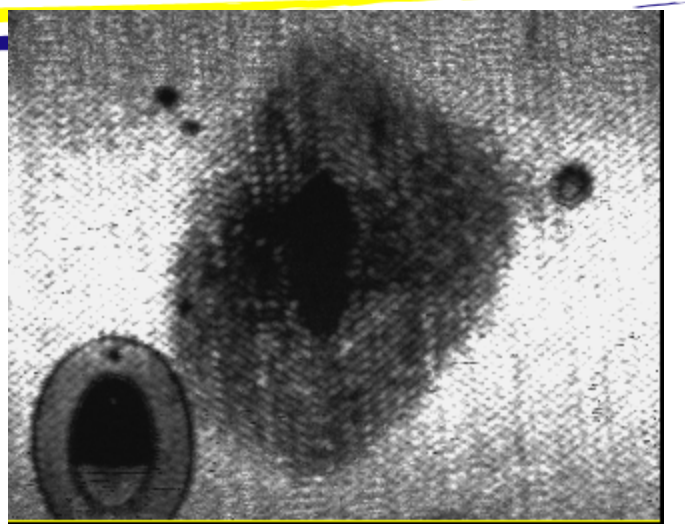
After Impact After 7 Days Thermal Cycling

- No Dramatic Growth present After 7 Days of Cycling.
- Continue Thermal Cycling
