**Screening for Biofouling and Corrosion of Tidal Energy Device Materials:
In-situ results for Admiralty Inlet, Puget Sound, Washington**

Northwest National Marine Renewable Energy Center Technical Memorandum

University of Washington, Seattle, WA, United States

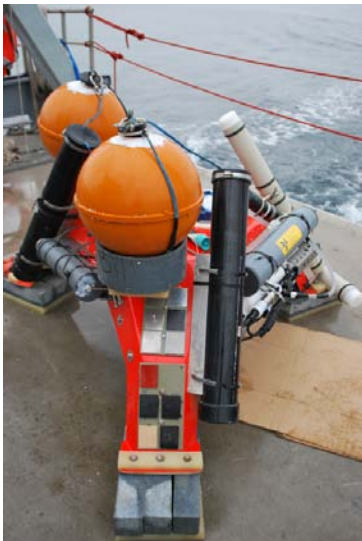
Figure 1.1 – Material samples attached to instrumentation tripod

The test matrices consist of uncoated and coated coupons, nominally 2.5 inches wide, 2.25 inches long, and 0.125 inches thick. For expediency, coupons are attached to a fiberglass plate using a marine grade adhesive (3M 5200). Each plate is secured to the leg of an instrumentation tripod, as shown in Figure 1.1. The primary purpose of this tripod is to characterize the physical and biological environments at tidal energy sites.
