The Fort Davis National Historical Site Post Hospital Restoration Program 2008

COMPLETION REPORT

PREPARED FOR THE NATIONAL PARK SERVICE
BY
THE SCHOOL OF ENGINEERING
UNIVERSITY OF VERMONT

July 2009

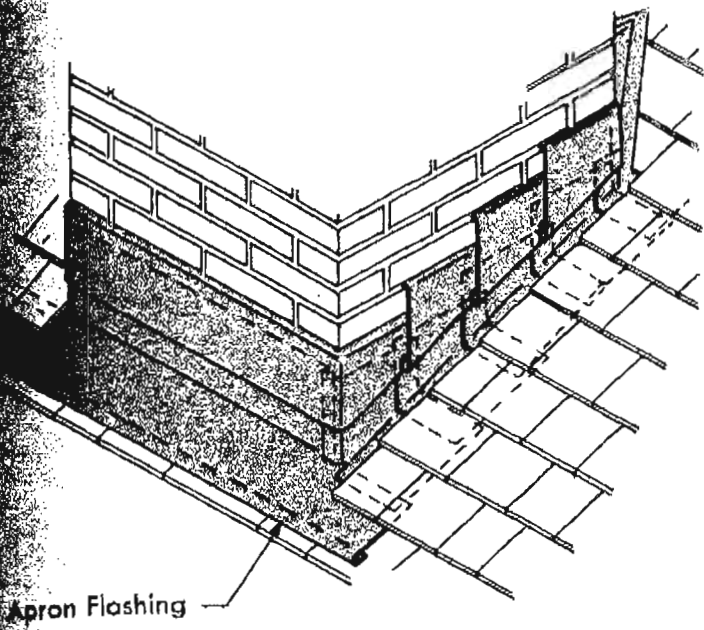
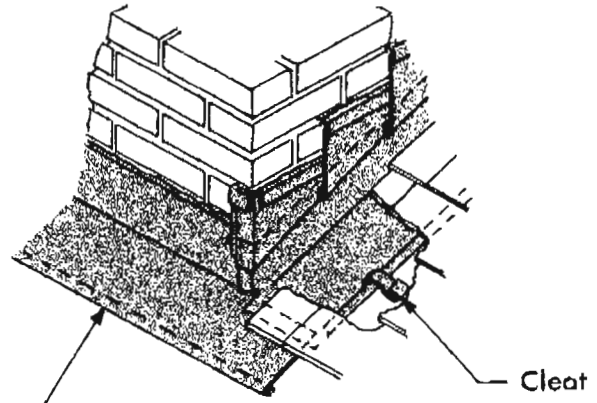
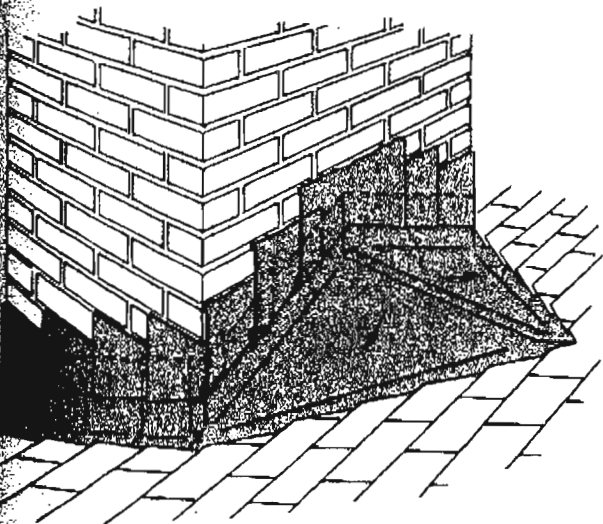
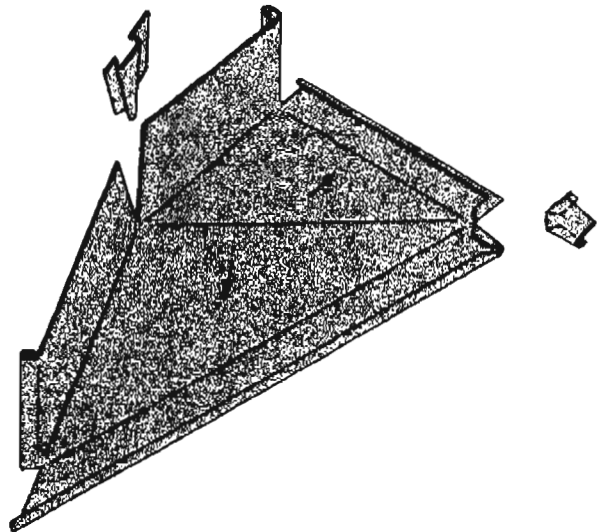
PLATE 69

Plate 69 illustrates a flashing system for a chimney penetrating a sloping roof.

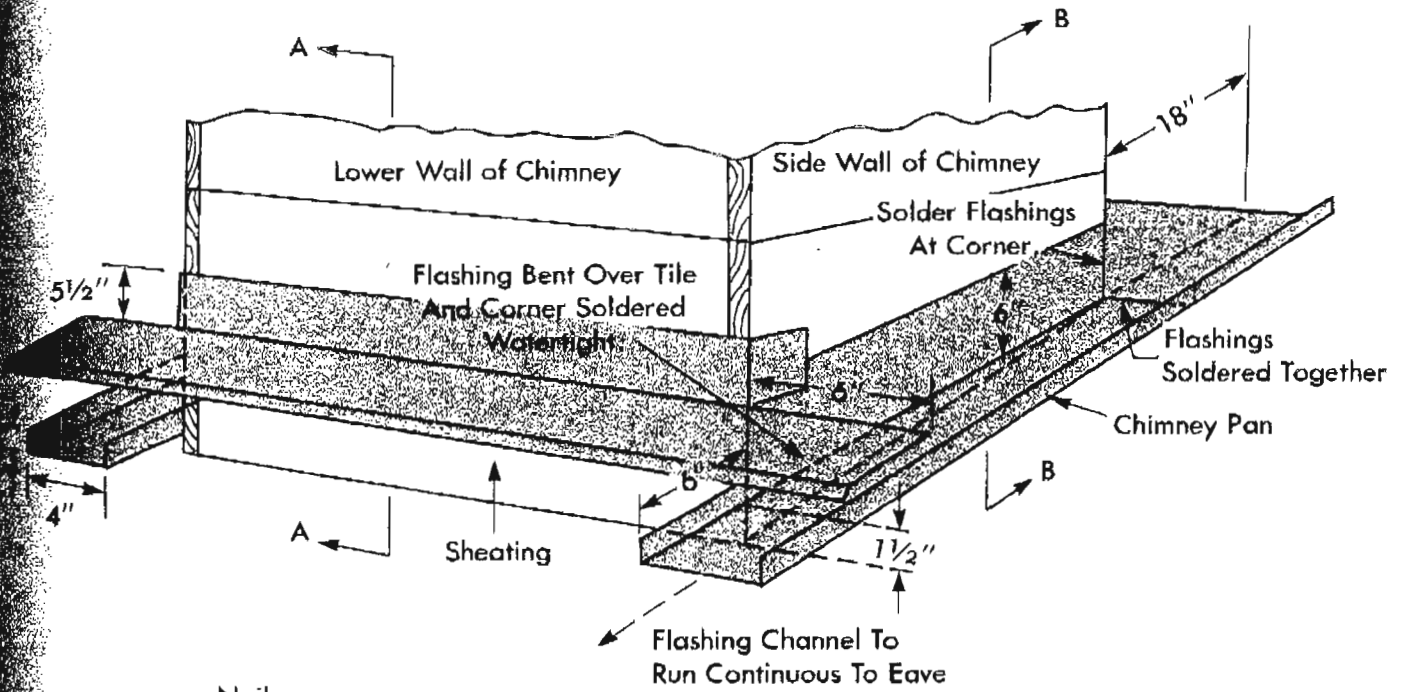
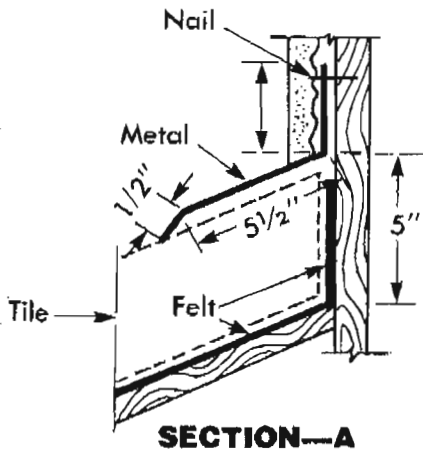
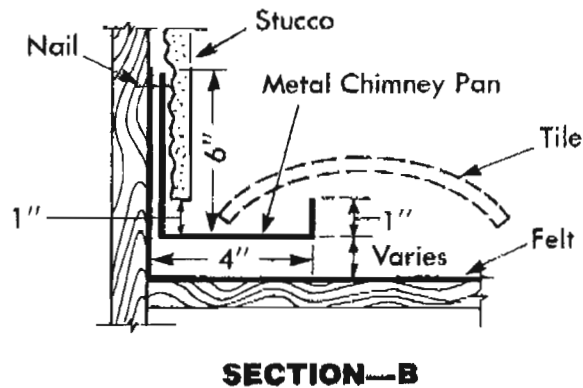
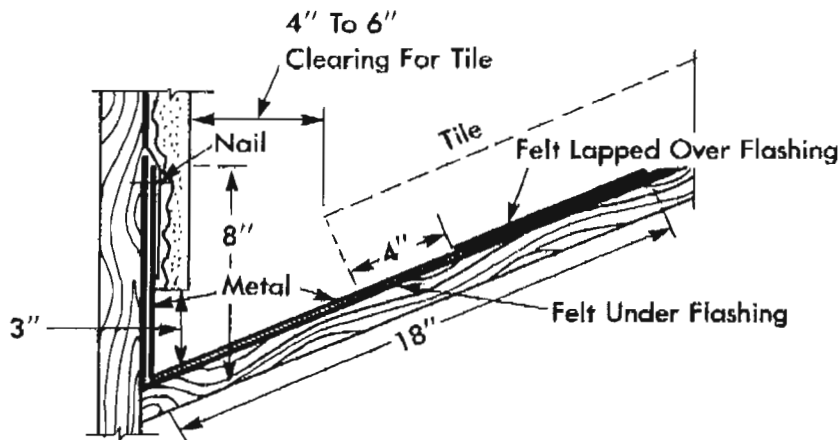
PLATE 70

Plate 70 shows a method of flashing a stucco chimney in a tile roof. Tile manufacturers may have specific requirements or recommendations that deviate from these details. Modification would be necessary for any area with more than light snow accumulation.
