Effectiveness Of  
Concrete Bridge Deck  
Asphalt-Membrane Protection

WA-RD 75.1

Final Report

September 1985

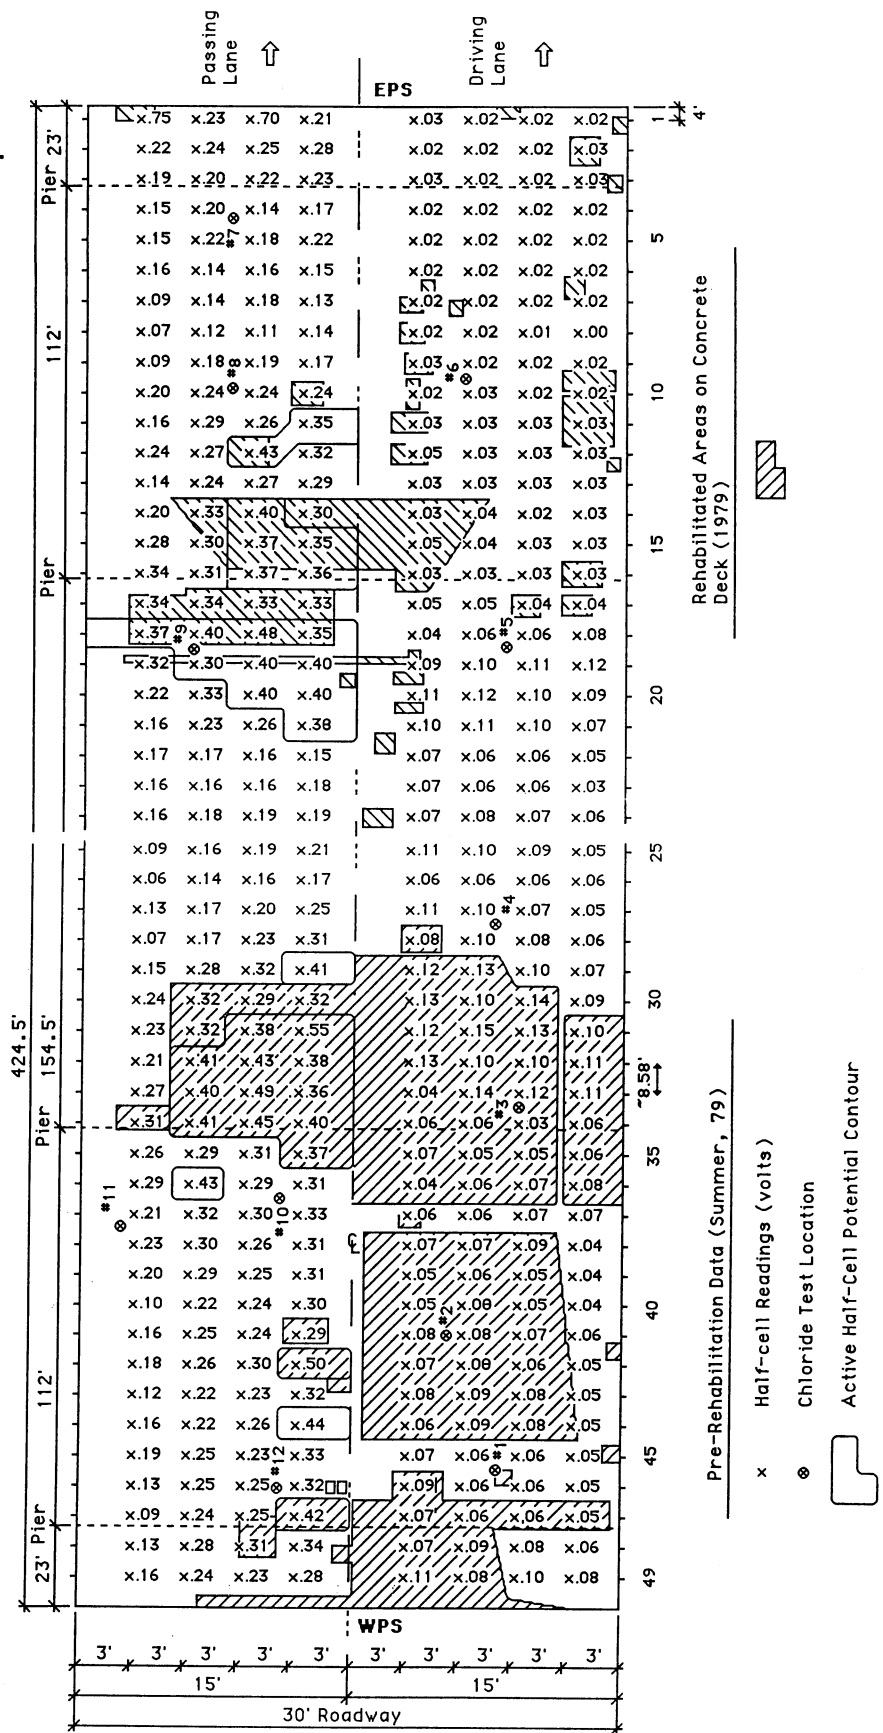
Bridge 90/136S "S. Cle Elum Rd. OC"  
(Continuous Concrete Box Girder)

Pre-Rehabilitation Chloride/Half-Cell Data and Location of Concrete Repairs on Bridge 90/136 S.

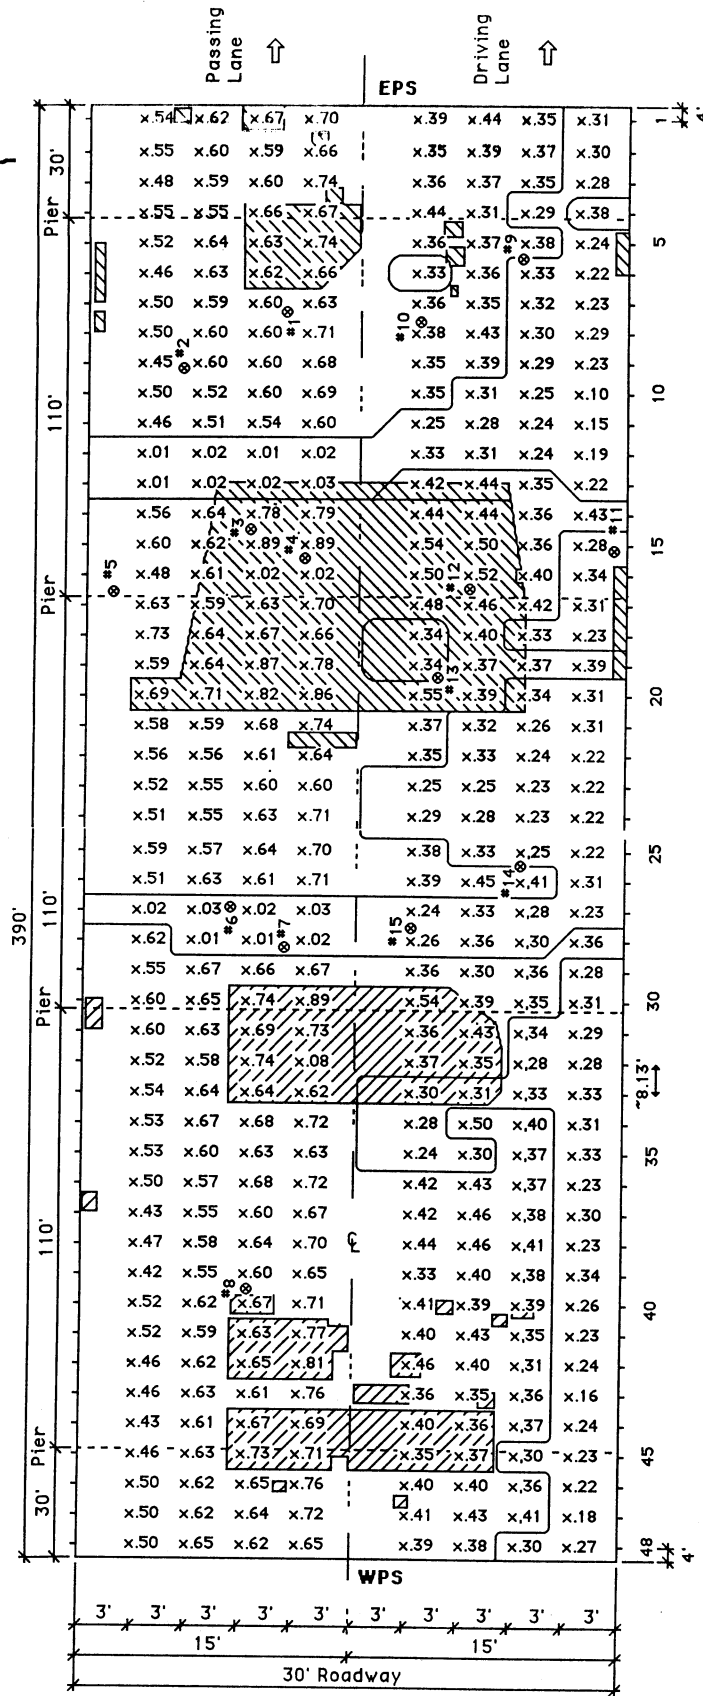
Bridge 90/140/S "Yakima River"  
(Continuous Concrete Box Girder)

Rehabilitated Areas on Concrete Deck (1979)

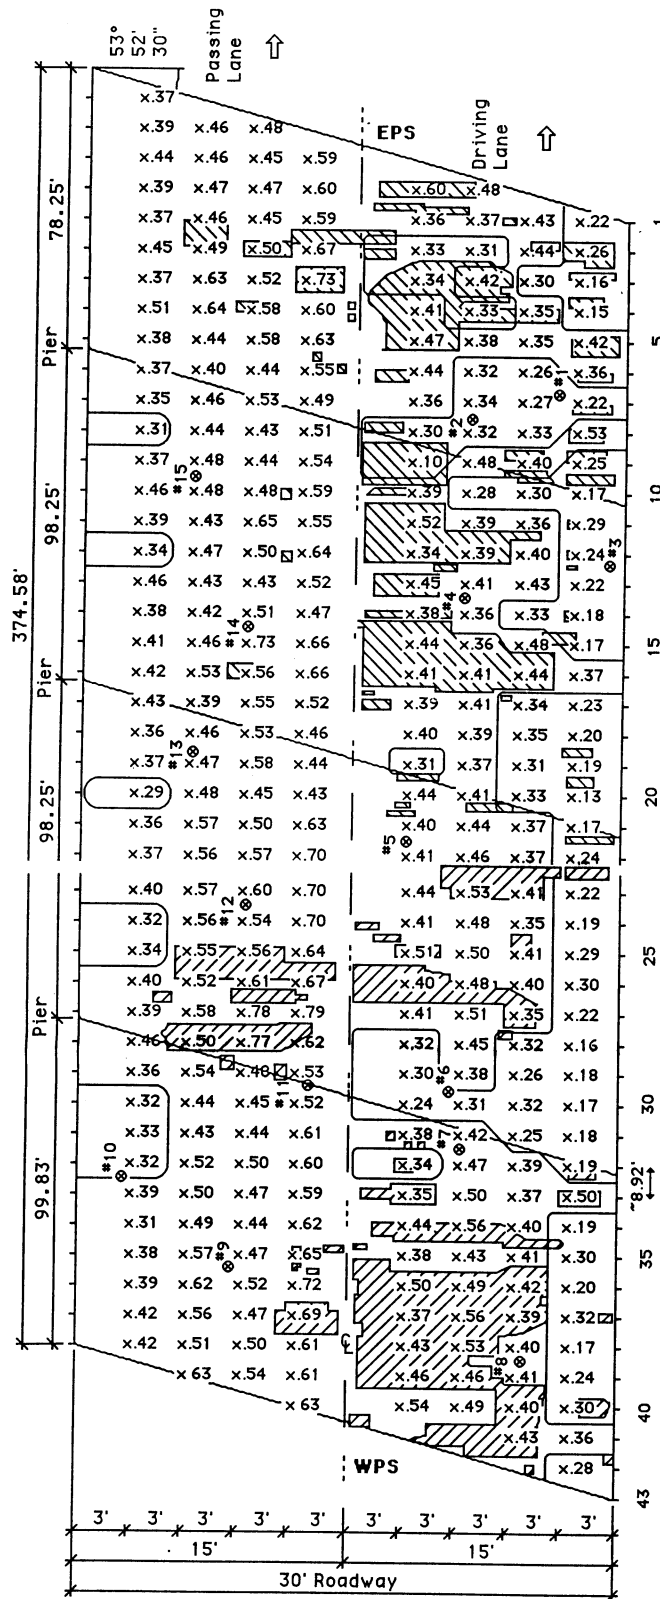
Bridge 90/141 S "CMSTPP RR PEOH RD OC"  
(Partially Continuous Prestressed Beams)

Rehabilitated Areas on Concrete Deck (1979)

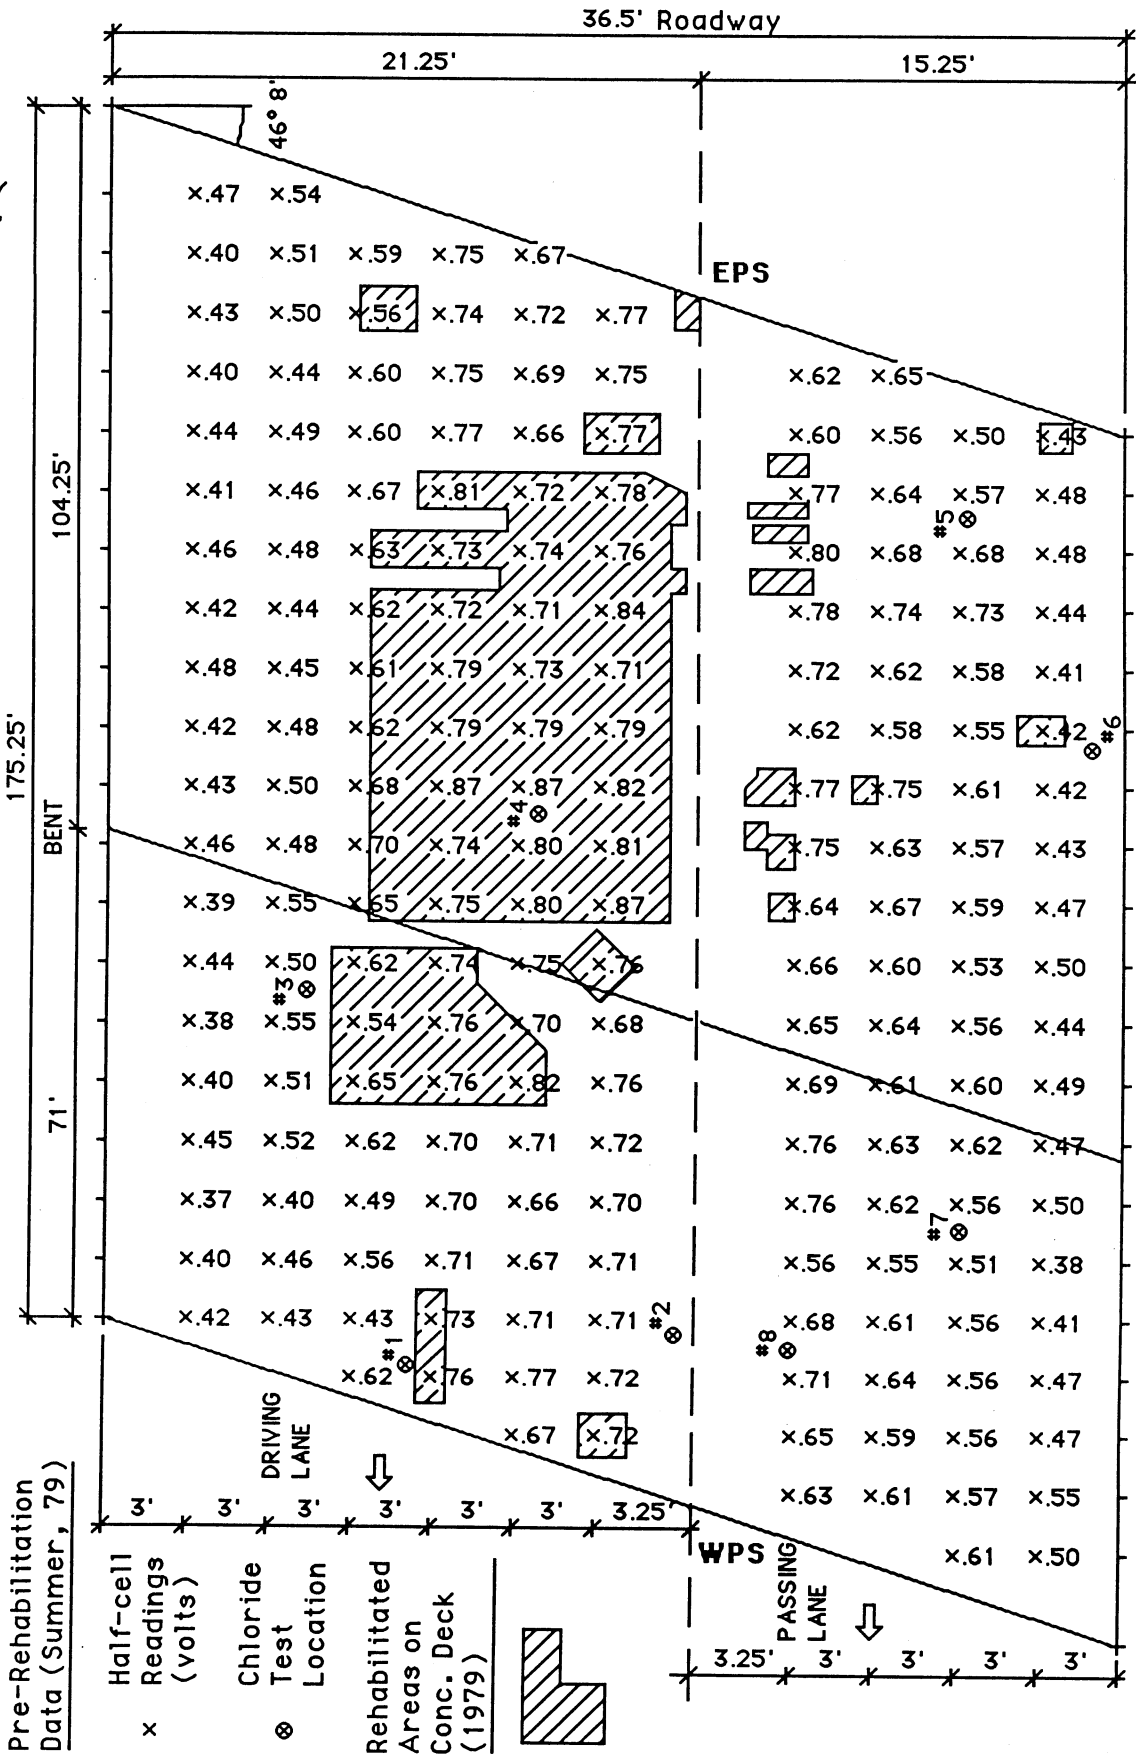
Bridge 90/145 N "Highline Canal"  
(Simple Span Prestressed Conc. Beams)

Pre-Rehabilitation Data (Summer, 79)

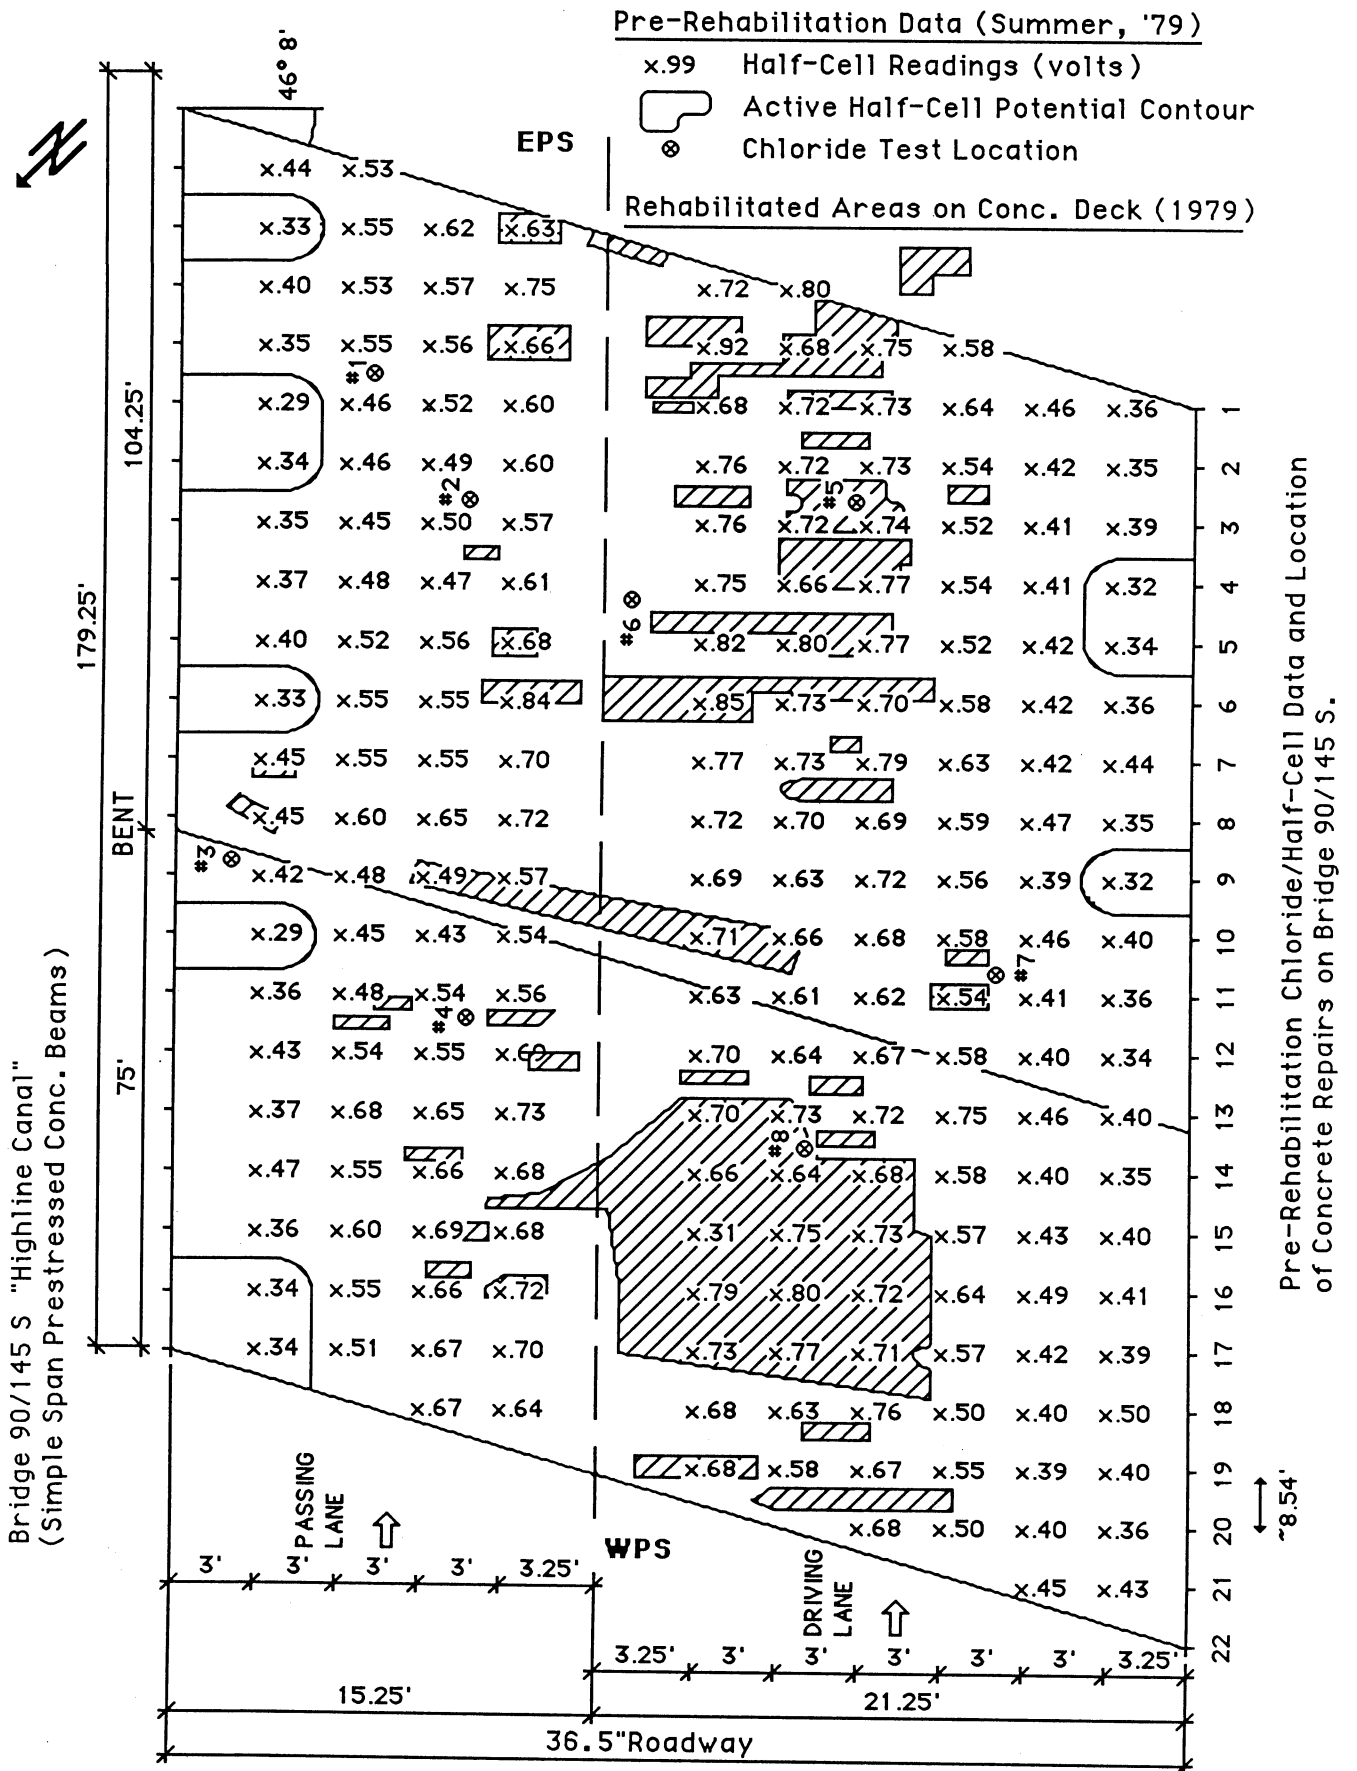
Bridge 90/145 S - continued\*

<u>Sample Number</u>	<u>Chloride Content, lb/cy**</u>
1	0.49
2	0.84
3	0.49
4a (3/4" - 1 1/4" depth)	1.58
4b (1 1/4" - 2 1/4" depth)	0.54
4c (2 1/4" - 2 3/4" depth)	0.25
	<u>Passing Lane</u>
	<u>Driving Lane</u>
5	9.89
6	4.95
7	1.98
8a (3/4 " - 1" depth)	5.74
8b (1" - 1 3/4" depth)	0.99
8c (1 3/4" - 2 1/4" depth)	0.25

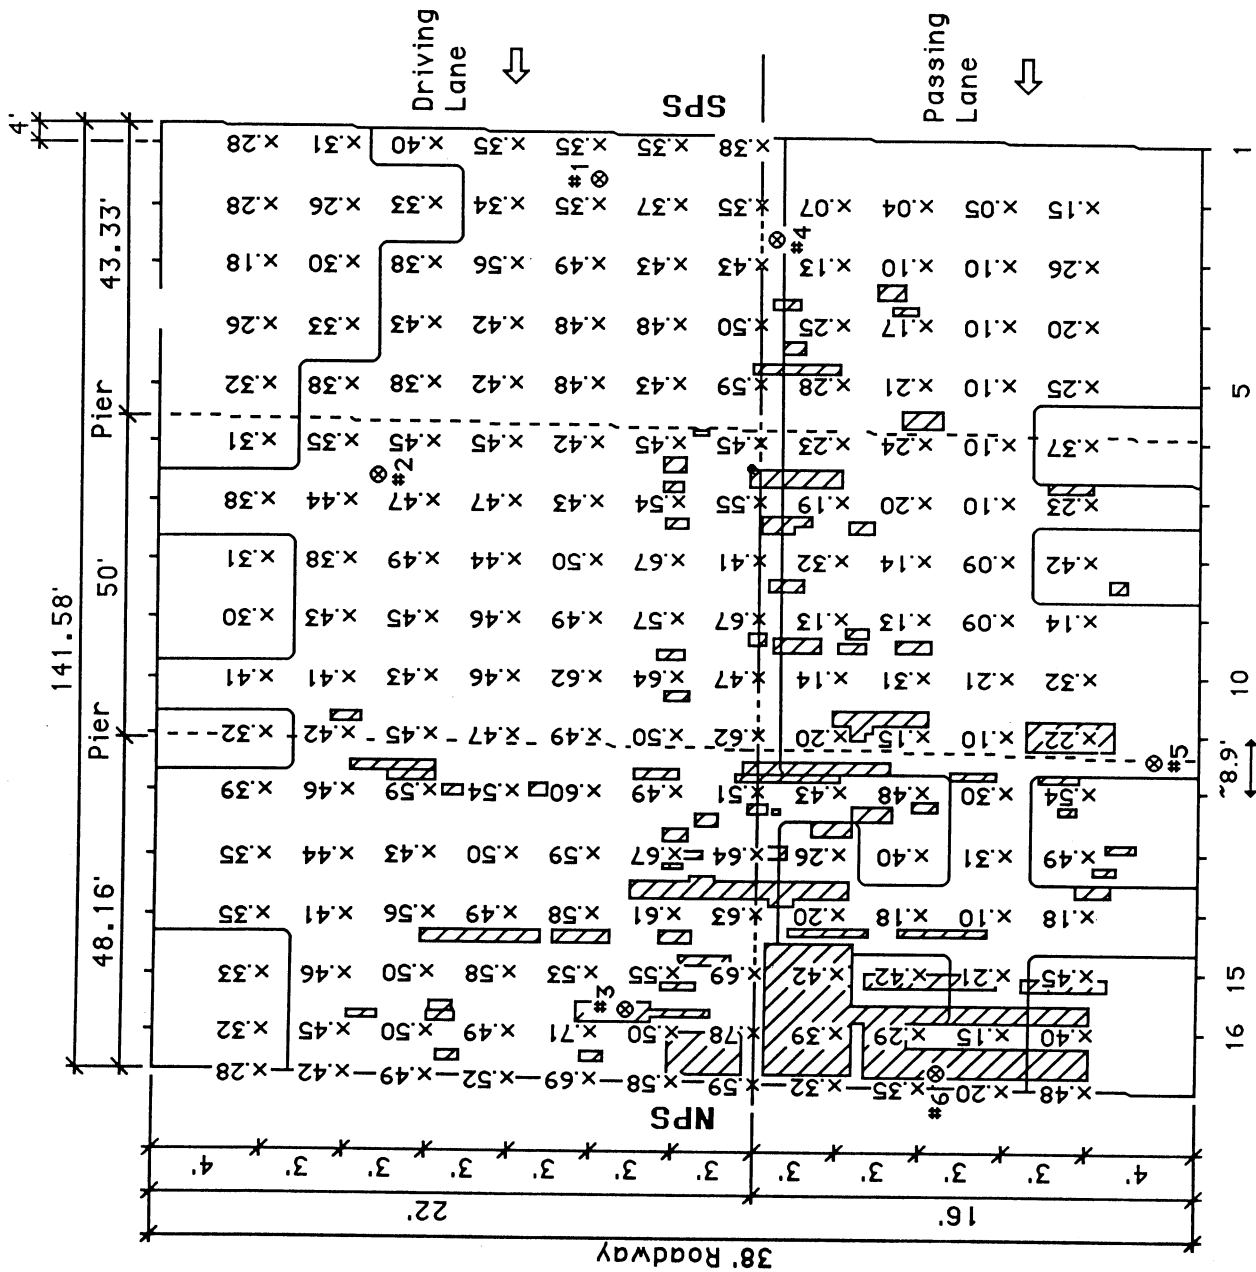
Pre-Rehabilitation  
Chloride/Half-Cell/  
Delamination Data  
on Bridge 82/20 N.

<u>Sample Number</u>	<u>Chloride Content, lb/cy**</u>
1	4.39
2	3.54
3	5.39
<hr/>	
	<u>Driving Lane</u>
	<u>Passing Lane</u>
4	3.70
5	5.89
6	2.54

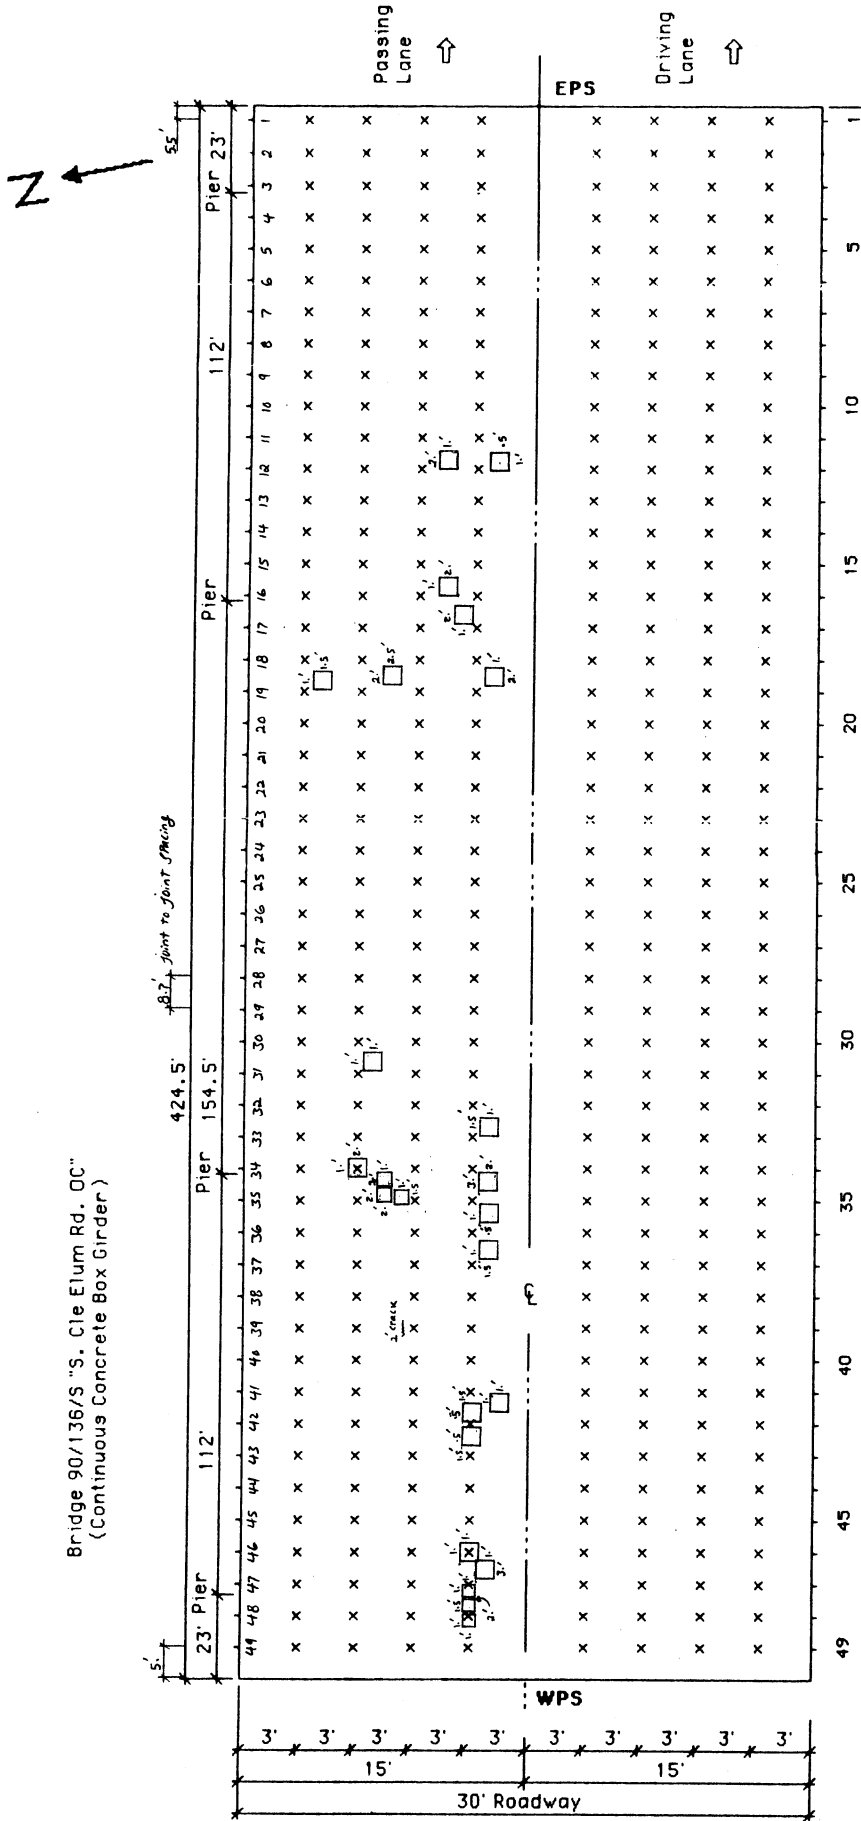
Bridge 90/136/S "S. Cle Elum Rd. OC"  
(Continuous Concrete Box Girder)

Defective areas as indicated  
by chain dragging AC.  
S-23-65

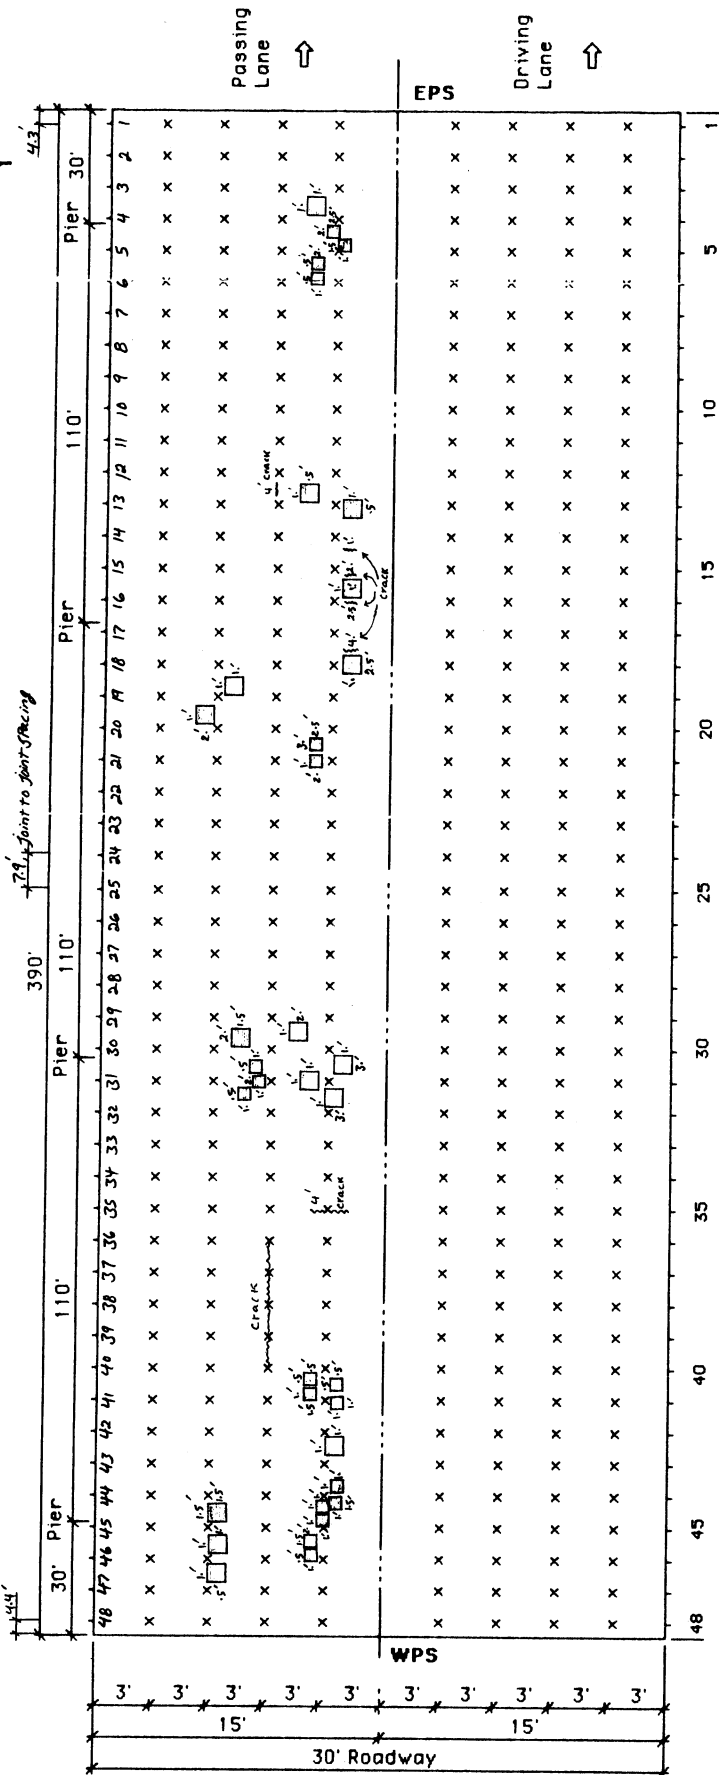
Bridge 140/S "Yakima River"  
(Continuous Concrete Box Girder)

Defective areas as indicated  
by chain dragging AC  
5-29-85

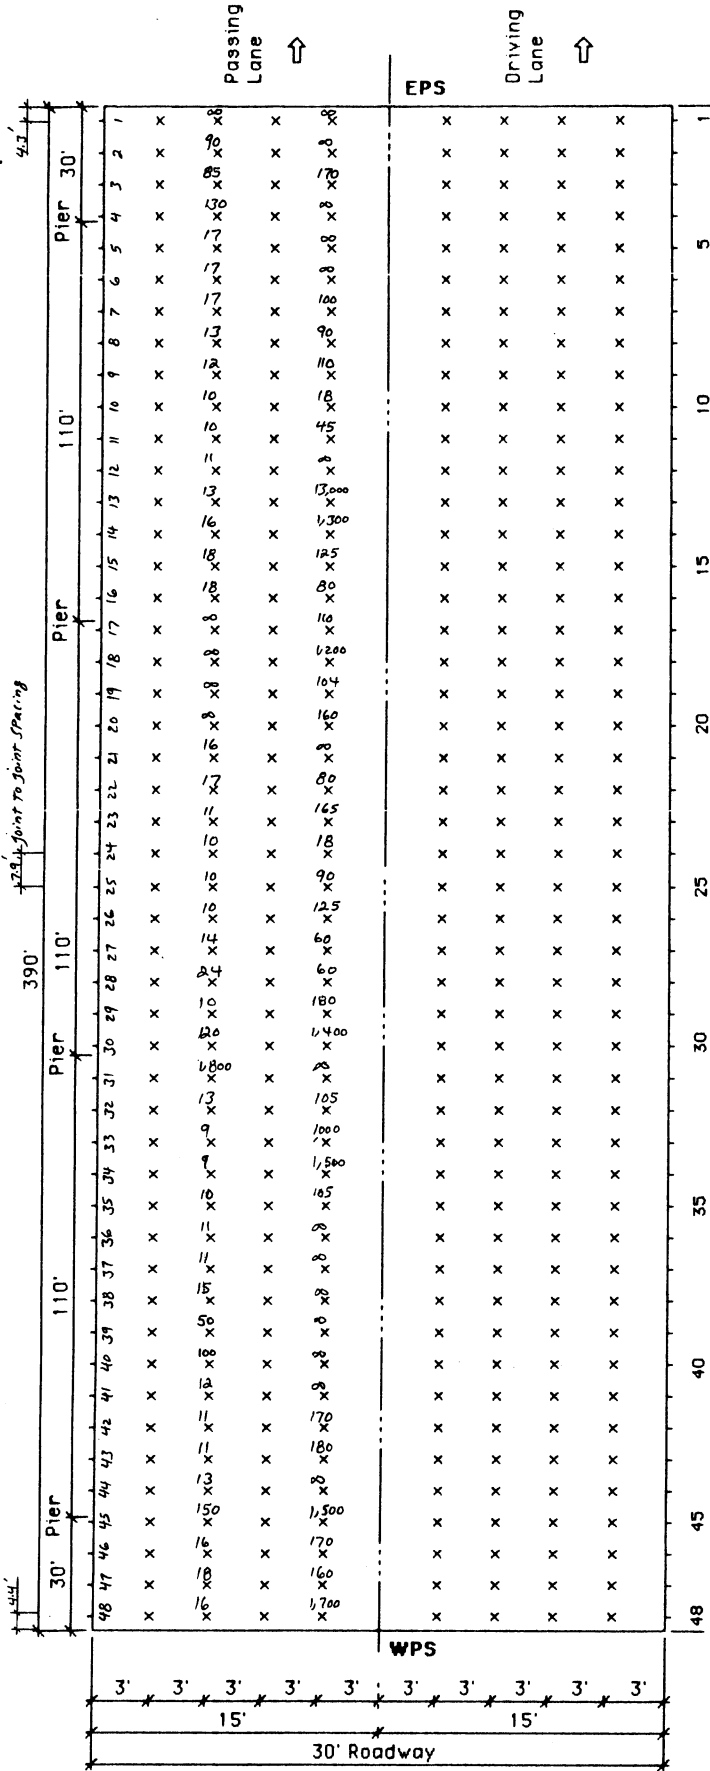
Bridge 140/S "Yakima River"  
(Continuous Concrete Box Girder)

Electrical Resistivity on AC  
(1000 Ohms)  
5-29-85

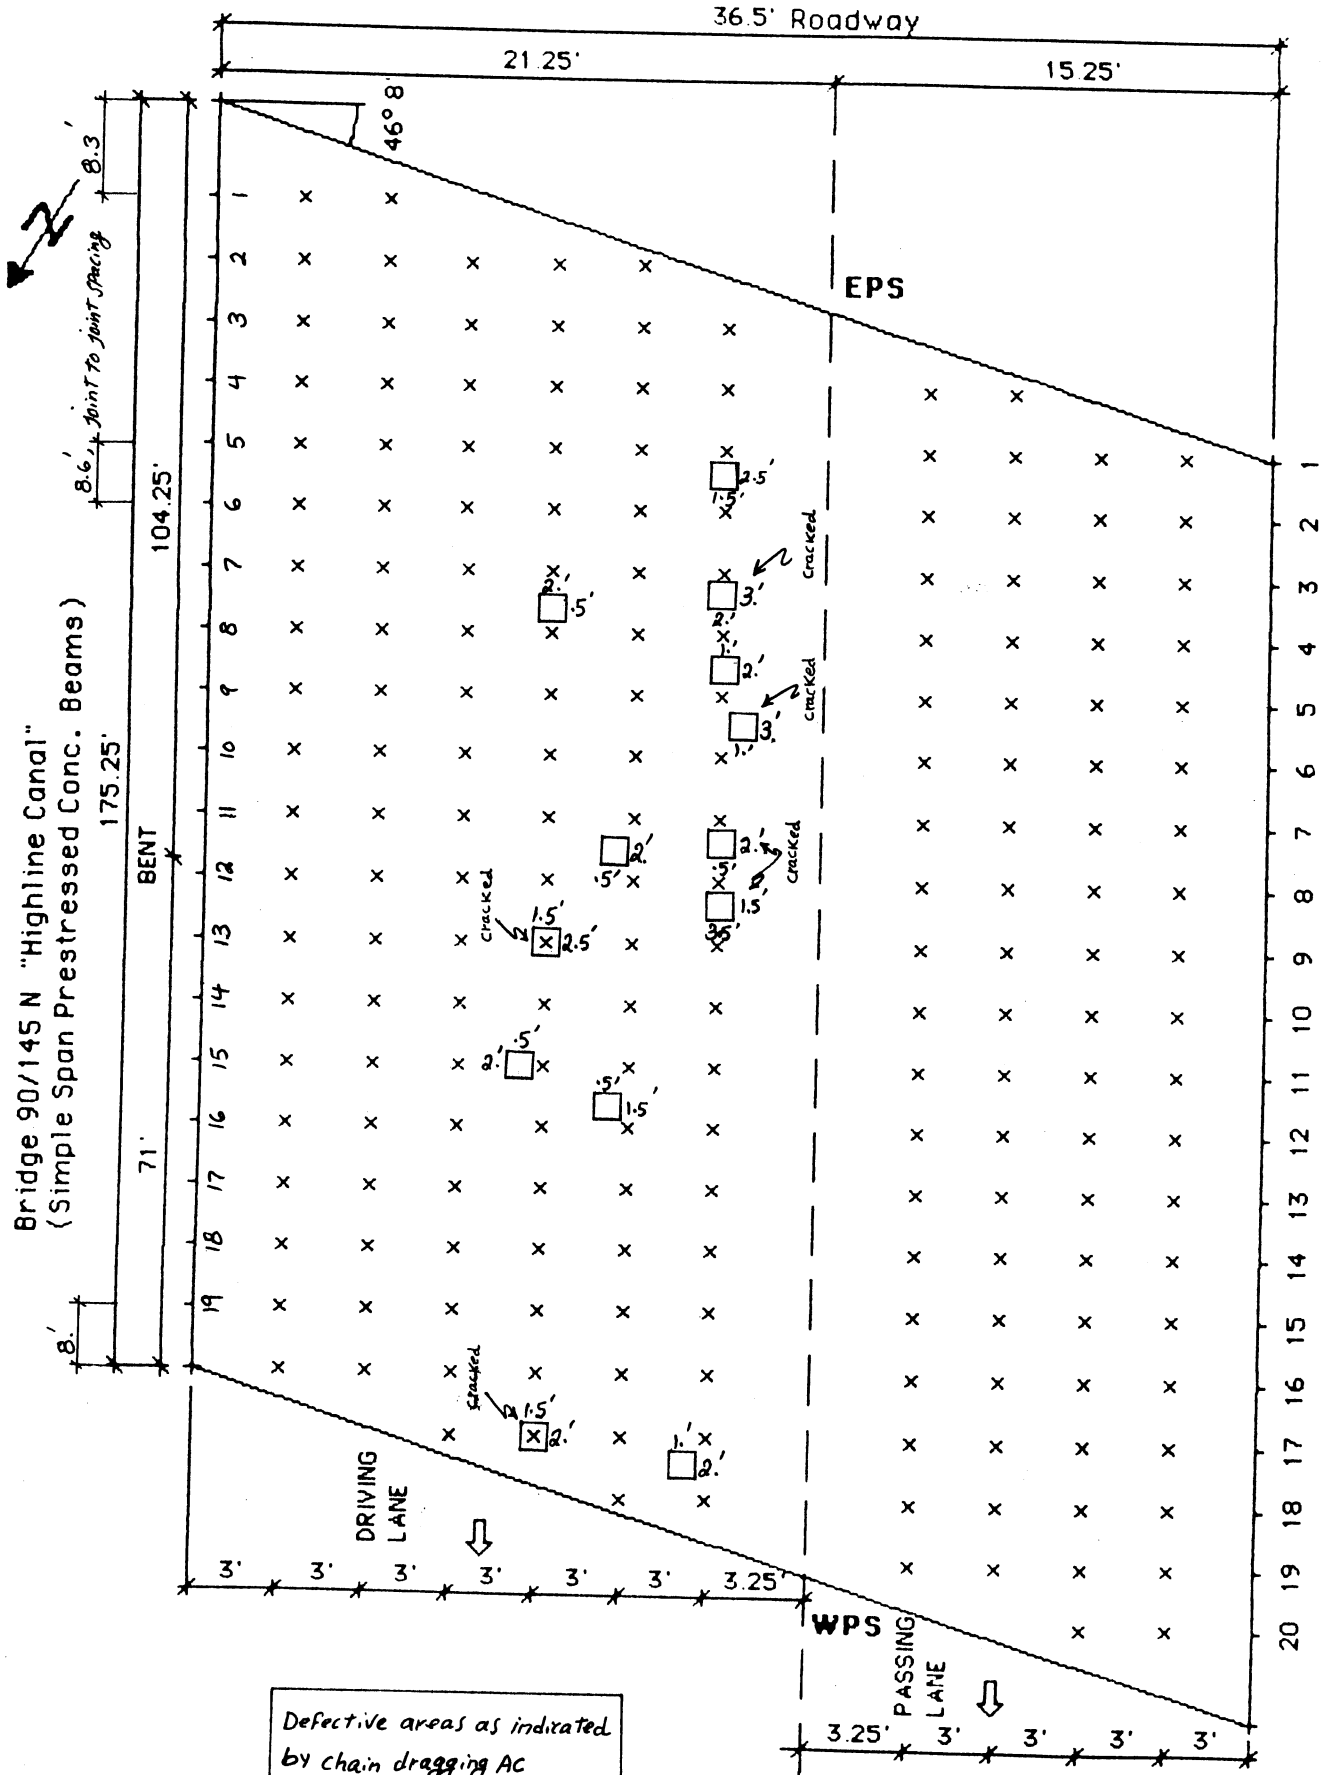
Bridge 90/145 N "Highline Canal"  
 (Simple Span Prestressed Conc. Beams)

Defective areas as indicated  
 by chain dragging AC  
 5-21-85

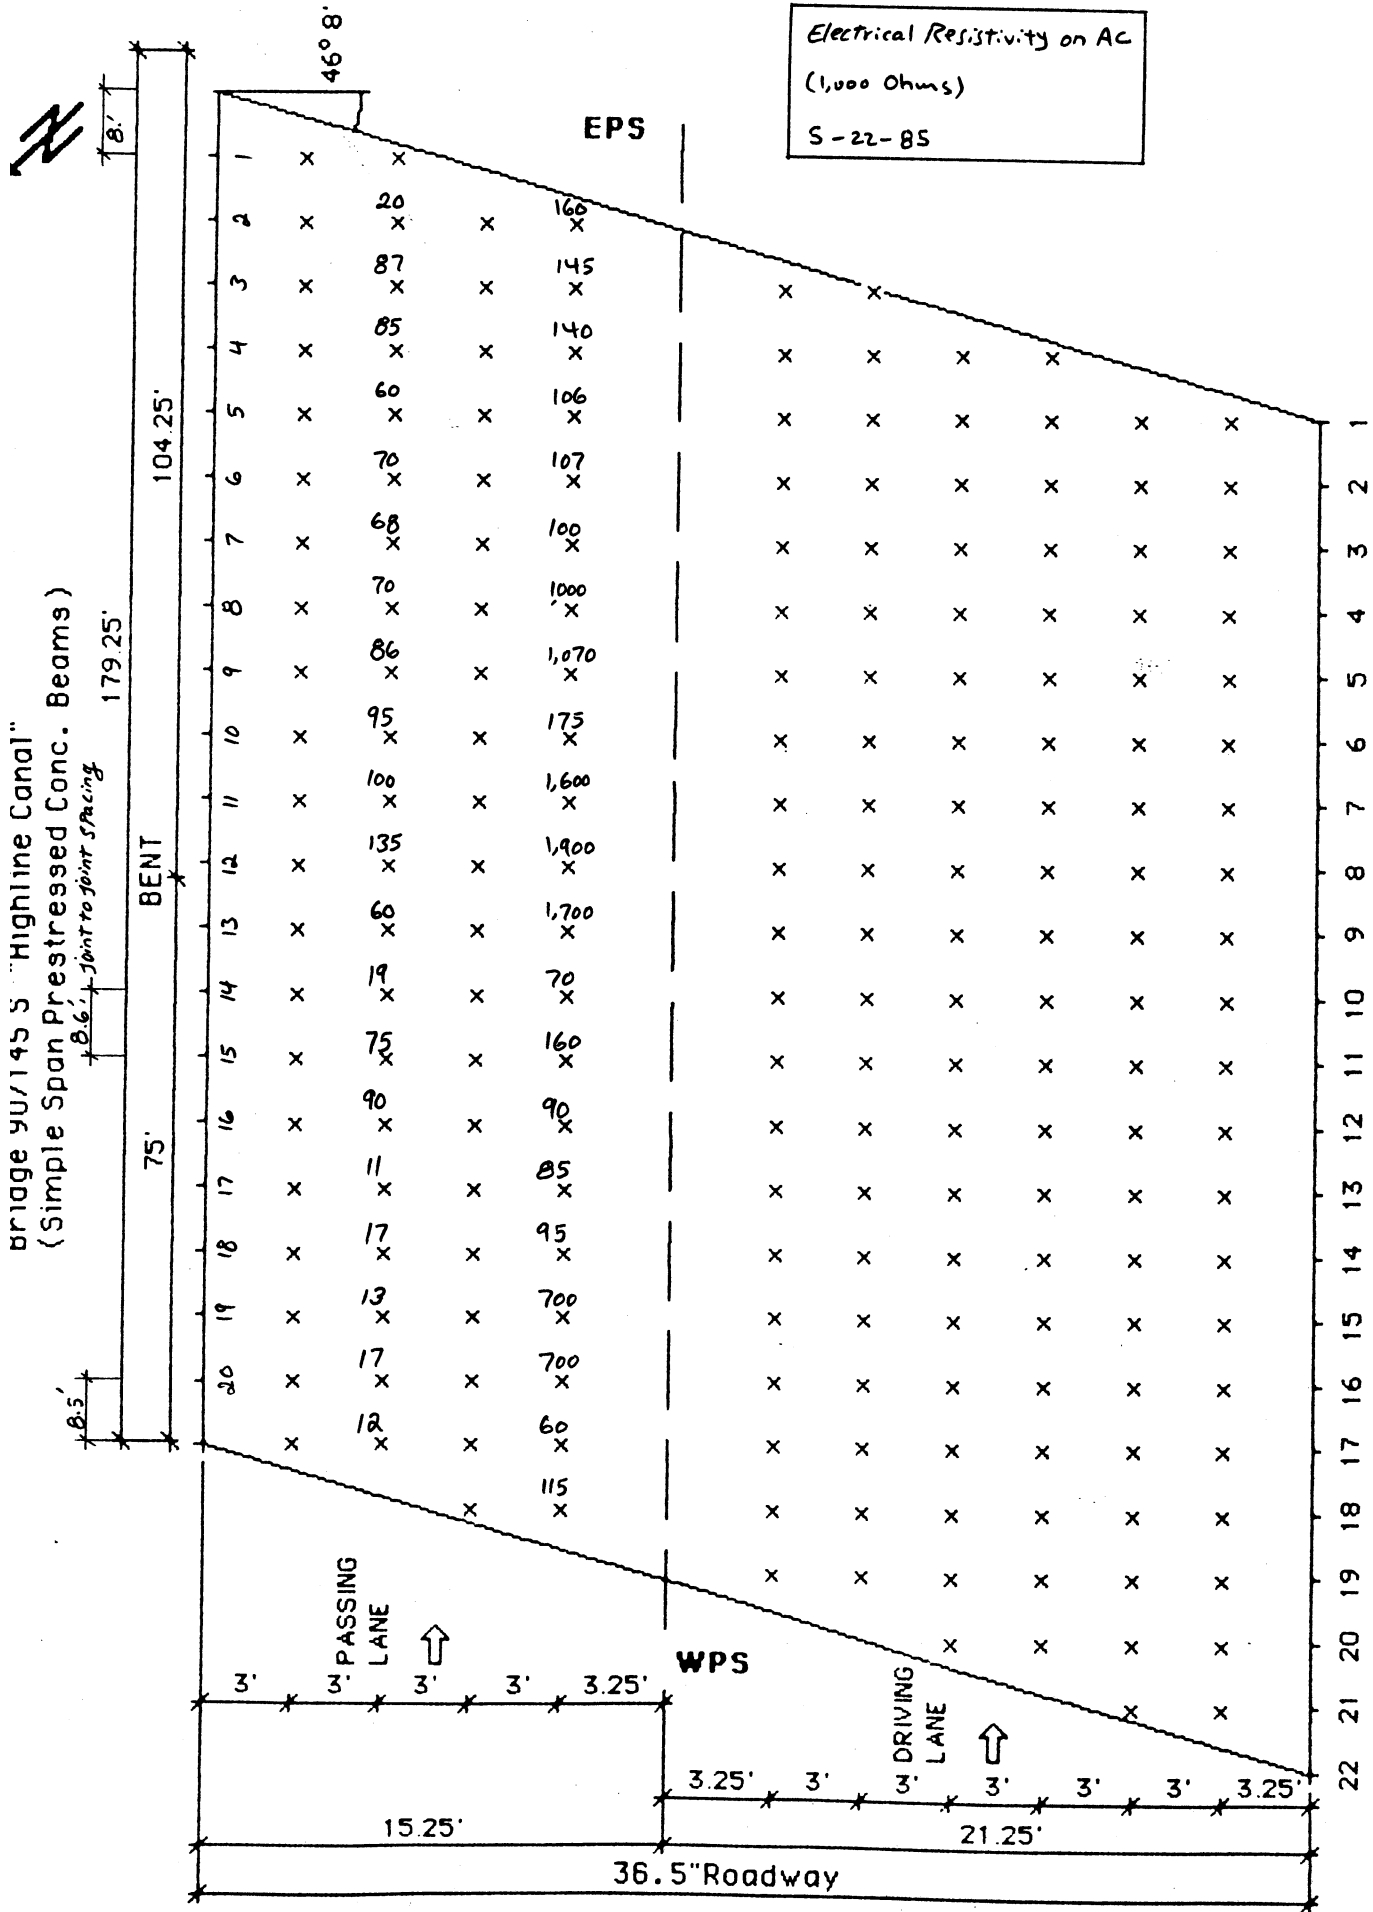
Bridge 90/145 S "Highline Canal"  
 (Simple Span Prestressed Conc. Beams)  
 +8.6' Joint to Joint Spacing

Electrical Resistivity on AC  
 (1,000 Ohms)  
 S-22-85
