Materials Report

WA-RD-117.1

Asphalt Concrete Class D

Bridge Deck Overlays

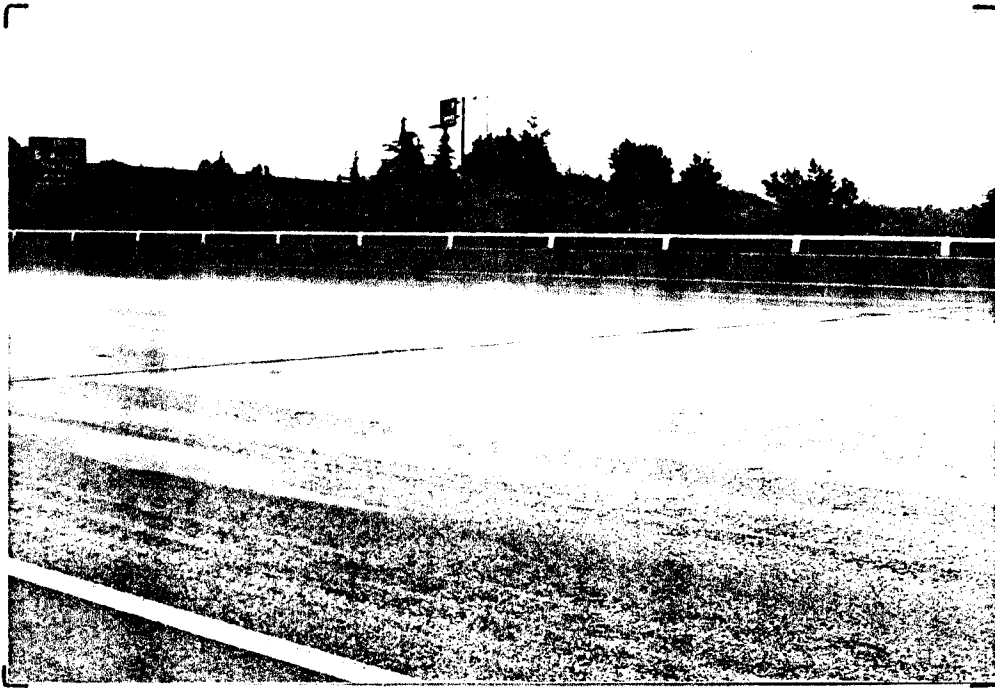
5/525.5 E -Flushing pavement at various points on the deck. Rutting can be seen at the joints.

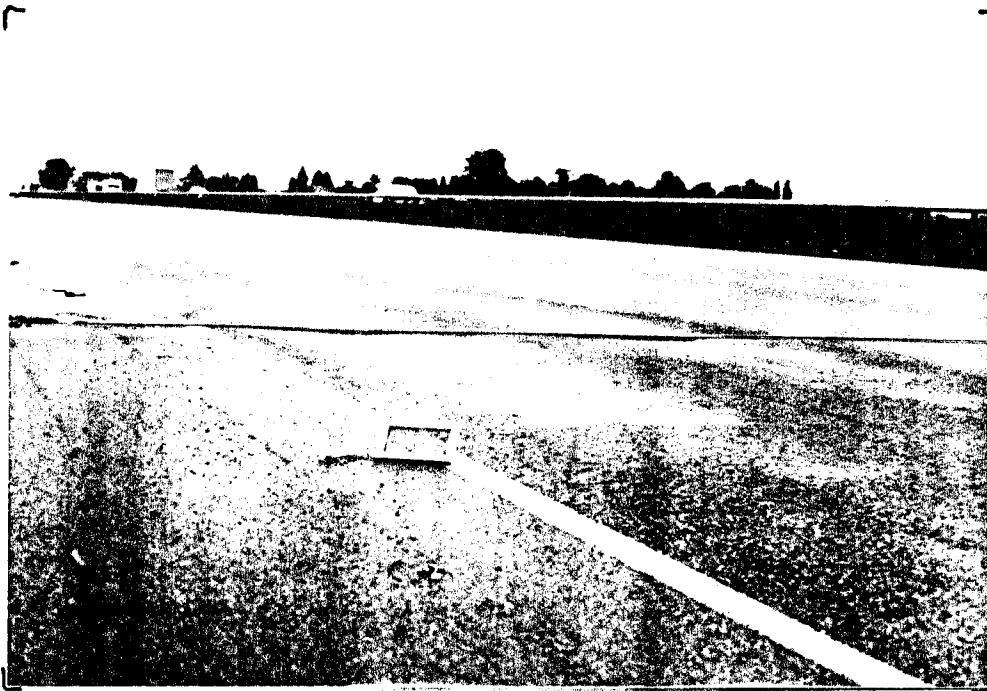
5/645 E - Surface shows some raveling,
rutting and flushing in various areas.
Heavy high speed traffic. Paved 1982.
Rated 9
