Bridge Approach Slab Effectiveness

WA-RD 227.1

Final Report
December 1991

**Research Project GC 8286, Task 35
Bridge Approach Slab Effectiveness**

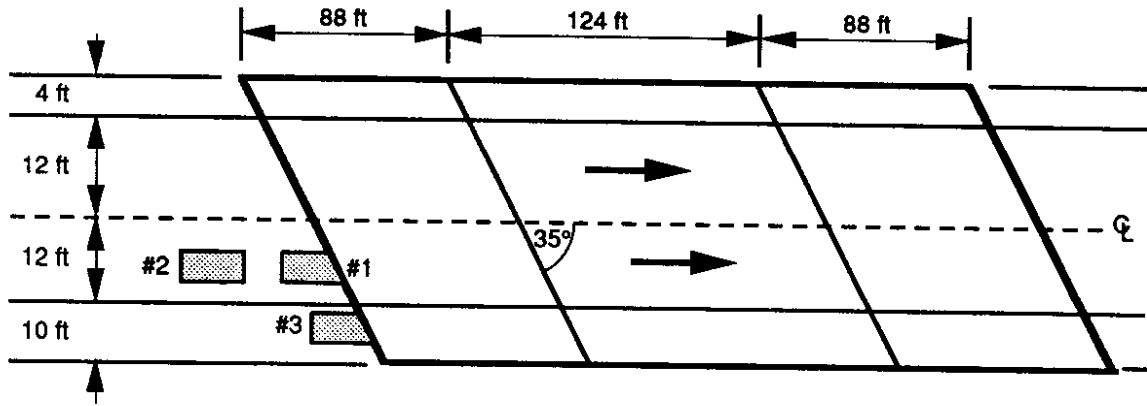
Figure 5. Location of Test Sections in Northbound Lanes of Sidney Road Overcrossing

Three test sections were chosen at the locations shown in Figure 5. Sections 1 and 2 were situated in the right wheel path of the travel lane. Test section 1 was located adjacent to the abutment, and test section 2 was near the edge of the zone in which distress was observed. For comparison, test section 3 was located adjacent to the abutment in the shoulder, where wheel loading was expected to be minimal.

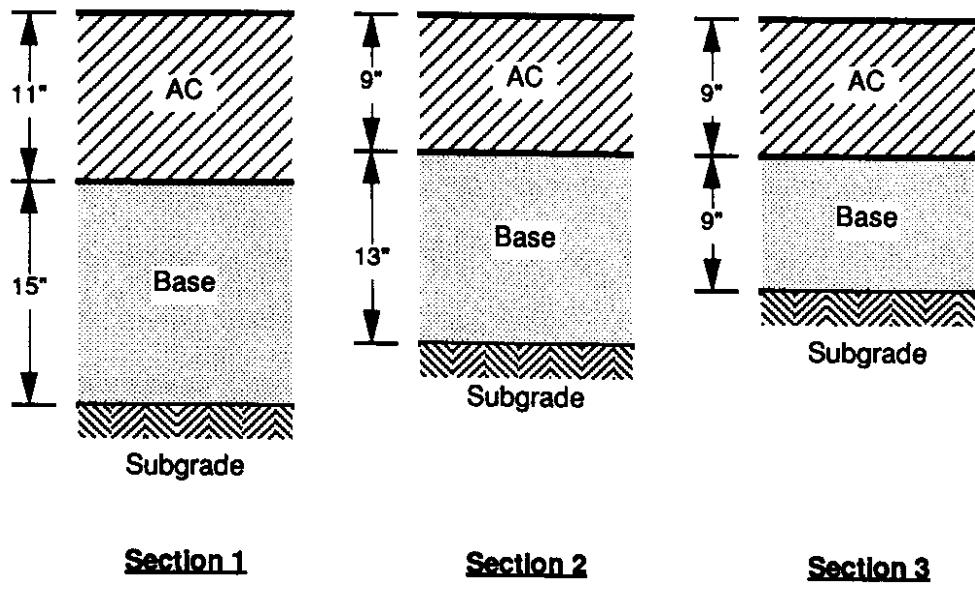
Figure 8. Subsurface Conditions at Excavated Sections, Sidney Road Overcrossing

State crew members cut the asphalt pavement with a jackhammer and carefully removed it to differentiate the skin patches and any other asphalt that had been placed after original construction. As the cutting continued, possible pavement overlays or other paving events were noted but were not always easy to distinguish. A photograph of test section 1 after the AC pavement had been removed is shown in Figure 6. Upon removal of the asphalt pavement, basecourse samples were taken and tests performed. The basecourse materials were then removed to expose the surface of the subgrade soils. At approximately the level of the bottom of the pavement, the backwall of the abutment protruded horizontally for about 7 inches, forming a pavement seat as shown in Figure 7. Asphalt and basecourse section thicknesses were measured and are shown in Figure 8. A 1- to 2-inch layer of gravel larger than the basecourse was encountered on top of the subgrade. Generally, the soils near the abutment did not appear to be as stiff and dense as those further from the abutment backwall.

Using a digging bar as a probe, the crew encountered a large void in an area behind the abutment backwall near the "corbel," as shown in Figure 7. This void appeared to have formed along the entire backwall, since it was nearly impossible to compact soils under the

corbel. The void directly under the corbel ranged from 4 to 5 inches deep and extended 5 to 6 inches from the abutment backwall. The void appeared to continue down along the abutment backwall as a 1- to 2-inch gap between the abutment and the soil. Around the void, the soils were loose and soft enough to excavate by hand. Figure 9 is a photograph of the upper portion of the void.

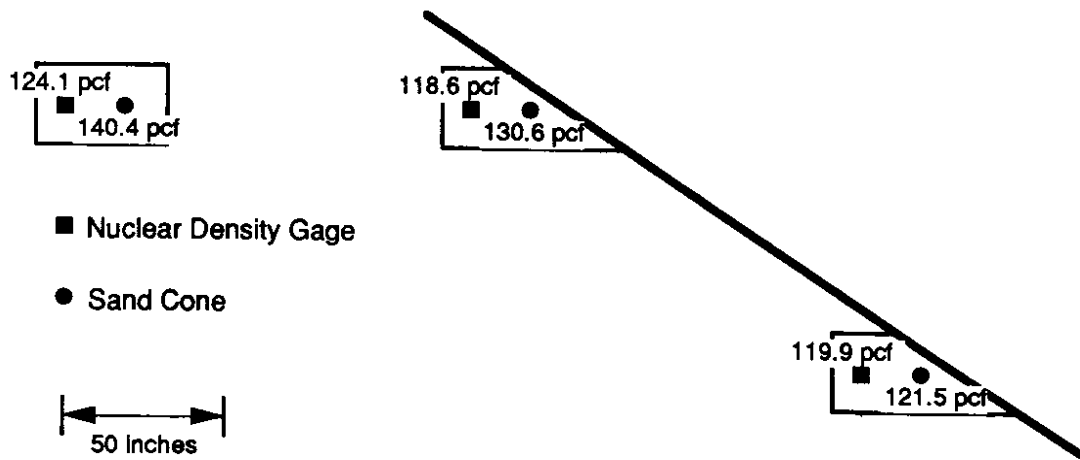
Figure 14. Dry Unit Weights for Sidney Road Overcrossing Basecourse

2. Densities. Densities of the basecourse and subgrade, measured at a number of locations, were as shown in Figures 14 and 15. They may have been affected by vibrations caused by the jackhammer during the pavement cutting operation. Density measurement with the nuclear density gauge may have been flawed in deeper test pits because of uncertainty associated with the trench corrections required for moisture content. This problem probably explains the large differences in measured density the sand cone and nuclear gauge produced. Sometimes lower densities were observed in areas closer to the bridge. However, overall, the values were much lower than the maximum dry densities obtained from proctor tests. Modified proctor test results indicated a maximum dry density of 139.5 pcf at an optimum moisture content of 6.5 percent for the subgrade, and a

maximum dry density of 144.0 pcf at an optimum moisture content of 7.5 percent for the basecourse. From these maximum dry densities, relative compactions for the basecourse ranged from 82 to 86 percent when calculated with the nuclear density gauge readings and 84 to 97 percent when based on the sand cone. Relative compaction for the subgrade soils ranged from 82 to 90 percent with the nuclear density gauge and 83 to 93 percent with the sand cone.

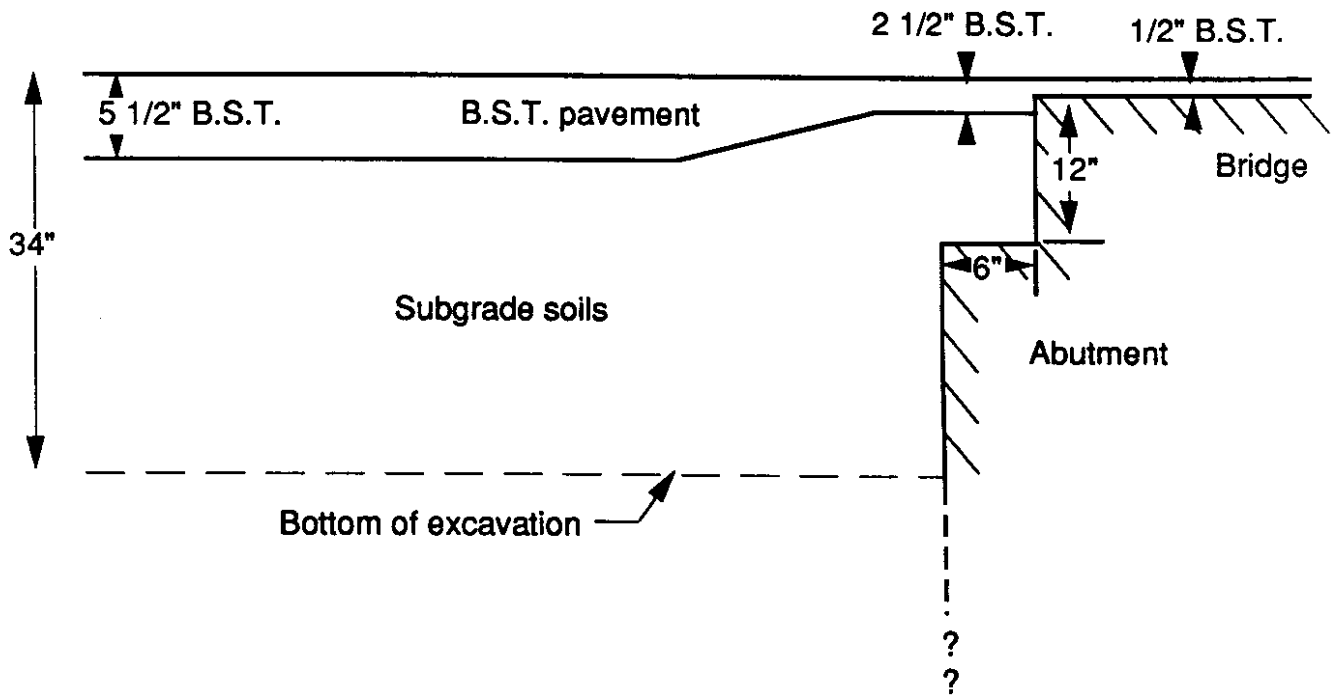
Figure 19. Approach Cross Section at Excavated Test Section, San Poil River Bridge (M.P.106)

The asphalt pavement was cut by state crew members with a jackhammer and carefully removed. The BST pavement was crumbly and adhered to the underlying subgrade soils. Within the test section, about 6 inches from the edge of the abutment, the pavement was only 2 1/2 inches thick, as shown in Figure 19. Farther than about 6 inches from the abutment, the pavement was approximately 5 1/2" thick. The soils were firm at every point, and no voids were observed anywhere in the test section.

Approach distress on this bridge has resulted from differential settlement between the bridge deck and the approach embankment. The strongest indication of differential settlement was observed in the sudden change in pavement thickness over the pavement seat area. Field testing and hand probing indicated that the embankment soils were firm and properly compacted. Gradations did not show large deviations, though the measured moisture contents of the embankment soils in the test section tended to describe water

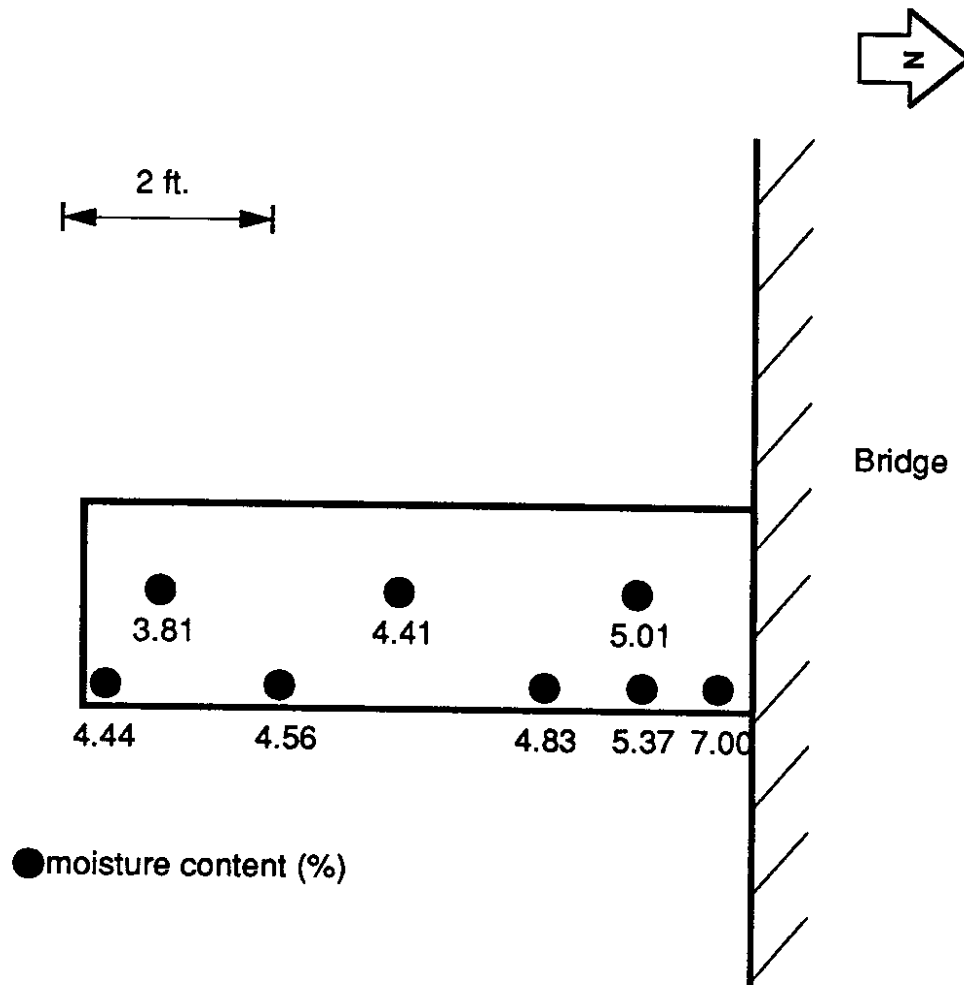
Figure 23. Moisture Content (in percent) of San Poil River Bridge (M.P. 106) Fill

3. Moisture Content. Moisture content samples were taken at several locations in the test section, as shown in Figure 23. The tests indicated that water contents gradually increased toward the abutment, indicating that water either has entered near the abutment/embankment interface or is trapped near the abutment.

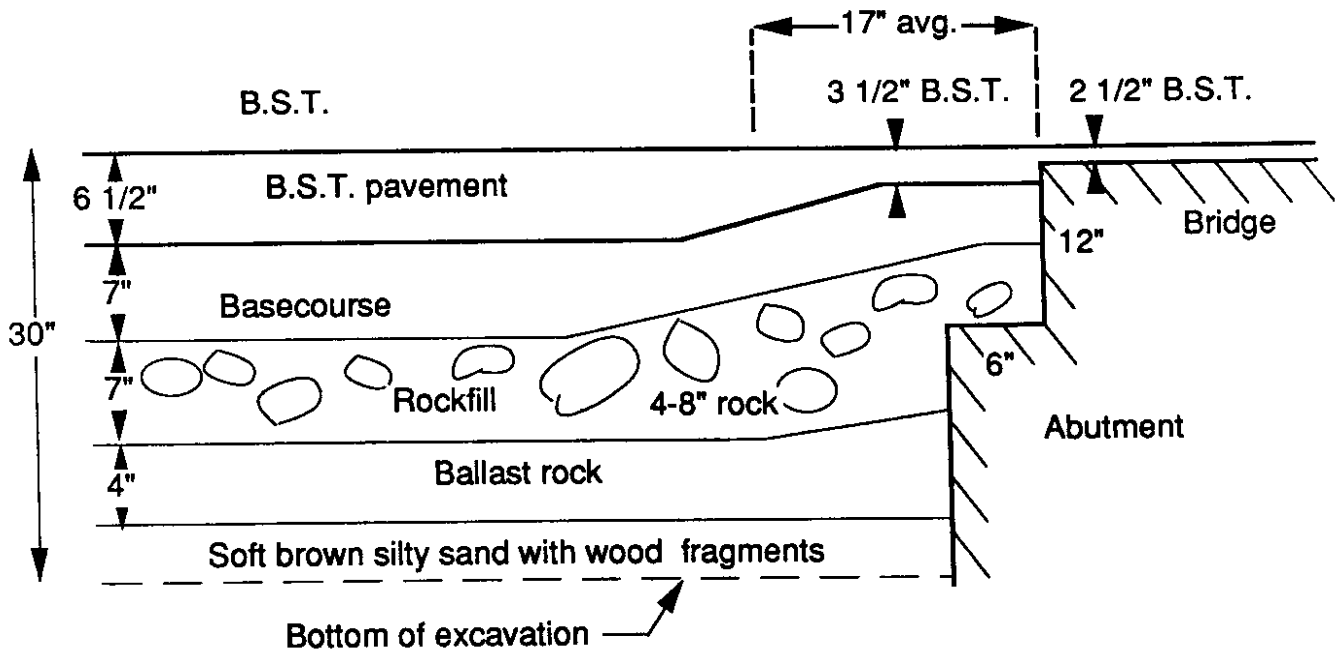
Figure 26. Approach Cross Section Parallel to Highway Alignment at Excavated Test Sections, San Poil River Bridge M.P. 123.

The BST pavement was cut by the state crew members with a pneumatic hammer and removed easily. At approximately 17 inches from the edge of the abutment — measured parallel to the alignment of the road — the pavement thickened from 3-1/2 inches to 6-1/2 inches. The variation in pavement thickness can be clearly seen in Figure 25. As the excavation continued, a very unusual subgrade soil profile was observed in the test section, as shown in Figure 26. Under the pavement was a firm, 7-inch layer of basecourse underlain by rockfill with cobbles ranging from 4 to 8 inches, mixed into a

4-inch layer of ballast rock. This rockfill-ballast layer was jumbled and did not appear to be particularly dense, since it was easily removed with a pick and shovel. Below this layer was a dark brown, silty sand with some wood fragments. A pavement seat was encountered at 1 foot below the bridge deck elevation, but its face was vertical to the bottom of the 29-inch-deep excavation.

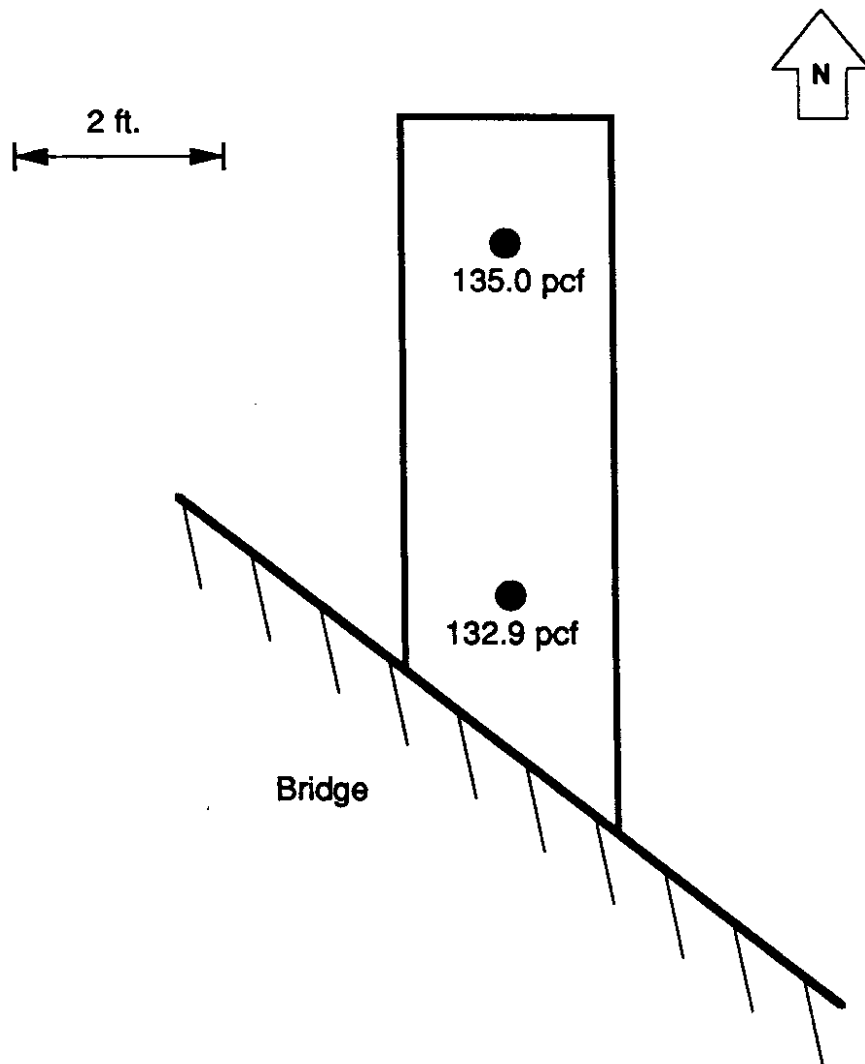
Figure 29. Dry Unit Weights for San Poil River Bridge (M.P. 123) Basecourse.

2. Densities. Densities of the basecourse were measured at the locations shown in Figure 29. The densities appeared to be slightly lower closer to the abutment. The lower densities near the abutment may have been due, in part, to soil disturbance from settlement over the pavement seat. The dry unit weight of the basecourse averaged 134 pcf, while modified proctor test results indicated a maximum dry density of 138 pcf at an optimum moisture content of 8.8. On that basis, relative compactions of the basecourse were estimated to be approximately 97 percent.

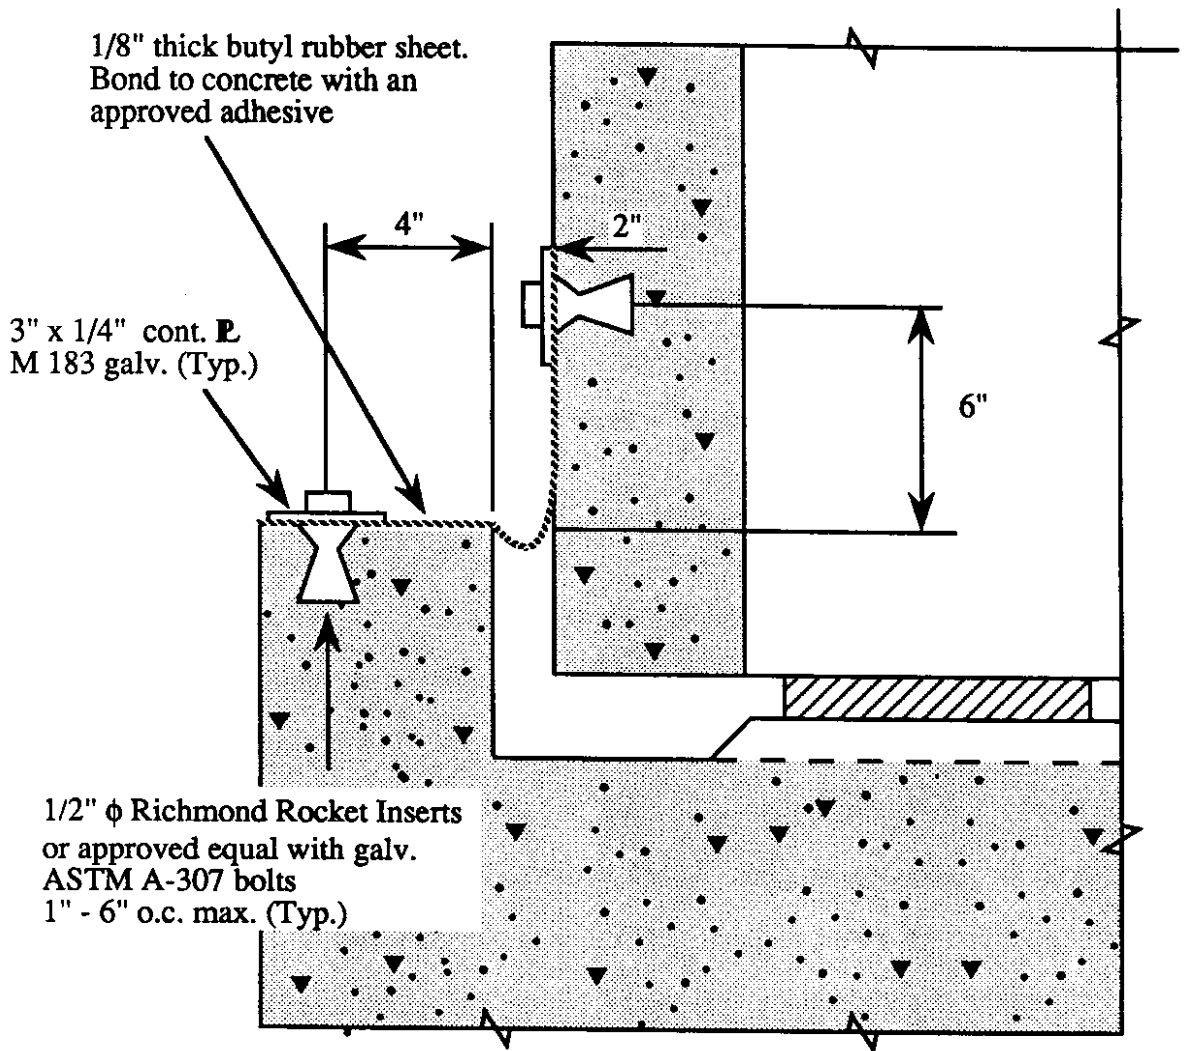
Figure 38. Section of Butyl Rubber Sheet on Curlew Creek Bridge Abutment

The actual abutment was encountered at 22 1/2 inches below the bridge deck. The abutment design utilized to connect the precast concrete bridge beam sections to the abutment is shown in Figure 38. The concrete beams had been installed with gaps of 2 to 3 inches between them. A waterproofing membrane was placed on the deck before

paving. A butyl rubber strip fit between the abutment and the precast girders and stretched the full length of the abutment to seal the backfill out. Apparently, there was some problem with the rubber seal, since backfill was observed on the underside of the bridge sitting in small piles on the abutment below the gaps between adjacent beams, as shown in Figure 39. The amount of material that had migrated out was indicated by the piles of soil and the water marks on the abutment under the the bridge. The small piles contained rock fragments from the basecourse, but consisted predominantly of fines. The rubber seals and fasteners connecting the the precast girders were intact and in good shape in the test pit.

The approach distress at this structure is most likely caused by localized settlement. The depression in front of the abutment could have been caused by a couple of mechanisms. One possible explanation is that the membrane that seals the ends of the precast sections is allowing backfill through the space between the sections. Though the excavated test section did not show any such leakage, other locations along the abutment may have leaked, especially if the membrane was damaged during construction. The second cause of localized approach problems may be that the basecourse was not compacted sufficiently on top of the connectors at the bridge segments for fear of damaging the rubber connector. Densities measured in the field attest to slightly lower than acceptable relative compactions. This second hypothesis logically explains the continuous depression along the end of the bridge. Erosion around the ends of the bridge did not appear to be a problem during the investigation but will probably become more significant within the next few years.

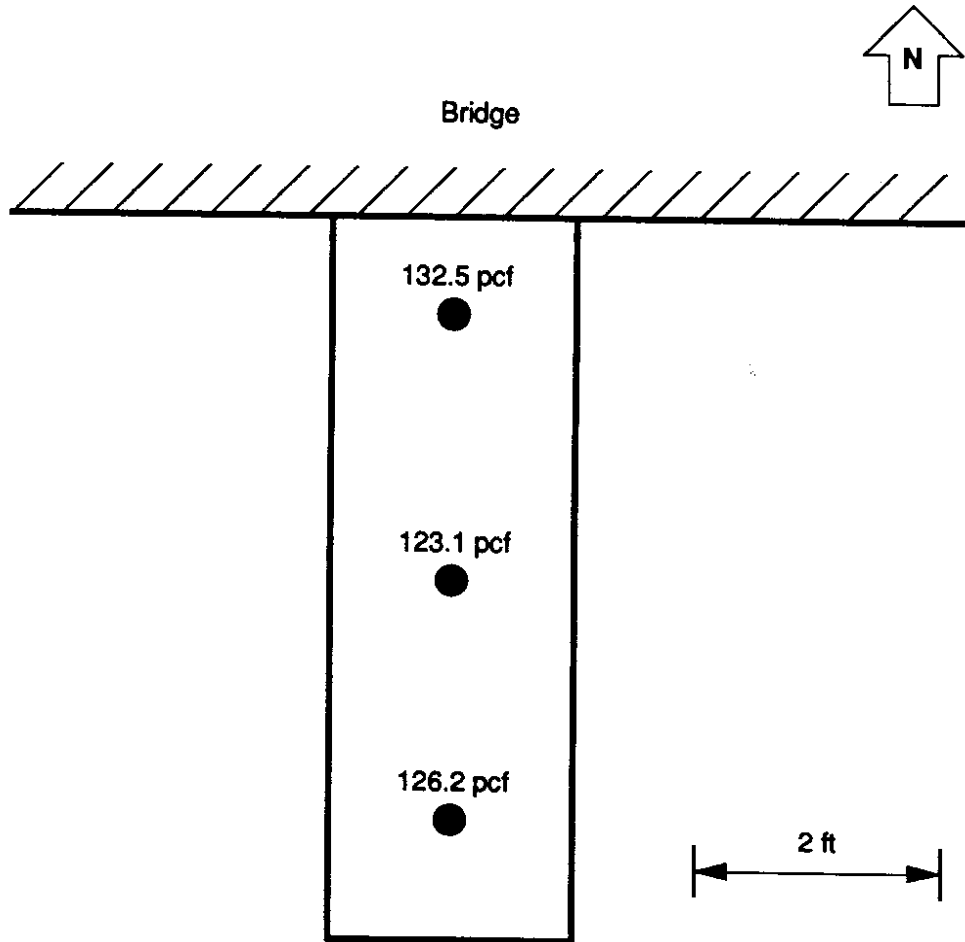
Figure 44. Dry Unit Weight for Curlew Creek Bridge Basecourse

2. Densities. Basecourse densities were measured at the locations shown in Figure 44. The densities appeared to be higher near the abutment. The dry unit weight of the basecourse averaged 127.3 pcf., while modified proctor test results indicated a maximum dry density of 138.5 pcf at an optimum moisture content of 7.5 percent. With this maximum dry density, relative compactions of the basecourse averaged 92 percent. Densities were also measured for the native subgrade soil, as shown in Figure 45.

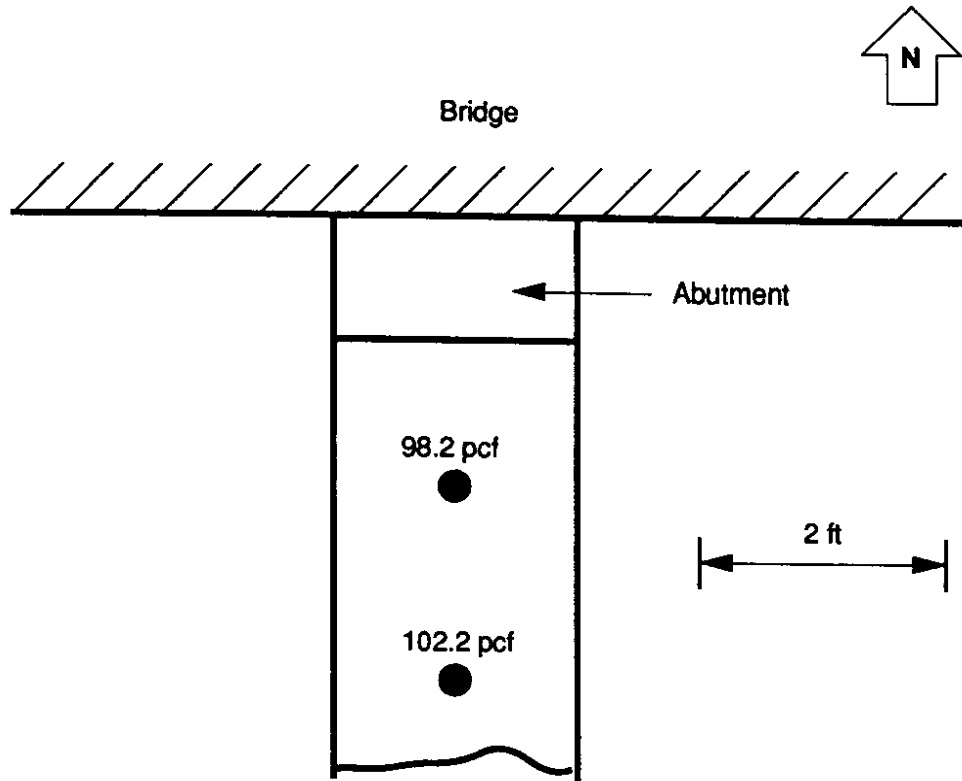
Figure 45. Dry Unit Weight for Curlew Creek Bridge Subgrade

Densities averaged 100.2 pcf and were lower against the abutment. Modified proctor test results indicated a maximum dry density of 129.5 pcf at an optimum moisture content of 8.8 for the subgrade soils. Relative compaction of the native subgrade fill averaged 77 percent.

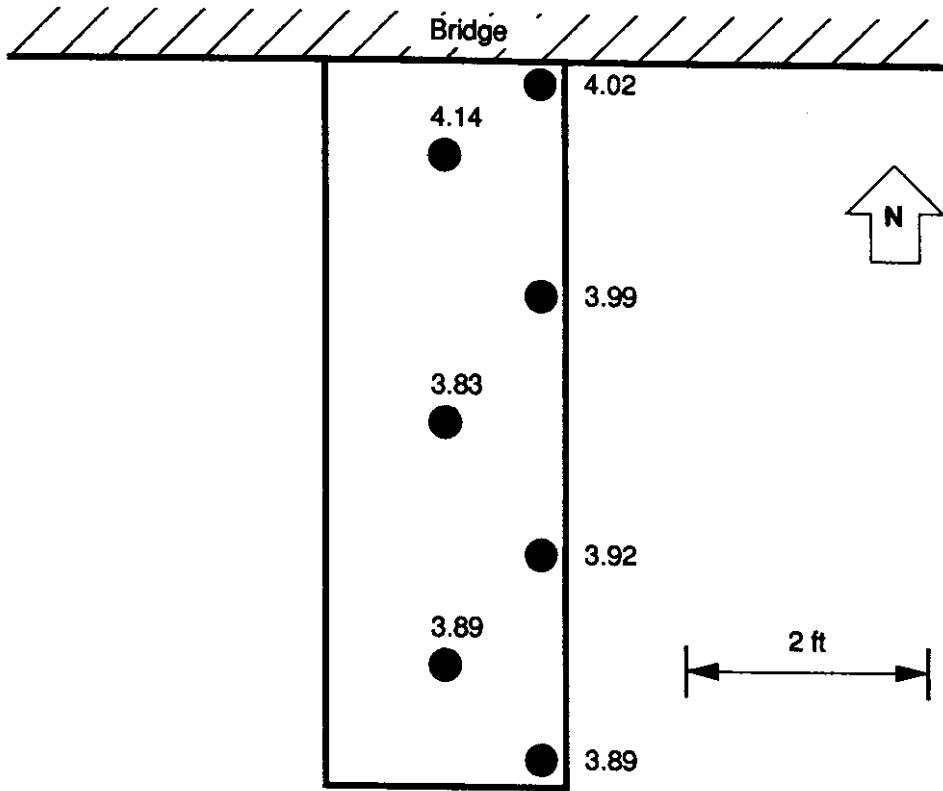
Figure 46. Moisture Content (in percent) of Curlew Creek Bridge Basecourse

3. Moisture Content. Moisture content samples were taken at several locations in the test section for both the basecourse and the subgrade. The results of the moisture content tests on samples from the upper 2 inches of the basecourse are shown in Figure 46. Moisture contents of the basecourse averaged 4.0 percent. Moisture contents averaging 12.3 percent for the subgrade soils are shown in Figure 47. In both cases, moisture contents gradually increased closer to the abutment.

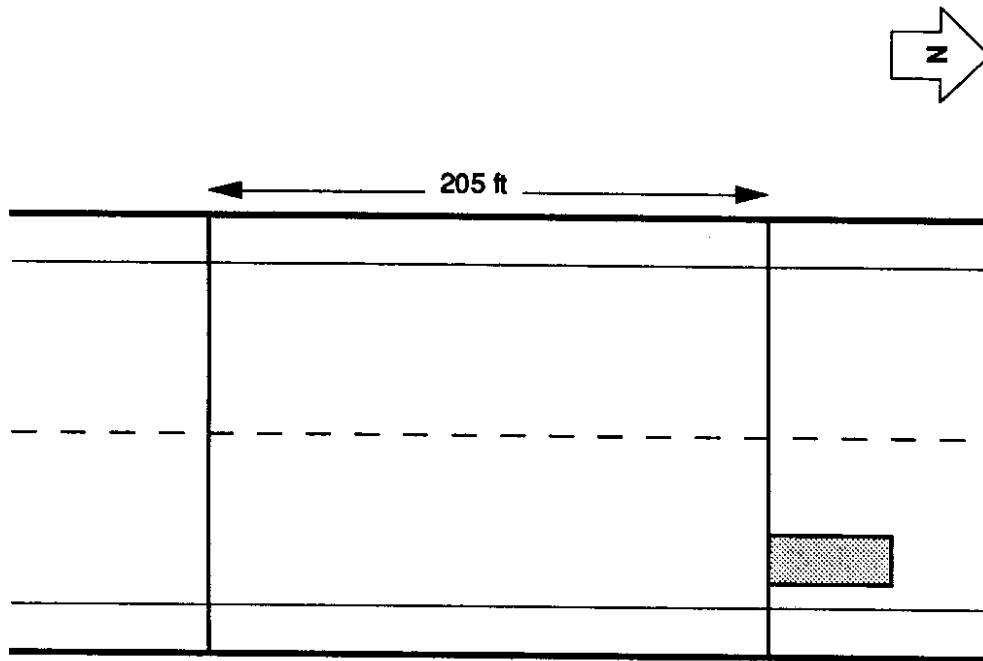
The field investigation was conducted in the afternoon of Thursday, September 13, 1990 in warm and sunny conditions. A state maintenance crew of two men controlled traffic by closing a section of the southbound lane across the bridge. The state crew also recompact and patched the test section after the field investigation had been completed. One test section was removed in the northbound lane, on the departure side of the bridge, in the wheel path closest to the shoulder, as shown in Figure 48.

Figure 48. Location of Test Section in Northbound Lane of the Kettle River Bridge (M.P. 156)

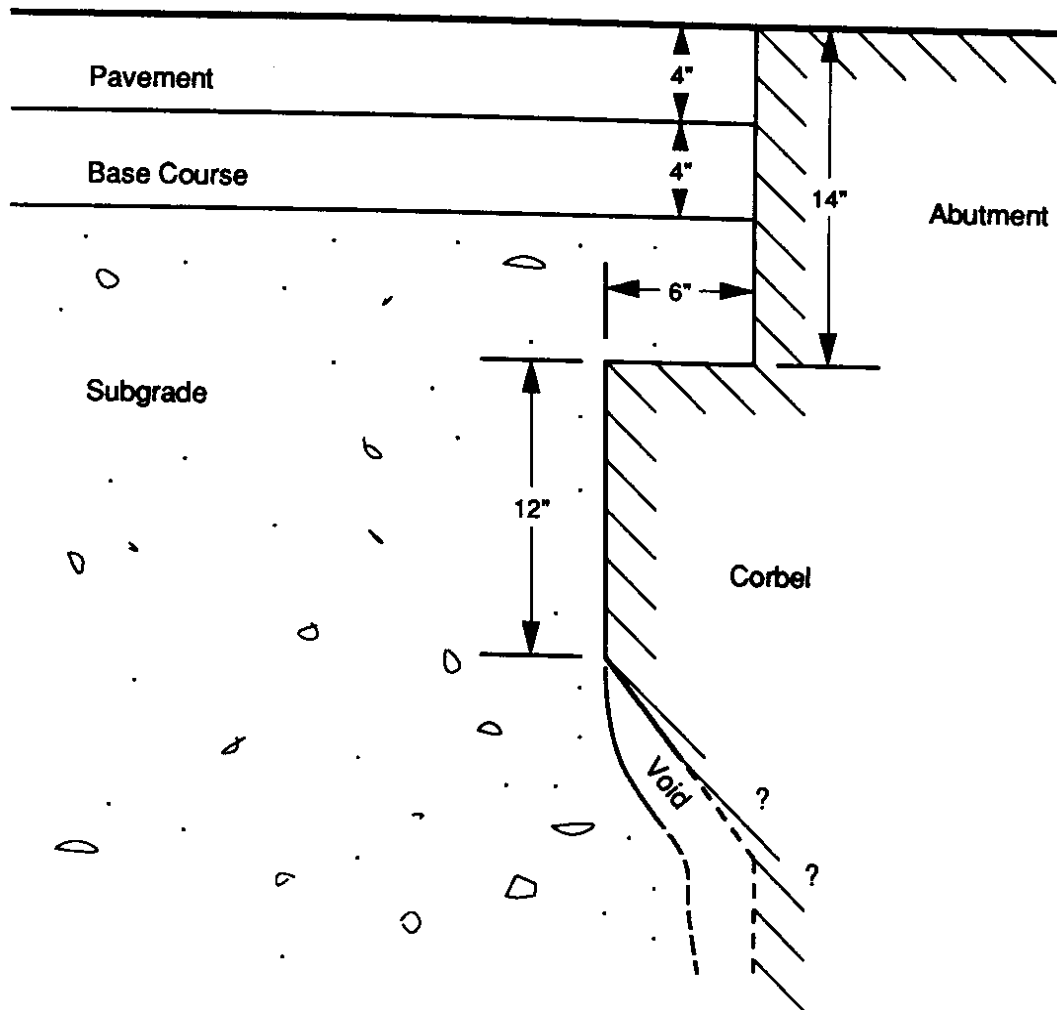
The BST pavement was removed easily and in nearly one piece. The pavement was consistently 4 inches thick, which was considerably thicker than pavement thicknesses for the other structures along SR 21. The 4-inch-thick basecourse beneath the BST was easily excavated and required only minor picking. The basecourse appeared very similar to the subgrade fill, but was more of a manufactured, fractured face mix. Digging down into the sandy gravel fill against the abutment, a large void - 4 inches out from the abutment and 6 inches down the abutment backwall - was uncovered at the corbel, as shown in Figure 49. The upper portion of the void is shown in Figure 50. The excavation was stopped at this level.

Figure 49. Profile through Kettle River Bridge Abutment

The apparent cause of approach distress on this bridge is a void that had been forming under the corbel of the abutment. Test results indicated lower densities in both the basecourse and the subgrade soils at distances close to the abutment. The lower densities may have been related to inadequate compaction or piping of fines caused by seepage to the void. Since the moisture contents and the gradations taken in the test section were relatively uniform, inadequate compaction is considered the likely cause of the observed distress.

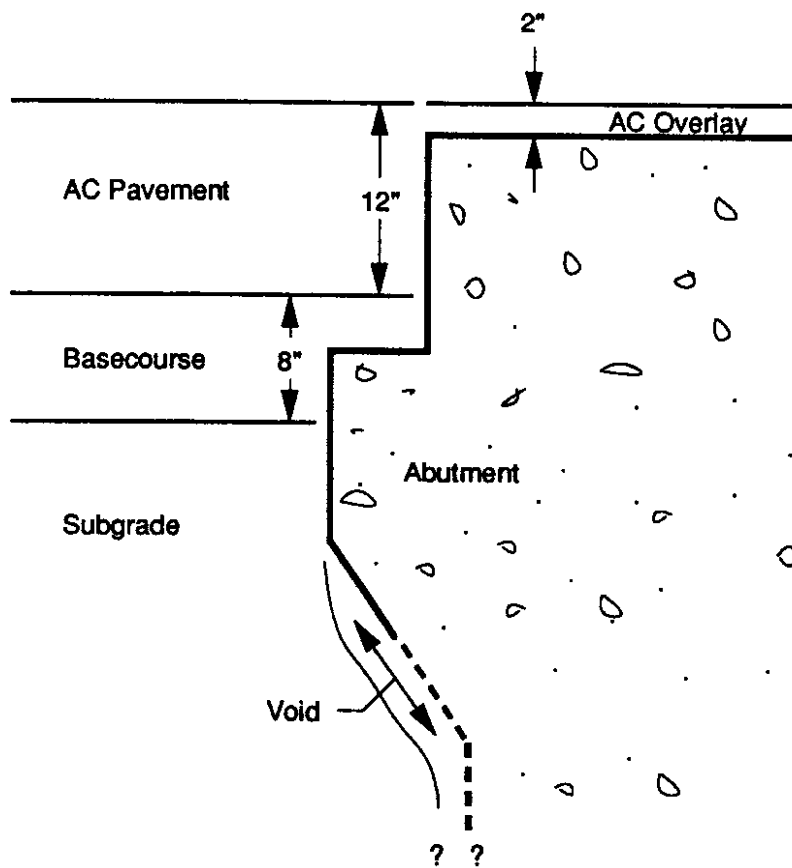
was a fill subgrade composed of rounded gravel and numerous large cobbles. The remaining fill was of very rounded, sandy gravel. The pavement seat was found at a depth of 15-1/2 inches and extended outward for 6 inches, then dropped vertically down for 12 inches more, as shown in Figure 61. A void and/or loose zone was noted within approximately 2 inches of the sloping part of the corbel. The void was distinct in some places, but appeared to have filled with loose slough at other locations. The void and many cobbles in the embankment fill can be seen in Figure 62. Inspection of the appurtenant areas revealed no evidence of erosion underneath or at the sides of the bridge.

The probable cause of approach pavement distress at this bridge is poor compaction of the embankment fill adjacent to the bridge abutment, which may have been compounded by thermal movements of the bridge. Final paving construction completed on frozen subgrade soils could also have contributed to the overall approach problems. Subgrade soil

Figure 61. Soil Profile Behind Abutment

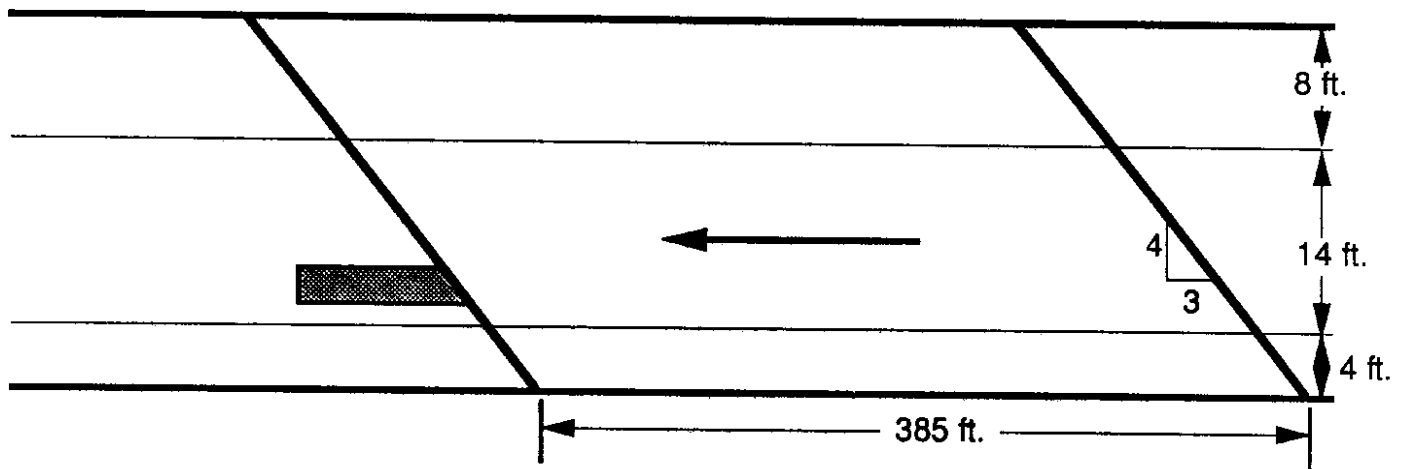
The field investigation of the westbound ramp took place on Tuesday afternoon, September 25, 1990. Weather conditions were favorable. One test section was chosen in the left side of the single ramp lane as shown in Figure 65.

Figure 65. Location of Test Section for West-West Ramp SR 82

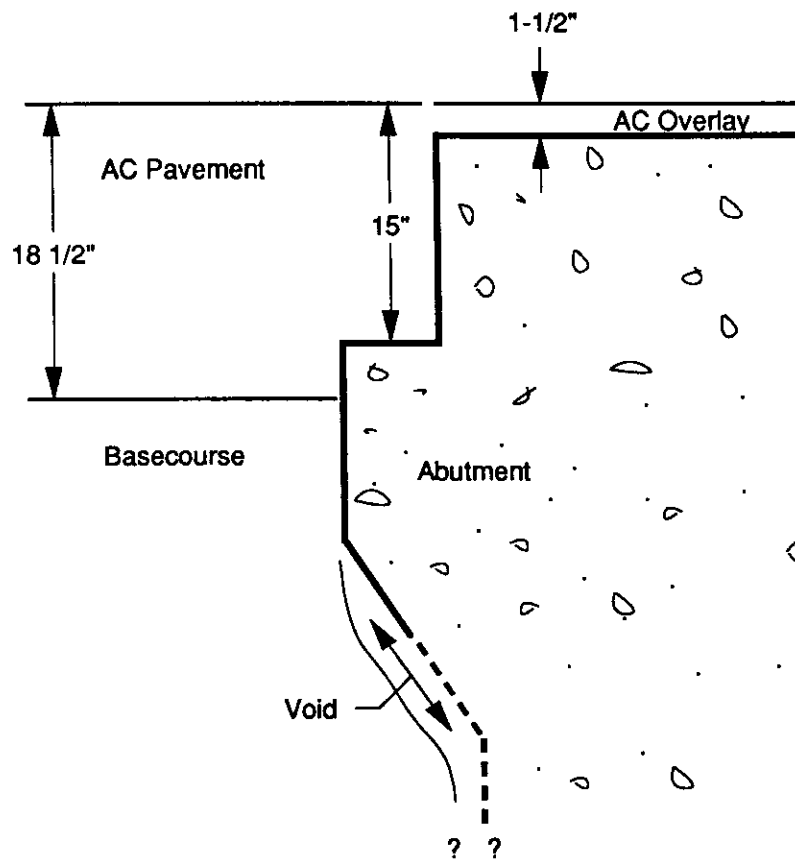
Measurements of the cut pavement section disclosed roughly 5 inches of patches in approximately 1-inch-thick layers. The top of the basecourse was 18-1/2 inches down. Basecourse conditions were similar to those at the last bridge. The basecourse appeared wetter toward the bottom of the pavement seat. The abutment pavement seat and corbel were located 15 inches below the road surface, as shown in Figure 66. Again, a void between the abutment backwall and the adjacent soil was observed in the sloping portion of the backwall. The upper portion of the void is shown in Figure 67. The subgrade, which was 25 inches down, contained numerous, closely spaced cobbles.

Figure 66. Soil Profile Behind Abutment

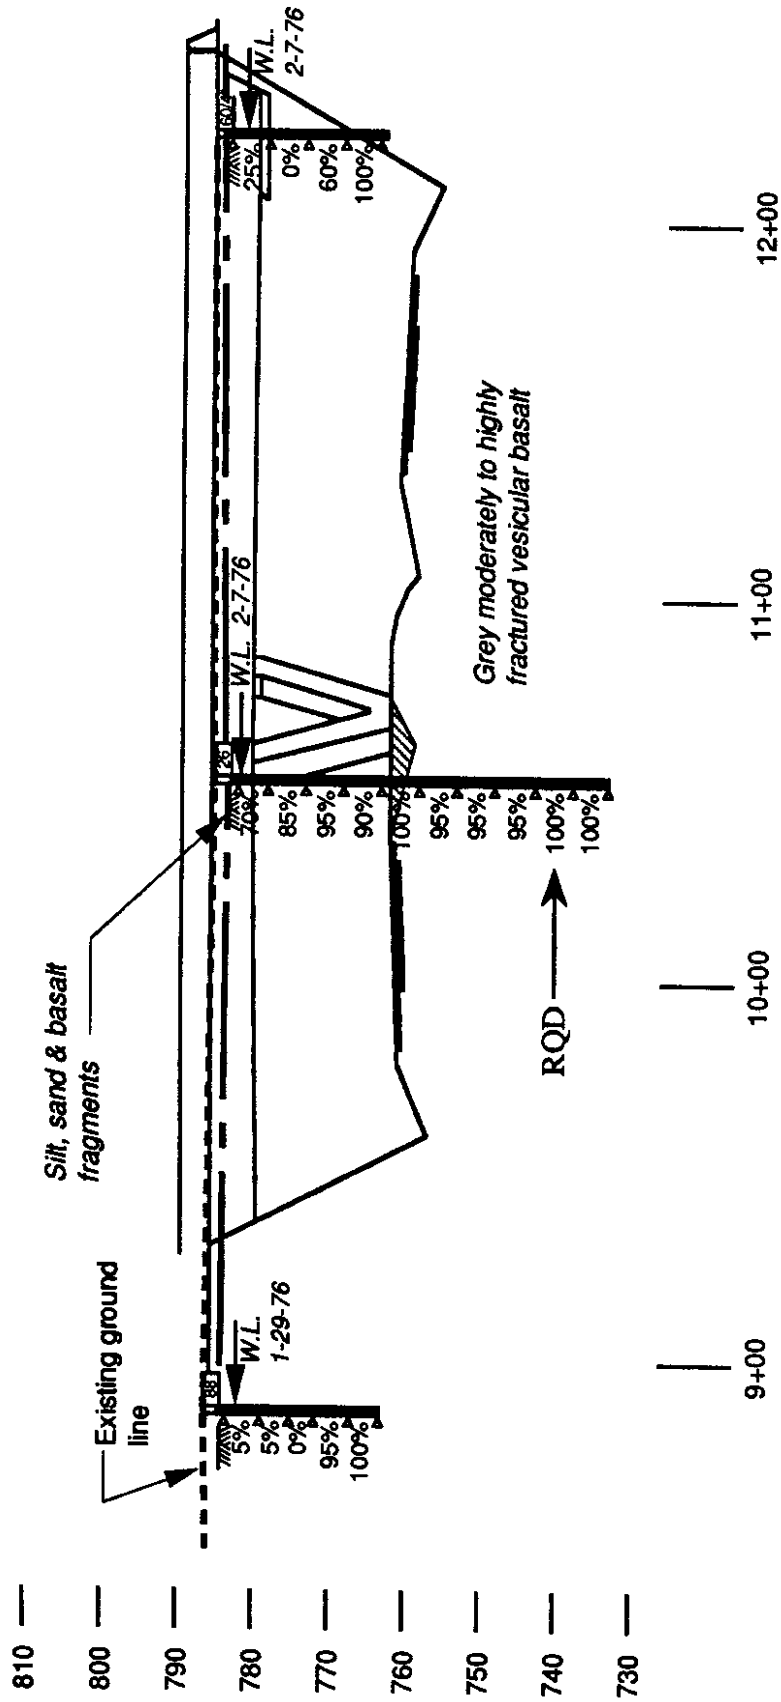
The Johnson Road Undercrossing is a 317-foot-long, two span, post-tensioned, concrete box girder bridge with a 45 degree skew. Apparently, small gaps were left between the girders, and the girders extended somewhat beyond the abutments. No approach slabs exist on this structure, since both approaches are essentially at grade. SR-82 passes below the bridge in a cut section with 3/4:1 slopes at the bridge. Rock beneath the bridge ends was excavated with pre-split methods. All three piers are supported by spread footings on rock as shown in Figure 71. In addition, because of the poor quality of the rock at the bridge ends, the front of the footings had to be located at least 10 ft. behind the face of the slopes.

Figure 71. Profile View of Johnson Road Undercrossing

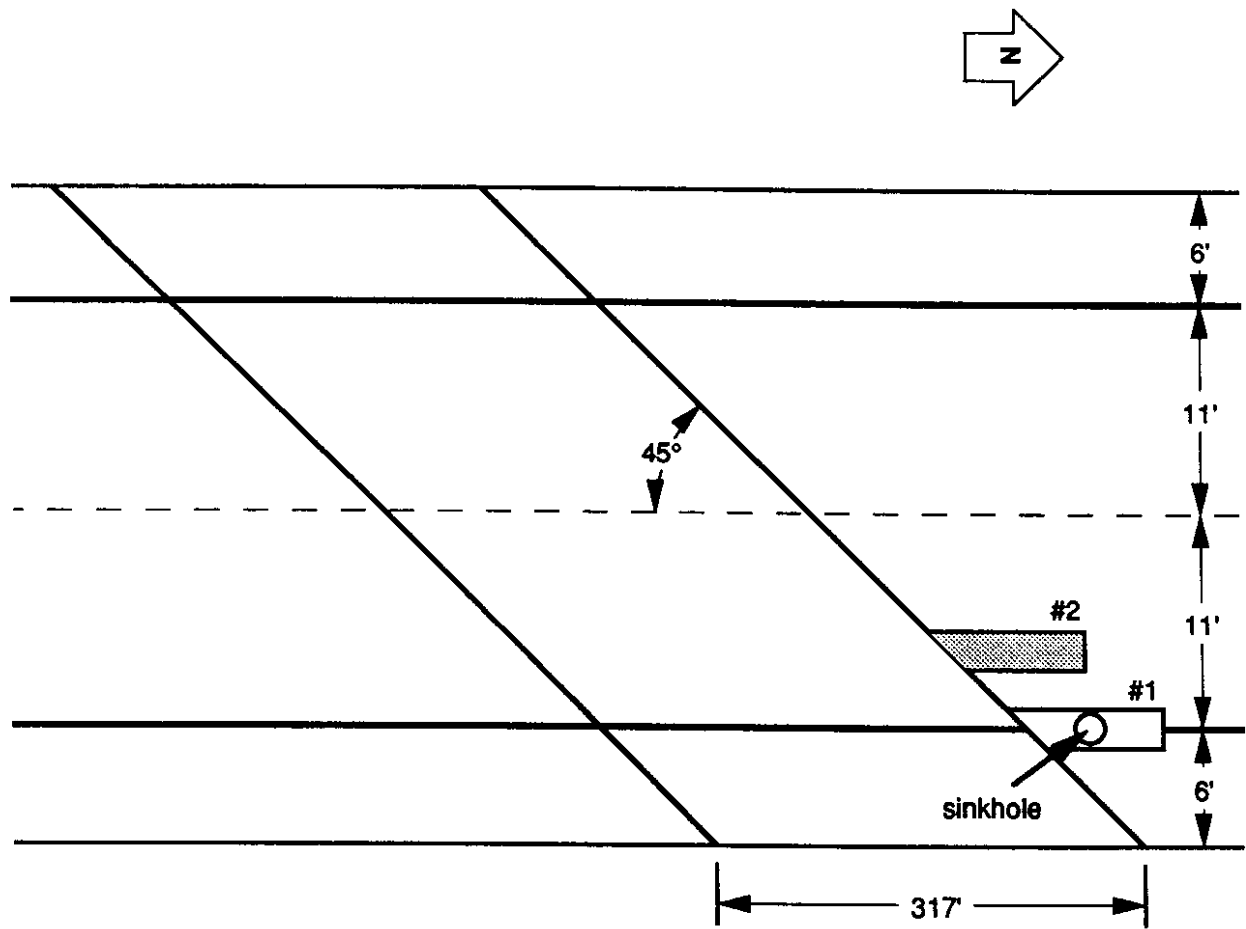
Two test sections were removed in the northbound lane one in the wheel path and the other closer to the shoulder as shown in Figure 73. The first test section was centered on the painted shoulder line, where a sinkhole was forming in the surface pavement. The second test section was excavated to observe the underlying soil profile and obtain samples.

Figure 73. Location of Test Section in Southbound Lane of the Johnson Road Undercrossing

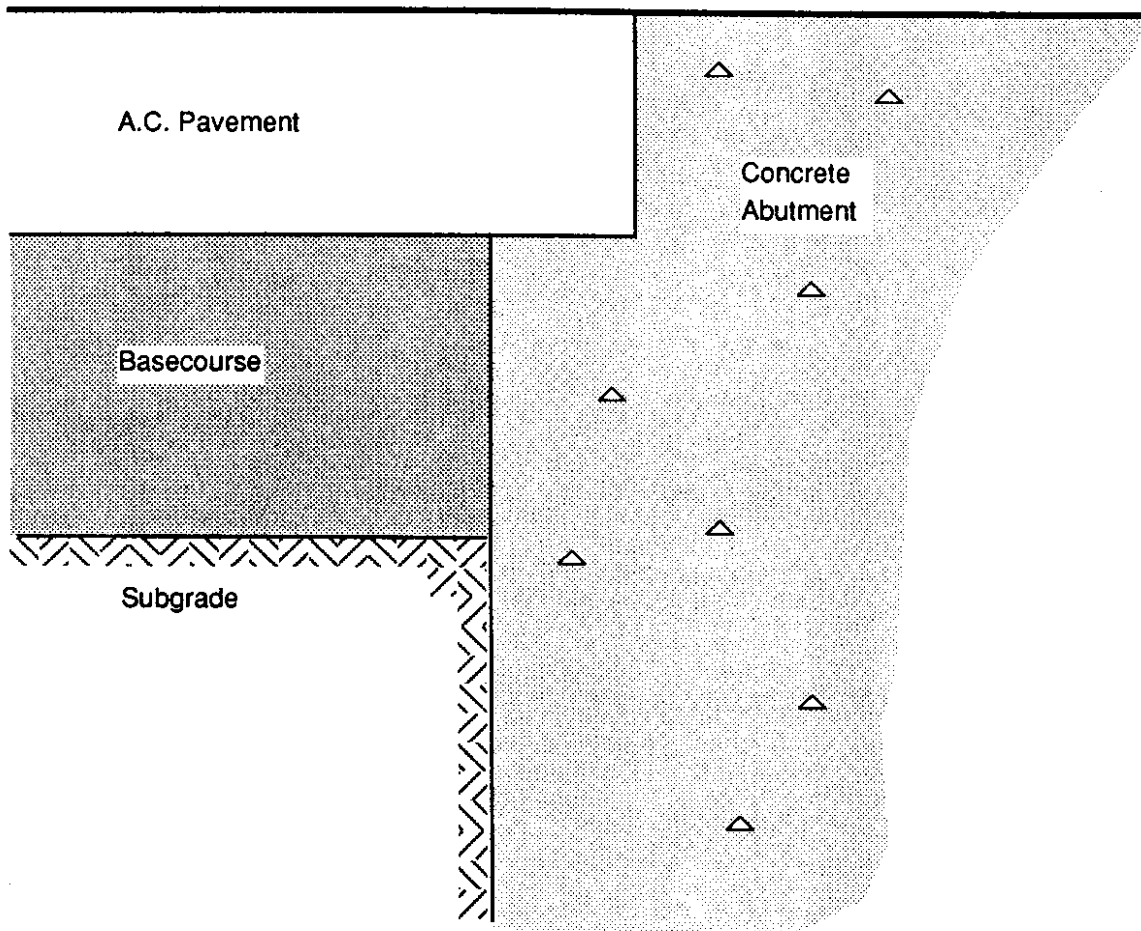
Figure 76. Schematic Illustration of Suitable Abutment Profile

6. For bridges at which approach slabs are determined to be unnecessary, the following steps should be taken:
 - a. The abutment detail should be reviewed to ensure that no overhanging ledges are present to produce zones in which compaction will be impeded. An abutment detail similar to that shown in Figure 76 should be specified.
 - b. The abutment backfill should be constructed of select granular fill material that meets the standard WSDOT specification for good quality granular material. The use of controlled density fills for abutment backfill should be investigated.
 - c. The abutment backfill should be compacted to at least 95 percent relative compaction.
 - d. Continuous inspection of the placement and compaction of abutment backfill should be provided.
