PERFORMANCE OF GEOTEXTILE SEPARATORS IN WESTERN WASHINGTON

WA-RD 321.1

Final Technical Report
May 1994

Final Technical Report
Research Project T9233, Task 13
Geotextile Separator Performance—II

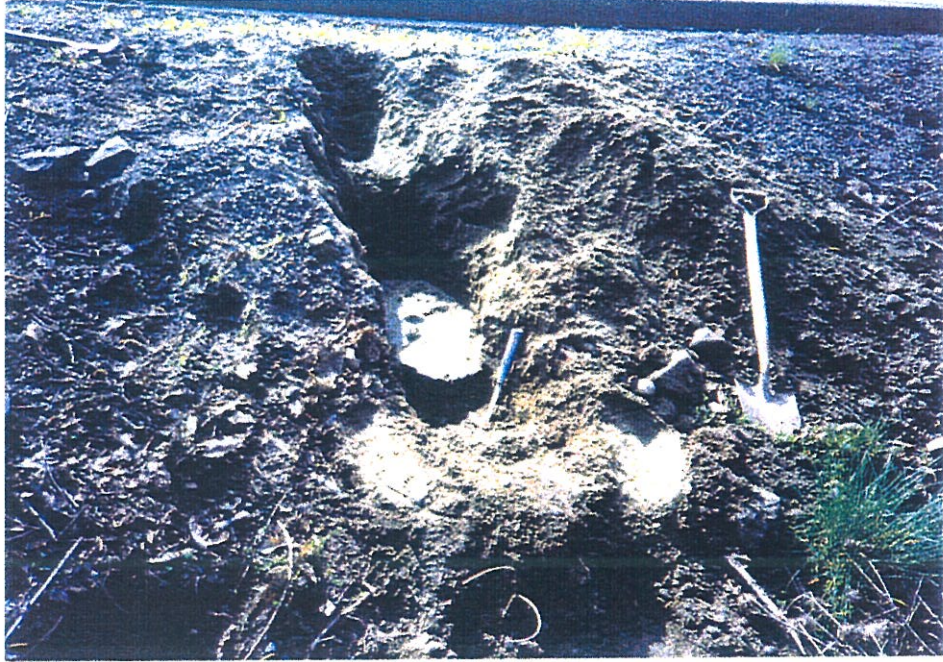
The geotextile shown in Figure 4.3 was installed as part of the SR-16 Tremont Interchange construction (Contract no. C-3025) in 1986. It can be seen that the fill above and below the geotextile consists of the same gravel and sand material. This fabric was installed in the middle of the embankment. The geotextile shown in Figure 4.4 was used under Parpalla Road which was constructed as part of the SR-101 Naselle River Bridge construction (contract no. C-2641) in 1985. The material under the geotextile is the same crushed gravel and cobble sized material (ledge rock) which was on top of the geotextile. The photograph in Figure 4.5 shows the geotextile separator being placed in the middle of

Figure 4.3 - Exposed geotextile separator at Tremont Interchange, SR-16.

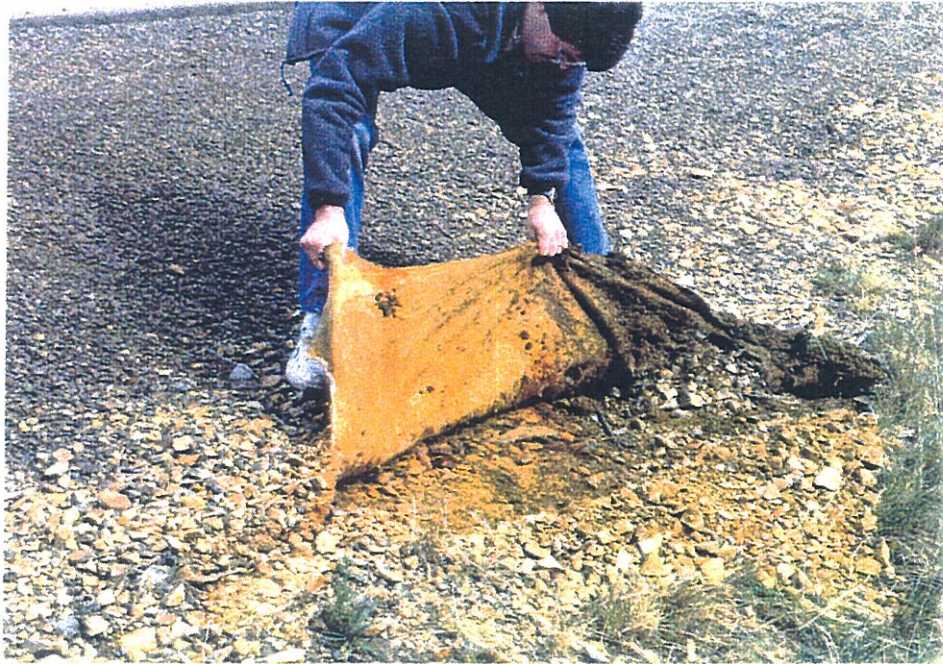
Figure 4.4 - Exposed subgrade under fabric on Parpalla Road.

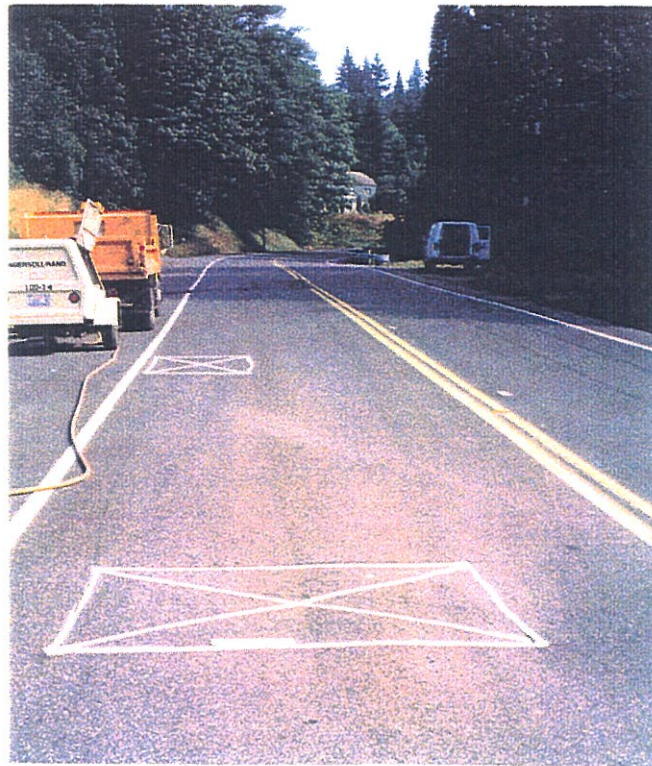
were repaired, there was one smaller area, approximately 1.2 by 1.5 m, with fatigue cracks and a small amount of rutting. This area was selected as the new location for the distressed pavement site investigation (1a). Figure 5.2 shows the locations of the two excavations with testpit 1a in the foreground, and testpit 1, 9 m to the north and adjacent to the west side of the south bound lane. Note one of the two earlier repaired sections in the background. The roadway was to receive an additional 50 mm of asphalt concrete pavement (ACP) in the summer of 1992. The two testpits were marked on June 2, 1992, for future sawcutting and excavation.

Figure 5.2 - Testpit layout; testpit 1a is in the foreground.

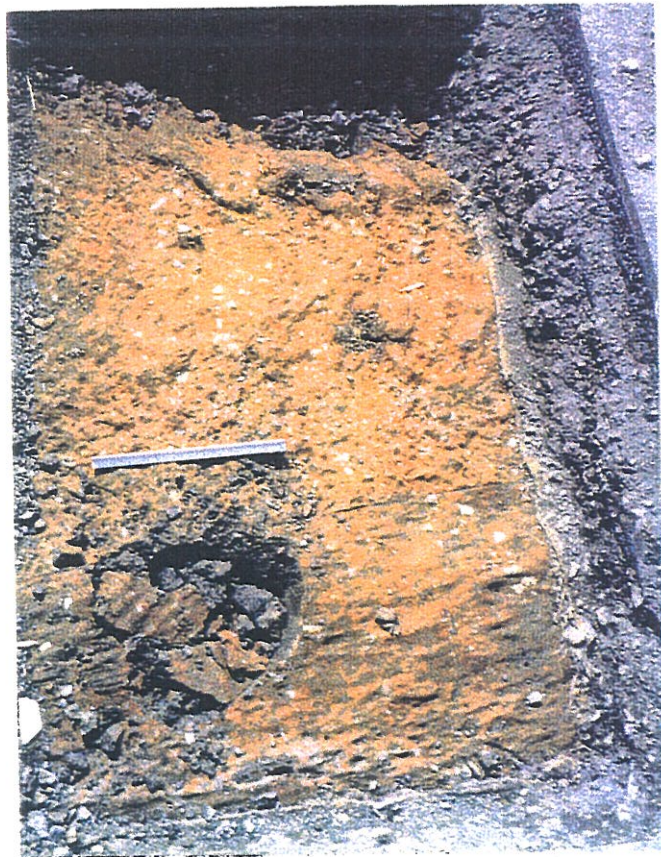
When the geotextile was cut and folded back, Figure 5.5, the subgrade was exposed and consisted of a reddish-brown, heavily iron stained, lean to fat clay, with some gravels at the surface which probably came from the placement of the base course, Figure 5.6. Note in Figure 5.6 the change in the subgrade indentations just below the scale where

the overlap existed. The gravel indentations in the subgrade above the scale are more numerous and much more pronounced, and should be expected since there is only one layer of geotextile in this area. Upon closer observation when the underlying thicker geotextile was removed, there was a large number of very small, approximately 2 to 3 mm in diameter, holes in the overlapping geotextile which was in contact with the base course. Surprisingly, fewer holes were found in the fabric where it was only one layer thick and where there were deeper indentations in the subgrade. Figure 5.7 shows a photograph of the bottom surface of the exhumed geotextile placed on a light table, with the section in contact with the subgrade on the right side and the overlap on the left side. Note the sharp color contrast due to the iron staining and the fewer holes on the right side. Figure 5.8 shows a magnified (~2X) photograph of some of the holes in the overlapping geotextile. Note the very rounded appearance of the holes. Figure 5.9 is a close-up (magnified ~2X) of the bottom surface of the geotextile showing the iron staining and gravel indentations. The geotextile appeared to be moderately clogged with the fine-grained subgrade soils.

Figure 5.6 - Subgrade surface after subgrade samples had been taken, testpit 1a.

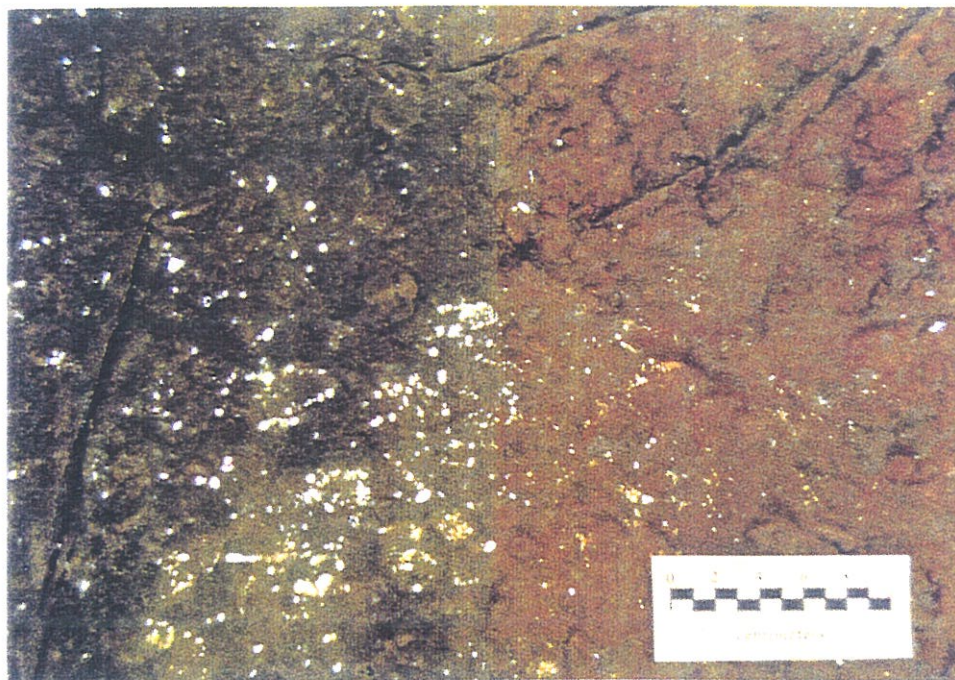
Figure 5.7 - Laboratory photograph on a light table showing the contrast in color, and numerous holes on the left side of the overlap contact, testpit 1a.

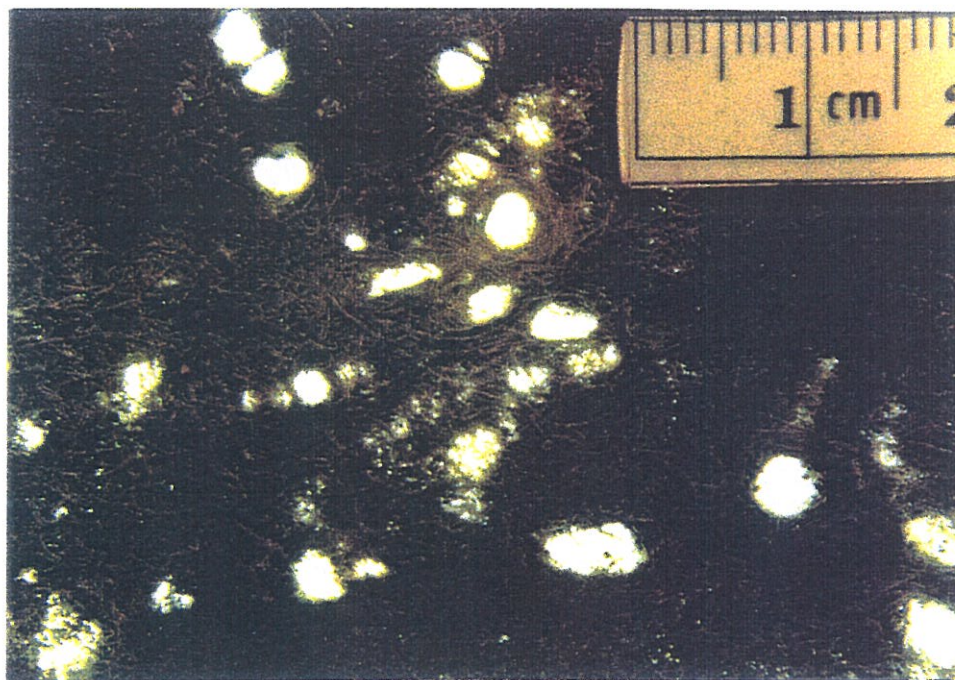
Figure 5.8 - Magnified (~2X) laboratory photograph of the small holes in the overlap.

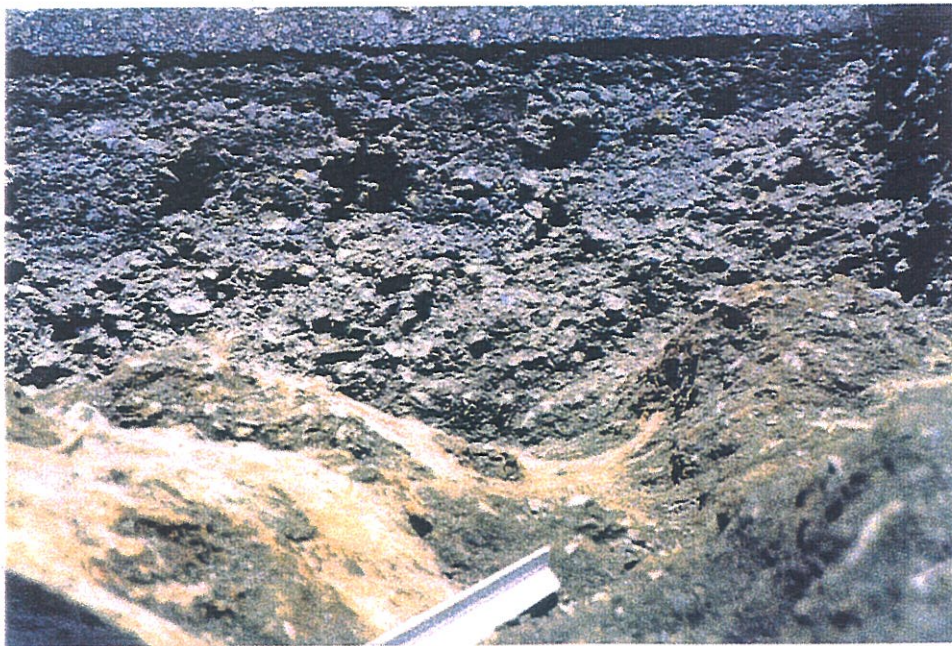
Figure 5.13 - Shows up to 130 mm of rutting which occurred during construction.

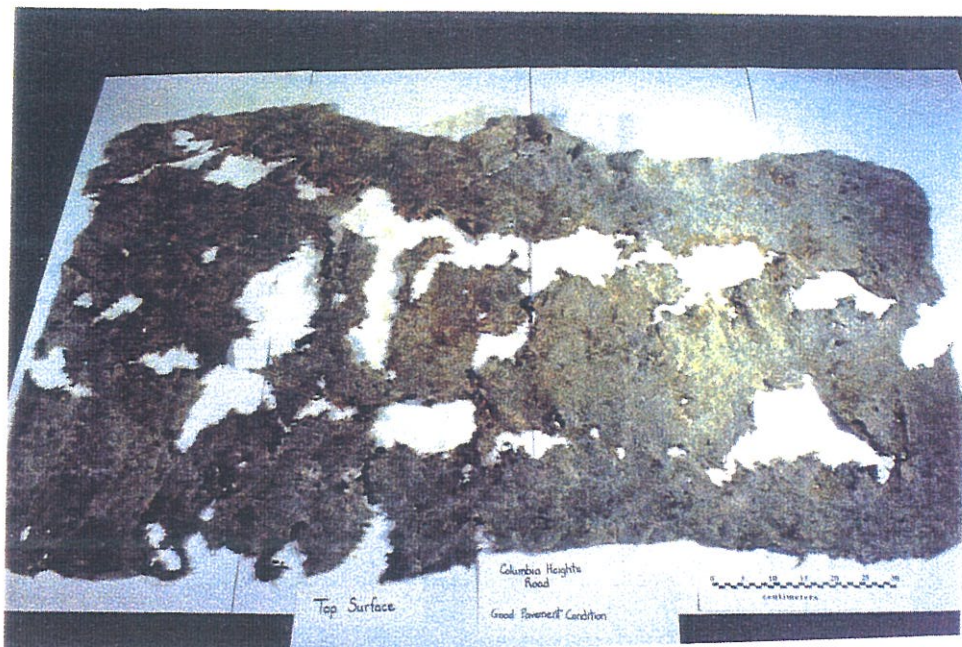
Figure 5.14 - Laboratory photograph of the exhumed geotextile separator, testpit 1.

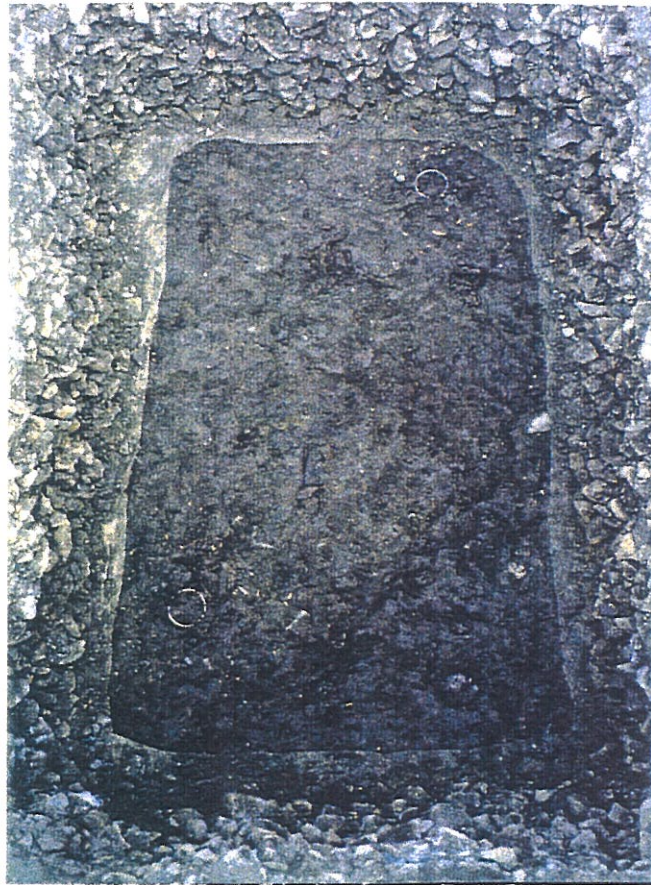
area was the site of an old timber holding area for a local lumber mill. Figure 5.21 shows the exposed subgrade conditions with the two Shelby tubes driven in and ready to be retrieved.

Figure 5.21 - Exposed subgrade with driven Shelby tube samples.

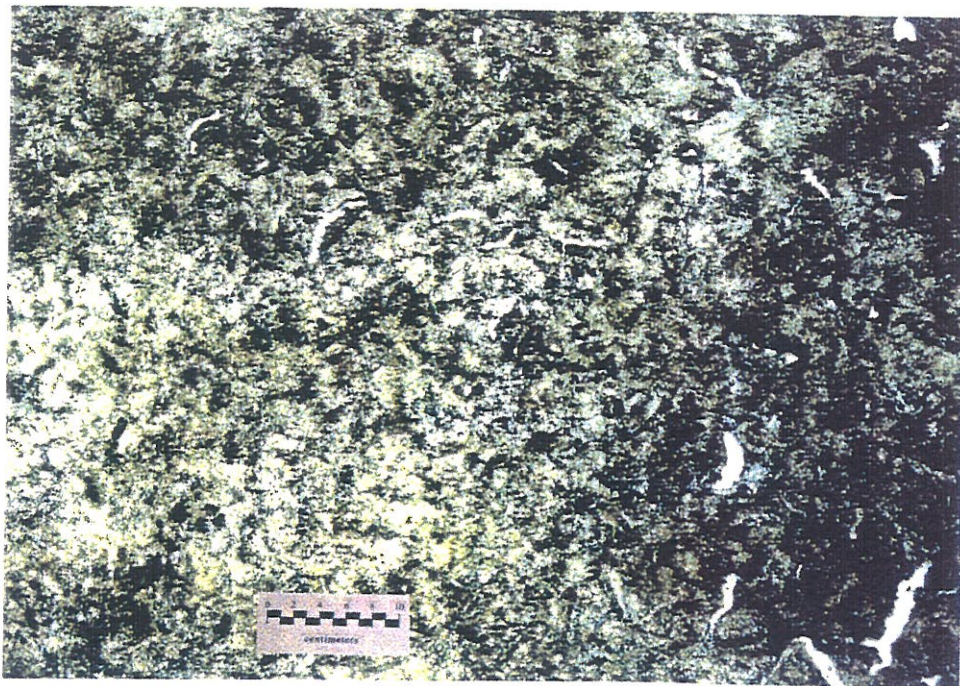
The exhumed geotextile had tears in it up to 75 to 100 mm long. Figure 5.22 shows a laboratory photograph of the bottom surface of the geotextile with a small iron stained spot (bottom middle). Figure 5.23 shows a photograph of the geotextile over a light table in the laboratory. The heaviest damage was generally on the north side of the exhumed geotextile. The geotextile appeared to be minor to moderately clogged with silt and fine wood particles. The geotextile was typically moderately damaged, although it was severely damaged in local areas.

Figure 5.23 - Photograph of the geotextile over a light table.

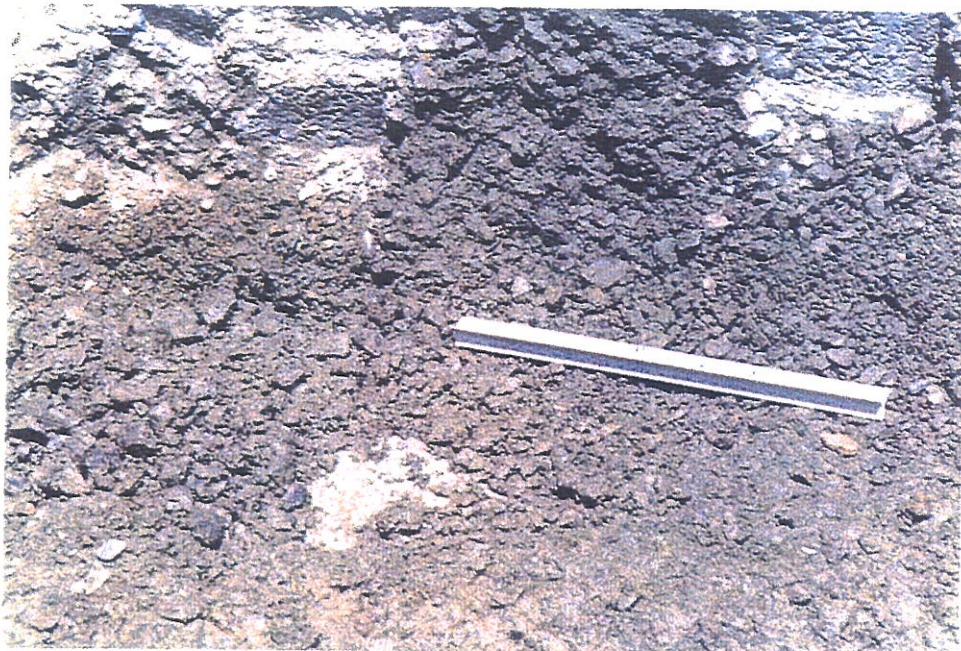
Figure 5.26 - Wet base course immediately above the geotextile.

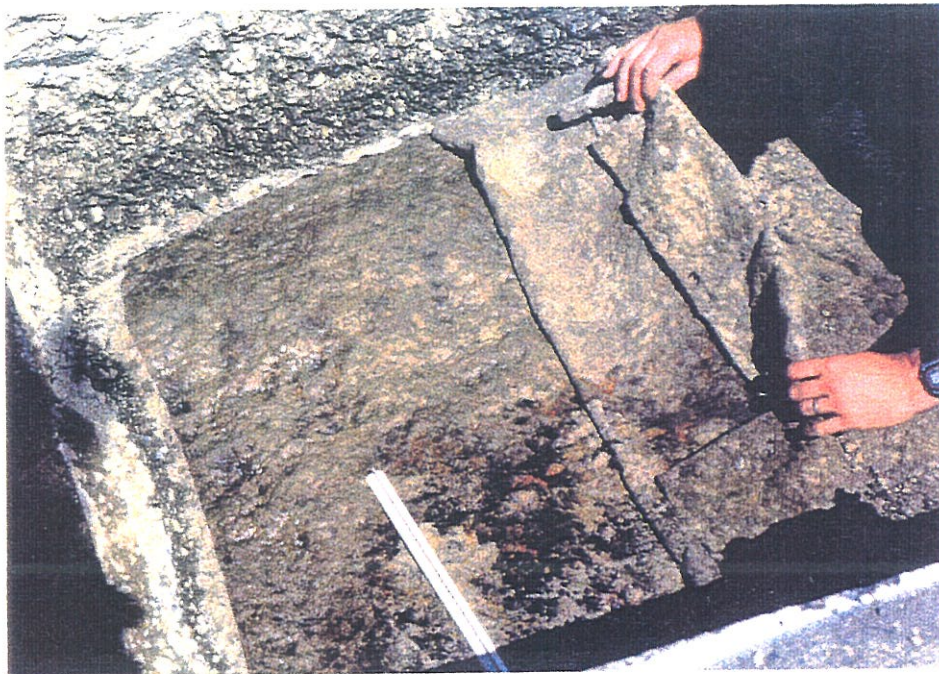
Figure 5.28 - Geotextile pulled back to expose the subgrade surface.

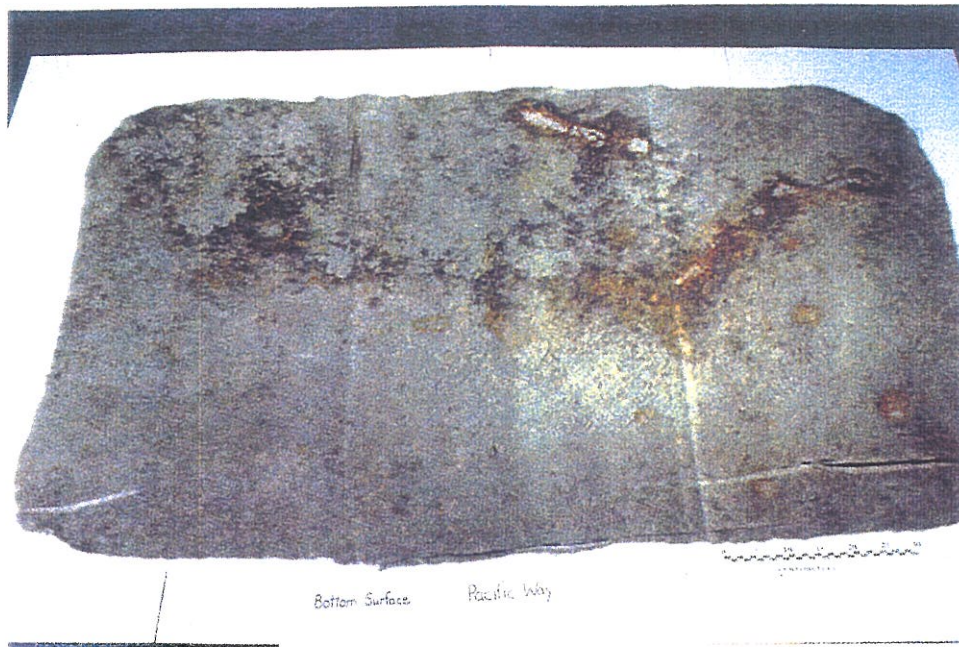
Figure 5.30 - Laboratory photograph of the bottom surface of the exhumed geotextile.

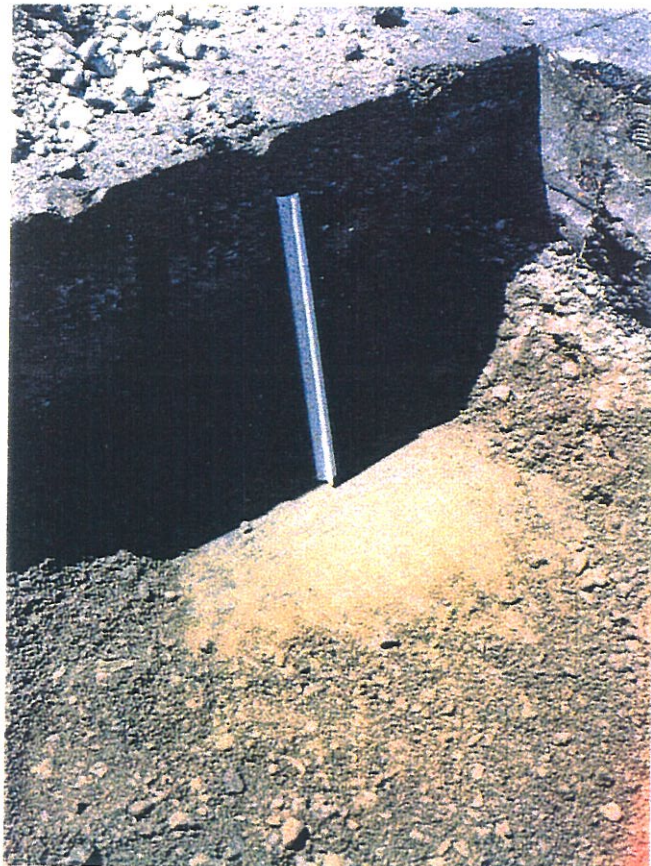
The testpit was excavated on June 23, 1992. The pavement was in good condition with no signs of distress. The geotextile was located about 40 to 43 cm below the pavement surface. As shown in Figures 5.32 and 5.33 the ACP was approximately 250 mm thick, with 150 to 180 mm of CSBC immediately over the geotextile. The upper surface of the geotextile was heavily caked with silt particles which may have settled down during the construction operation or may be due to subgrade fine migration. Figure 5.34 shows a representative photograph (~2X magnification) of the caked upper surface of the geotextile. There were many small abrasions on individual tapes and several small punctures in the geotextile due to the base course penetrating down into the subgrade. Figure 5.35 shows a magnified (~2X) photograph of a typical puncture viewed from the bottom surface. There appeared to be minor to moderate damage to the geotextile. Upon removal of the geotextile the exposed subgrade was found to be imported pitrun rock consisting of subrounded sands, gravels, and some silt. The very upper surface of the

subgrade had a thin, 0.5 to 1 mm, silt layer which had the geotextile weave imprinted on it. The bottom of the geotextile showed evidence of minor blinding.

Figure 5.33 - Photograph showing exposed geotextile and pavement/base course section.

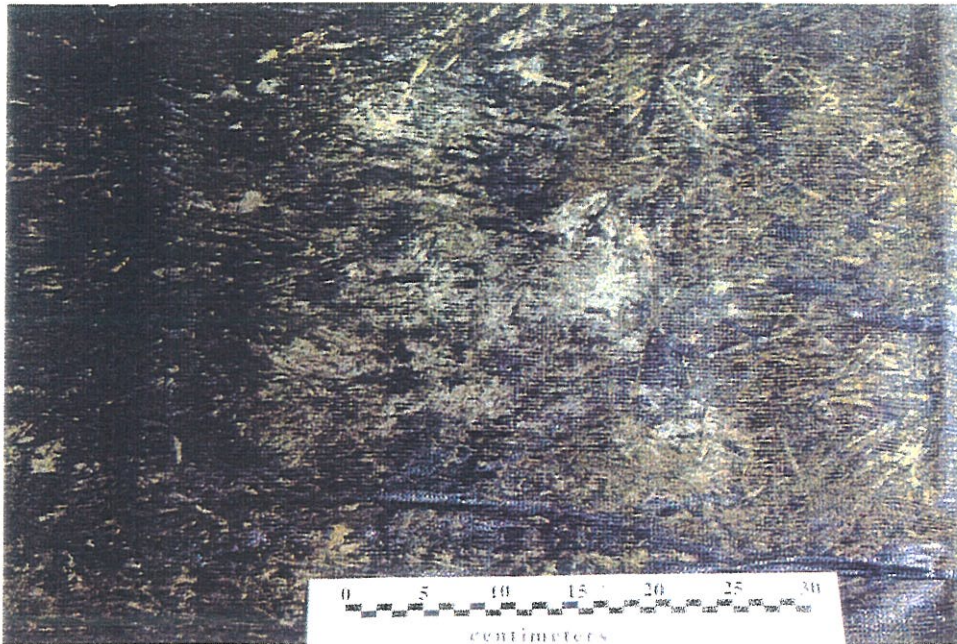
silty subgrade was in direct contact with the geotextile. When the geotextile was removed some of the vegetation remained adhered to the bottom surface. Figure 5.38 shows a photograph of the bottom surface of the geotextile. Figure 5.39 shows a close-up (~2X magnification) over a light table of the organic blinding caused by the vegetation, while Figure 5.40 shows a close-up (~2X magnification) of a typical area blinded with organics and silt particles. Note the iron-oxide deposits forming between the weaves in Figure 5.40. The iron-oxide deposits may be clogging the pore openings of the fabric.

Figure 5.38 - Laboratory photograph of the organics on the bottom surface of the geotextile.

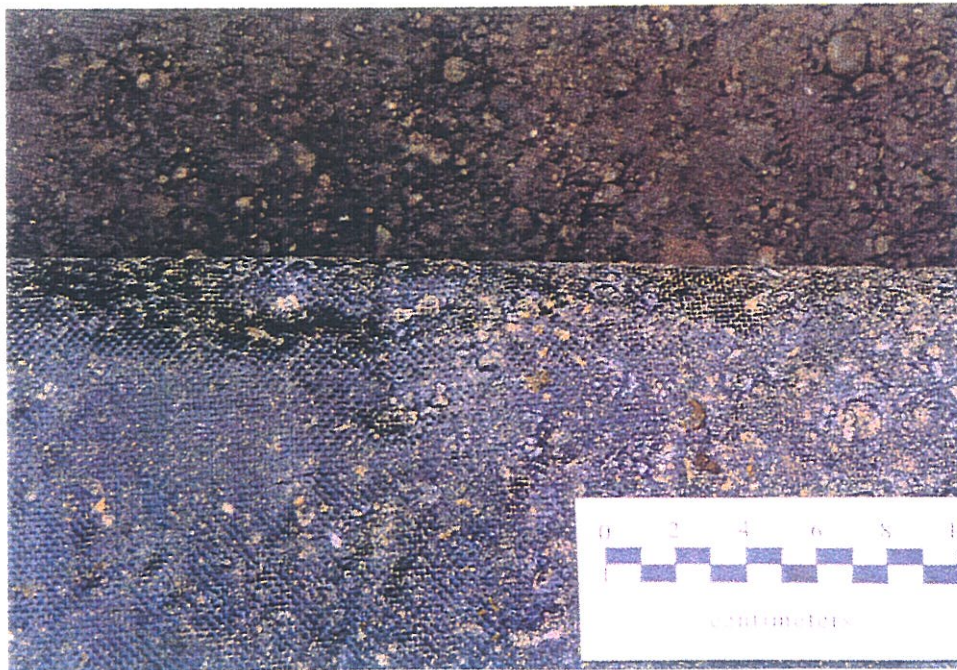
The upper surface of the geotextile, Figure 5.45, was in relatively good condition with only a few small holes but it had numerous indentations. Figure 5.46 shows the geotextile folded back to expose the subgrade which consisted of a moist, dark brown, subrounded gravel with silt and sand. The gravel in the subgrade appeared to be very similar to the base material, may have been placed on the softer subgrade material during construction to provide better working conditions. Although there was a high content of coarse material in the subgrade, the geotextile weave was still imprinted on the surface of the subgrade soils. Figure 5.47 is a photograph of the bottom surface of the geotextile showing minimal blinding and revealing that most of the indentations penetrate upwards from the subgrade into the backfill material. Figure 5.48 shows typical water stain patterns on the bottom surface of the geotextile. Figure 5.49 is a magnified (~2X) photograph showing typical blinding on the bottom surface of the geotextile. Overall, the geotextile appeared to show minimal damage.

Figure 5.46 - Geotextile folded back to expose the subgrade material.

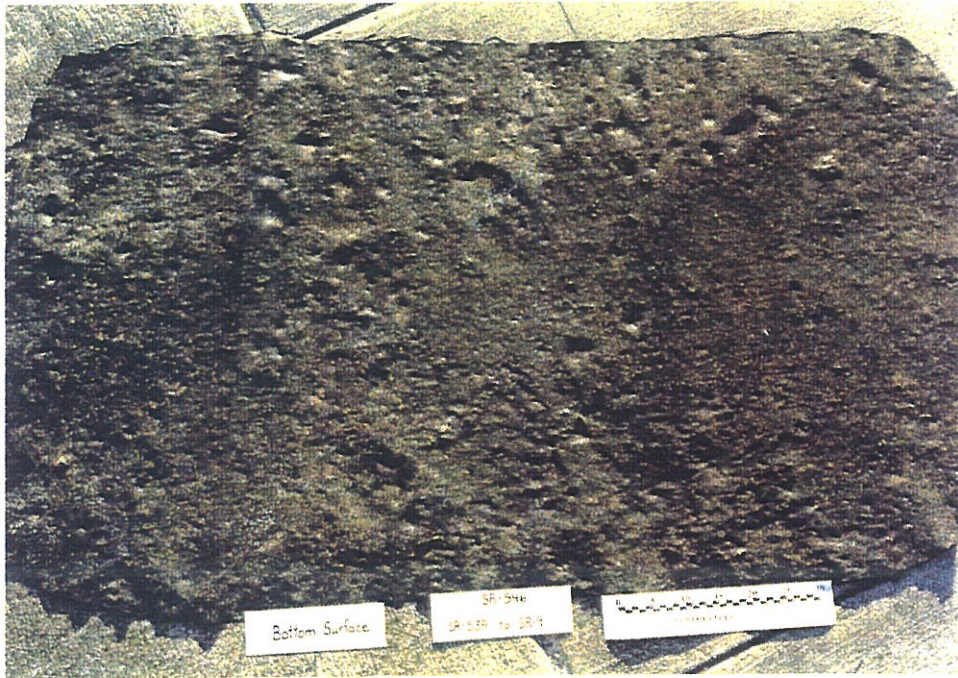
Figure 5.47 - Laboratory photograph of the bottom surface of the geotextile.

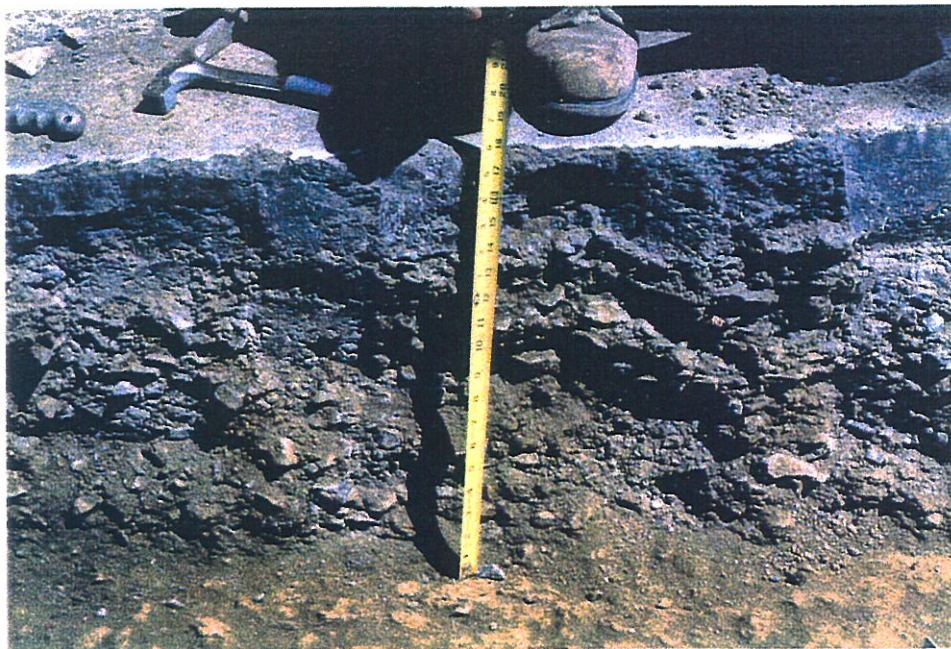
As shown in Figure 5.51, the geotextile blended in with the subgrade very well and was difficult to see. Figure 5.52 shows numerous angular holes, typically 6 to 25 mm long, in the geotextile with rocks in the subgrade protruding up through them. The geotextile was then folded back to expose the subgrade (Fig. 5.53). The subgrade generally consisted of the same material as the base course, except that the subgrade appeared to have more fines (silts and clays). Figure 5.54 shows the entire subgrade surface with the geotextile removed. Figure 5.55 shows the condition of the bottom surface of the geotextile immediately after it was removed from the testpit. Note the dark brown areas which consisted of silt and clay, and the white areas which were almost like new. Figure 5.56 is a photograph of the severely damaged geotextile and the multitude of angular holes. There were many areas on the geotextile which appeared to be moderately to heavily clogged. The clean looking fabric appeared to be located in areas where the geotextile bridged across coarse gravel in the subgrade.

Figure 5.51 - Pavement section overlying the geotextile.

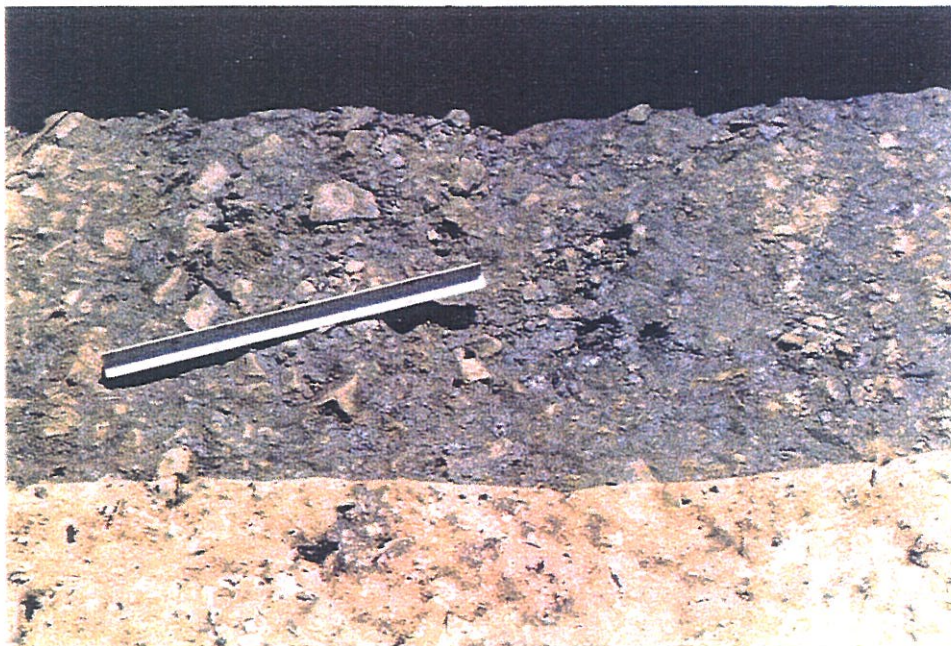
Figure 5.52 - Close-up of the geotextile showing gravels in the subgrade penetrating up through the fabric.

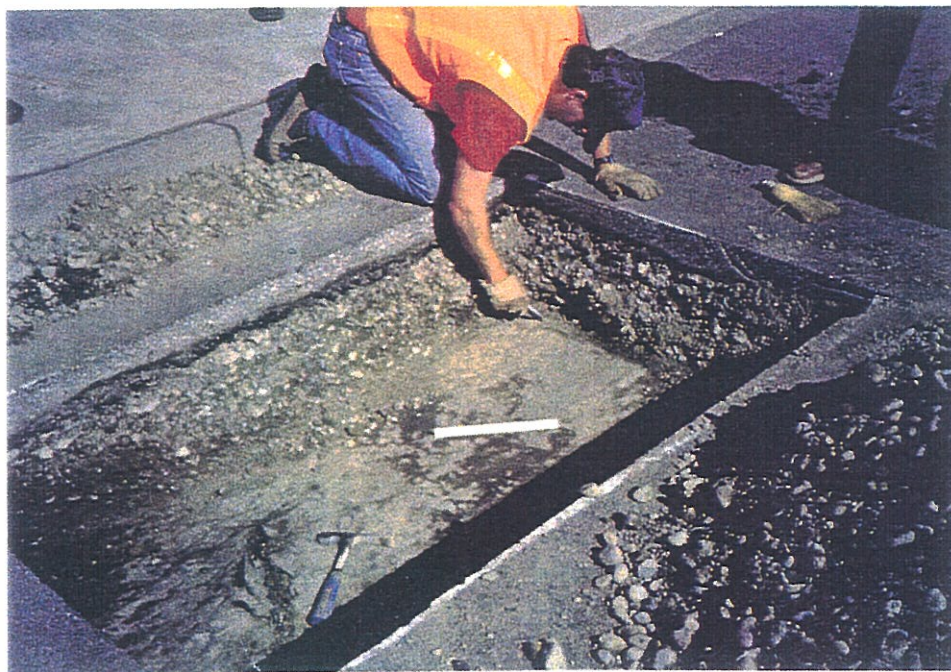
Figure 5.65 - Geotextile being cut prior to being removed.

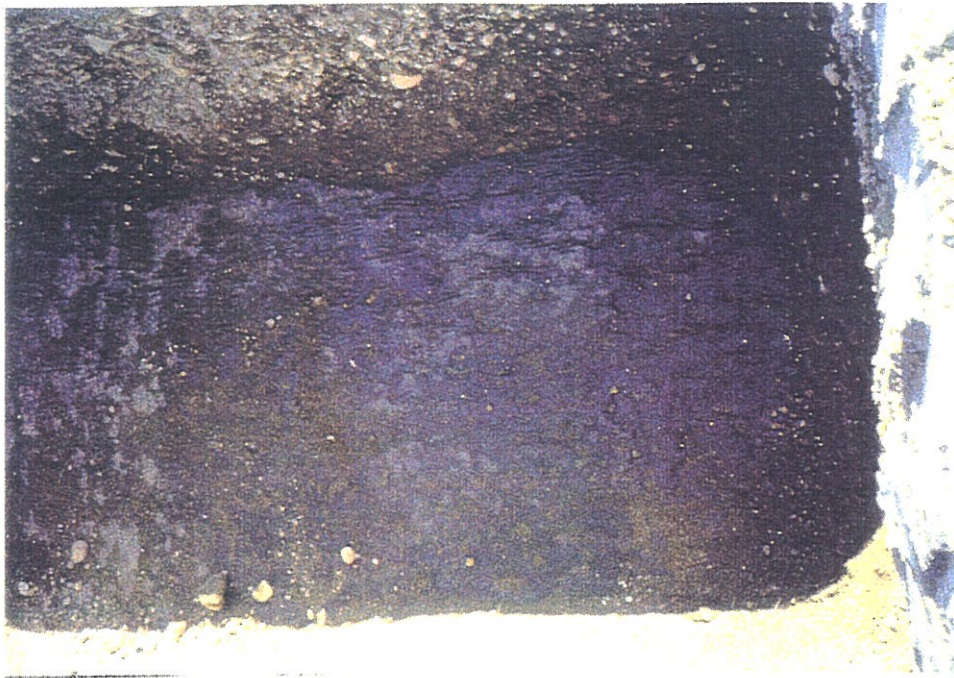
Figure 5.74 shows the condition of the top surface of the geotextile after the base material was removed. The geotextile was in very good condition with no holes or other

damage. The upper surface did have fines caked on it which may have come from the overlying base material or they may be subgrade fines. Figure 5.75 shows the geotextile folded back and the subgrade surface exposed. The weave of the geotextile was imprinted over the entire surface of the subgrade which was composed of a moist, brown, lean clay. Figure 5.76 is a photograph of the bottom surface of the geotextile immediately after being removed and Figure 5.77 is a laboratory photograph (~2X magnification) over a light table showing minor blinding which was typical throughout the bottom surface of the geotextile.

Figure 5.74 - Upper surface of the exposed geotextile separator.

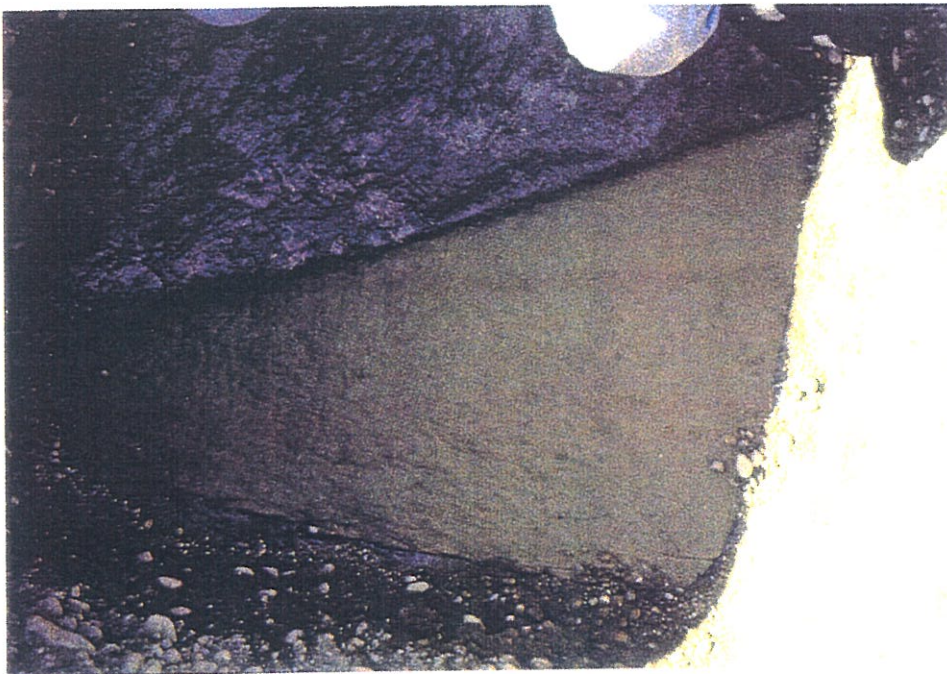
Figure 5.75 - Geotextile folded back exposing the subgrade surface.

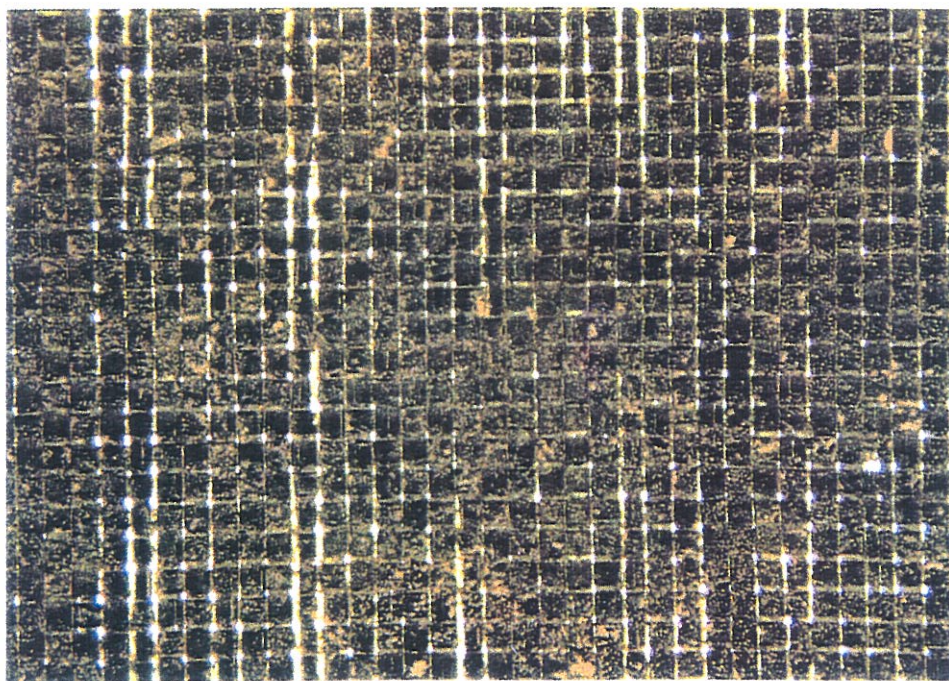
Figure 5.77 - Laboratory photograph showing typical blinding on the bottom surface of the geotextile (~2X magnification).

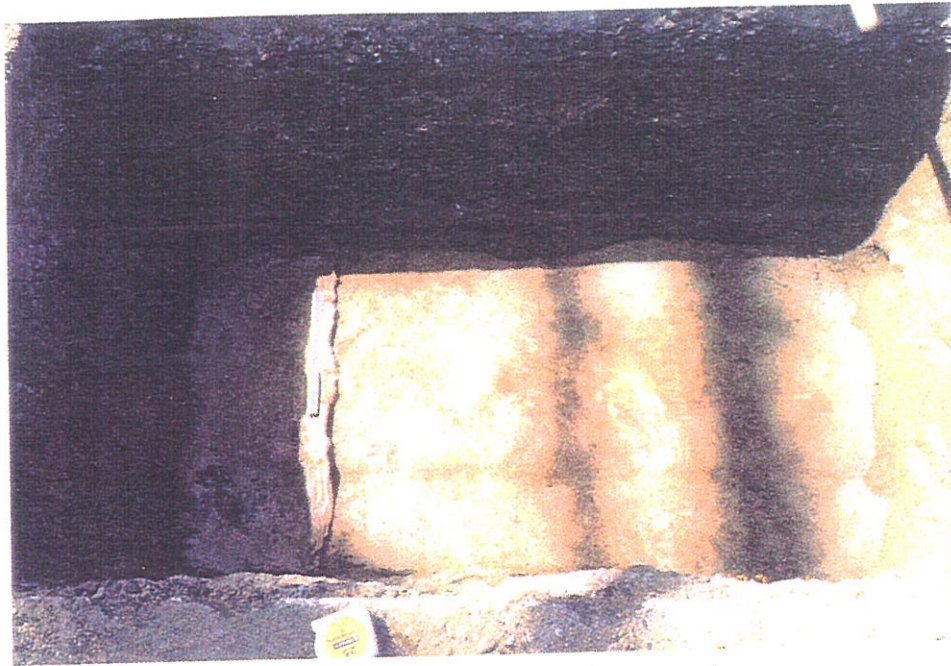
Figure 5.82 shows the completely exposed geotextile and a 36 cm overlap on the east side of the excavation. The bottom surface of the exhumed geotextile is shown in Figure 5.83. Figure 5.84 shows the geotextile folded back to expose the surface of the subgrade. The surface of the geotextile was very irregular with up to 50 mm of grade change across subgrade surface. An apparent rut, due to pumping of the subgrade during

Figure 5.82 - Top surface of the exposed geotextile, showing the overlap on the east side.

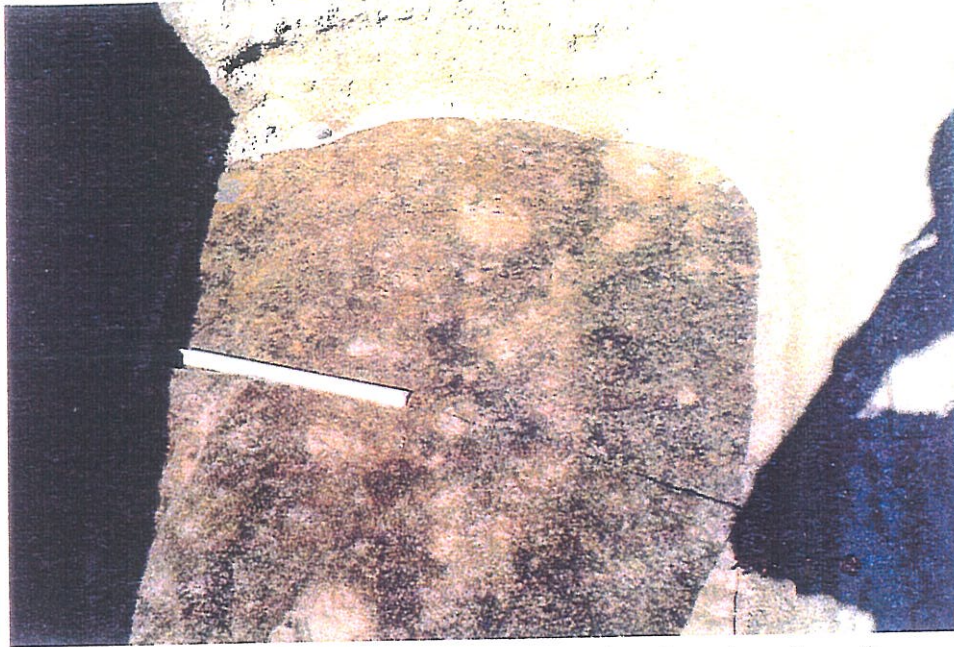
Figure 5.84 - Geotextile folded back exposing the subgrade surface.

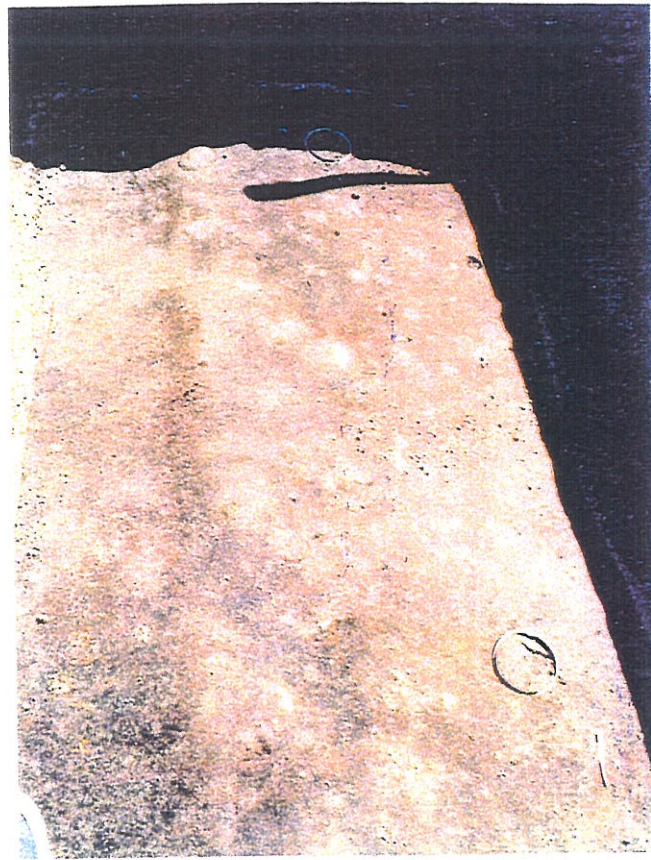
construction, was found on the north side (left side of Fig. 5.85) of the excavation and accounts for most of the irregular surface. The subgrade soils consisted of moist, brown, sandy lean clay, with occasional gravels and cobbles. There were a few indentations in the geotextile due to the underlying gravels and cobbles. Figure 5.85 also shows the locations of the Shelby tube samples.

Figure 5.85 - Subgrade surface with the rut shown on the left side.

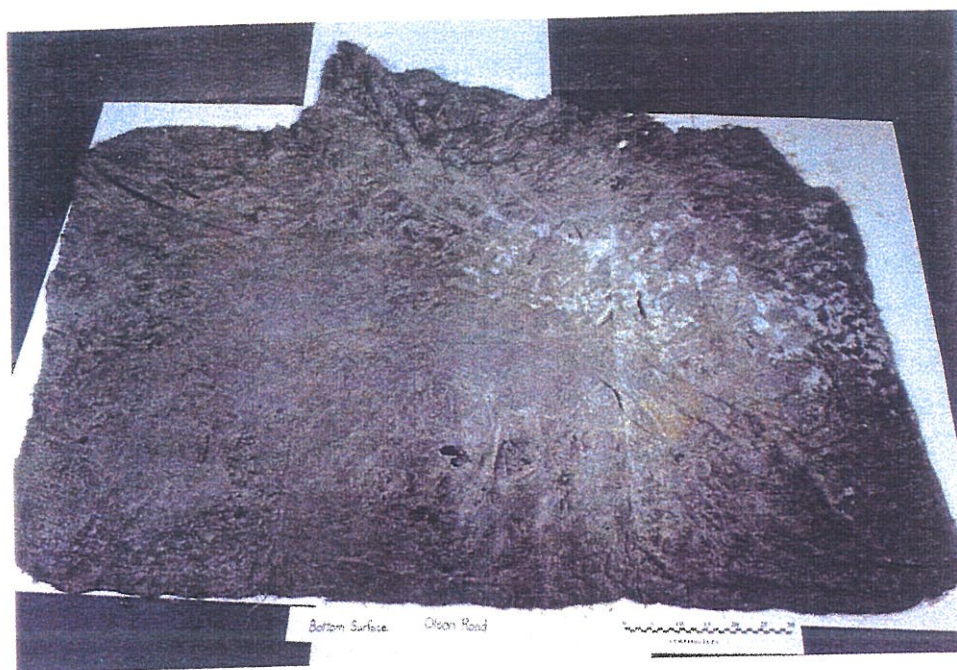
The bottom surface of the exhumed geotextile is shown in Figure 5.95. There were some areas of iron staining and other white areas which were like new and were probably sections which bridged across the large underlying rock. Figure 5.96 shows a photograph of the bottom surface of the geotextile illuminated from behind by a light table. It is interesting to note the abundance of holes towards the bottom and to the left of the photograph, which were the areas overlying the large angular rocks on the south and east sides of the testpit. The top and right side have relatively few holes and were the areas overlying the fine-grained soils which had relatively few large rocks. The geotextile was in fair to good condition over the fine-grained soil while it was in poor condition over the angular rock. The geotextile appeared to be moderately clogged with fine-grained soil particles.

Figure 5.95 - Laboratory photograph of the bottom surface of the geotextile.

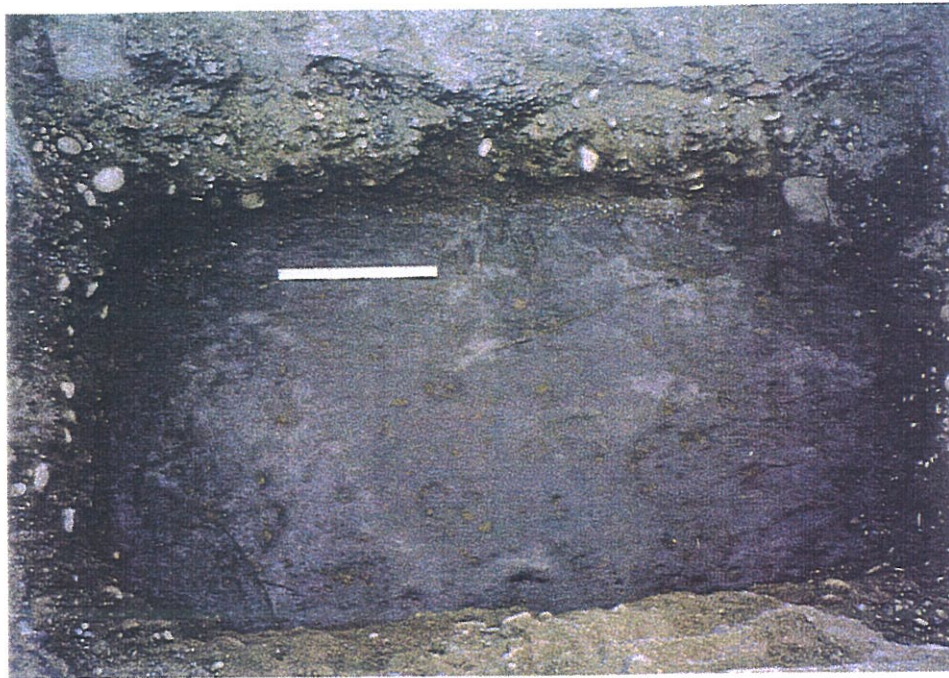
Figure 5.101 - Exposed geotextile showing the indentations from the base material.

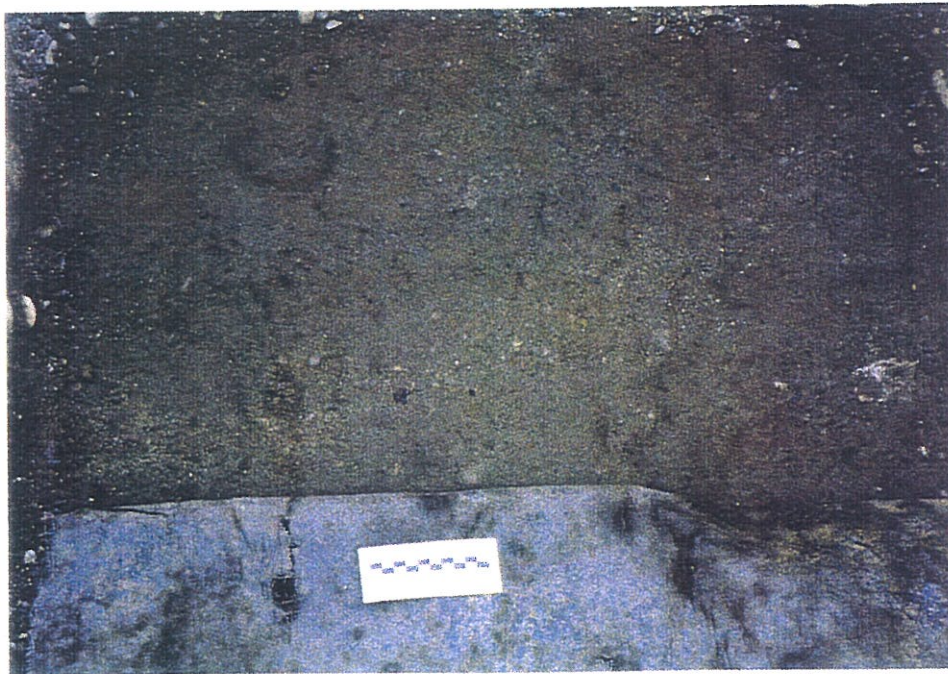
5.102 shows the geotextile folded back and the subgrade surface exposed. Also shown is moderate to heavy iron staining on the geotextile and subgrade.

Figure 5.102 - Geotextile folded back exposing the subgrade surface.

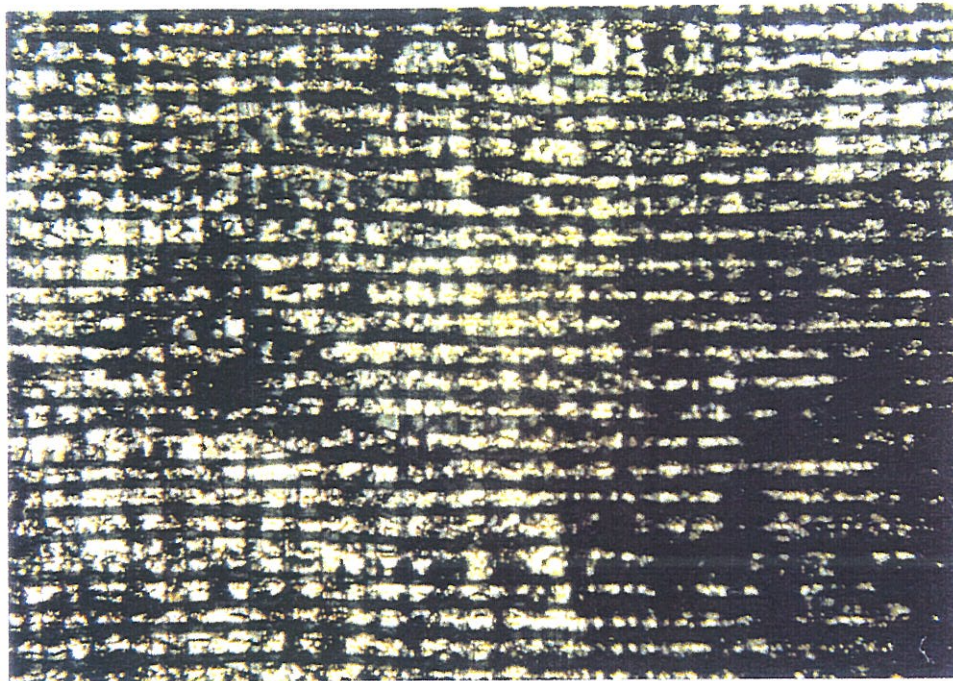
The surface of the subgrade, 0 to 10 mm below the geotextile, was brown to rust colored and contained a few small gravels and some coarse sand. When taking subgrade samples the material just below the surface was much finer grained and grey in color, Figure 5.103. Figure 5.104 shows the bottom surface of the geotextile with the iron staining, and numerous indentations. The geotextile showed minor damage although it had several holes which were typically smaller than 6 mm. The bottom of the geotextile was minor to moderately blinded. Figure 5.105 shows a magnified (~2X) photograph of a typical blinded area, while Figure 5.106 shows a typical area with negligible blinding (magnified ~2X).

Figure 5.105 - Magnified (~2X) laboratory photograph of a typical blinded area.
