PERFORMANCE OF GEOTEXTILE SEPARATORS IN WESTERN WASHINGTON

WA-RD 321.1

Final Technical Report
May 1994

Final Technical Report
Research Project T9233, Task 13
Geotextile Separator Performance—II

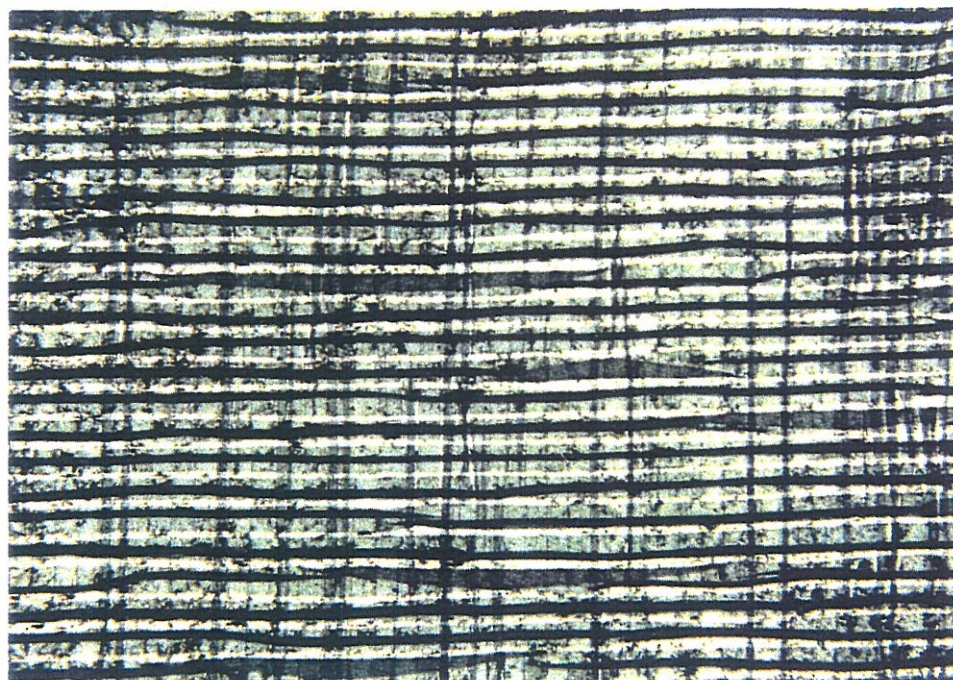
The surface of the subgrade, 0 to 10 mm below the geotextile, was brown to rust colored and contained a few small gravels and some coarse sand. When taking subgrade samples the material just below the surface was much finer grained and grey in color, Figure 5.103. Figure 5.104 shows the bottom surface of the geotextile with the iron staining, and numerous indentations. The geotextile showed minor damage although it had several holes which were typically smaller than 6 mm. The bottom of the geotextile was minor to moderately blinded. Figure 5.105 shows a magnified (~2X) photograph of a typical blinded area, while Figure 5.106 shows a typical area with negligible blinding (magnified ~2X).

Figure 5.106 - Magnified (~2X) laboratory photograph of a typical area with little blinding.

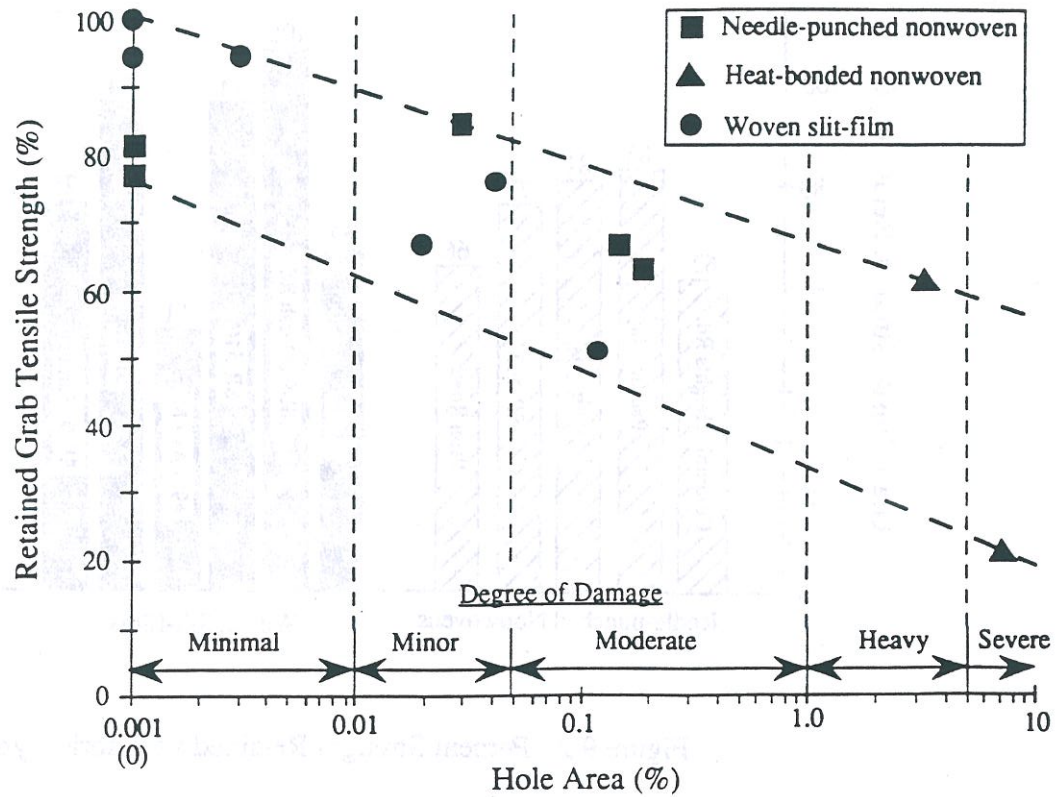
Figure 9.1 - Percent Retained Strength vs. Percent Hole Area.

The damage survey performed in Chapter 7 and summarized in Figure 9.1 shows the results of the retained grab tensile strength (Table 8.5) as a function of percent hole area (Table 7.1) for the 13 tested fabrics. The trends showed decreasing retained strength of the fabric with increasing damage, as should be expected. Since the data was plotted on a semi-log graph, the zero percent hole area was assigned to the 0.001 logarithmic value for presentation purposes.

The results shown in Figure 9.1 are similar to those found by Koerner and Koerner (1988 and 1990). They plotted their results as a function of the number of holes greater than 6 mm, rather than the percent hole area. Thus, a hole 30 mm in diameter would have the same credit as a hole 6 mm in size. It would seem to be more meaningful to plot the percent retained strength as a function of the percent hole area of each fabric. The holes included in the estimate should also be much smaller than 6 mm since in the case of woven fabrics, many slit tapes are approximately 1 mm wide, and therefore a 6 mm wide hole would include six slit tapes. The results shown in Figure 9.1 include holes down to approximately 1 mm in size. This appeared to be more meaningful, since a fabric can be heavily damaged with holes less than 6 mm in size. A good example is the fabric from Columbia Heights Road (testpit 1a), where the average sized hole was 2 to 3 mm; yet the fabric was heavily damaged in some areas.

It is interesting to note, that of the four fabrics which had no damage, the two woven fabrics had higher percent retained strengths as compared to the two needle-punched nonwoven geotextiles. Although the heat-bonded nonwovens had the highest percent hole areas, the fabric from the Coal Creek Road site had reasonable retained strength values which could be partially attributed to the fact that most of the holes in the fabric were quite large and the test specimens were not taken in those areas. The fabric from the Carroll Road site had numerous very uniform holes and the retained strength values are quite indicative of its present condition.

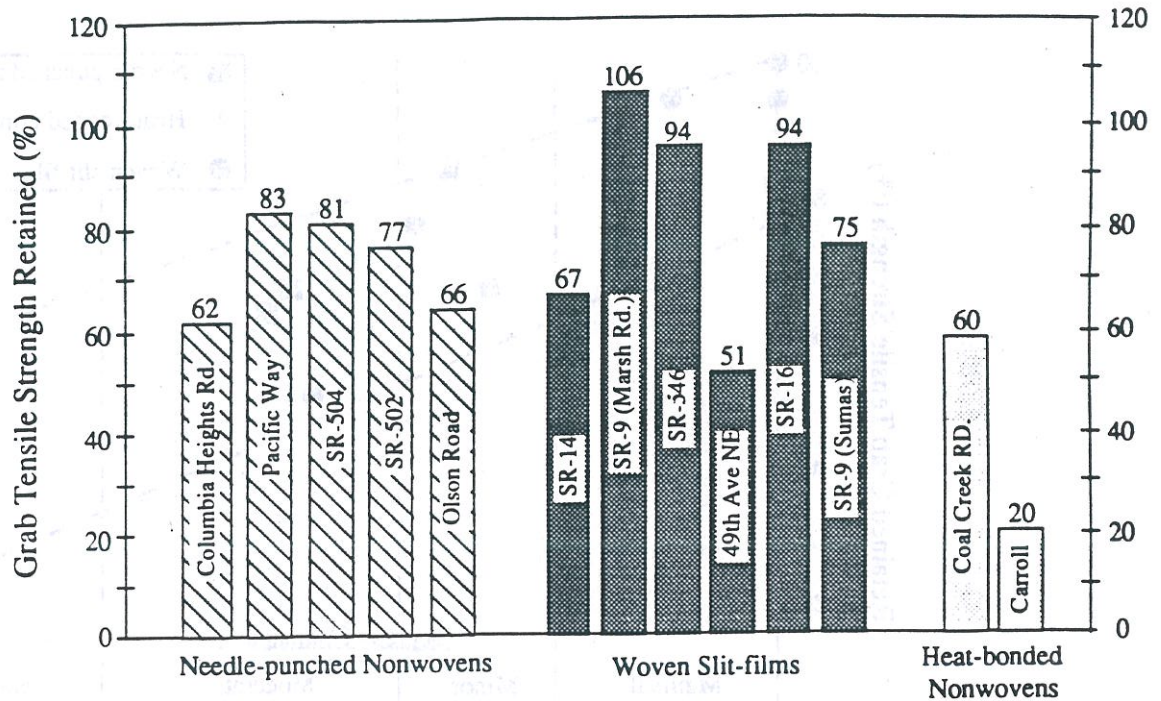
Figure 9.2 - Percent Strength Retained vs. Fabric Type.

The average percent retained strength for each fabric was also plotted as a function of the type of fabric, as shown in Figure 9.2. As can be seen in this figure, the retained strength values for the needle-punched nonwovens and the woven slit-films are somewhat similar, although the woven fabrics had the three highest retained strengths. Also shown are the two low retained strength values for the heat-bonded fabrics. The estimated survivability levels for each site at the time of installation (Table 9.2) must also be taken into account when assessing the short-term performances of the fabrics.

It is interesting to note that of the seven fabrics which had greater than 70 percent retained strengths, six of them were installed under rounded to subrounded base materials. The only exception was the fabric which was recovered from the Pacific Way site. Even the fabrics from SR-546, which had gravels in the subgrade, and SR-9 (Sumas), which had a thin initial lift, still retained a relatively high percentage of their strengths. However, all the sites which had an angular aggregate placed over the fabric also had the thinner initial lifts. In any event, this may indicate that the type of base aggregate is more important than the initial lift thickness, and therefore both must be designed for. Paulson (1990) reached similar conclusions.

One concern regarding the durability with respect to retained strength was when the two undamaged needle-punched nonwovens (SR-504 and SR-502), rather than the two undamaged woven slit-films, had significantly lower values (Figs. 9.1 and 9.2). The two needle-punched nonwovens were composed of polyester fibers, while the two woven fabrics had polypropylene slit tapes. The lower retained strength values for these two nonwoven polyester fabrics may be due to hydrolysis. The fabric from the SR-504 site was very wet when uncovered, although there was no standing water on the subgrade surface in the testpit. The fabric from the SR-502 site was moist, but not wet. The fabric from the SR-502 site did have significant iron staining on the bottom surface, while the fabric from the SR-504 site had negligible iron staining. On the other hand, as discussed in Section 9.2.2, the two woven slit-film polypropylene fabrics had significantly lower retained elongations at break which may indicate potential brittle behavior with time.

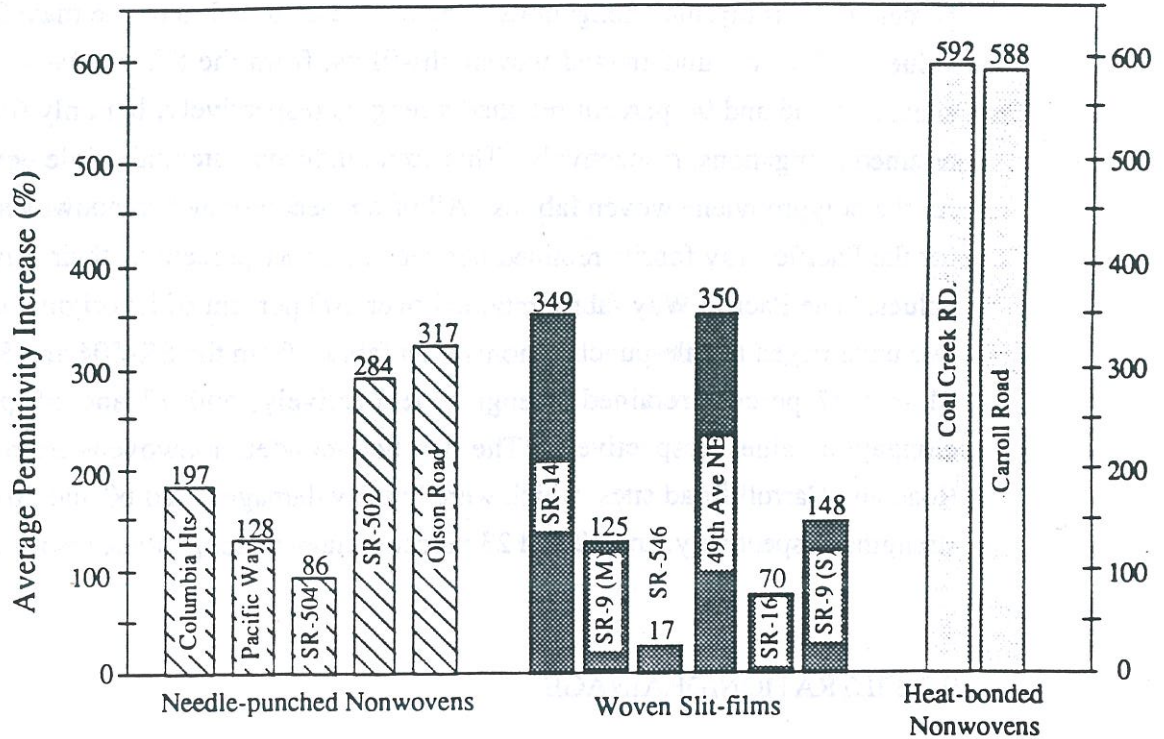
Figure 9.3 - Average Percent Permittivity Increase (after washing) vs. Fabric Type.

Permittivity tests were conducted in the laboratory to obtain information on the general blinding/clogging characteristics of the recovered geotextiles. The results of the permittivity tests are summarized in Figure 9.3. In this figure, the results are presented as percent permittivity increase after washing versus the type of geotextile. As can be seen, the needle-punched nonwovens and the woven slit-films had similar performances. The two needle-punched nonwovens with the greatest increases, from the SR-502 and Olson Road sites, were installed over lean clay and silty sand subgrades, respectively. The woven fabrics with the greatest washed permittivity increases had a significant amount of caking on the fabrics. Both of the heat-bonded nonwovens showed the highest increases in the washed permittivities. Even the heat-bonded fabric overlying the organic debris at the Coal Creek Road site had a high washed permittivity increase. This would indicate that the heat-bonded nonwovens were more susceptible to clogging than the other fabrics.

Although the woven slit-films and needle-punched nonwoven fabrics had similar average percent increases (Fig. 9.3), the wovens had lower increases because they were disturbed the most prior to testing. Observations indicated that the wovens were most susceptible to blinding. However during the course of handling, after they were exhumed and prior to testing, a great deal of the blinded particles (generally silt) fell off the fabric, especially after they lost even a small amount of moisture. Also, just removing the woven slit-films from the subgrade probably stripped most of the blinded particles away from the fabric. On the contrary, the needle-punched nonwovens were most susceptible to clogging and little material was lost while handling the fabric, because the soil particles were trapped within the fibers of the geotextile. Thus, the permittivity values for the needle-punched

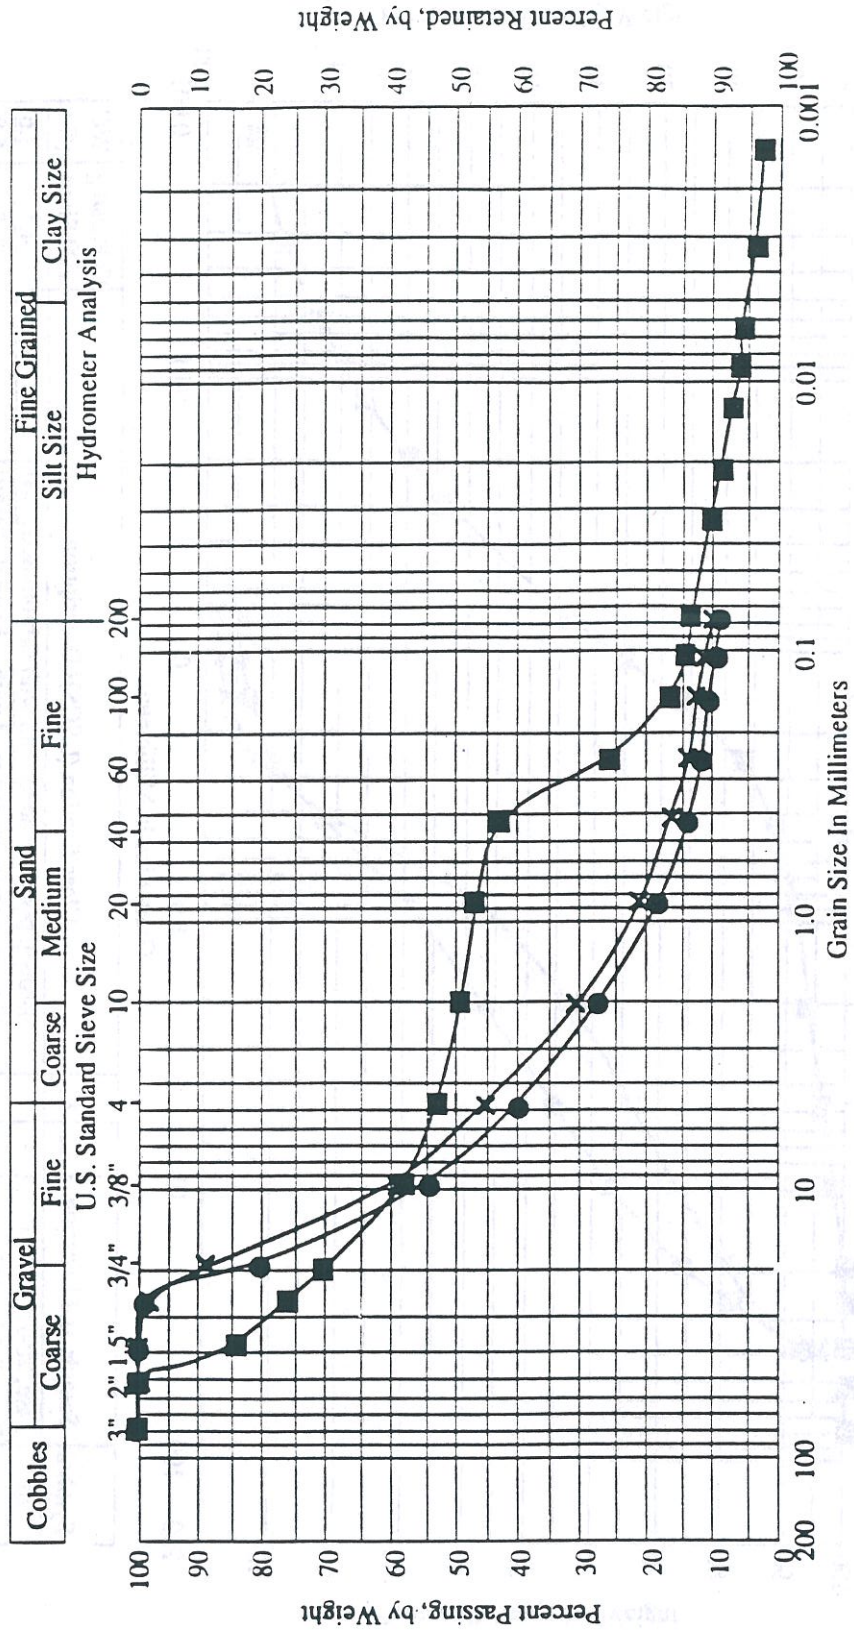
Figure B.5 - Grain Size Distribution for SR-14.

Although the subgrade soils at the SR-14 site consisted of gravel with sands, it was gap-graded, with 13 percent passing the No. 200 sieve. Carroll (1983) found gap-graded soils to be susceptible to piping which can lead to fabric clogging. But in the case of woven slit-films, the pore sizes may be too large to prevent the soils from passing through them when piping occurs, and the fines could then be deposited on the surface of the fabric.
