RESEARCH REPORT
Agreement T2695, Task 90
DBR Evaluation

**EVALUATION OF DOWEL BAR RETROFIT
FOR LONG-TERM PAVEMENT LIFE
IN WASHINGTON STATE**

May 2009

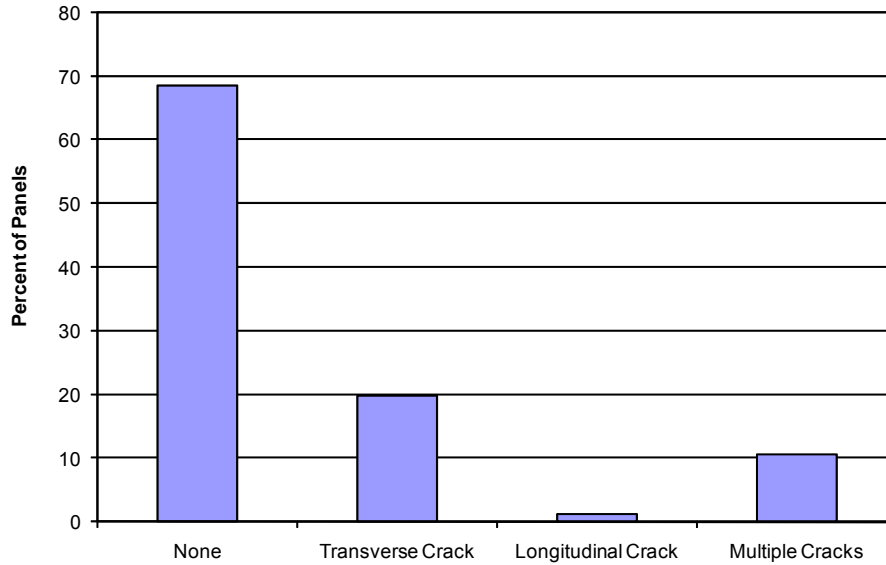
To further investigate the cracking noted in the panel replacements, an analysis was conducted to determine the extent of the panel cracking. All panel replacements that occurred within the surveyed lane (typically the rightmost lane) were reviewed and summarized based on no cracking, a single transverse crack, a single longitudinal crack, or multiple cracks. From this it was determined that approximately 30 percent of all panel replacements contained some type of crack (Figure E-2), with transverse cracking being the most predominant.

Figure E-2. WSDOT dowel bar retrofit test section cracking.

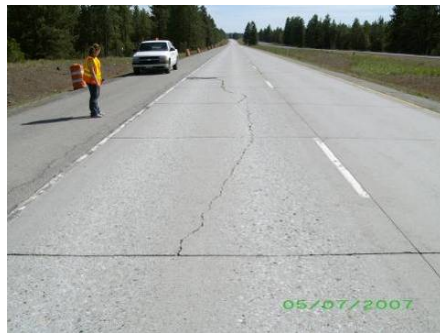
a. Longitudinal cracking

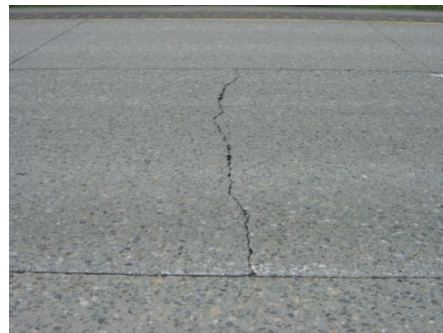
b. Transverse cracking

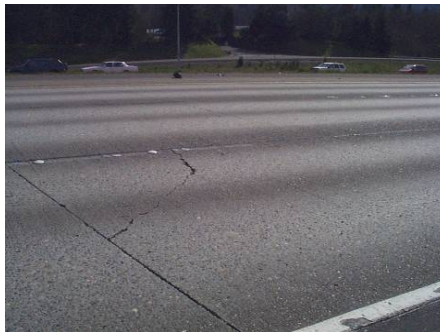
c. Corner cracking

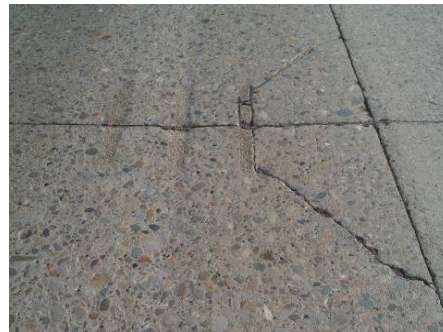
d. 45-degree cracking

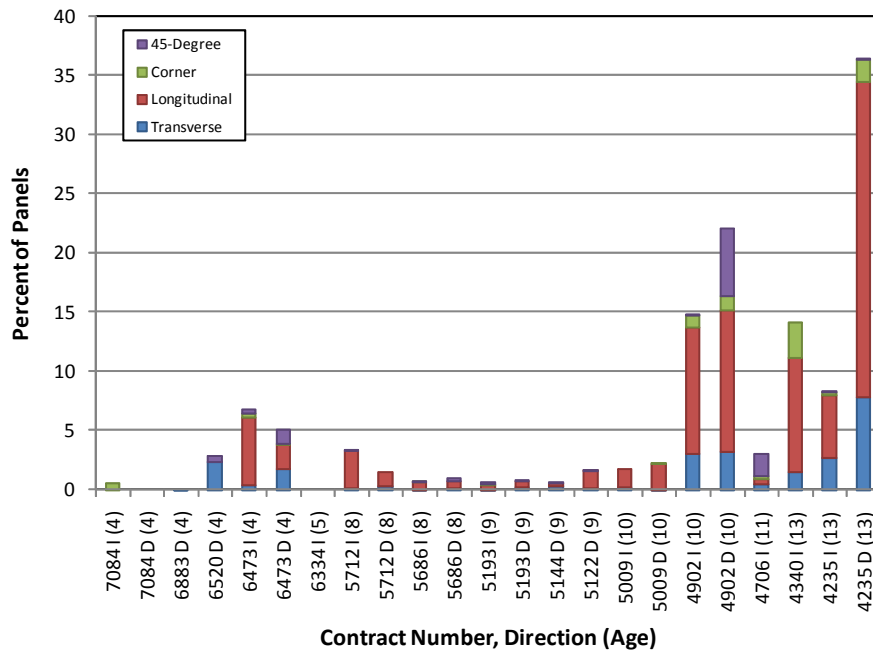
In the detailed review of the Washington State dowel bar retrofit projects, an assessment was made to determine the presence of transverse, longitudinal, corner cracking, and 45-degree cracking (Figure E-3) that developed after dowel bar retrofit construction. Of the 23 roadway sections reviewed, the occurrence of new cracking is relatively low, below 10 percent (Figure E-4), for all but Contracts 4235, 4340 and 4902. These three projects are all located on I-90 in the vicinity of Snoqualmie Pass and are subjected to other pavement performance issues (freeze-thaw and/or cracking due to failure of the longitudinal tape joint from initial construction). As can be seen in Figure E-4, longitudinal cracking is the prevalent distress on the majority of projects and is considered to be the primary mode of distress for dowel bar retrofitted pavements.

Figure E-4. Cracking by dowel bar retrofit project.

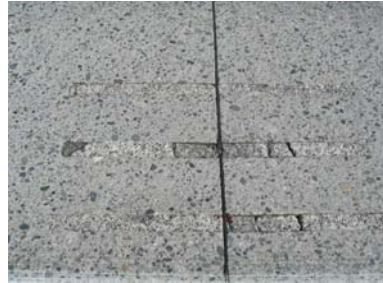
a. Cracking

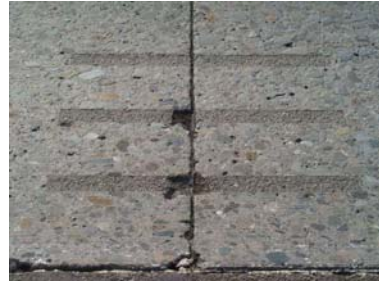
b. Spalling

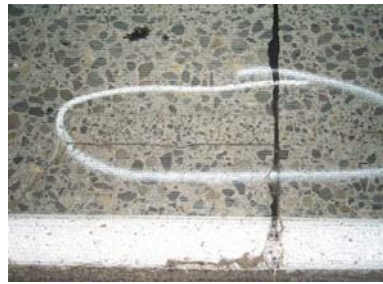
c. Debonding

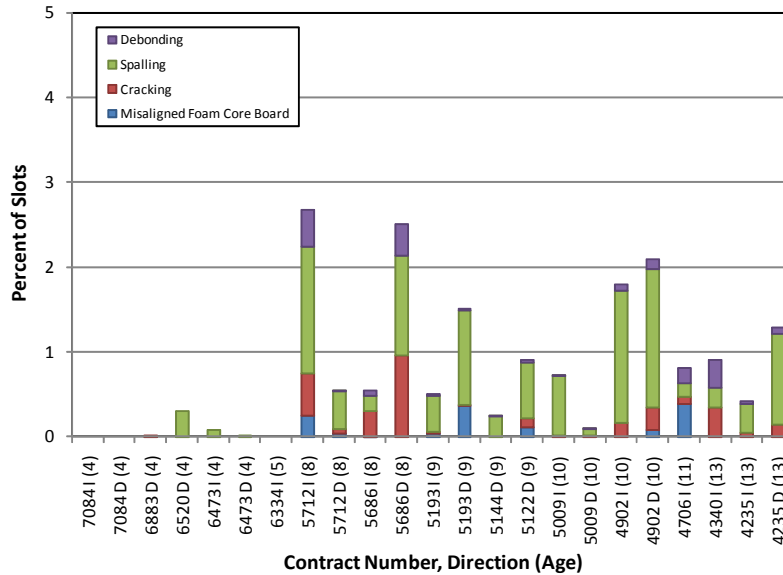
Figure E-6 illustrates the primary distresses found within the dowel bar retrofit slot. As with new panel cracking, the presence of dowel bar retrofit slot distress is very low in all projects and is well below one percent of the total slots on many projects.

Figure E-6. Slot distress by dowel bar retrofit project.

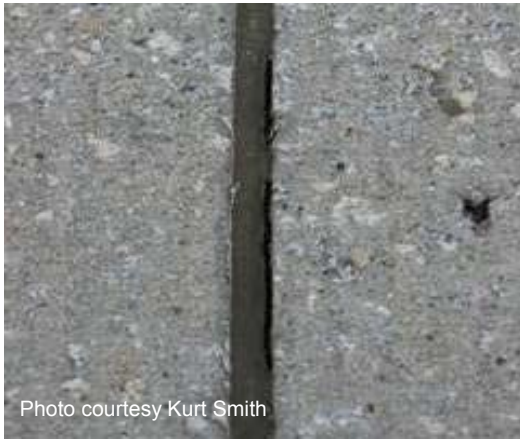
There are five primary forms of joint seal damage: (1) adhesive failure occurs when the joint seal material debonds from the concrete surface (Figure 13a); (2) cohesive failure occurs when the joint seal material splits within the sealant (Figure 13b); (3) extrusion occurs when the joint sealant is pushed or pulled out of the joint due to slab movement and/or traffic; (4) oxidation occurs due to exposure to the elements; and (5) infiltration occurs when incompressibles and/or vegetation is present in the joint (Hall et al., 2001). Regardless of the type of joint seal damage, the end result is a joint that no longer functions as intended, which is to keep moisture and incompressibles out of the joints. Moisture entering the joint can lead to

(a) Adhesive failure.

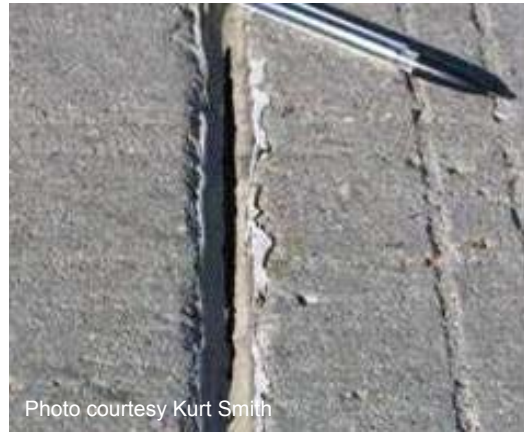
(b) Cohesive failure.

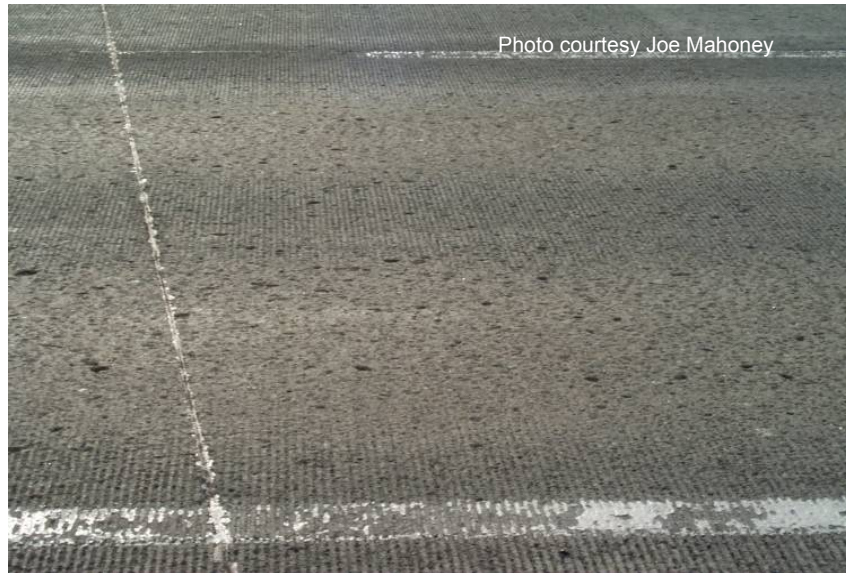
Damage caused by studded tires (Figure 14 and Figure 15) is a predominant distress of concrete pavements in Washington State. Studded tires remove the fine aggregate/cement from the concrete surface leaving an uneven roadway surface similar to rutting in HMA.

Figure 14 Moderate studded tire wear (SR 395 - no tining in wheelpaths).

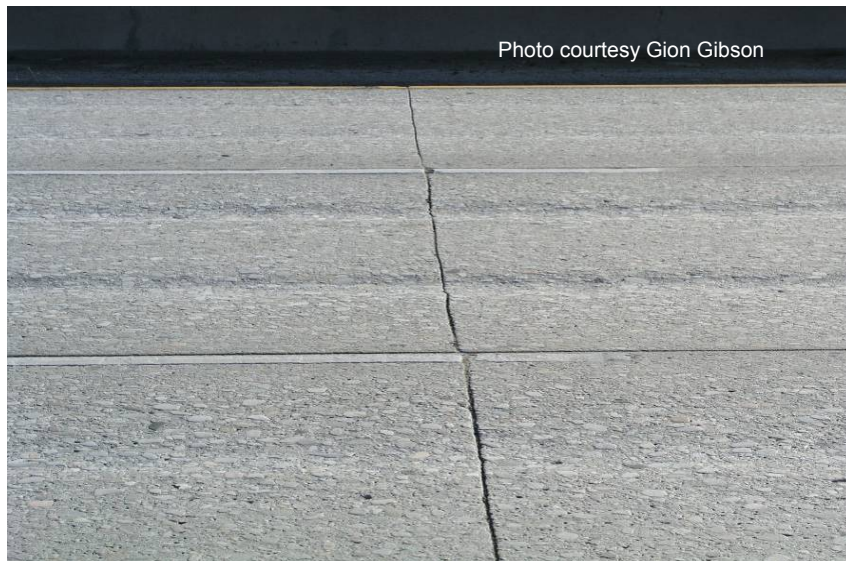
Figure 15 Severe studded tire wear (I-90 Spokane).

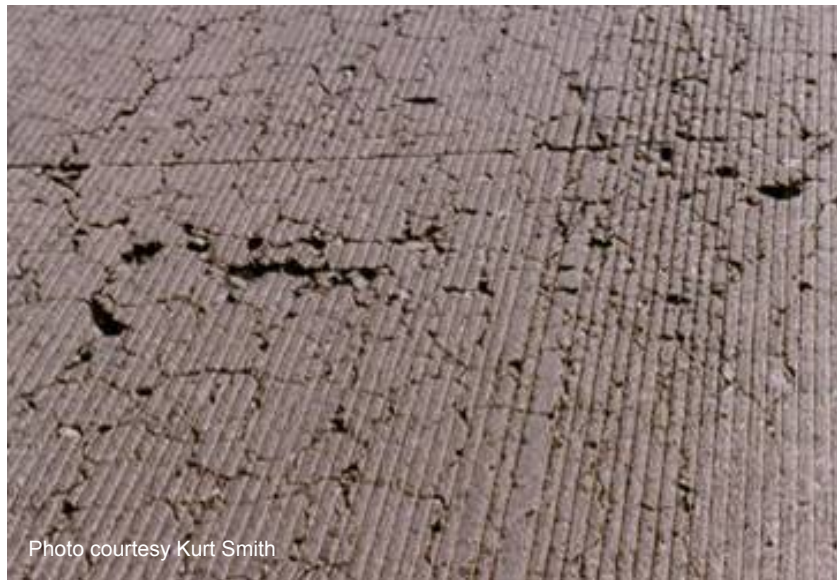
Alkali-silica reaction (ASR) is the more common type of alkali-aggregate reaction (Figure 16). Aggregates containing certain forms of silica react with the alkali hydroxide in concrete. This reaction forms a gel which can swell as it adsorbs water from the surrounding cement paste and/or the environment (PCA, 2007). The swelling of the gel can induce enough expansive pressure to cause cracking in the concrete.

Figure 16 Alkali-Silica Reactivity.

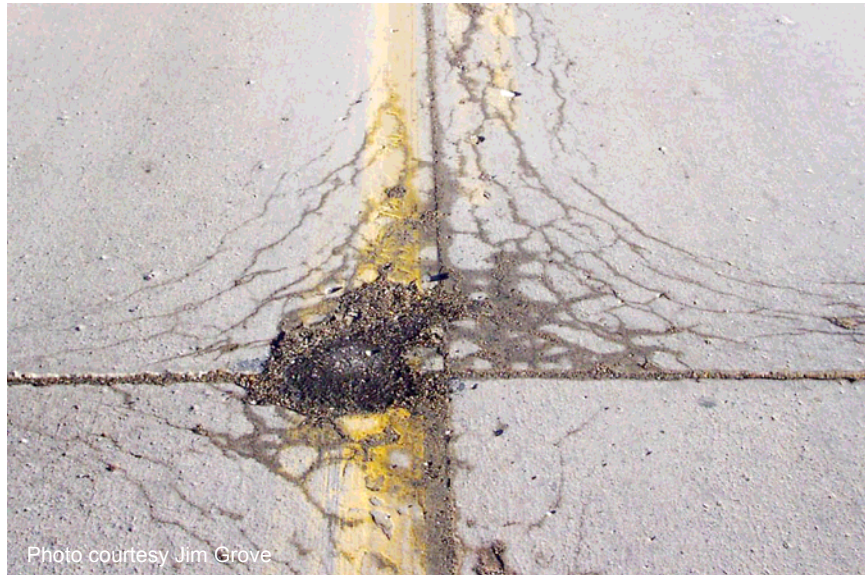
Durability or D-cracking (Figure 17) is a result of freeze-thaw damage in the large aggregate. D-cracking most commonly occurs with the use of sedimentary aggregate (such as limestone and dolomite) and is a function of freeze-thaw cycles, presence of moisture, pore size distribution, and the maximum aggregate size (Hall et al., 2001).

Figure 17 D-cracking.

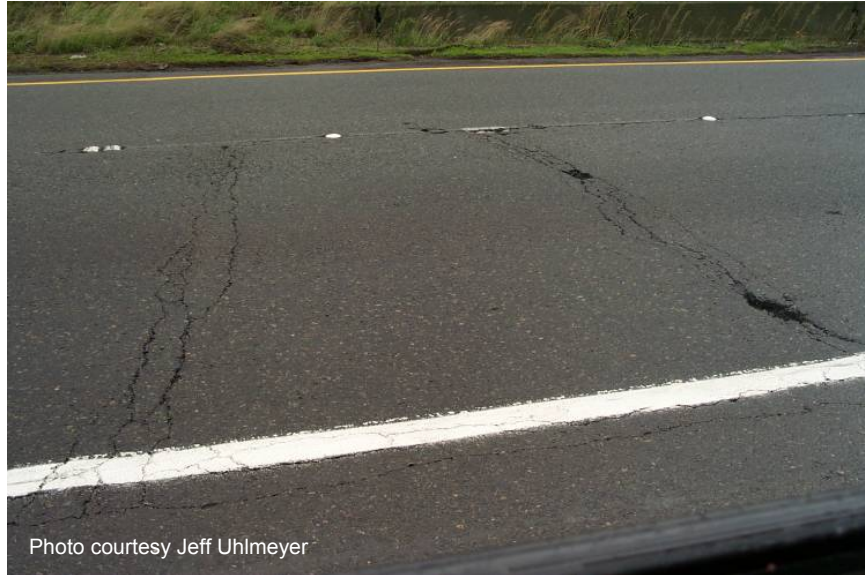
WSDOT successfully overlaid a number of non-interstate concrete pavements by placing two to four inches of HMA directly over the concrete pavement. Since the major concrete pavement distress in Washington State is joint faulting, reflective cracking (the underlying concrete continues to move horizontally and vertically due to temperature, moisture and traffic

loadings, resulting in excessive tensile stress in the HMA overlay cracking at the approximate joint location) was always a concern and the main factor which drove future rehabilitation (Pierce, 1997) of the HMA overlay (Figure 106).

Figure 106 Reflection cracking (I-5 Centralia vicinity).

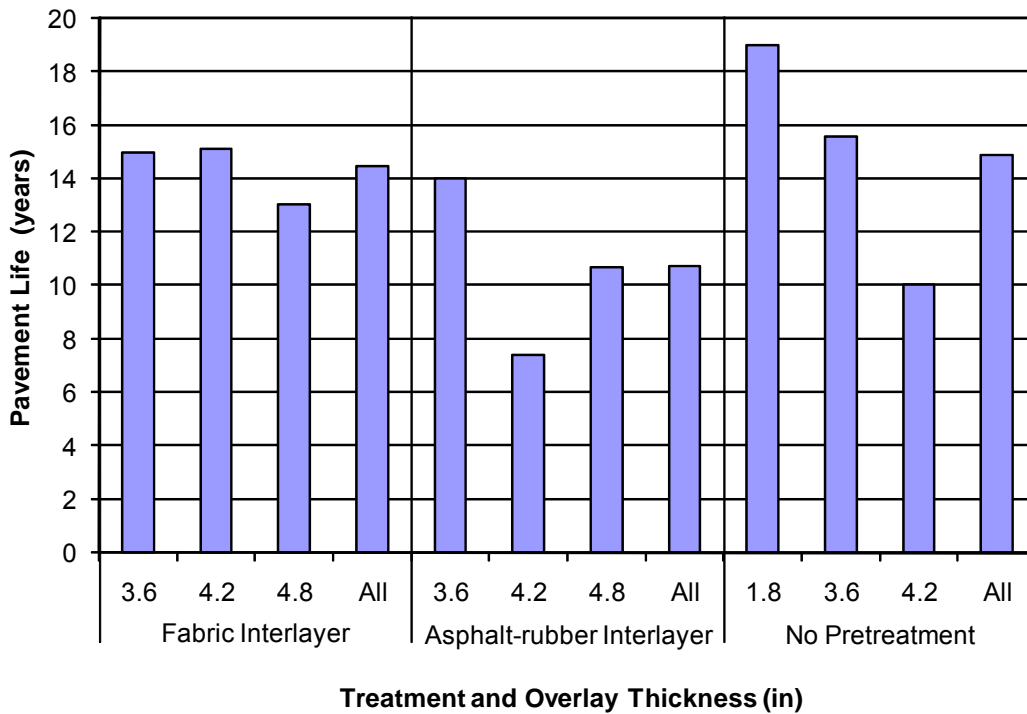
The weighted average pavement life for all fabric interlayer sections was 14.4 years, asphalt-rubber interlayer sections 10.7 years, and 14.9 years for the no pretreatment sections. Some sections consisted of very short paving lengths and may provide inconclusive results. The weighted average pavement life for each test section is shown in Figure 107.

Figure 107 Performance life of HMA overlays.

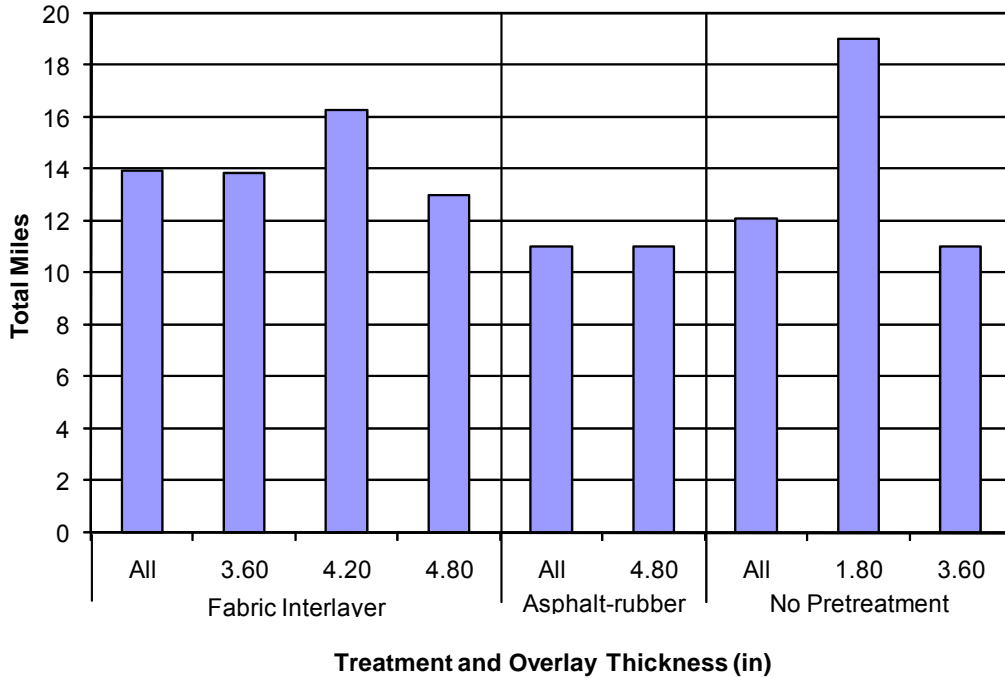
Analytical studies (Coetzee et al., 1979) have shown that an asphalt-rubber interlayer is effective in reducing stresses that lead to reflective cracking; however, field studies have shown mixed results. A study conducted by the Minnesota DOT (Allen et al., 1985) determined that a three inch HMA overlay placed with an asphalt-rubber interlayer had significantly more reflective cracking than a four inch HMA overlay with no interlayer. In contrast, a study (Kudd, 1981) by the Federal Highway Administration concluded that asphalt-rubber interlayers effectively control reflective cracking. Based on field test sections constructed by WSDOT, it was concluded (Jackson, 2007) that the use of an asphalt-rubber interlayer was ineffective in reducing reflection cracking. This rehabilitation treatment is no longer used by WSDOT.

Figure 109 Performance life of HMA overlays that failed due to cracking.

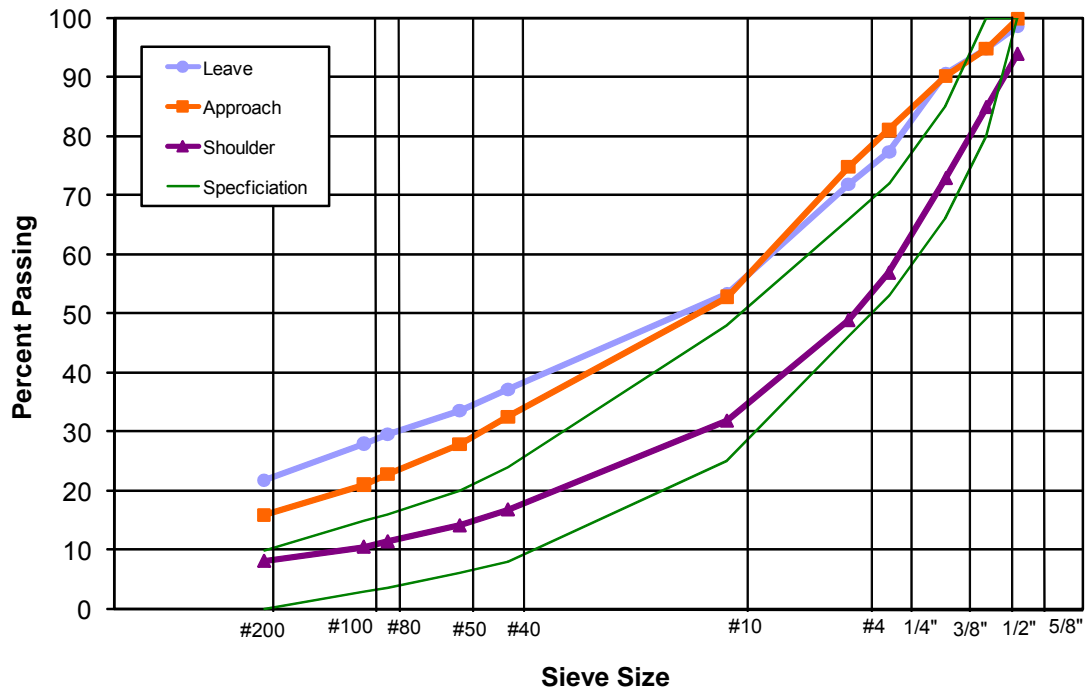
Figure 110 illustrates the base course material gradation beneath the right wheelpath of the approach slab, the leave slab, and the shoulder. The gradation of the shoulder base course material is within WSDOT gradation specification requirements, while the material at the approach and leave sides of the joint have a considerably finer gradation, and the gradation of the leave slab is finer than the approach slab. In all cases, tests showed that the base material beneath the leave slab was finer than the base material beneath the approach slab, validating the upward movement of the fine material and the development of a wedge of fine material and not a void.

When the concrete pavement was constructed over a cement treated base, the presence of a void was confirmed. Cement treated bases in Washington State were constructed with relatively high cement contents (more than five percent). When subjected to loading, and in the presence water, these cement treated bases became highly erodible due to the high pressure water action at the transverse joints. In these instances, subsealing successfully filled the voids and provided some level of support.

Since the primary distress of concrete pavements in Washington State is joint faulting and the majority of the concrete pavements are constructed on a crushed stone base, subsealing alone was determined not to be a viable rehabilitation treatment for addressing faulted concrete pavements.

Figure 110 Typical base course gradation.

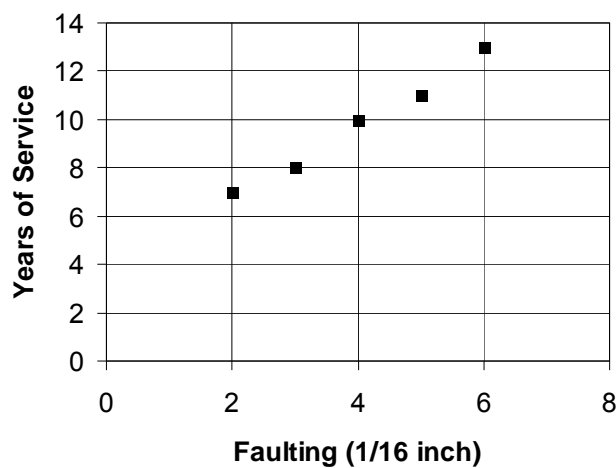
If the concrete pavement has lost its structural integrity (i.e. cracking), load transfer restoration is not an appropriate rehabilitation treatment. Load transfer restoration results for the New York study are illustrated in Figure 118. Bendana et al. indicated that joint faulting became noticeable to the traveling public when it averaged $\frac{1}{8}$ inch and objectionable at $\frac{3}{16}$ to $\frac{1}{4}$ inch. Long-term performance is dependent on quality control during the construction process, the use of quality patching material, load transfer restoration being performed on sound concrete slabs, and ensuring that adequate load transfer devices are used. In addition, this study indicated that using fewer than four dowels per wheelpath may be satisfactory.

Figure 118 Faulting of dowel bar retrofit (redrawn, Bendana et al., 1992).

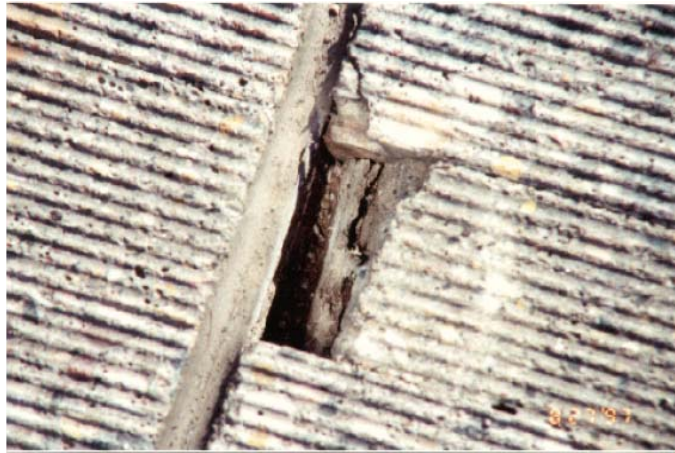
- In general, load transfer prior to dowel bar retrofit on the first project ranged from 20 to 30 percent, and after dowel bar retrofit the average load transfer was approximately 76 percent. On the second project, load transfer prior to installation ranged from 20 to 30 percent, and after dowel bar retrofit the load transfer averaged approximately 85 percent;
- On one project the contractor had challenges with the foam core board (width of $\frac{1}{4}$ inch) remaining vertical in the dowel bar slot during placement of the patching material. Typical distress associated with foam core board movement is shown in Figure 119;

Figure 119 Typical distress caused at core board failure (Dunn et al., 1998).

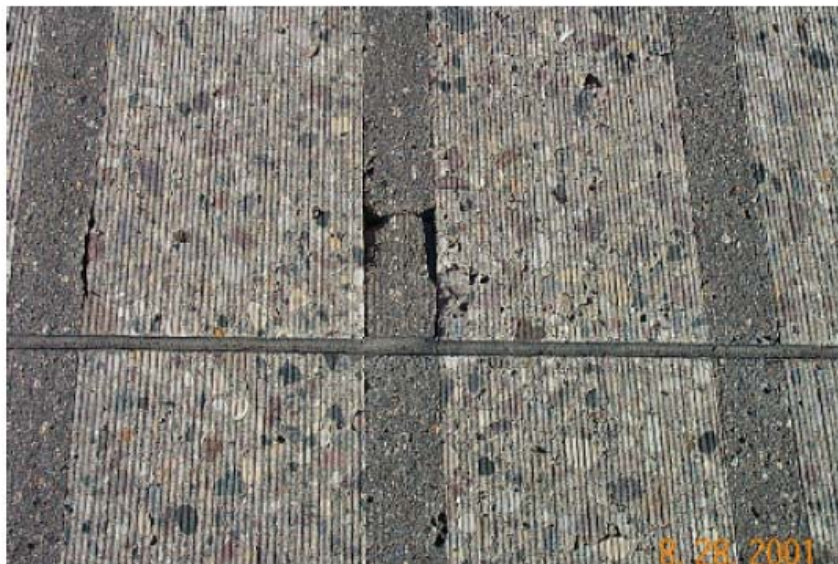
- Shrinkage cracking occurred within the MNDOT mixture;
- A prevalent distress in the Patchroc 10-60 material is shown in Figure 121 and is believed to be due to lack of consolidation around the dowel bar;
- In general, nearly all of the distresses (in both the Patchroc 10-60 and the MNDOT 3U18) in the dowel bar slots appear to be either related to the mix, bonding, core board failures, or improper vibration of the mix. The majority of distresses could be avoided with proper control of construction practices.

Figure 121 Typical distress in Patchroc 10-60 (Dunn et al., 1998).

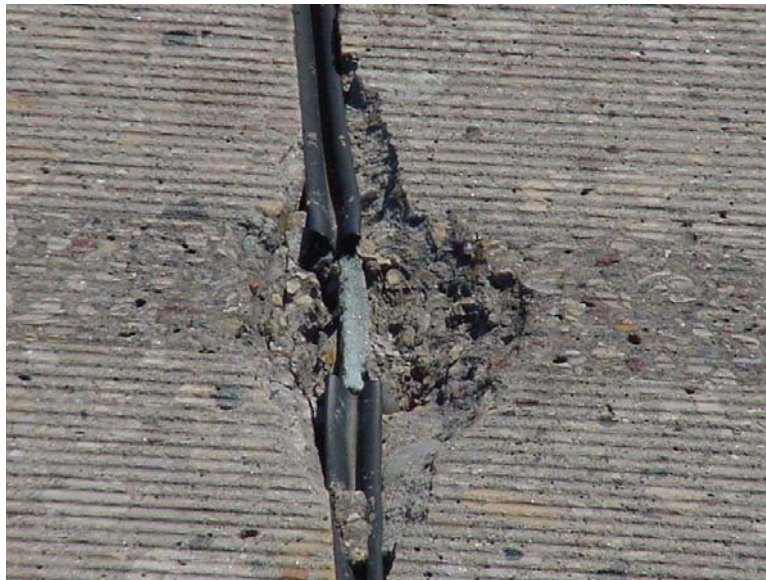
In 1999, Wisconsin DOT constructed its first dowel bar retrofit test section (several more followed in different areas of the state). Two years after construction, Wisconsin noted good load transfer efficiency (Bischoff et al., 2002), but frequent locations where the patching material failed (Figure 122) around the dowel bars.

Figure 122 Mortar deterioration and spalling (Wilson et al., 2002).

In 2001, the Wisconsin DOT placed a moratorium on the continued use of dowel bar retrofit until resolution of the patching material failure could be determined. A 2002 study

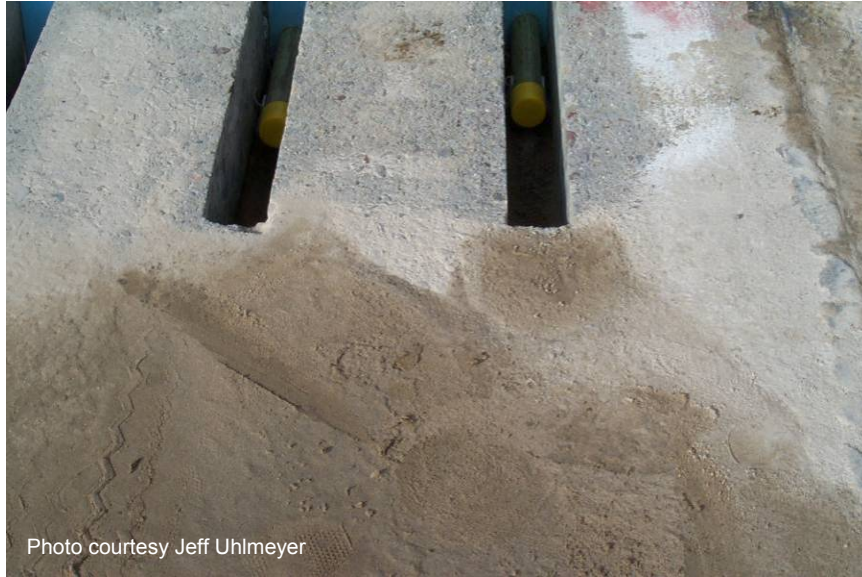
that the Contractor did not remove the debris very far from the dowel bar slots (Figure 124). The debris was continually kicked into the dowel bar slots by both observers and workers;

Figure 124 Debris left adjacent to dowel bar slots.

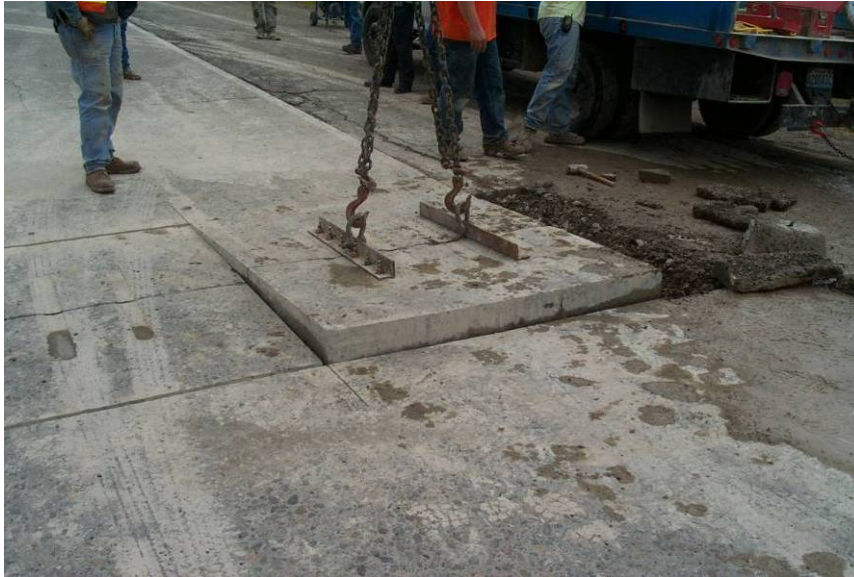
Results from the I-90 joint evaluation showed that a considerable amount of corrosion had formed beneath the epoxy coating at the center of the dowel (i.e. at the joint). The corrosion of the bar was shown to be a likely contributor to the reduction in load transfer efficiency (Harvey et al., 2005). In general, the corrosion study concluded that corrosion is a problem for bare steel dowels and a potential problem for epoxy coated steel dowels. Corrosion may be a contributor to a loss of load transfer efficiency with dowel bars retrofitted in concrete pavements. Prior to use, a quality control check should be conducted on dowel bars to ensure that the epoxy coating completely covers the bar and is free of holidays.

Figure 125 Removal of dowel bar retrofitted joint on I-90 test section.

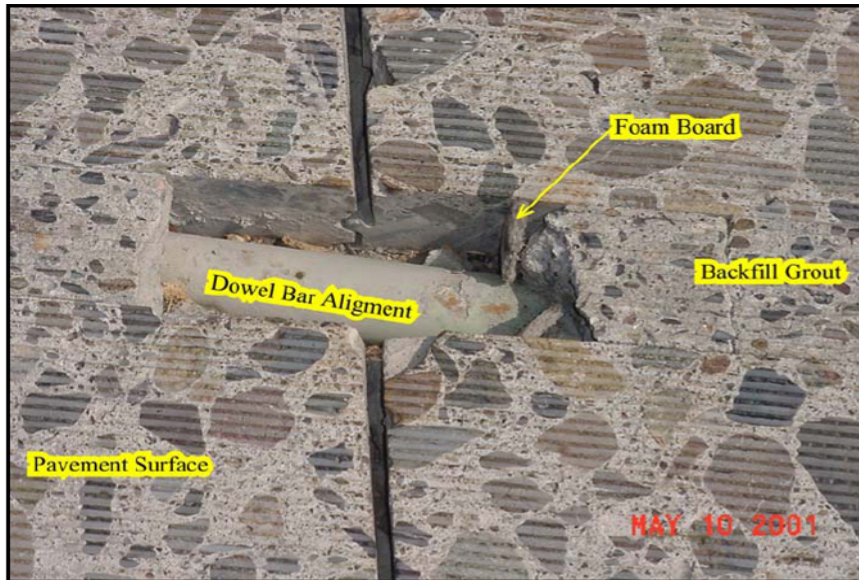
Caltrans launched an investigation to determine the cause of the dowel bar retrofit failures (Figure 126 to Figure 128). The Caltrans investigation included all 12 projects with an in-depth investigation of six representative sites (ranging from poor to good performance).

Figure 126 Misaligned foam core board I-405 (Glauz et al., 2002a).

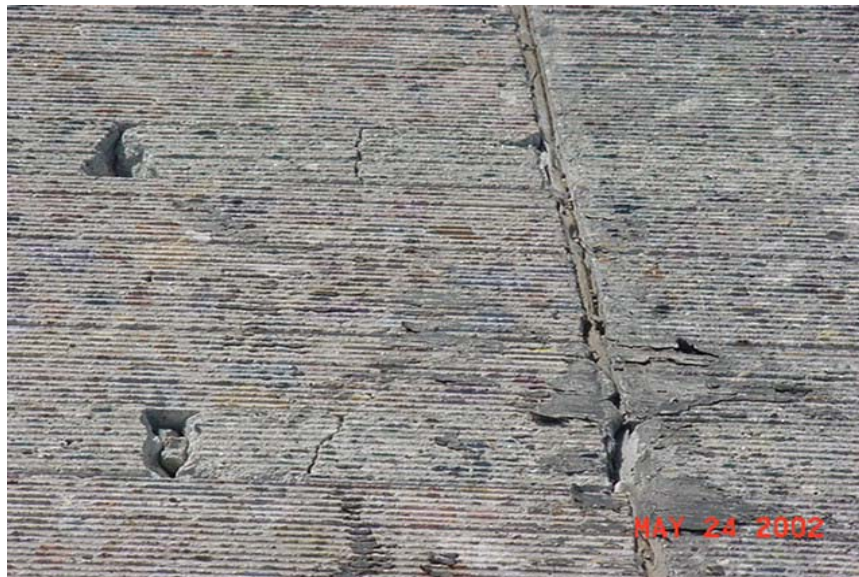
Figure 127 Shrinkage cracking and spalling State Route 8 (Glauz et al., 2002b).

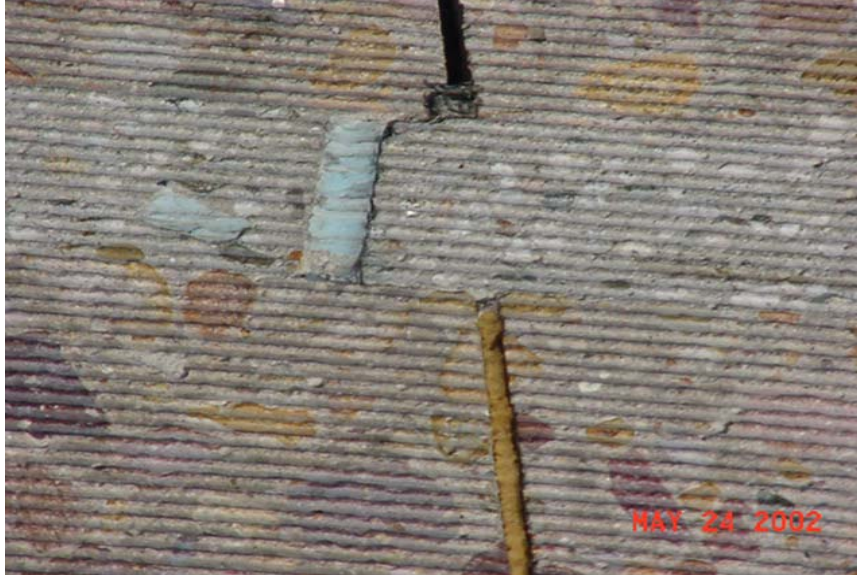
Figure 128 Misaligned foam core board State Route 8 (Glauz et al., 2002b).

material was not properly consolidated, and deleterious material was found between the patching material and the existing concrete. Specific findings for the State Route 8 project indicated that the dowel bar slots were constructed incorrectly (construction crew used 60 pound jackhammers when 30 pounds was specified, and dowel bar slots were cut too short to allow proper placement of the dowel bar retrofit assembly), foam core boards were not properly aligned with the existing transverse joint, and joint sealant was not applied.

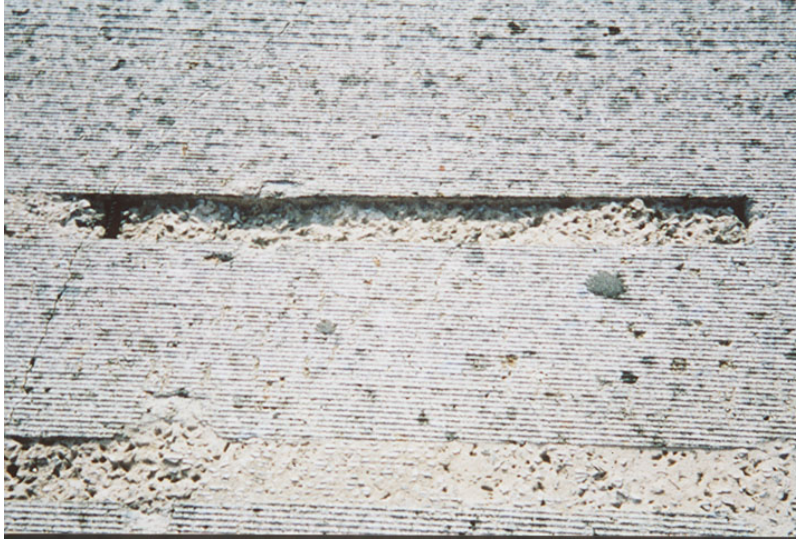
Michigan (Eacker, 2008) – It has been reported that a couple of dowel bar retrofit projects had major failures (spalling of patching material due to over consolidation [Figure 133] and cracking around slots [Figure 134] due to use of larger than specified jackhammers). Currently, there is very little interest in using dowel bar retrofit due to previous failures. One dowel bar retrofit project is scheduled to be let in 2008 (4,500 slots). Michigan DOT requires a two year materials and workmanship warranty (Appendix B);

Figure 133 Spalling of patching material.

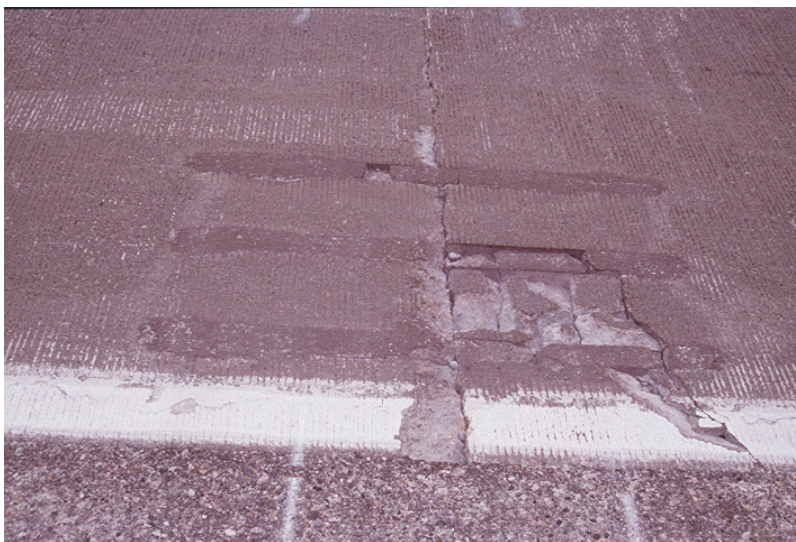
Figure 134 Cracking between dowel bar slots.

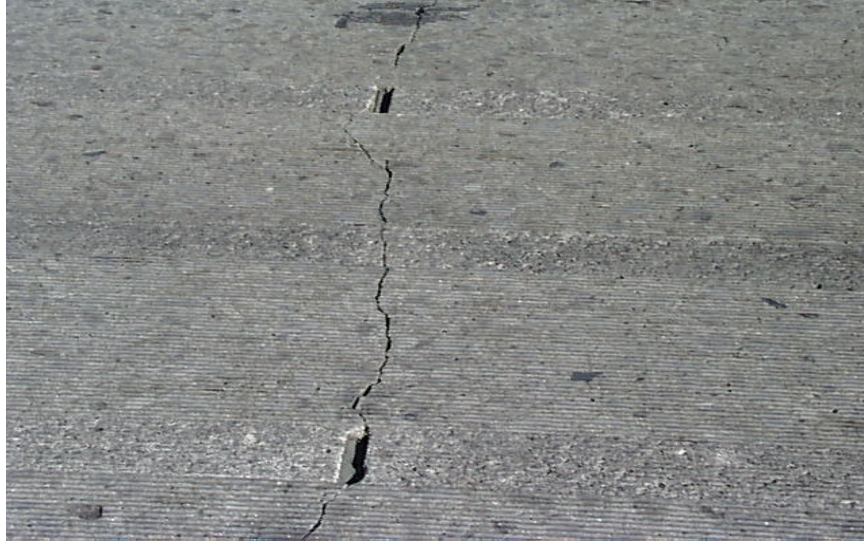
Figure 135 Minor spalling between foam core board and transverse crack.

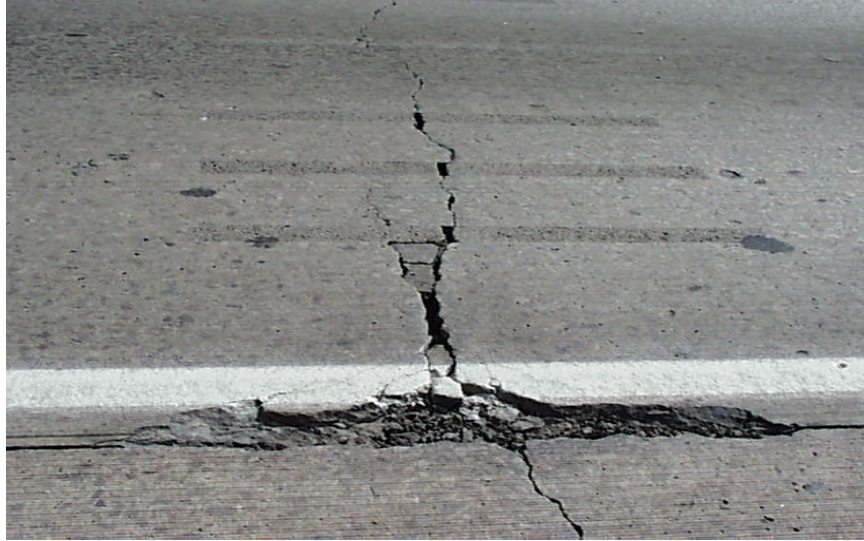
mixed, with failures primarily due to improper installation or use on badly deteriorated cracks (Figure 136). It is currently recommend that dowel bar retrofit only be applied to hairline or narrow cracks and that full depth repairs be conducted on working and/or faulted cracks. Future dowel bar retrofit is anticipated to be less than 70 lane miles;

Figure 136 Spalling of dowel bar retrofitted transverse crack.

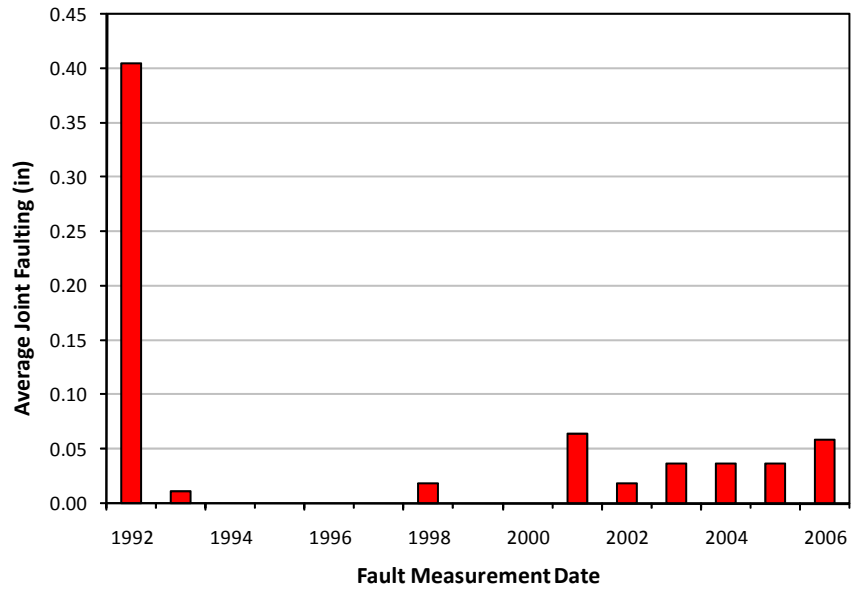
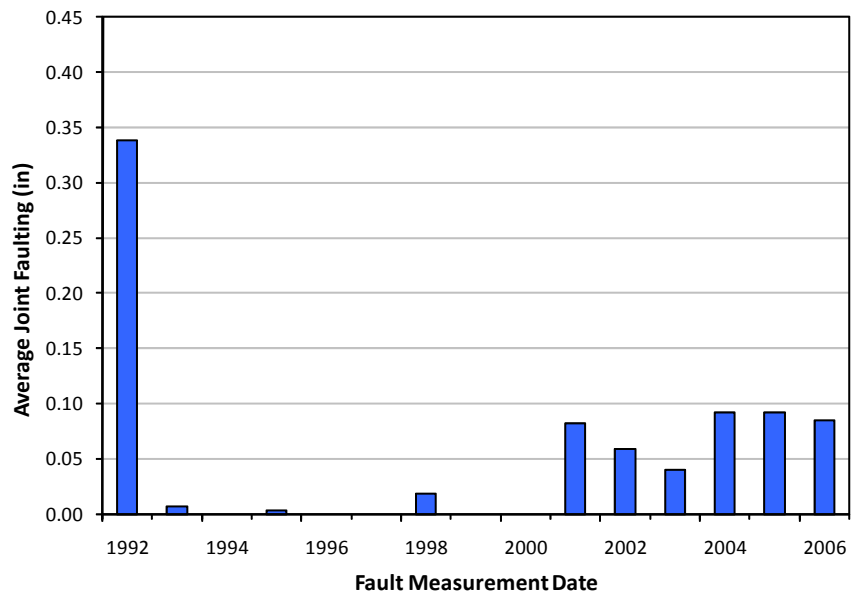
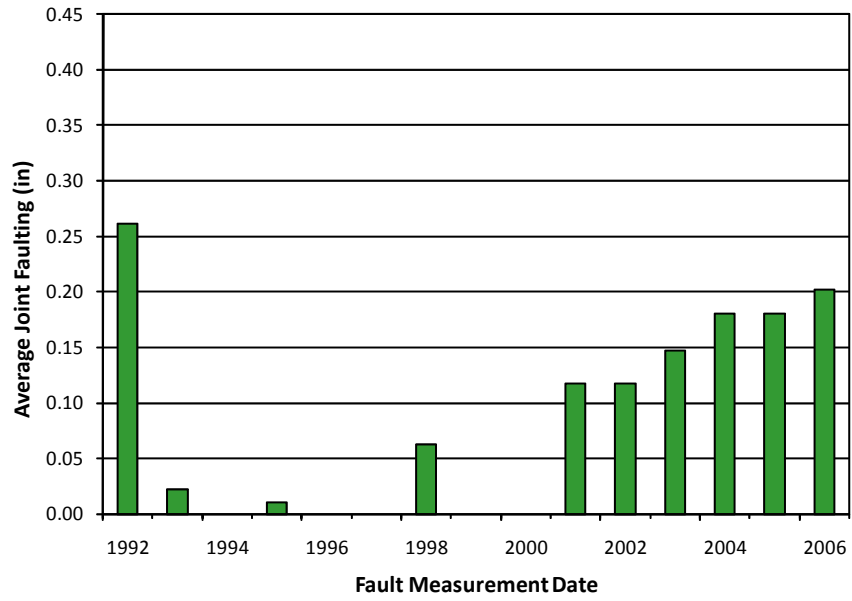
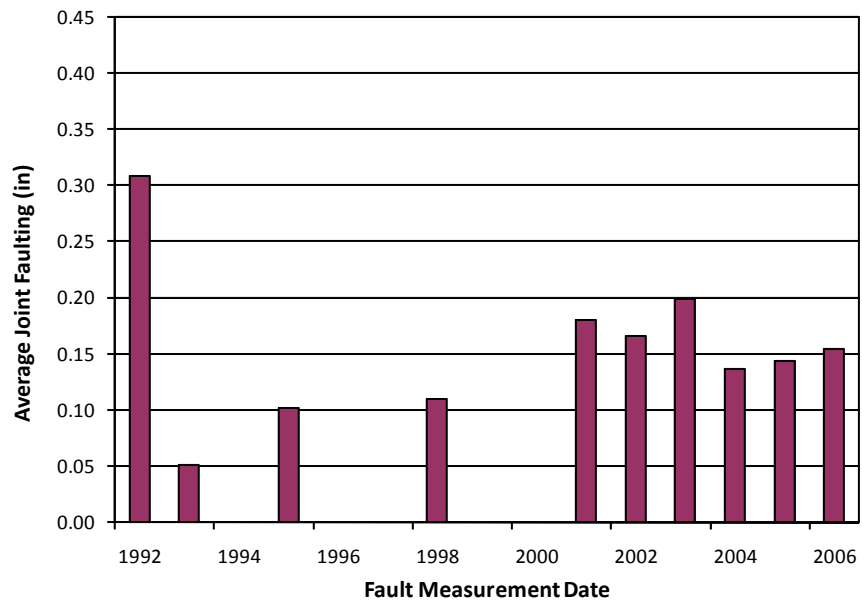
In addition to joint load transfer testing measuring was also done. Joint faulting was measured just prior to dowel bar retrofit construction in 1992, and routinely up to 2006. Joint fault measurements were conducted by placing a 10 foot straightedge longitudinally (in the direction of traffic) across the transverse joint and measuring the distance between the bottom of the straightedge and the top of the pavement using a ruler with a 1/16 inch accuracy. The results of the faulting measurements are shown in Figure 148 through Figure 151.

Faulting measurements were not recorded annually between 1994 and 2000; only two years (1995 and 1998) of data measurements are available over this seven year period. As with joint load transfer results, minor variation, in fault depth measurement were noted on all test section features. Variations in test results can, in part, be due to testing error and/or curling of the panels. Regardless, as with the load transfer results, faulting trends are noted between the various test section features. The dowel bar retrofit sections show the least amount of fault return, with relatively little difference between the two dowel bar retrofit sections (Table 9).

Figure 148 Average joint faulting dowel bar retrofit only.

Figure 149 Average joint faulting dowel bar retrofit with concrete shoulder beam.

Figure 150 Average joint faulting concrete shoulder beam only.

Figure 151 Average joint faulting control.

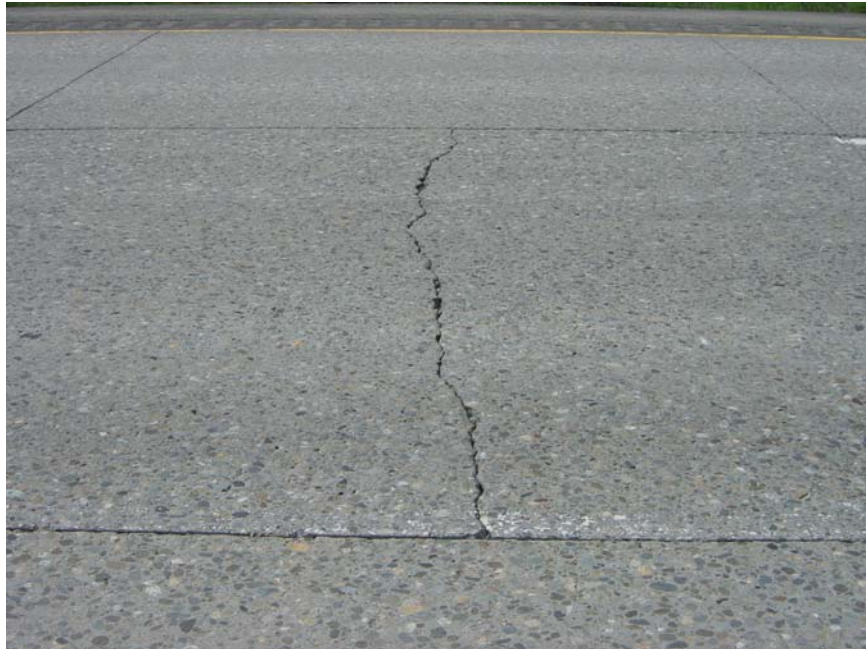
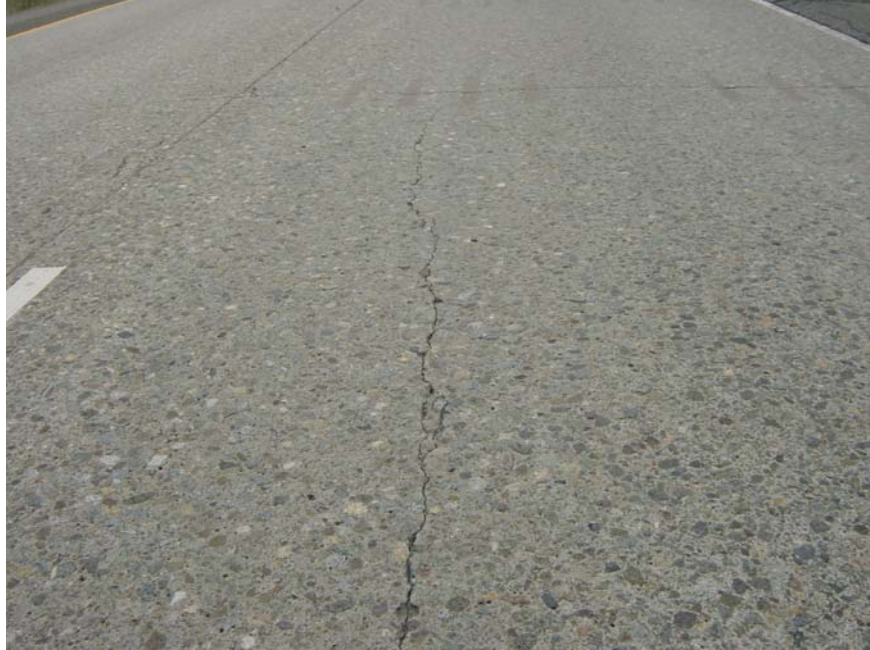
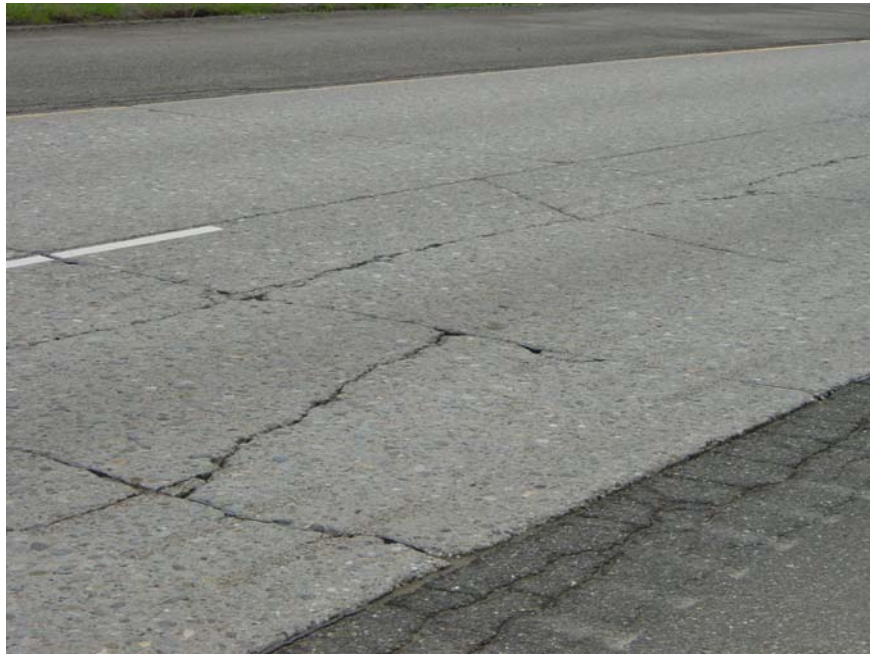
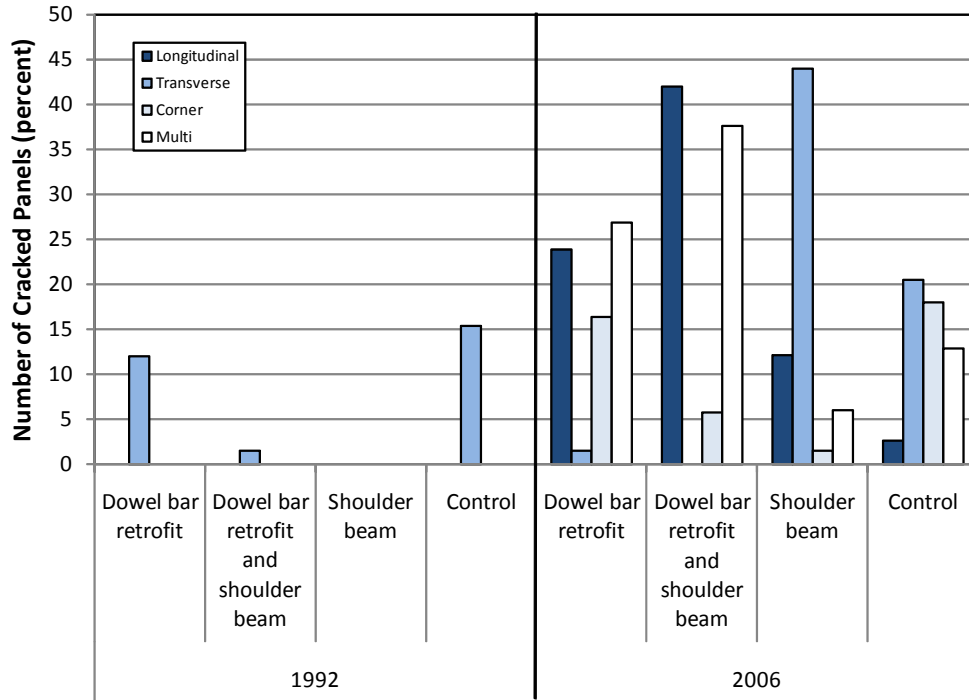
Each panel of the test section was reviewed for the presence of transverse, longitudinal, corner, and multiple cracks. As stated previously prior to construction, the entire test section had only 15 panels distressed with only one single transverse crack. After 14 years of service, all sections have significantly increased in the amount of cracked panels. Examples of test section cracking are shown in Figure 152 through Figure 154. Figure 155 summarizes the percent of panels (just prior to construction in 1992 and according to the 2006 pavement condition survey) that have a single transverse crack, a single longitudinal crack, a single corner crack, and panels that contain multiple cracks. A detailed cracking assessment of the test section is shown in Appendix C.

Figure 152 Test section – transverse cracking.

Figure 153 Test section – longitudinal cracking.

Figure 154 Test section – multi-cracked slab.

Figure 155 Summary of test section cracking.
