RESEARCH REPORT
Agreement T2695, Task 90
DBR Evaluation

**EVALUATION OF DOWEL BAR RETROFIT
FOR LONG-TERM PAVEMENT LIFE
IN WASHINGTON STATE**

May 2009

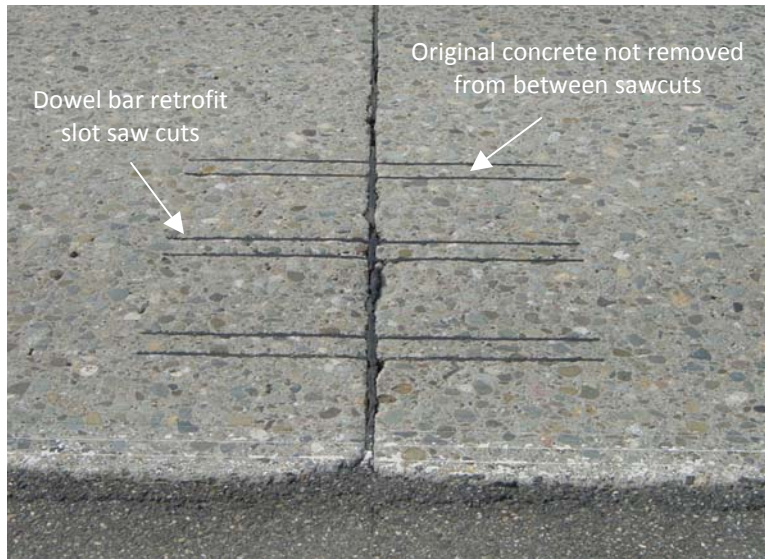
Due to the lack of load transfer restoration, it is expected that the control section should show an increase in the number of cracked panels (from 15 percent in 1992 to 54 percent in 2006). Notable is the increase in both the number of longitudinally cracked panels and the number of multiple cracked panels. This may in part be attributed to a dowel bar retrofit project (Contract 4902) in 1996 that encompassed the dowel bar retrofit test section. On Contract 4902 the Contractor sawcut the dowel bar retrofit slots within the control section but did not remove the concrete from between the parallel sawcuts (Figure 156). In consultation with the Pavements Office, the Project Office was requested to not remove the concrete from between the sawcuts (Figure 157) but to instead seal the sawcuts with an epoxy material. This action had no effect on the load transfer characteristics of the control section. However, several panels within the control section have since cracked longitudinally (Figure 157), initiating at the sawcut for the dowel bar retrofit slot. It is probable that this cracking is a function of the creation of an inconsistency (by sawcutting the dowel bar retrofit slot) within the concrete panel which created a point of high stress which may have led to crack initiation.

Figure 156 Test section – dowel bar slots sawed and material not removed.

tensile stress and potentially causing the longitudinal crack. Another explanation may be the construction of a discontinuity in the concrete panel with the dowel bar retrofit slot. This would explain why the control section cracked longitudinally when the slots were sawcut but the concrete was not removed. The presence of the longitudinal cracking will be discussed below in the Distress, Cause and Evaluation section.

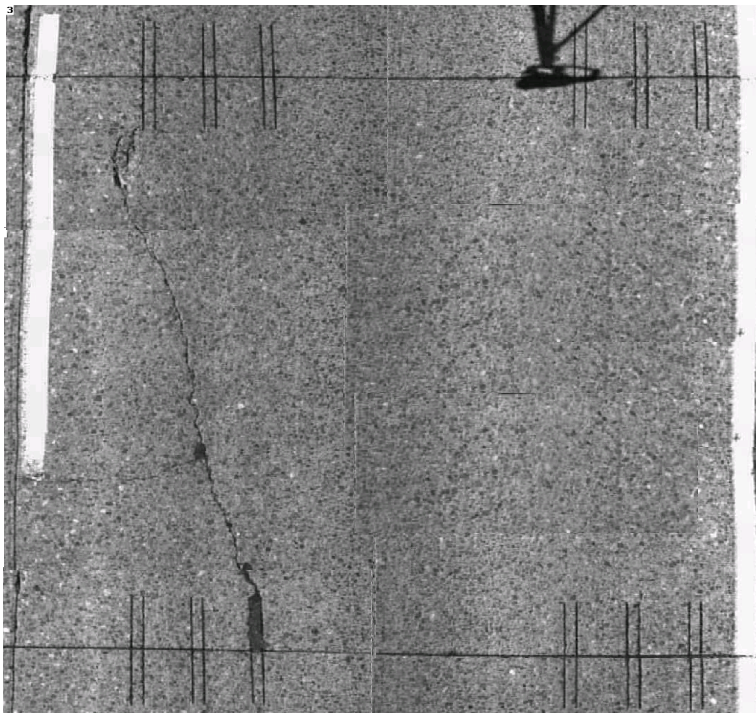
Figure 157 Longitudinal cracking in control section.

As stated previously, it is believed that the longitudinal cracking is fatigue related, not construction related. One hypothesis (Mahoney et al., 1991) is the potential existence of in-plane compressive stress parallel to the pavement centerline. The basis for this hypothesis was a typical concrete pavement section located on I-5 north of Seattle, which demonstrated high transverse joint load transfer results, low average faulting, and longitudinal cracking. It is believed that this also explains what is occurring on the dowel bar retrofit projects, especially since longitudinal cracking is not a common occurrence on eastern Washington concrete pavements. The test section load transfer was very low prior to dowel bar retrofit. Dowel bar retrofit has restored the joint load transfer to the high 80s, resulting in the potential build-up of

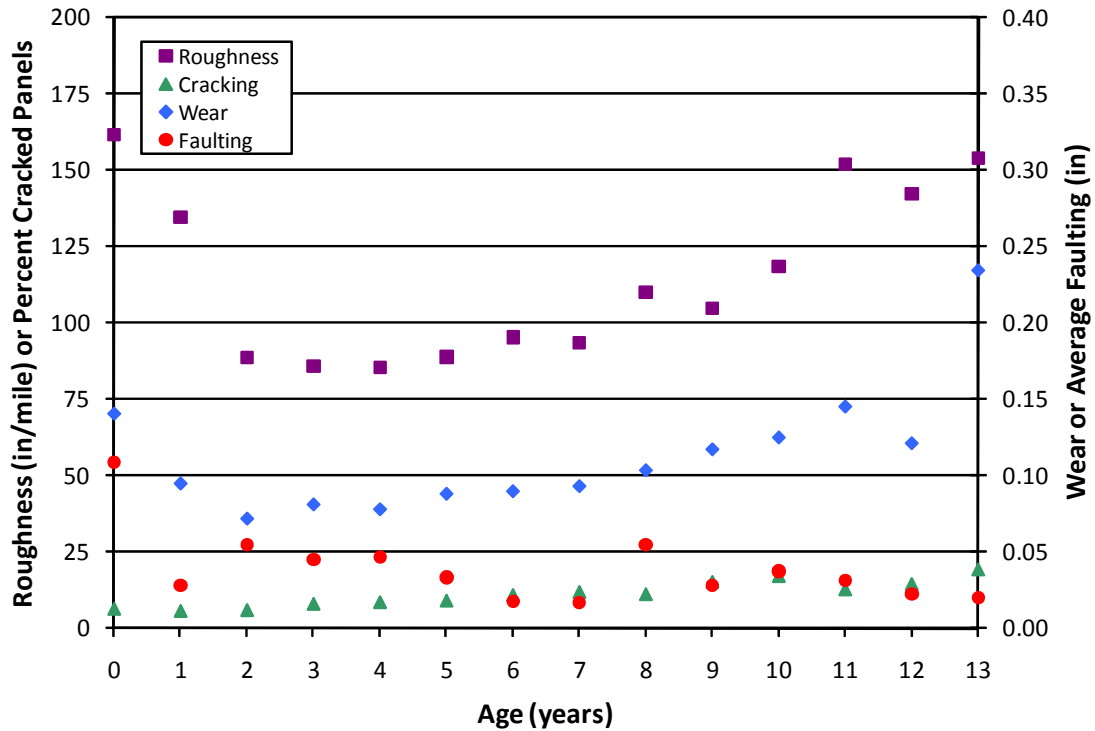
Figure 163 Dowel bar retrofit pavement performance.

As seen in Figure 163 (project details are in Appendix D), pavement roughness just prior to dowel bar retrofit construction (year 0) averaged slightly more than 160 inches per mile. After

From Figure 163, the rate of roughness return (slope of the regression line) does not occur at the same rate as that of pavement faulting. This demonstrates that the increase in roughness cannot be totally explained by the presence of joint faulting. Though faulting can play a role, the increase in roughness noted in Washington State can also be explained by the return of studded tire wear. Based on personal observations and the performance evaluation shown in Figure 163, dowel bar retrofit projects (e.g. Contracts 4235, 4340, and 4902) that appear to have a significant increase in roughness, the roughness is due to the return of wear caused by studded tires and not the return of joint faulting. This was the case on Contract 4235 on I-90 in the vicinity of Snoqualmie Pass. In 2000, WSDOT regional personnel contacted the WSDOT Materials Laboratory with concerns that the dowel bar retrofit placed in 1993, under Contract 4235, was failing due to a perceived increase in pavement roughness. Visual investigation of the project by the WSDOT Materials Laboratory personnel, it appeared that roughness was more a function of studded tire and snow chain wear than failure of the dowel bar retrofit application. This conclusion was based on driving the project and noting that, when the car was driven in the wheelpath, the pavement roughness was noticeably greater (motion of the car in response to the pavement surface increased) than when the car was driven outside of the wheelpath. To help confirm this, the WSDOT Materials Laboratory initiated a small study (Pierce, 2004) to investigate the perceived increase in pavement roughness. Between 2001 and 2003, pavement roughness measurements were taken to determine if the roughness was due to seasonal effects (curling), increased studded tire wear, or construction and/or design related issues with dowel bar retrofit. In an attempt to quantify the effects of curling, the pavement condition van was to be operated at various times during the two year period. Unfortunately, due to operational

The average pavement wear depths (Figure 163) prior to dowel bar retrofit were approximately 0.14 inches. After 13 years they have returned to similar levels as prior to dowel bar retrofit. Interestingly, the increased rate of pavement wear seems to track with the increased rate of pavement roughness (Figure 163), which tends to support the idea that the

Panel cracking has also increased over the 13 year performance period. From Figure 163, panel cracking at year 0 was approximately six percent; after 13 years panel cracking has increased to 19 percent. As will be described later, this increase is believed to be due in part to panel replacement cracking, propagation of existing cracks to adjacent panels, and cracking associated with dowel bar retrofit.

Prior to dowel bar retrofit the average faulting levels for all projects was 0.11 inches (Figure 163). Though varying from one year to the next, faulting after 13 years has slightly increased and, for the most part, has stayed below 0.05 inches. This is substantially less than the 0.15 inches at which a pavement is considered to have poor load transfer capabilities (Heinrichs et al., 1989; Reiter et al., 1988; Roberts et al., 2001, Harvey et al., 2003a). The challenge with this faulting analysis is that prior to 2001, WSDOT faulting measurements were based on visual inspection, while since 2001, faulting has been measured using laser technology. Some of the variation noted in Figure 163 can be due to measurement error, error in calculating faulting, and/or the lower number of miles used in this analysis (Table 17).

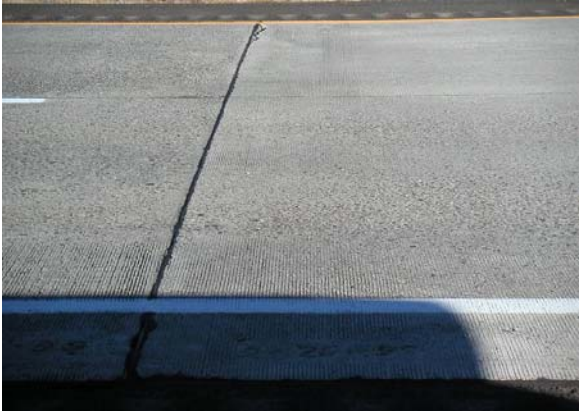
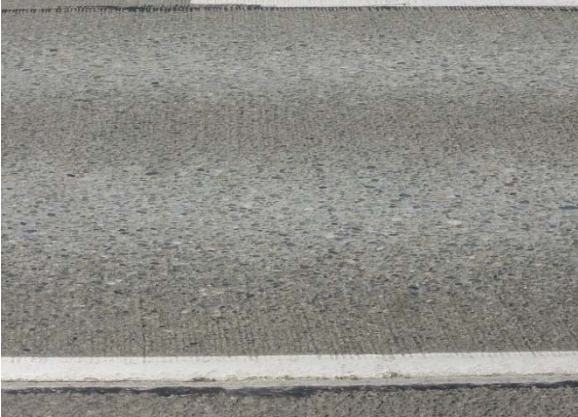
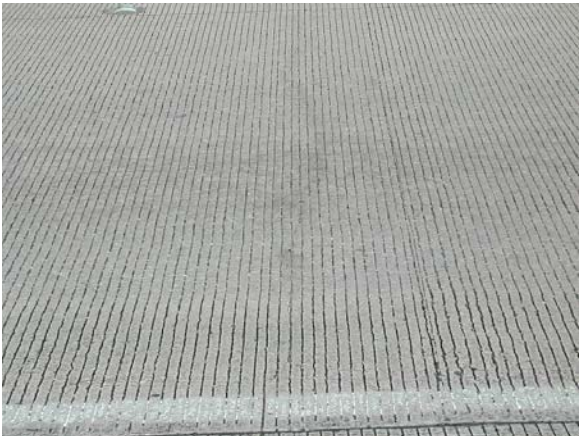
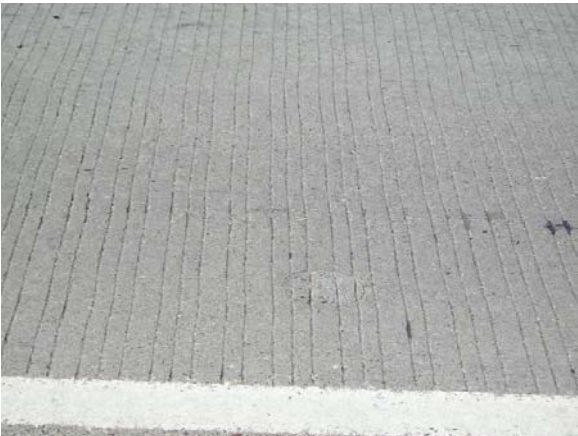
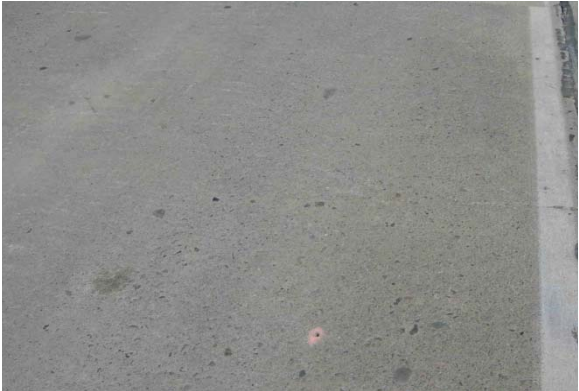
What is interesting to note from this analysis is that the pavements in California, Minnesota, and Texas are subjected to similar traffic loadings as those in Washington State. However, wear of the concrete pavement surfaces in these three states is nonexistent. Specifically, in Figure 167, images (a) and (b) illustrate concrete pavement surfaces in Washington State and demonstrate the lack of tining within the wheelpaths due to studded tire wear, while images (c) through (e) show concrete pavement surfaces from the other three states where tining within the wheelpath is still visible.

Figure 167 Pavement surface images from various state highway pavements.

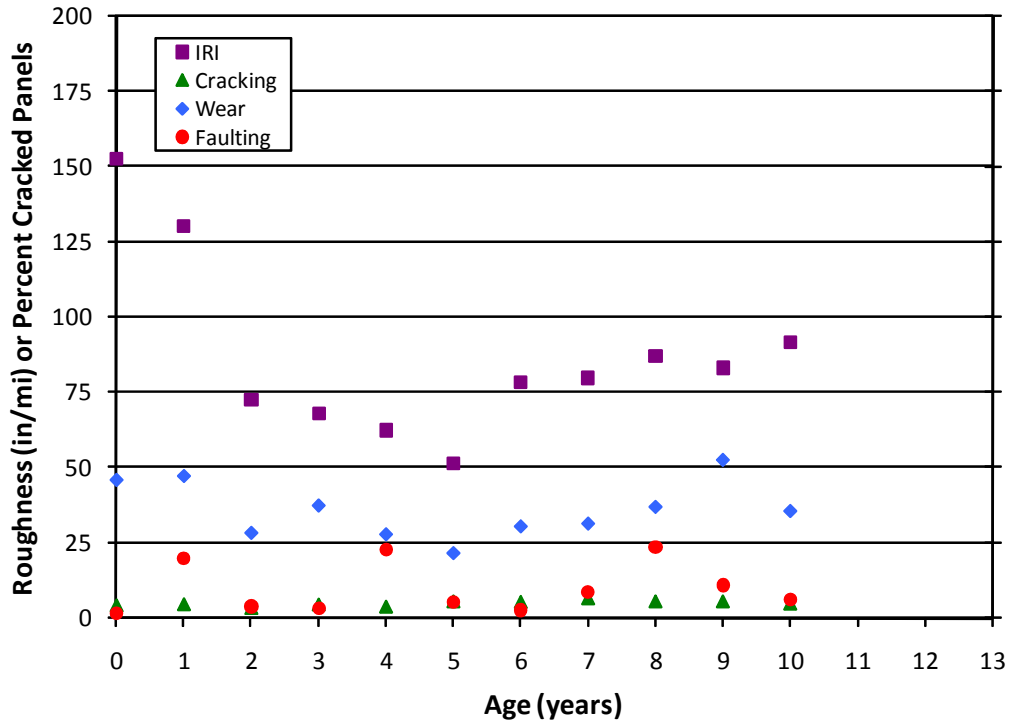
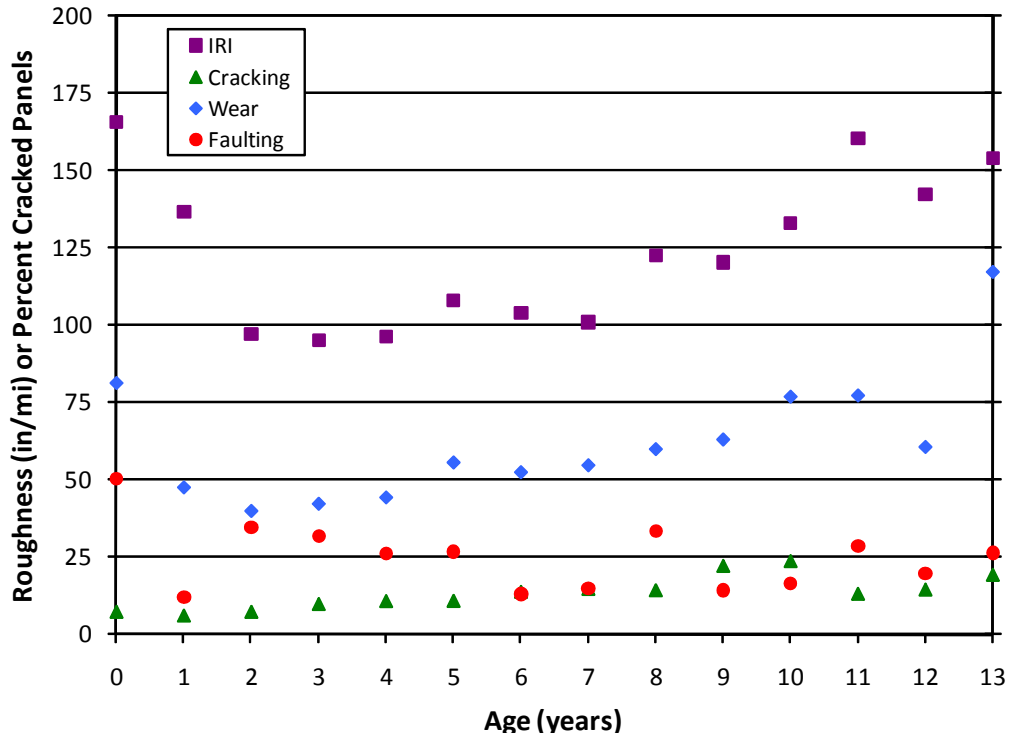
Comparing the results of Figure 168 to those in Figure 169, all distress types (roughness, cracking, wear, and faulting) were lower prior to dowel bar retrofit (year 0) for the five projects as compared to all other dowel bar retrofit sections. The progression of each distress was also less on the five projects. Additional observations follow:

- Roughness on the five projects, prior to dowel bar retrofit, averaged 153 inches per mile and have not exceeded 100 inches per mile after 11 years of service. All dowel bar retrofit sections (excluding the five projects), the average pre dowel bar retrofit roughness values was 166 inches per mile, not far different from the five projects. However, after 11 years of service roughness values exceed 150 inches per mile, which is a significant difference;

Figure 168 Dowel bar retrofit pavement performance – five projects only.

Figure 169 Dowel bar retrofit pavement performance – all other projects.

- The percent of cracked panels remains relatively consistent over the 11 year period for the five projects, starting at four percent prior to dowel bar retrofit and increasing to nine percent after 11 years. For all dowel bar retrofit sections (excluding the five projects), the original number of cracked panels is seven percent prior to dowel bar retrofit and after 11 years, increases to 13 percent;

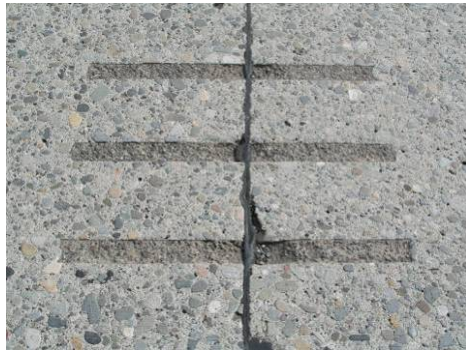
(a) Dowel bar slot spalling.

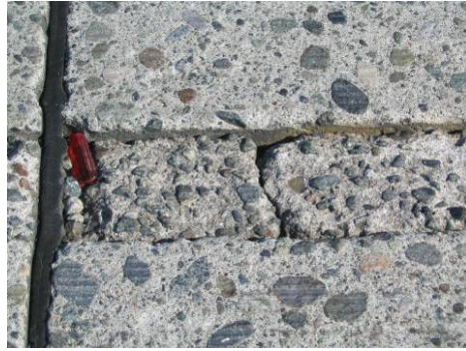
(b) Dowel bar slot cracking.

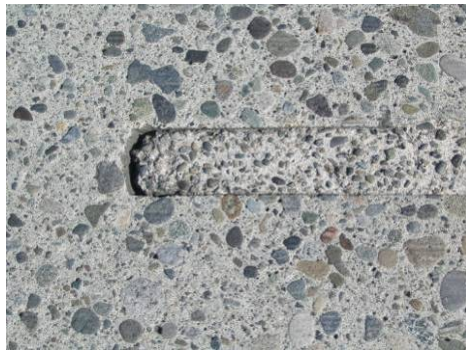
(c) Dowel bar slot debonding.

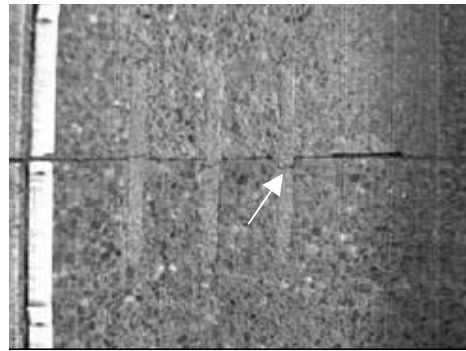
(d) Foam core board misalignment.

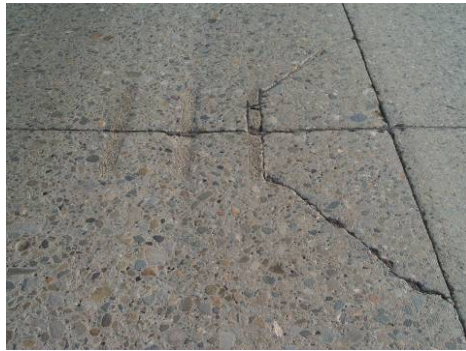
(e) 45-degree cracking.

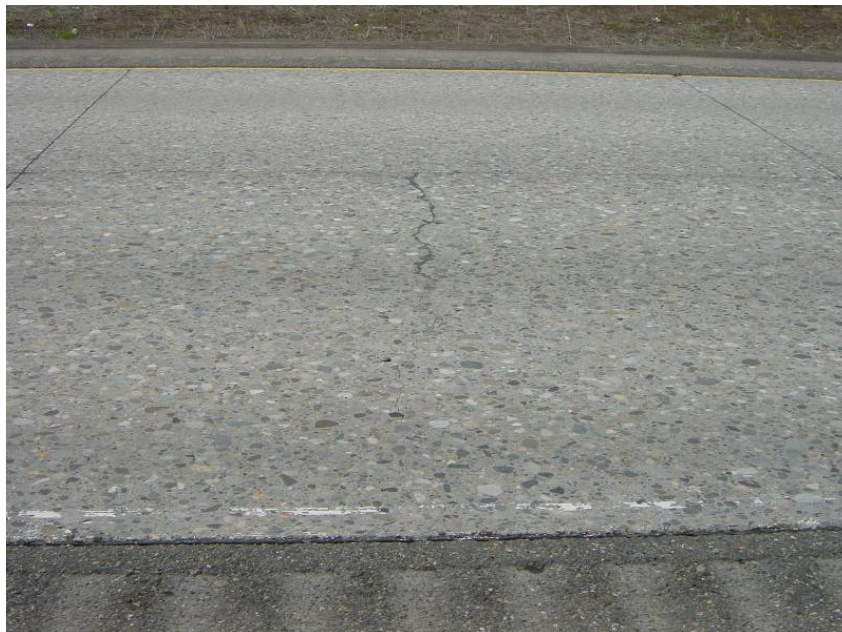
Figure 195 Transverse cracking after dowel bar retrofit.

In addition to the review of each individual dowel bar retrofit slot, an assessment was made to determine the presence of new transverse, longitudinal, and corner cracking that developed after dowel bar retrofit construction. Standard WSDOT practice applies dowel bar retrofits to all existing transverse cracks; therefore, any transverse crack noted from the review of the 2006 annual survey that had not been dowel bar retrofitted is assumed to have developed after dowel bar retrofit construction. Newly formed cracks will also have a relatively narrow crack width and may or may not extend across the entire slab width (Figure 195).

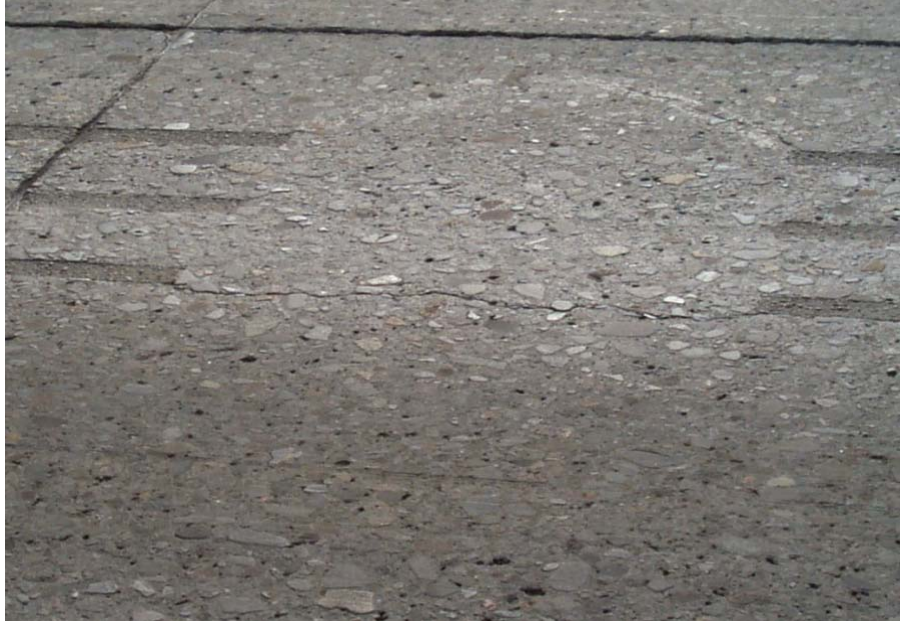
Figure 197 Longitudinal cracking after dowel bar retrofit.

For longitudinal cracking, the determination of crack development before or after dowel bar retrofit was not as clear as it was with transverse cracking. WSDOT practice, at a minimum, may only seal the longitudinal crack. In many cases the longitudinal crack will receive no treatment. Therefore, if the longitudinal crack had not been sealed (Figure 196) and a narrow crack width (Figure 197) was noted it was assumed that the longitudinal crack occurred after dowel bar retrofit.

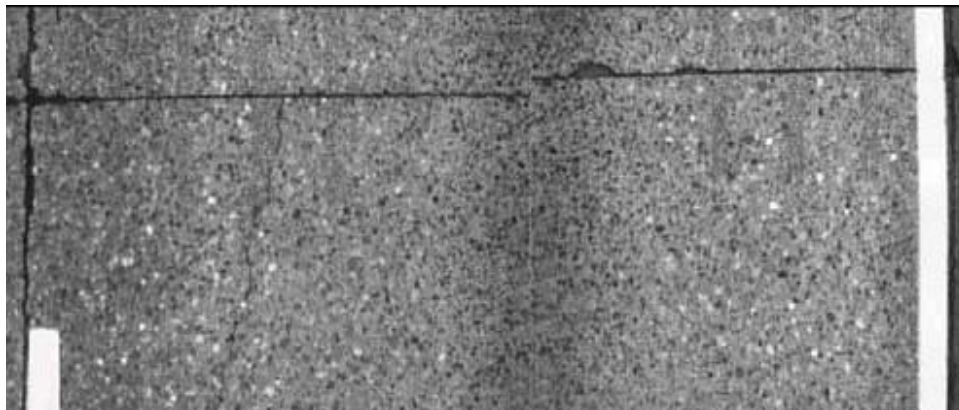
Figure 198 Corner cracking after dowel bar retrofit.

Similarly, any corner crack that was either not sealed or had a relatively narrow crack width (Figure 198) was estimated to have developed after dowel bar retrofit construction.

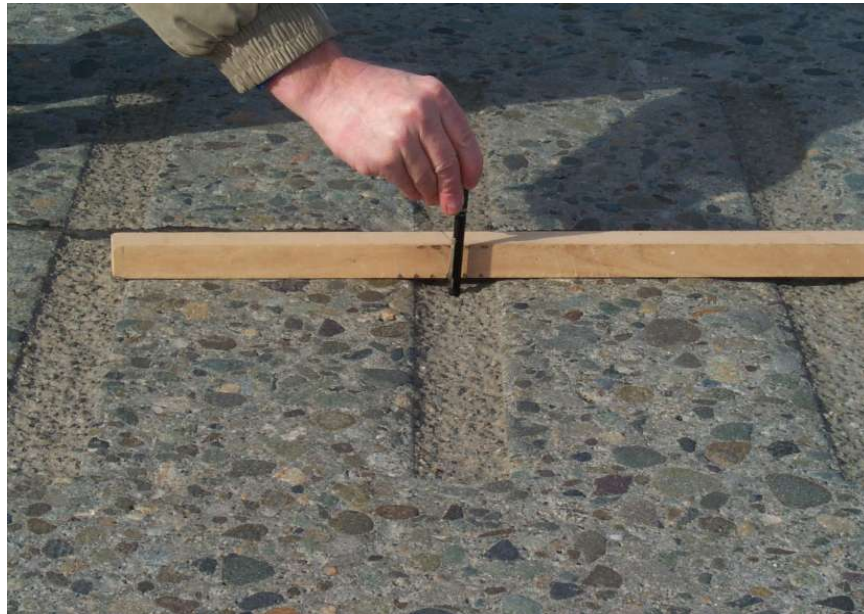
Figure 199 Studded tire wear of grout in dowel bar retrofit slot.

Studded tire damage – damage caused by studded tires is a prevalent form of distress on all concrete pavements in Washington State (WSDOT, 2006). Since the aggregate used in the

patching material for dowel bar retrofit consists of a smaller top size aggregate than the aggregate used in the original construction of the existing concrete pavement, the patching material may be more susceptible to studded tire wear. The dowel bar retrofit slot dimensions and the ability of the patching material to flow around the dowel bar limit the maximum aggregate size. Studded tire wear (Figure 199) within the dowel bar retrofit slot was noted on the first two dowel bar retrofit projects (Contracts 4235 and 4340) constructed on I-90 in the vicinity of Snoqualmie Pass. Wear within the dowel bar retrofit slot is the result of (1) high usage of studded tires and snow chains in this area, (2) the top size for the patching material aggregate was of insufficient size to minimize damage caused by studded tires, and (3) overworking of the patching material was noted during placement. Overworking of the patching material brings excessive bleed water and fines to the surface of the slot. This finer material is more susceptible to studded tire wear.

The first two dowel bar retrofit projects (Contracts 4235 and 4340) specified AASHTO Grading No. 57 for the extender aggregate. Due to the amount of noticeable wear after a short period of time, WSDOT realized that this aggregate gradation did not provide a sufficient uniform aggregate gradation (lack of intermediate size stone resulted in more area of paste between the larger stones, with the paste being more susceptible to studded tire wear) to minimize studded tire damage. In 1997 WSDOT modified the specification requiring the patching

material aggregate to meet either an AASHTO Grading No. 7 or No. 8 (Table 22). Since this specification modification studded tire wear within the dowel bar retrofit slots has not been noted on any other dowel bar retrofit project.

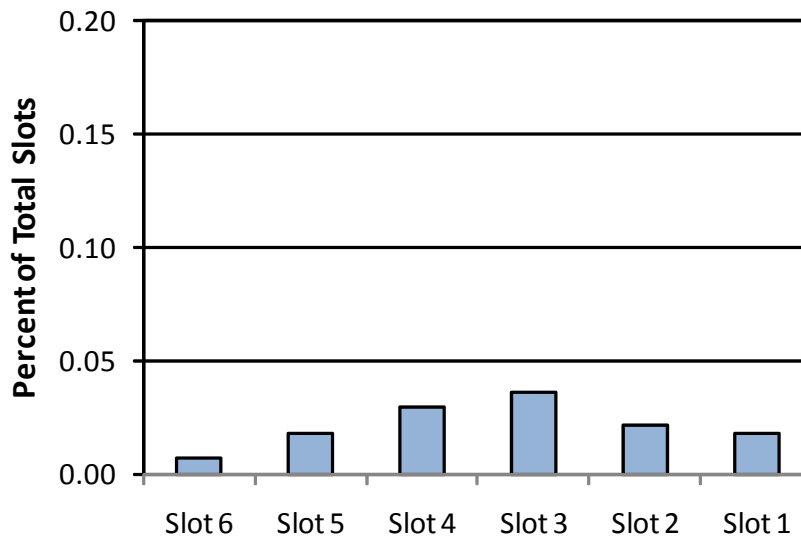
Figure 201 Patching material cracking by slot location.

Figure 201 illustrates the location and quantity of patching material cracking noted during the review of the 2006 pavement condition survey. For Washington State this distress occurs predominately in slots 3 and 4. Cracking within the patching material was found to occur in only 0.14 percent (or approximately three slots per mile) of the dowel bar retrofit slots. Figure 202 indicates the number of dowel bar retrofit slots per mile with patching material cracking.

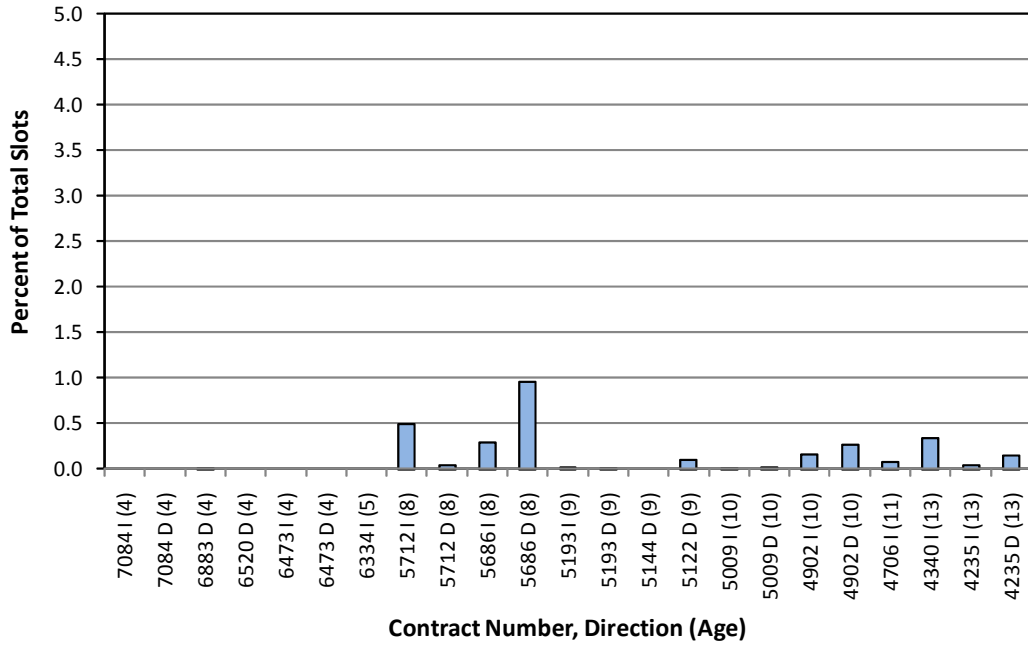
Figure 202 Patching material cracking by contract number.

As can be seen, the majority of the projects have a very low or no occurrence of patching material cracking.

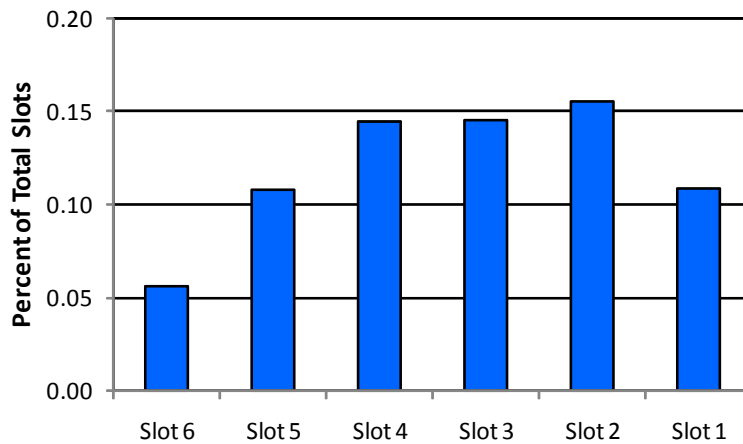
Figure 203 Patching material spalling by slot location.

Figure 204 illustrates the percent of dowel bar retrofit slots, by slot location, that have experienced spalling. Spalling has occurred in 0.73 percent (or approximately 15 slots per mile) of dowel bar retrofit slots. As with slot cracking, patching material spalling is not considered to be a major distress, since it occurs on such a low percentage of all dowel bar retrofit slots placed. There is a relatively even distribution of spalling in slots 2 through 4, with less spalling in slot 1 and relatively infrequent spalling in slot 6. Looking at slot orientation with respect to wheelpath locations, slots 1 through 5 receive higher load repetitions than slot 6 due to the proximity of both trucks and passenger vehicles to slots 1 through 5. The closer the proximity of Slot 6 to the adjacent lane, the fewer load repetitions and therefore the lower the spalling potential.

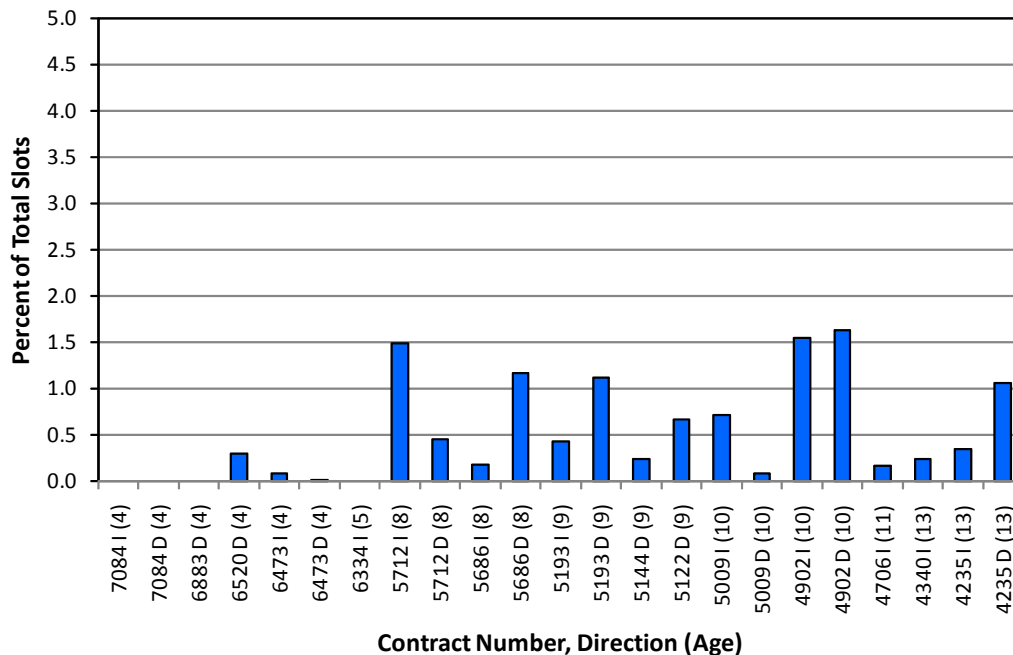
Figure 206 Patching material spalling by project.

Figure 206 illustrates the number of slots per mile that are spalled for each project reviewed. Slot spalling does not appear to be related to dowel bar age, though it is minimal in projects five years of age and less. Patching material spalling can be minimized via careful construction practices.

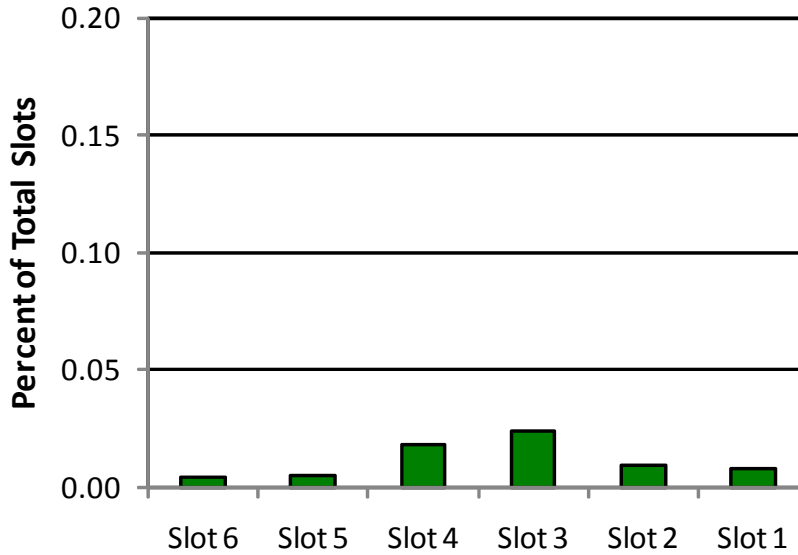
Figure 208 Patching material debonding locations.

Based on a review of WSDOT dowel bar retrofit projects, only 0.07 percent, or approximately two slots per mile (Figure 208) of dowel bar retrofit slots are exhibiting debonding. WSDOT has used the same dowel bar retrofit construction practices (Appendix A) for all dowel bar retrofit projects. A variety of patching material products (Fosroc Patchroc 10-60, CTS Rapid Set, Five Star Highway Patch, and Thoroc 10-60) have been used across the state. Based both on this and on the fact that very few of the dowel bar retrofit slots have failed due to debonding, it is believed that the debonding is a random distress related to inadequate cleaning of the sides of the dowel bar retrofit slot. As shown in Figure 209, debonding occurs infrequently on any given project and, when present, debonding occurs on less than 0.05 percent of all dowel bar retrofit slots.

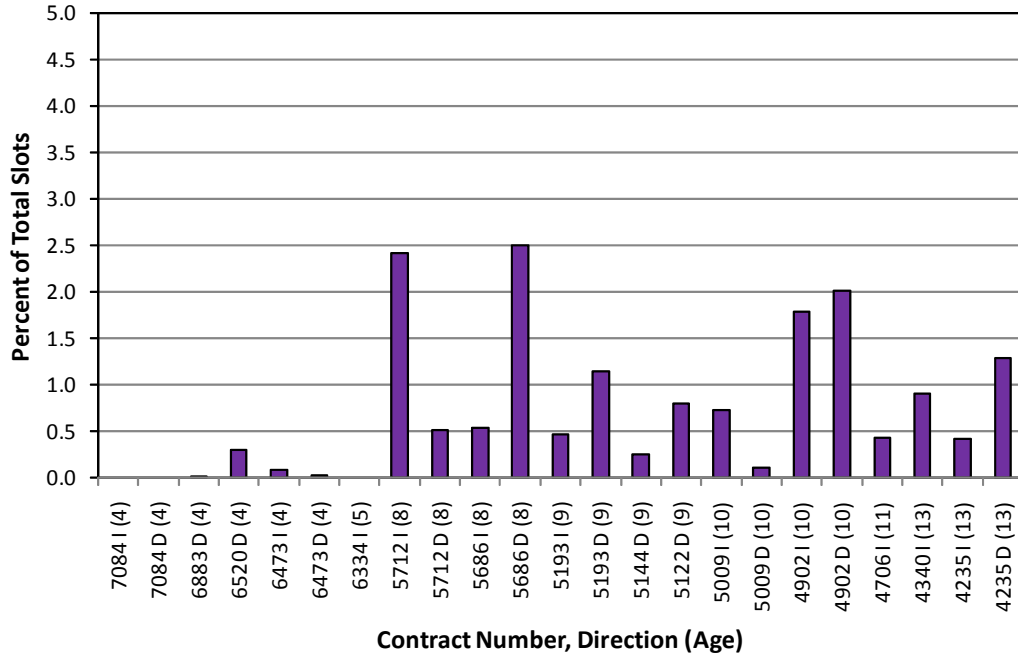
Figure 210 Number of total distressed slots by contract number.

In summary, approximately half of the reviewed projects have less than 0.5 percent (or 10 distressed slots per mile) of slots distressed with either patching material cracking, spalling, or debonding (Figure 210); only six projects have more than one percent (or 20 distressed slots per mile). As expected younger projects have fewer distressed slots, but three of the four oldest projects have less than one percent distressed slots per mile. It can be concluded that patching

material distress is a very infrequent occurrence on Washington State dowel bar retrofit projects. This suggests that considerable care was taken during the dowel bar retrofit construction and inspection process.

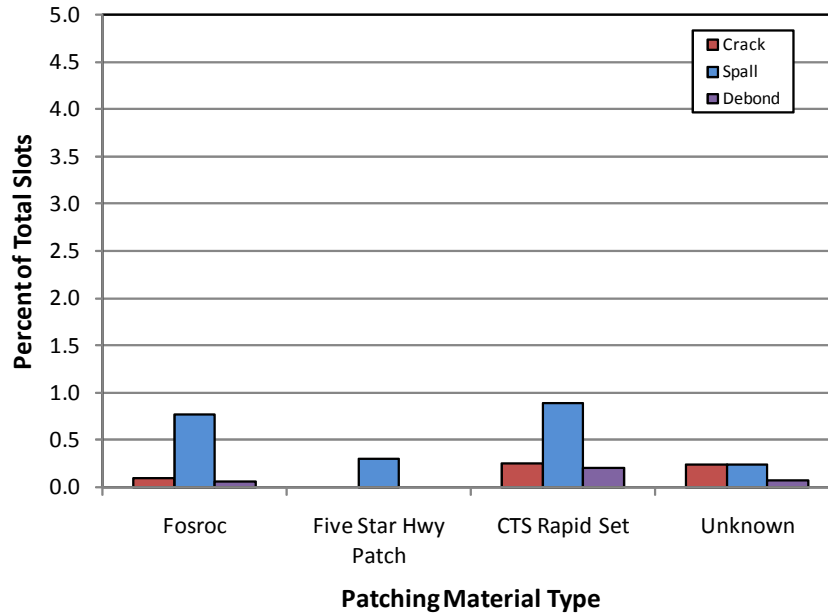
Figure 211 Distress by patching material type.

Even though dowel bar retrofit slot distress is very infrequent, an investigation was conducted to determine if any particular patching material product had improved performance over any other patching material product. Four patching material products have been predominately used in Washington State: Fosroc 10-60, which is currently manufactured as Thoroc 10-60; Five Star Highway Patch; and CTS Rapid Set. On six projects, the documentation on the type of patching materials used was unavailable. Therefore for this analysis these projects are shown as unknown. Figure 211 summarizes the various patching material products according to distress type.

The predominant distress in any patching material product is spalling and occurs on a higher frequency of the dowel bar retrofit slots that utilized the Fosroc/Thoroc and the CTS Rapid Set materials. Fosroc/Thoroc is the most predominant material (79 percent) used, while the CTS Rapid Set material is a distant second with 11 percent utilization (Table 23).

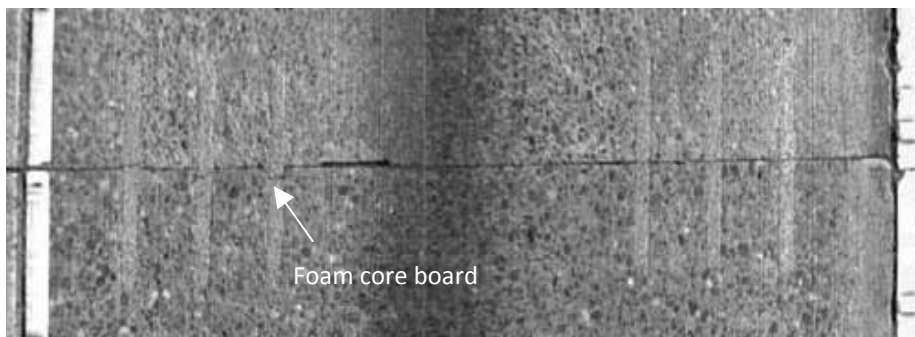
Figure 214 Misaligned foam core board.

Misaligned foam core board – is defined as the movement of the foam core board away from the transverse joint (Figure 214). Misalignment of the foam core board can occur due to (1) incorrect foam core board dimensions, which allows the foam core board to move during patching material placement; (2) improper placement of the foam core board on the dowel bar in relation to the transverse joint; (3) movement of either the entire dowel bar retrofit assembly or the foam core board during placement or consolidation of the patching material.

The primary concern with misaligned foam core boards is the occurrence of spalling between the foam core board and the transverse joint. Misalignment of the foam core board is an uncommon distress on Washington State dowel bar retrofit projects, occurring on only 0.06 percent (or fewer than two slots per mile) of dowel bar retrofit slots (Figure 215).

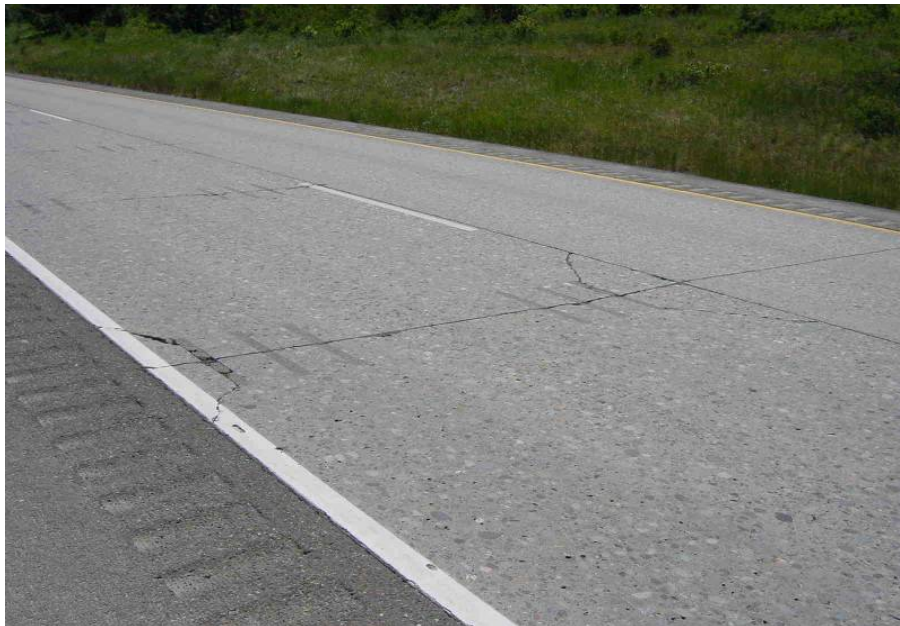
Figure 216 45-degree cracking.

45-degree cracking – is defined as a crack that develops between the end of the dowel bar retrofit slot and the longitudinal joint or lane edge (Figure 216), occurring at a 45 degree angle. With continued traffic loading, cracking within the patching material as well as the potential of settlement of the concrete within the 45-degree crack area can occur.

One project on I-90 (Contract 4902) had several hundred consecutive joints which were distressed with 45-degree cracking. WSDOT conducted a forensic investigation on this project and concluded (Uhlmeier, 2001):

- Specifications required that dowel bar retrofit slots be cut to a depth of 5-¾ inches; however, cores showed that slots had been cut to a depth of seven inches;
- Heavy (60 pounds) jackhammers were used for concrete removal;

Cutting the dowel bar retrofit slot too deep, in combination with the use of heavy jackhammers, may have caused cracking in the bottom of the dowel bar slot, which in turn may have increased the potential for the jackhammer to punch through the bottom of the slot. In addition, if the slots were cut too deep, there is a potential that the dowel bars were not placed at the neutral axis. The result of both of these possibilities would result in higher stresses around the dowel bar that could lead to the development of a 45-degree crack. In 1997, WSDOT revised the special provisions to limit the jackhammer size to less than 30 pounds. In addition, inspectors are now asked to confirm that slots have been properly constructed.

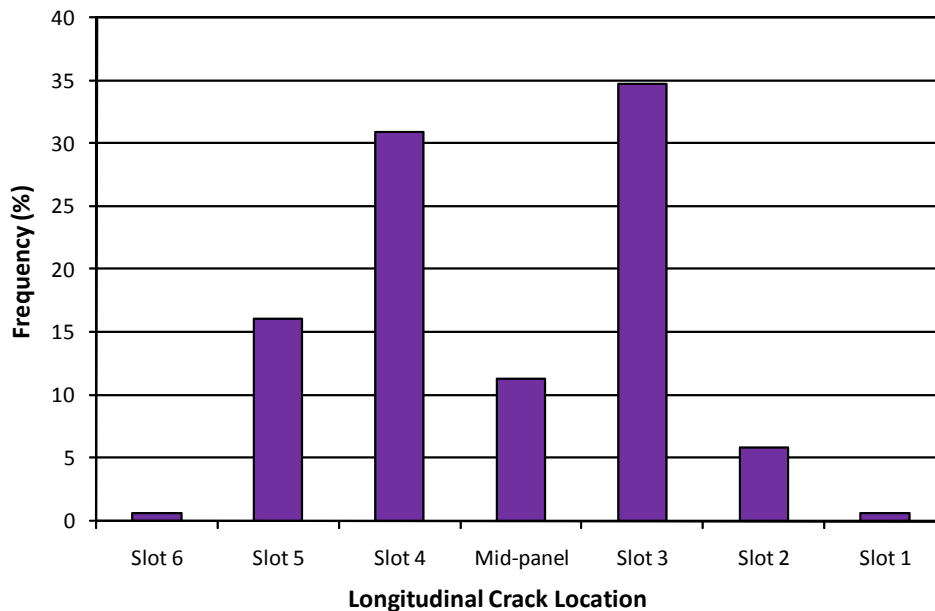
Figure 223 Longitudinal cracking after dowel bar retrofit by slot location.

A 10 percent sample length (first mile of each 10 mile segment) of the dowel bar retrofit projects was conducted. From this analysis it was determined that 35 percent of the new longitudinal cracks originated in the vicinity of slot 3, and 31 percent of the new longitudinal cracking originates in the vicinity of slot 4 (Figure 223), with over 75 percent of all longitudinal

cracks originating between slots 3 and 4. From this it appears that the development of new longitudinal cracking is not a function of slot proximity to the lane edge. However, it is interesting that the propensity of longitudinal cracking originates in slots 3 and 4, both of which are at the inner most locations of each wheelpath. It is unclear if this is a function of dowel bar retrofit. This will be investigated as part of the finite element analysis.

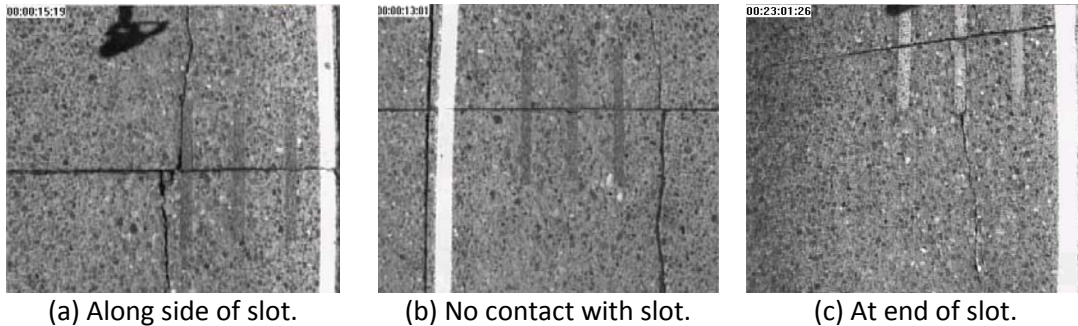
Figure 224 Longitudinal crack location with respect to dowel bar retrofit slot.

Three crack locations were identified: (1) along the dowel bar retrofit slot; (2) no contact with a dowel bar retrofit slot; and (3) at the dowel bar retrofit slot (Figure 224). The results of this analysis shows that approximately 63 percent of the cracks initiate along the slot edge, 35 percent of the cracks have no contact with the dowel bar retrofit slot, and two percent of the cracks initiate at the end of the dowel bar retrofit slot. Though a high percentage of longitudinal cracks originate at the dowel bar retrofit slot, the development of the longitudinal crack cannot be totally explained by the discontinuity caused by placement of the dowel bar retrofit slot. In

concrete pavements typically, discontinuities result in the potential for a high stress location which can lead to the development of a crack. At this time longitudinal cracking is not believed to cause a significant reduction in performance (as related to faulting or pavement roughness). The Finite Element Analysis chapter evaluates several different dowel bar retrofit scenarios and determines if a high stress location occurs that could potentially assist in explaining the development of the longitudinal cracking.

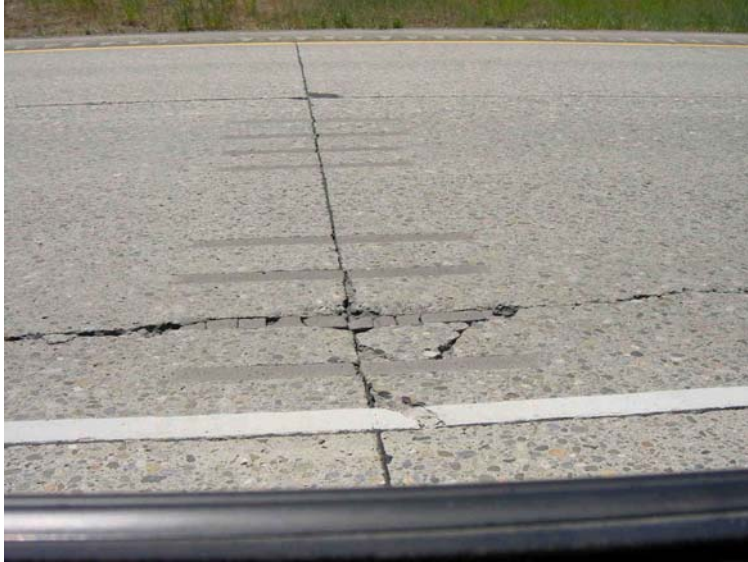
Figure 225 Existing longitudinal crack at dowel bar retrofit slot.

Based on the performance of the first several dowel bar retrofit projects, WSDOT determined that if an existing longitudinal crack intersects a dowel bar retrofit slot failure of the dowel bar retrofit slot will occur (Figure 225). Typically, the failure mechanisms are cracking, debonding, and eventual loss of material within the dowel bar retrofit slot. To minimize this distress, the dowel bar retrofit slots should be realigned to avoid the existing longitudinal crack, sawcut but not retrofitted (Figure 226), or completely eliminated (Figure 227). This modification has been included in the WSDOT Standard Specification, Section 5-01.3(6).

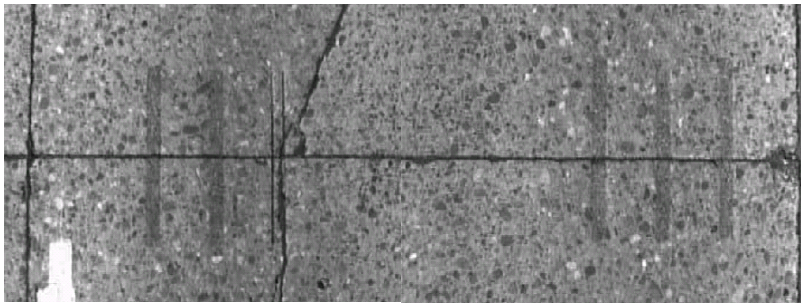
Figure 226 Dowel bar retrofit slot cut but not retrofitted to avoid longitudinal crack.

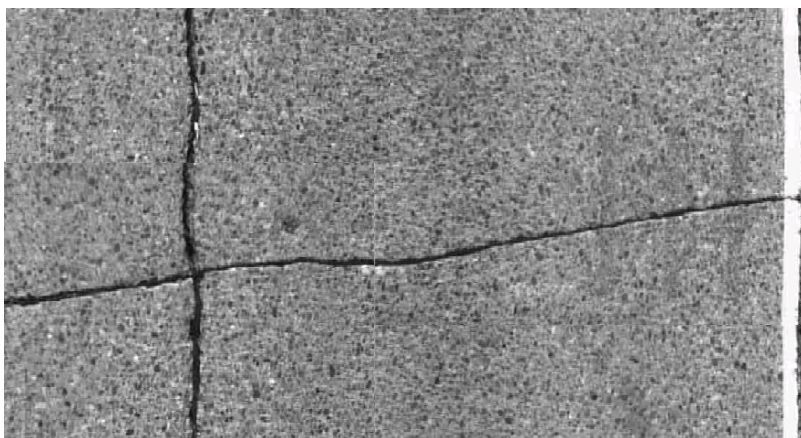
Figure 227 Dowel bar retrofit eliminated in left wheelpath to avoid longitudinal crack.

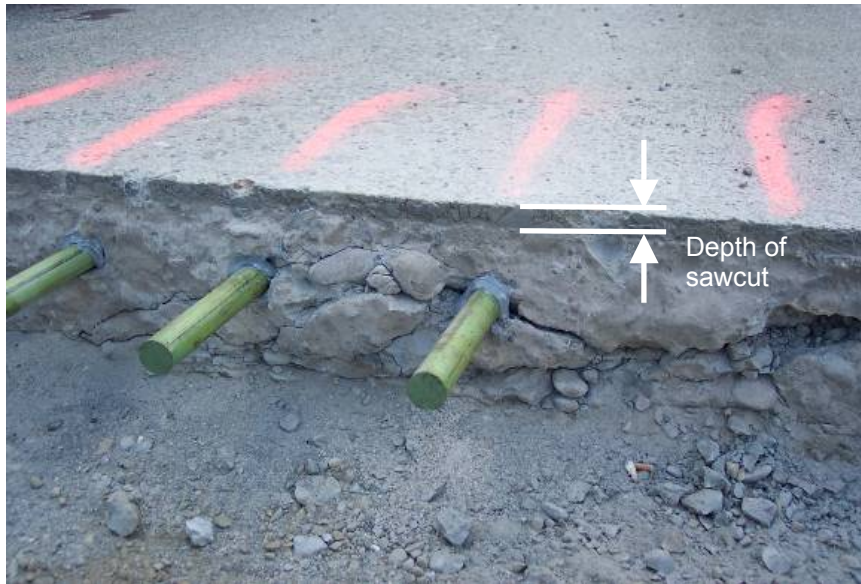
- Project records showed the existence of poor soil conditions in numerous locations, yet contract plans did not clearly identify areas for excavation, many of which were not addressed during panel replacement. However, not all areas that had been identified with weak soils resulted in panel cracking;
- Construction details included sawcutting the perimeter of the panels to be removed, breaking of panels with a guillotine style hammer, removing concrete with a backhoe equipped with a hoe point, and loading into end dumps with a backhoe. Dowel and tie bar holes were drilled into the existing adjacent panels using a pneumatic driven impact hammer (typical on WSDOT projects);
- In several instances full depth sawcutting did not occur (Figure 236);

Figure 236 Panel not sawcut full-depth.

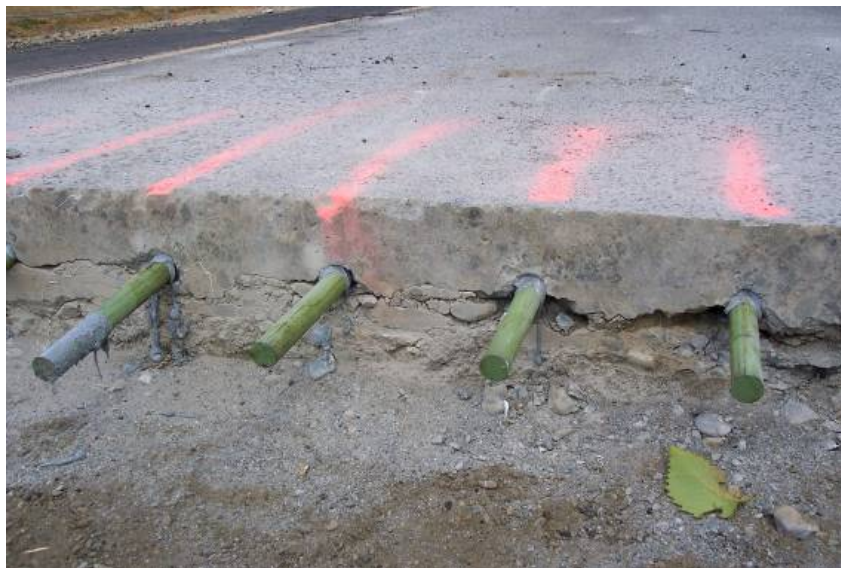
- During dowel bar installation spalling (Figure 237) beneath the dowel bars occurred and, at many locations, dowel bars were eliminated due to excessive spalling;

Figure 237 Spalling of concrete slab during drilling for dowel bars.

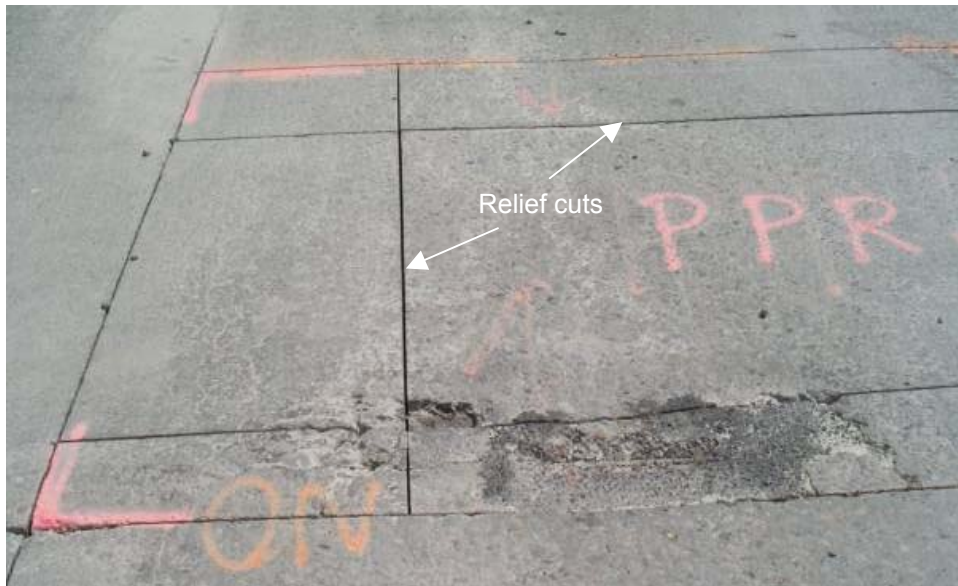
Figure 238 Relief cuts for panel replacements.

- Full depth relief cuts (Figure 238) are necessary to eliminate spalling. Relief cuts should be made at 18 inches inside the longitudinal and transverse joints. Pavement breaking would be restricted to the area inside the relief cuts. Relief cuts will also eliminate the transfer of force caused by the guillotine hammer to adjacent panels, which is the likely contributor to the panel cracking;
