RESEARCH REPORT
Agreement T2695, Task 90
DBR Evaluation

**EVALUATION OF DOWEL BAR RETROFIT
FOR LONG-TERM PAVEMENT LIFE
IN WASHINGTON STATE**

May 2009

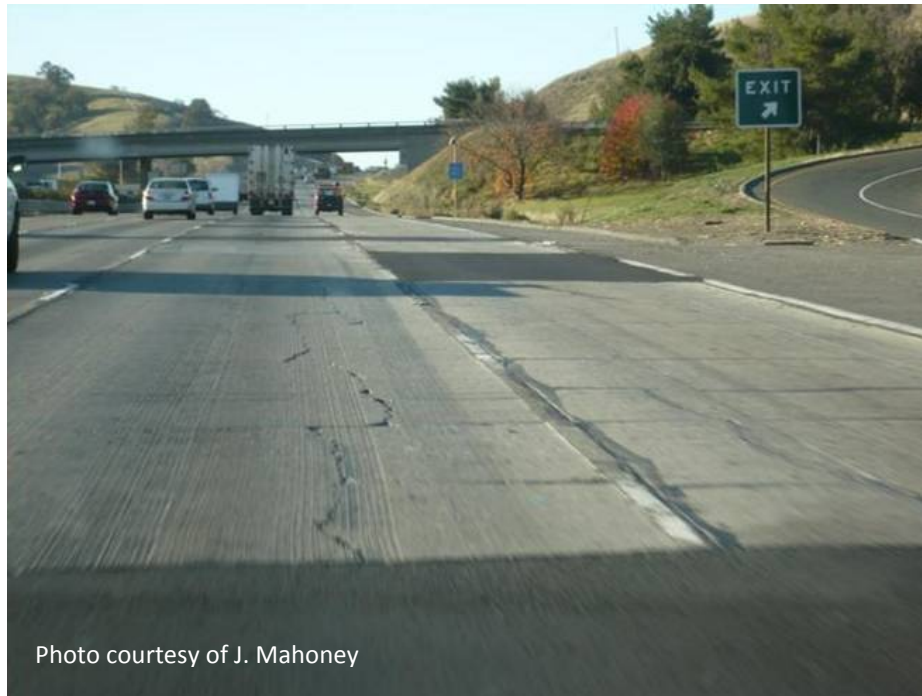
Work conducted by the California Department of Transportation (Caltrans) has shown that a relatively thick (4.2 inch) HMA overlay has performed well on severely faulted and cracked concrete pavements (Figure 240). The typical concrete pavement section in California consists of eight to 10 inches of undoweled concrete over a cement treated base. The Caltrans HMA overlay design practice includes placement of 1.2 inches of a HMA leveling course, an asphalt impregnated pavement reinforcement fabric, and a three inch HMA wearing surface (Lea et al., 2002). Performance life for this overlay design prior to needed rehabilitation ranges from 10 to 15 years, this includes either a mill and fill⁷ or a traditional HMA overlay (Harvey et al., 2007).

Figure 240 Severely deteriorated concrete pavement (I-80, California).
