# Field Analysis of Wood Guardrail Post Decay

WA-RD 890.1

WSDOT Research Report

Research Project T1462, Task 16

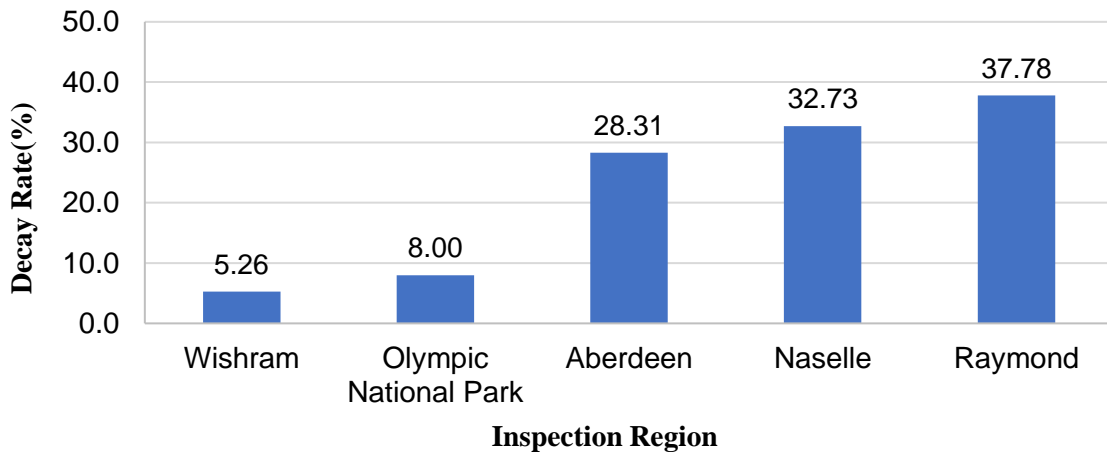
**Figure 10.** Decay rate for inspection regions

The decay rate of the inspected posts can be further classified by inspection region (shown in Figure 2), presented in Table 3. The Raymond and Naselle regions had the highest decay rates of approximately 38% and 33%, respectively. The Olympic National Park and Wishram regions had the lowest decay rates of approximately 8% and 5%, respectively. Scheffer climate index was used to quantify the environmental conditions

in each region and was calculated as the average climate index for the posts located in that region. Figure 10 presents the decay rate for each region and Figure 11 shows the decay rate for each region versus climate index.

As shown by Table 3 and Figure 10, the highest timber decay risk location in the sample was found to be in Raymond, with a decay rate of approximately 38%. The inspection regions of Aberdeen and Naselle had the next highest decay rates of approximately 30%. Additionally, Figure 11 and 12, demonstrate that Scheffer climate index is likely a good predictor of high decay rates. For posts in regions with climate index less than 40, virtually no cases of decay were found during field evaluations.

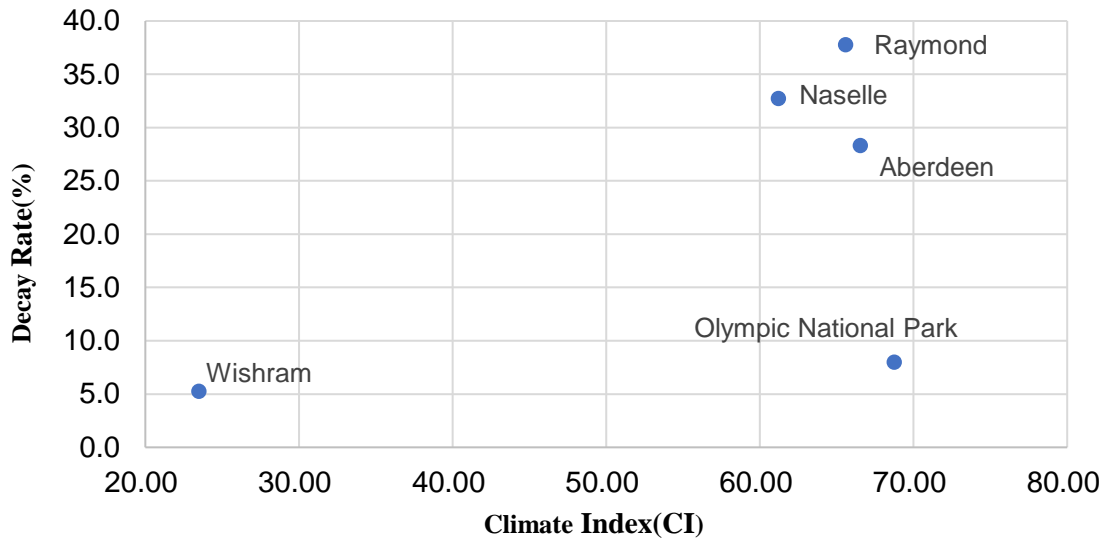
**Figure 11.** Decay rate versus climate index for inspection regions

Figure 11 clearly shows that the regions with higher climate index (CI) had significantly higher rates of decay. To understand more about the relationship between the climate index and wood post decay, the individual posts SWT velocity at the ground level (GL) were plotted versus the climate index of their location, shown in Figure 12. Based on the SWT Equation 1, a wave velocity for sound Hemlock was calculated to be approximately 38 in./ $\mu$ s, using the AWC/ANSI *National Design Specification* value for density and modulus (AWC 2015). For values of CI less than 40 only a handful of posts fell below the sound wood velocity of 38 in./ $\mu$ s, whereas for values of CI above 60 approximately 40% of the posts had velocities below 38 in./ $\mu$ s.

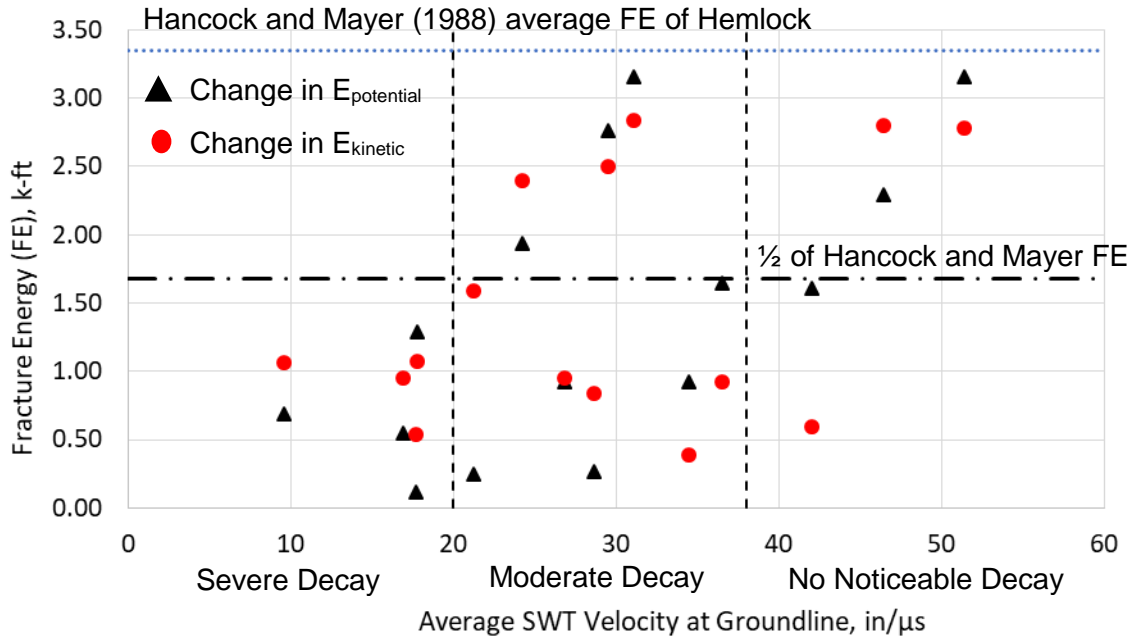
**Figure 17.** SWT velocity at ground level versus fracture energy

Lastly, Figure 17 presents the calculated fracture energies of the 15 posts using both methods. It can be seen that there is a substantial difference in calculated fracture energy between the two methodologies for an individual post, though the same trends exist. The fracture energy of new, stress-graded Hemlock posts, as tested by Hancock and Mayer (1988), is shown in Figure 17 to be 3.35 k-ft. None of the 15 posts achieved this fracture energy. There could be several reasons for this, but the most likely one is the age of the posts (>20 years in service) since the sound posts were not far below the Hancock and Mayer (1988) test data. None of the posts having severe decay, or SWT velocities at the ground level less than 20 in./ $\mu$ s, were able to attain half the fracture energy of the new sound posts from Hancock and Mayer (1988). Only half of the moderately decayed posts had fracture energy greater than half of the Hancock and Mayer (1988) tests. Interestingly, two of the moderately decayed posts had approximately the same fracture energy as two of the posts with no noticeable decay.

The impact testing results present a different conclusion on the effect of wood decay than previously conducted static bending tests, where even severe decay did not cause posts to lose their flexural capacity (Olszko and Bender 2015). In this case, the fracture energy of decayed posts was significantly less than that of sound posts. Table 5 presents the impact testing results for each post, including field and laboratory SWT velocity at the ground level, impact velocity, final velocity, peak negative pendulum displacement, and fracture energy calculated with both methods.
