CMH-17
COMPOSITE MATERIALS HANDBOOK

Inspection and Teardown of Aged In-Service Bonded Repairs

May 23, 2018

Waruna Seneviratne, John Tomblin, and Brandon Saathoff

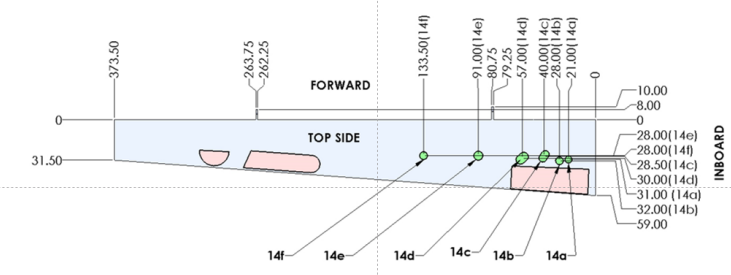
Repair 14A NDI Results

- The repair intersected a line of tape on the surface of the component.
- Core replacement and repair appear to be in good condition.
- One indication observed in the parent material (circled).

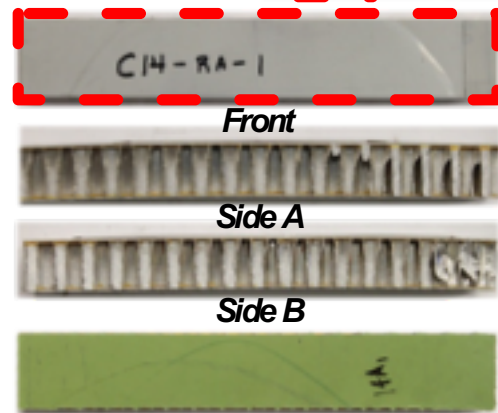
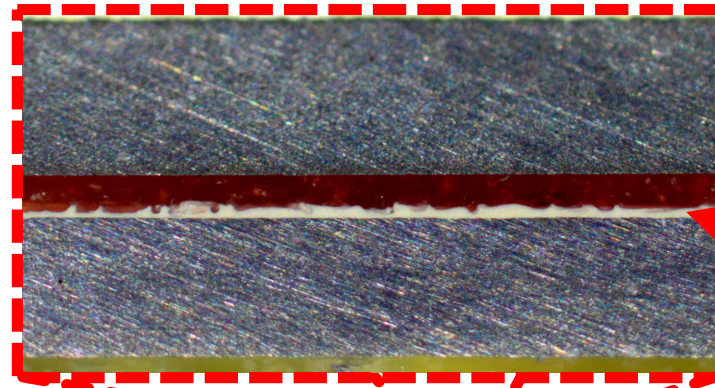
Specimen: C14-RA-1 (Side A)

Material of Concern

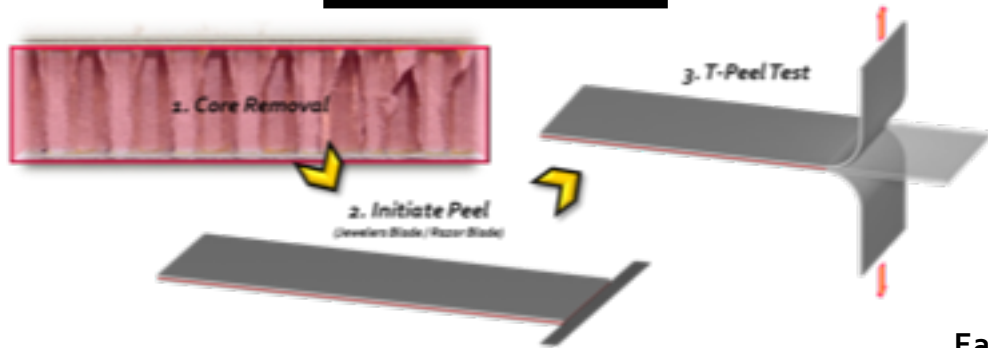
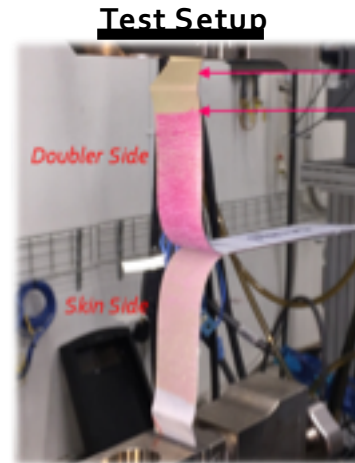
Repair Mechanical Testing – T-Peel

- T-Peel (ASTM D1876)
 - Repair Peel Strength: $\approx 64\%$ of BL panels
 - Repair failure along interfacial anomaly
 - BL specimens: Cohesive failures

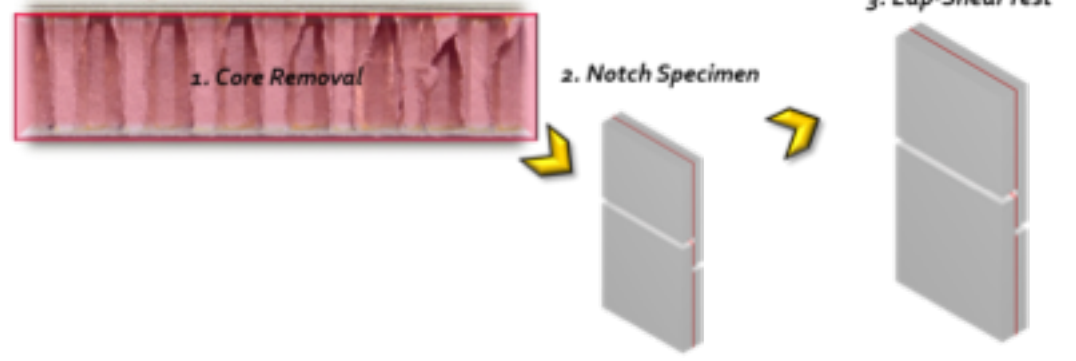
Repair Mechanical Testing – Lap-Shear

- Lap-Shear Testing (ASTM D3165)
 - Repair Shear Strength at failure: $\approx 50\%$ of BL panels
 - BL specimen failure controlled by adherend tensile strength
 - Repair specimens: Adhesive failure (primer)

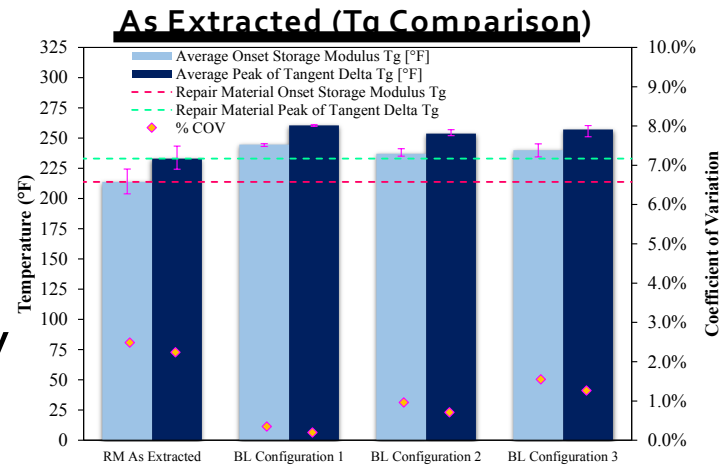
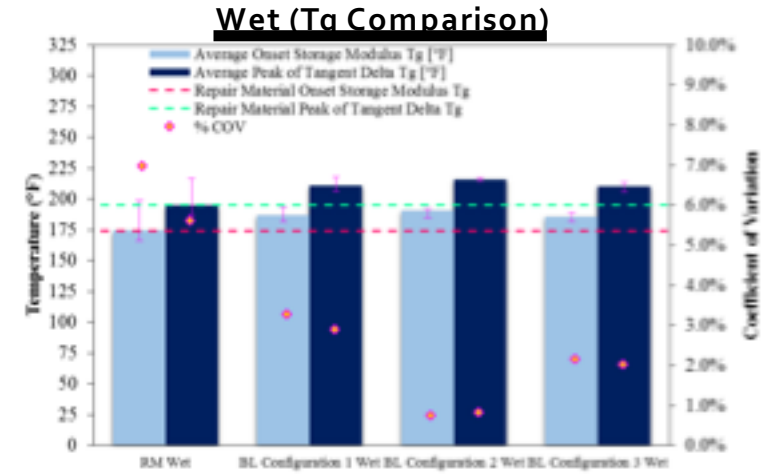
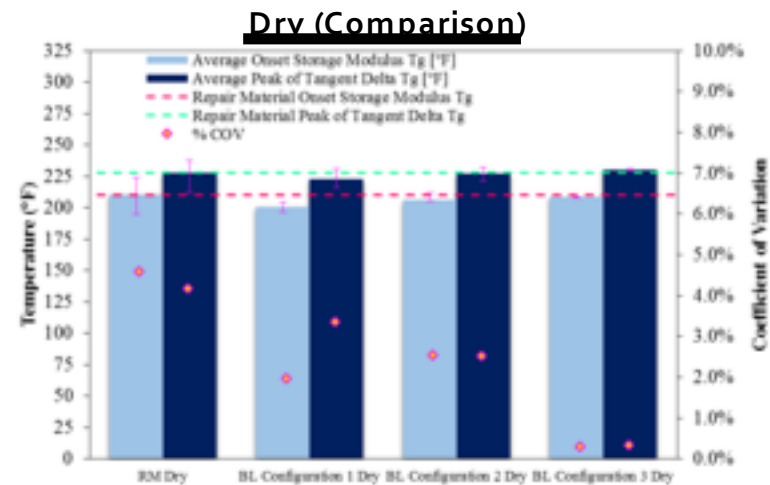
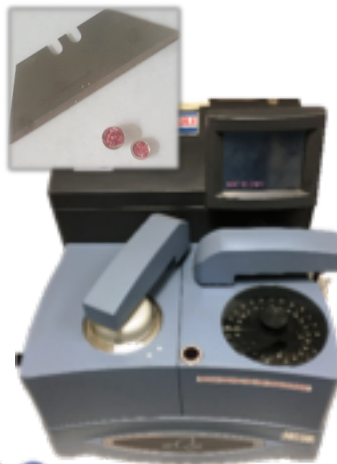
Thermal Analysis

- Dynamic Mechanical Analysis
 - As extracted
 - Conditioned: Dry
 - Conditioned: Wet
- Differential Scanning Calorimetry
 - Degree of Cure (%DOC)

- Interfacial anomaly found in 2 out of 3 repairs
 - T_g higher for repair with no interfacial anomaly
- **Thermal analysis**
 - T_g of the repair material to be within 8% of the BL panels in as extracted moisture configuration
 - Average repair adhesive DOC $\approx 97\%$

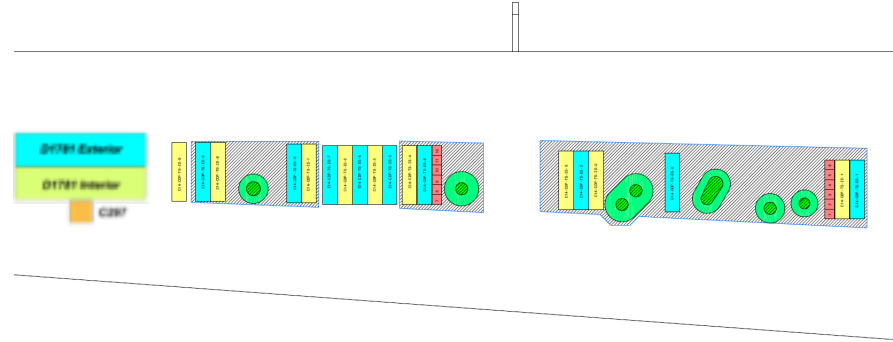
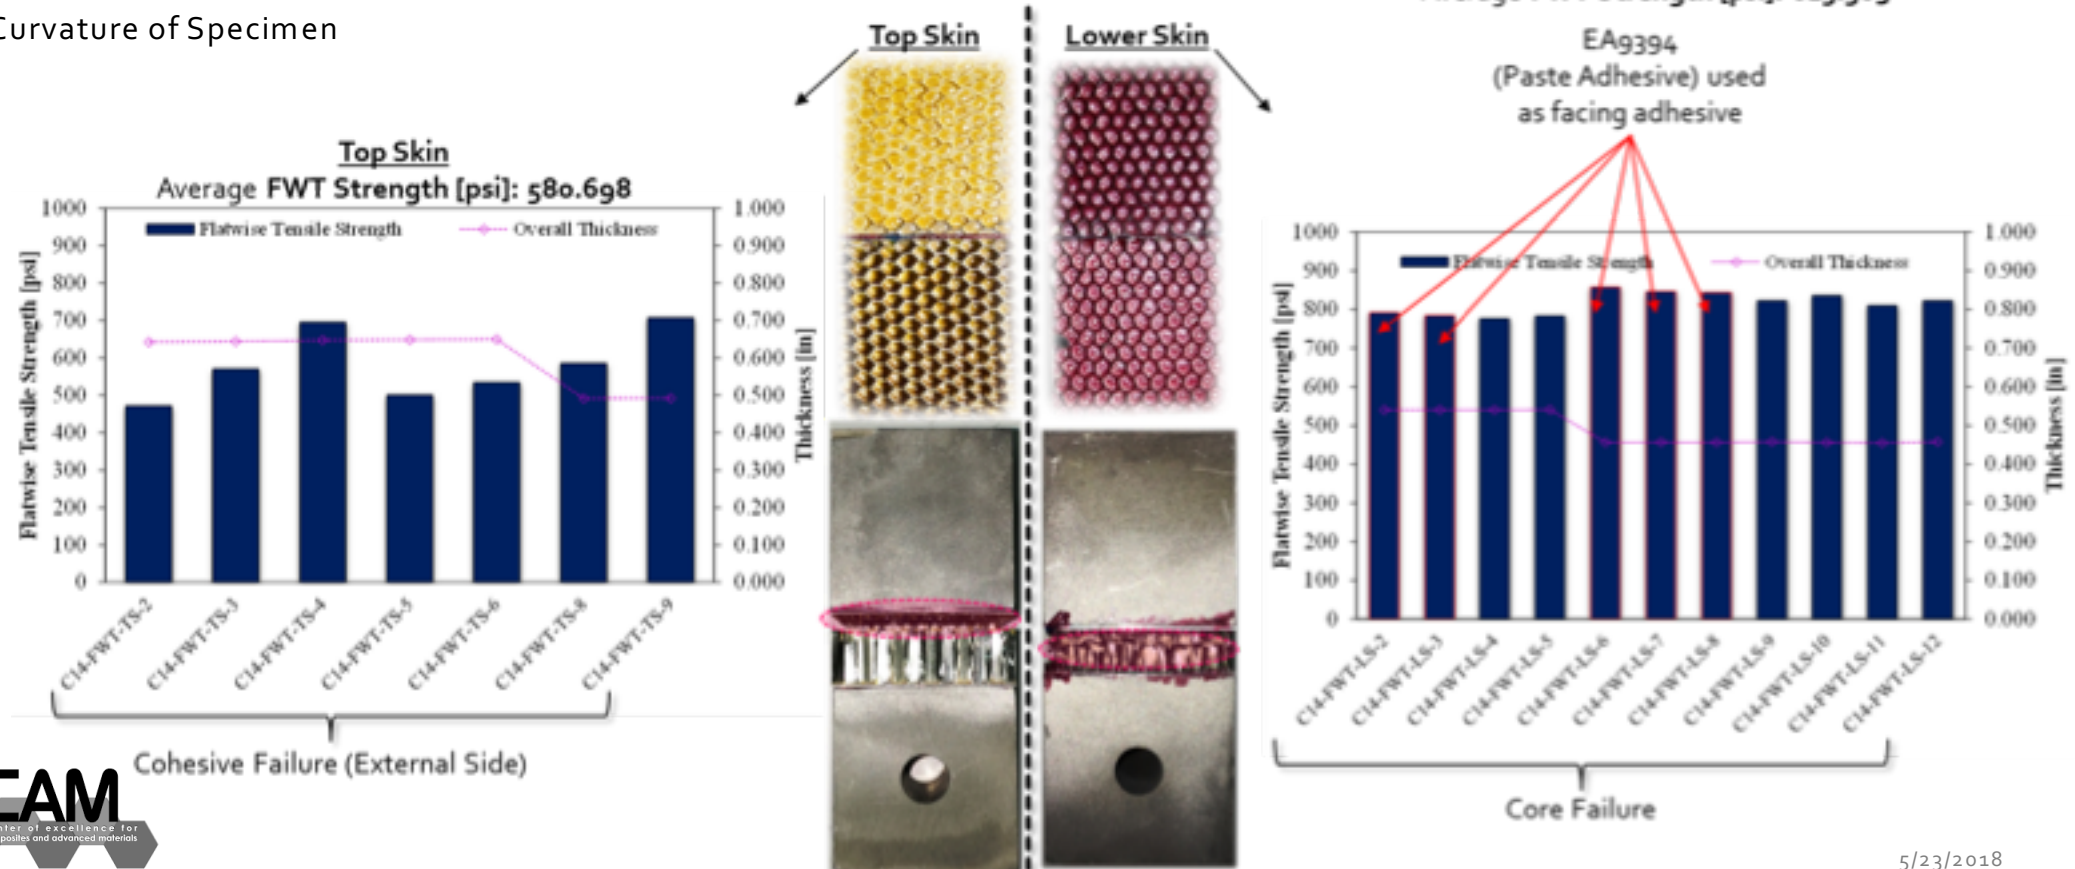
C14 Parent Material Mechanical Testing – FWT

- Flat-wise Tensile Strength (C297)
 - Top and Bottom Skin Evaluated
- Nuisance Variables
 - Adherend Thickness
 - Core Thickness
 - Curvature of Specimen

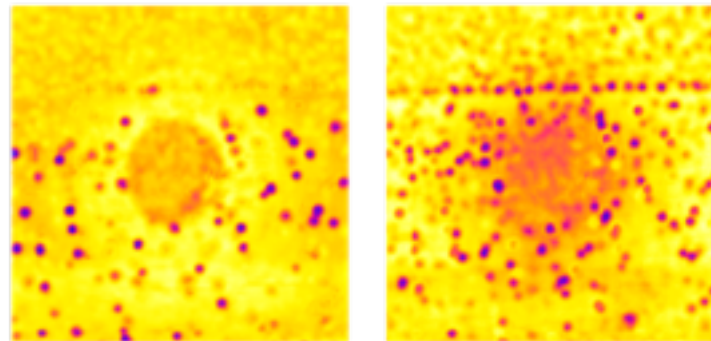
MAUSV – RESONANCE, 160KHz

- Structural Level Inspection Findings
 - Visual
 - Repair extended away from surface (not fully flush)
 - Paint Cracking
 - Speckling pattern noticed in many repairs and surrounding structure (Component 4 & 9)
 - Known that honeycomb structure can exhibit long-term degradation due to thermodynamic effects of trapped moisture in the honeycomb cells
 - Note that this can be evaluated away from the repair as it is seen in parent structure

Repair 4F

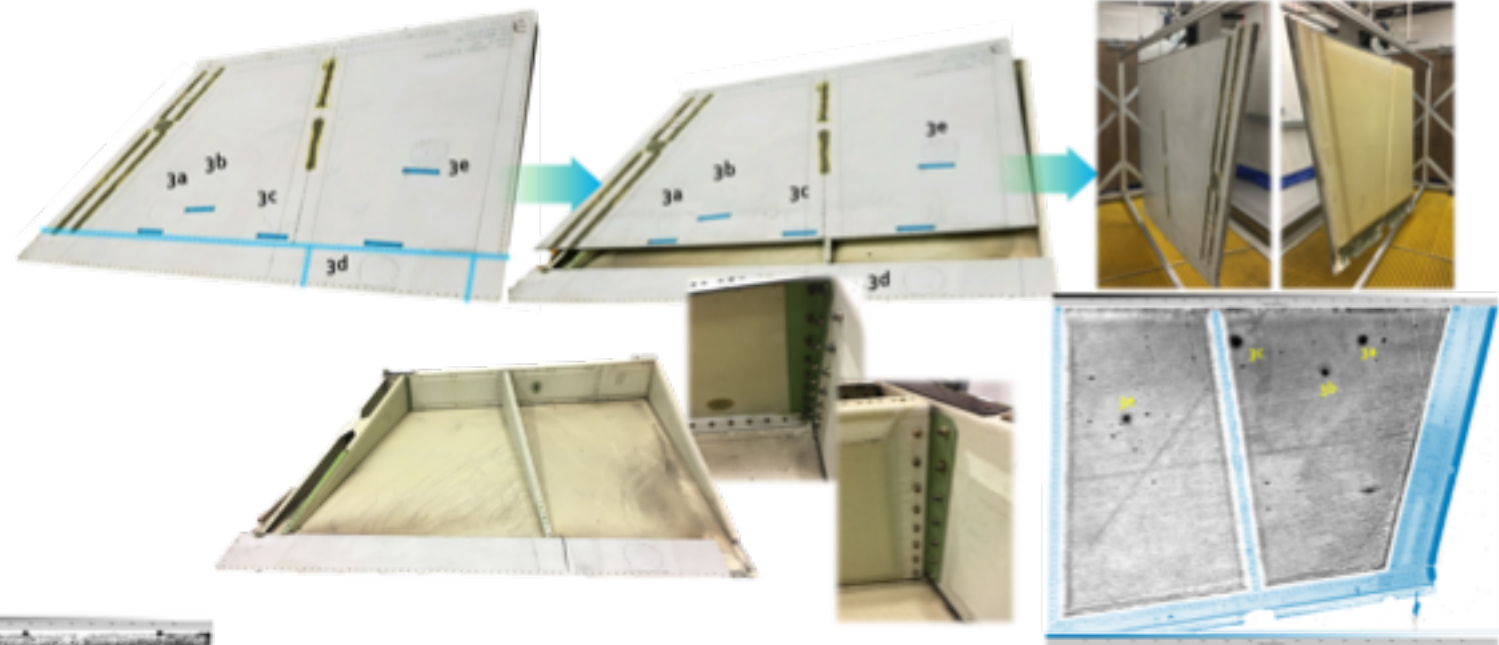
Component 3 (I/B Elevator)

- Panel Extractions
 - Detailed Inspections
 - TTU C-scans
 - X-ray CT
 - Specimen/Element Extractions

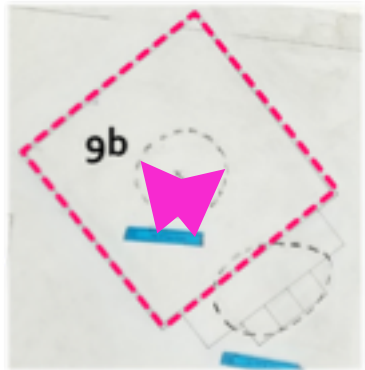
MAUSV - RESONANCE, 160kHz

- Repair gb
 - X-ray Computed Tomography

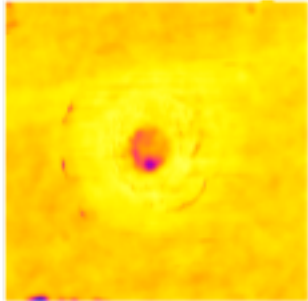
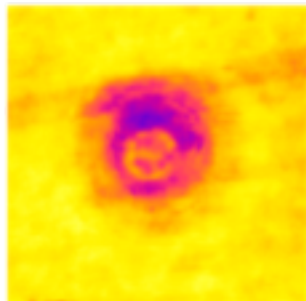
MAUS V – RESONANCE, 160KHz

- Repair 3e
 - X-ray Computed Tomography
 - No indication of speckling
