RESEARCH REPORT
Agreement T4118, Task 02
Pavement Deterioration

**ASSESSMENT OF THE I-5
PORTLAND CEMENT CONCRETE PAVEMENTS
IN KING COUNTY**

December 2007

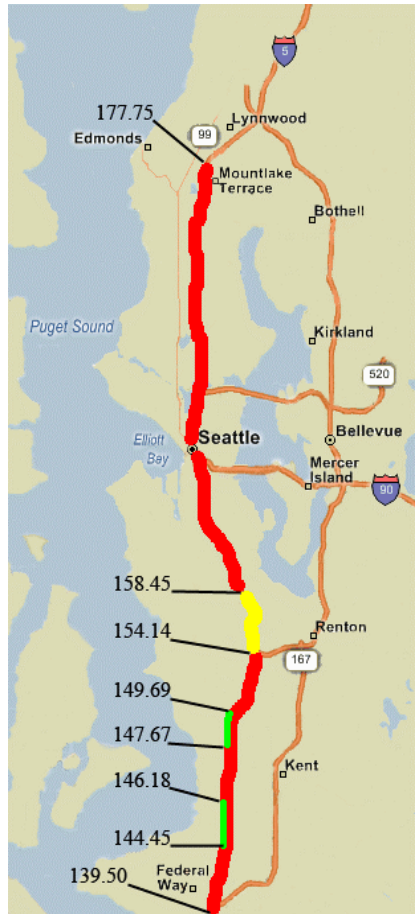
Figure 3.1. I-5 King County PCCP in 2004

The majority of the existing I-5 PCCP in King County was constructed between 1962 and 1971, and as of 2004, it had not been reconstructed or rehabilitated. Out of a total of 195.7 lane miles (refer to Figure 3.1), I-5 in King County has 162.9 lane miles of non-rehabilitated PCCP, or 83 percent. As might be expected given their age and traffic, these pavements are showing significant distress.

About 41 lane miles of diamond ground PCCP are on I-5 in King County. This grinding occurred in 1999 in both the northbound and southbound directions between mileposts 154.14 and 158.45 (refer to Figure 3.1). The performance of the ground PCCP exceeds that of the non-rehabilitated PCCP, as expected.

There are only two sections of dowel bar retrofit (DBR) and diamond ground PCCP on I-5 within King County (a total of 6.04 lane miles). As seen in Figure 3.1, these sections exist on southbound I-5 from mileposts 144.45 to 146.18 and mileposts 147.67 to 149.69.

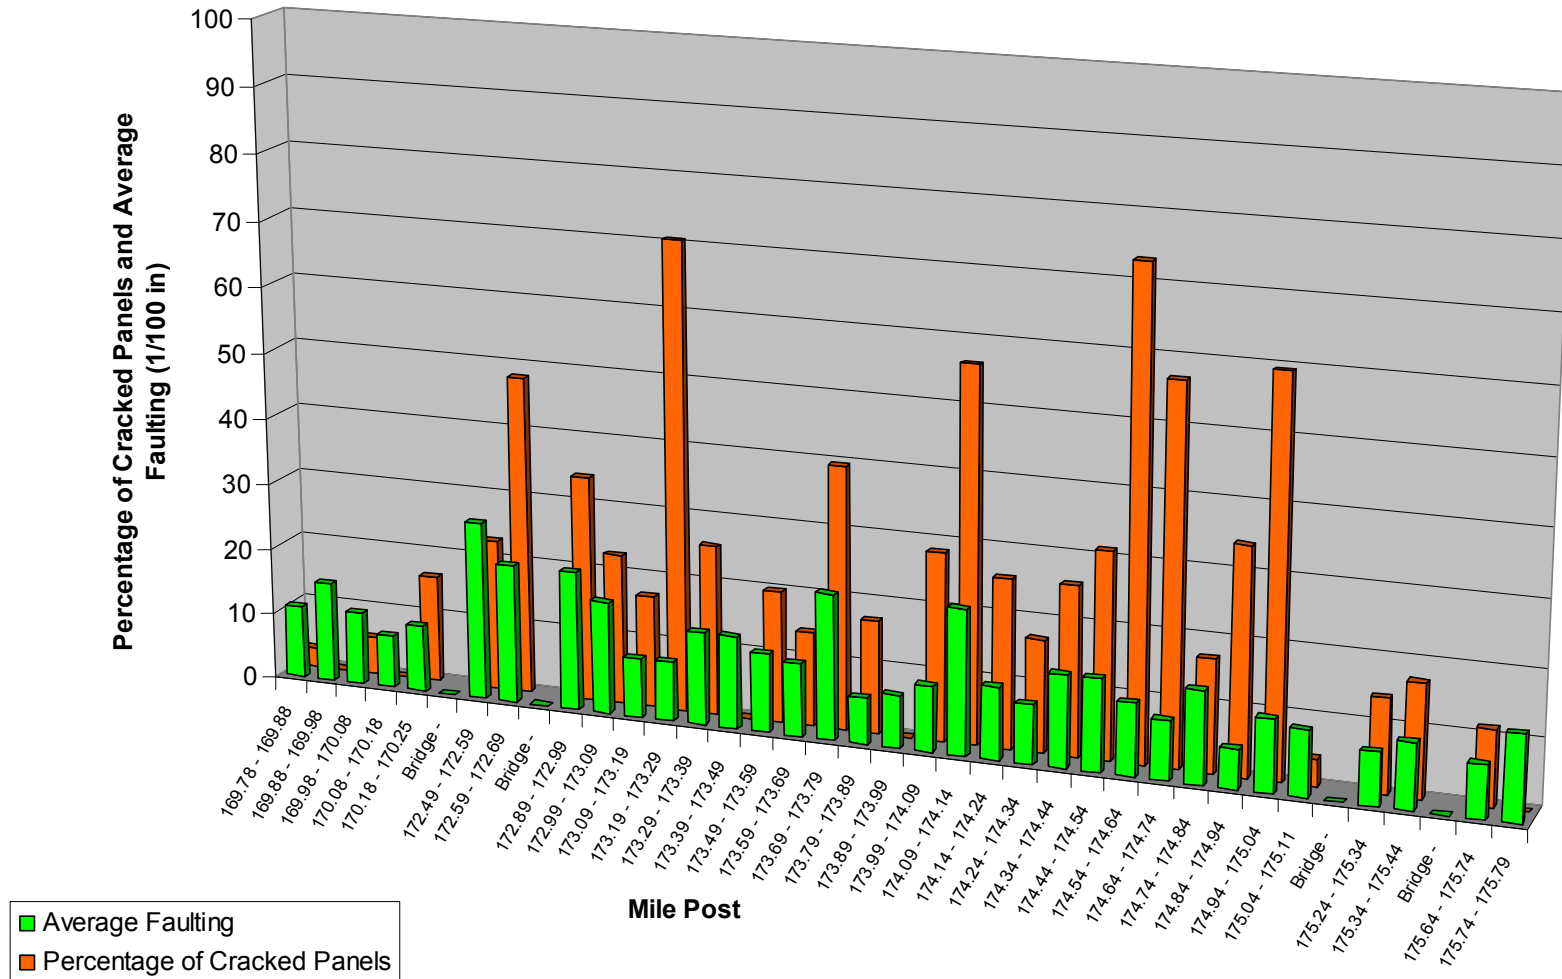
Figure 3.8. Example Plot of Percentage of Cracked Panels and Average Faulting

The distress plots for percentage of cracked panels and average faulting were developed to display any relationship between panel cracking and faulting. However, a review of this set of plots did not show any discernable relationship. Figure 3.8 is an example of what can be found in Appendix N.

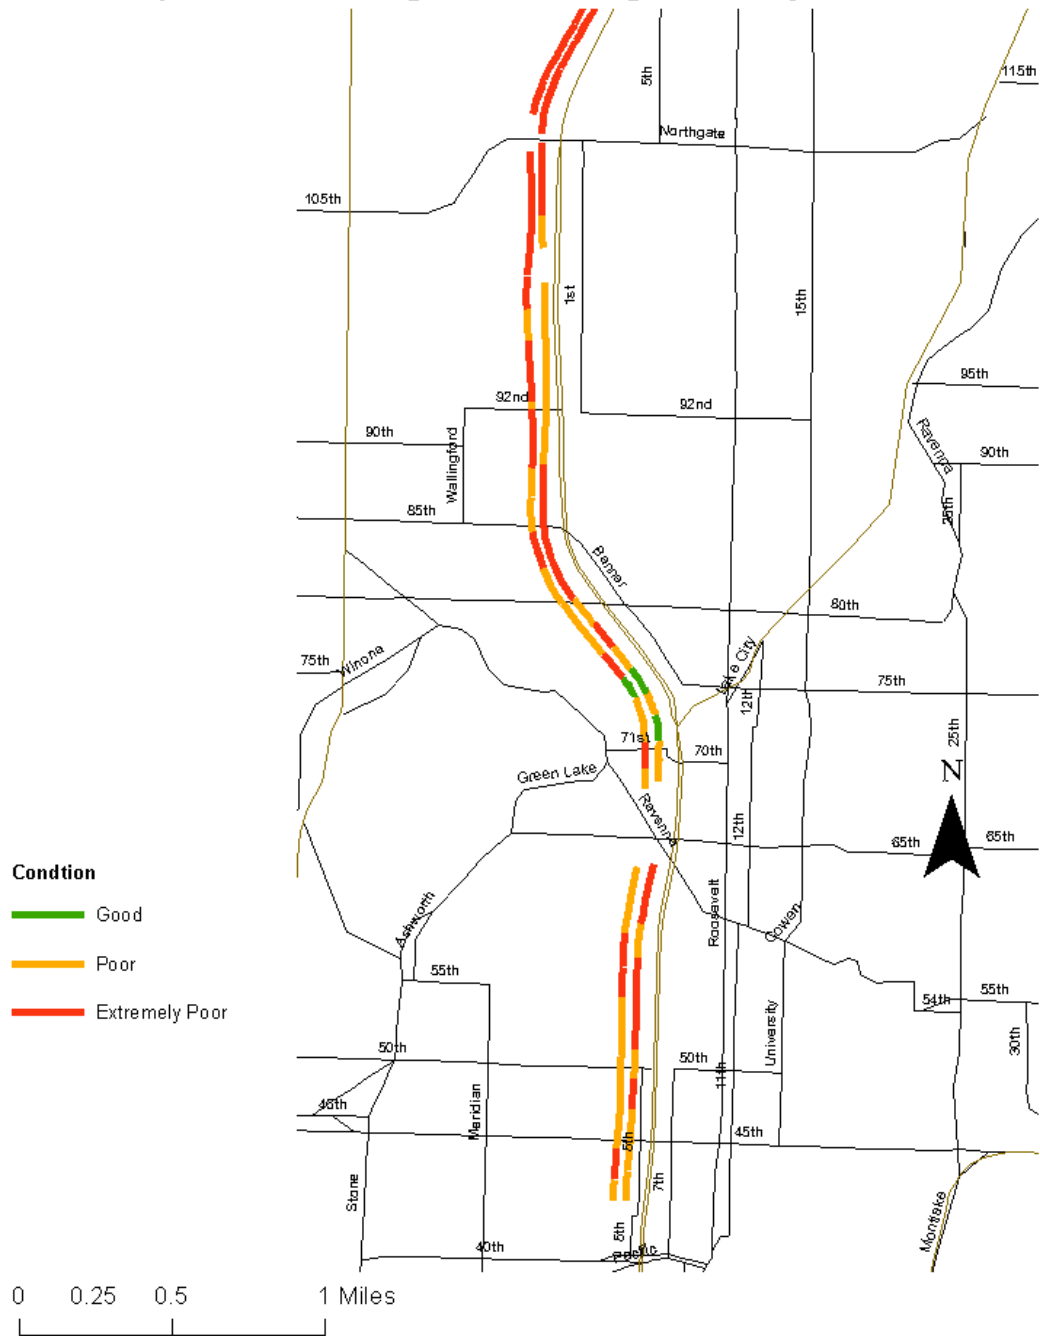
Figure 3.13. Example Image of General Pavement Condition

By definition, this method depicted I-5 pavements in their worst-case condition. Figure 3.13 is an example of the Arc GIS images for general pavement conditions resulting from the worst of the worst method that are contained in Appendix S.

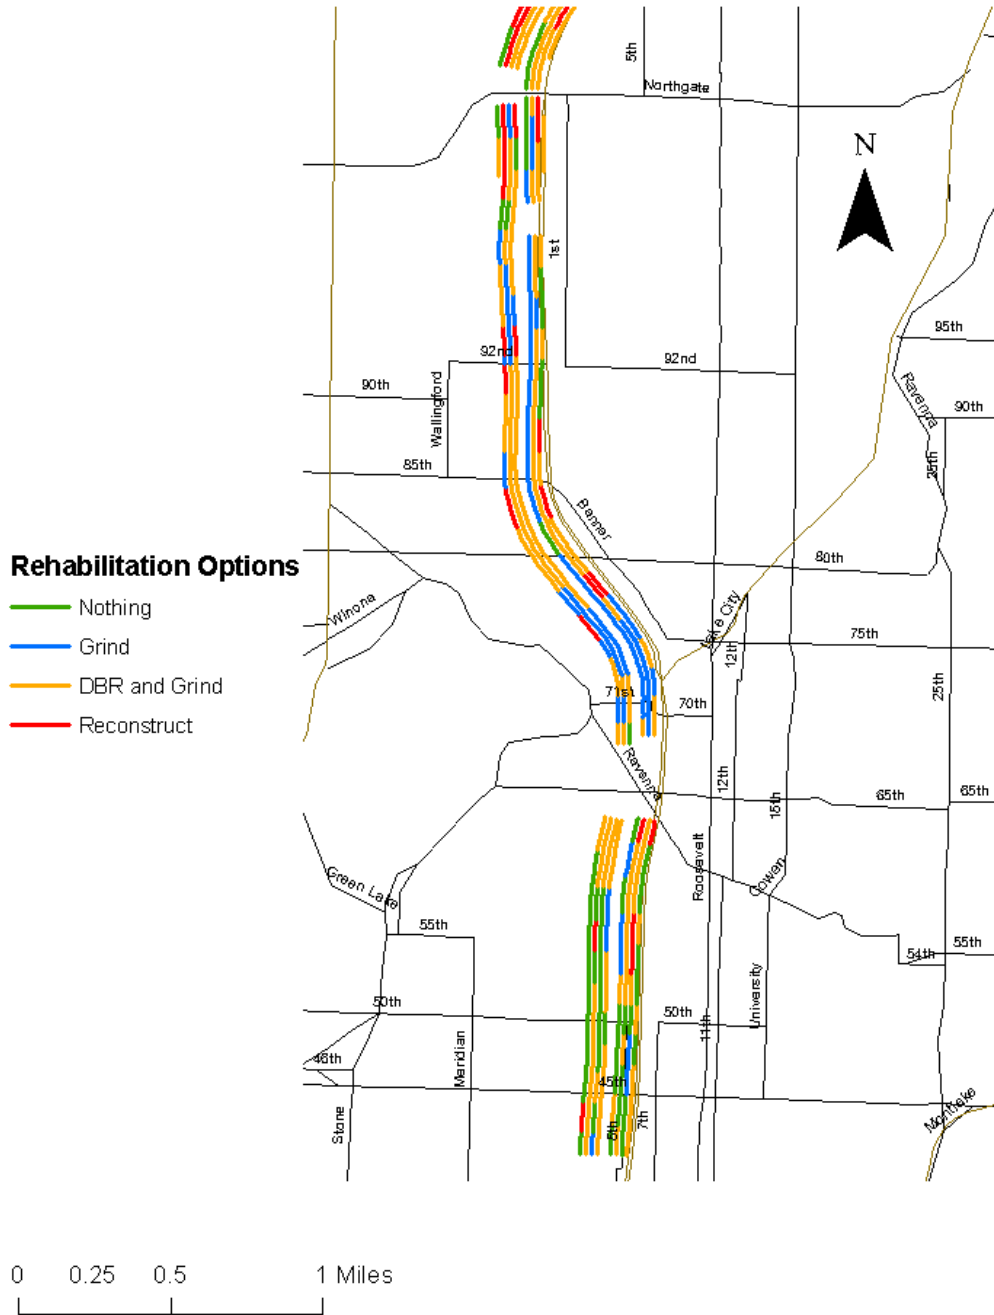
Figure 3.14. Example Image of Pavement Distress-Based Rehabilitation

WSDOT’s distress triggers were used to decide on pavement rehabilitation for each of the 1/10-mile sections of I-5. For each 1/10-mile section, the distress that triggered the highest order of rehabilitation was used to represent that section. Figure 3.14 is an example of the images, shown in Appendix T, that were developed by using the WSDOT trigger values. Note that actual rehabilitation project lengths will likely differ because of traffic control, funding constraints, and so on.

Table 3.9 breaks down the rehabilitation strategies in lane miles and percentages of lanes for each direction of I-5 according to the WSDOT trigger values. The result is about 26 lane miles of grinding, 47 lane miles of DBR and grinding, and 14 miles of reconstruction.
