TIRE NOISE PROPERTIES OF TWO RESURFACING
MATERIALS USED ON HIGHWAY BRIDGES FOR REPAIR OF WEAR

By
Rene H. Foss
Principal Investigator

November 14, 1972

APPLIED • PHYSICS • LABORATORY
A DIVISION OF THE UNIVERSITY OF WASHINGTON

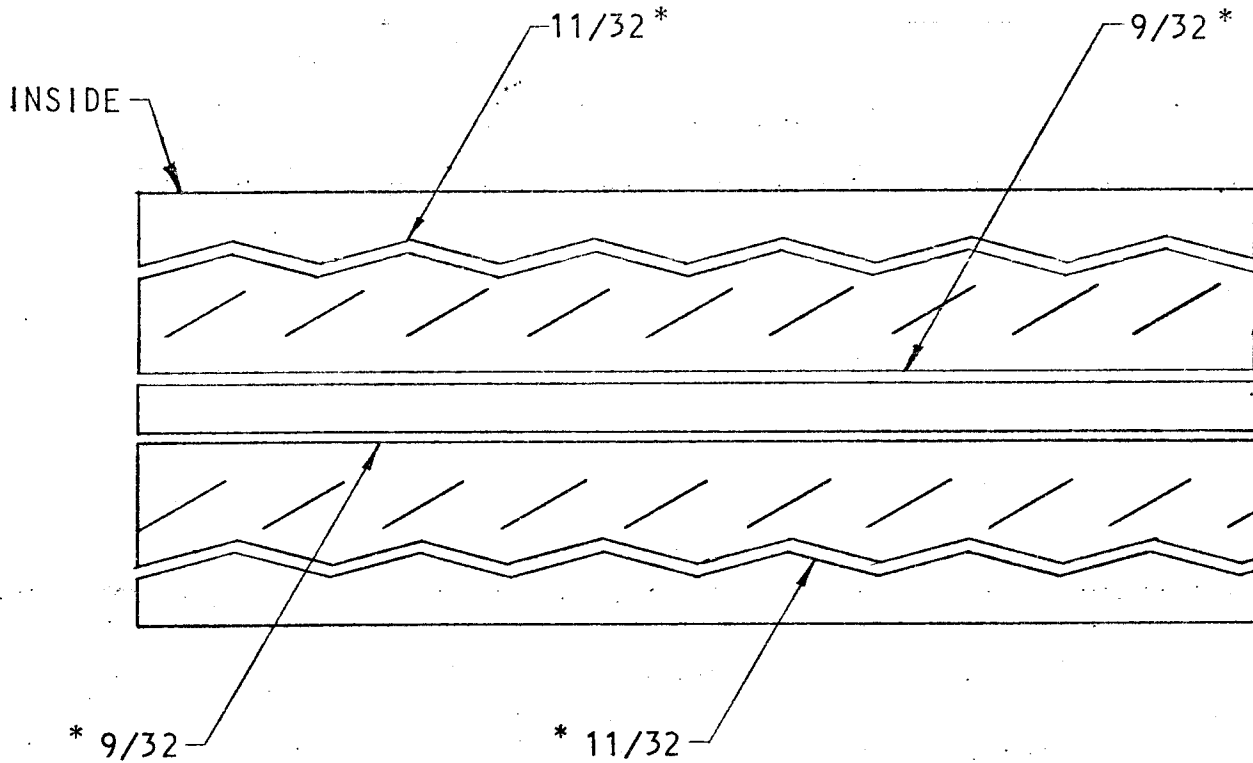
TEST TIRE TREAD DESIGN

PENNSYLVANIA PATROL SPECIAL
6 PLY RATED 4 PLY
MAX LOAD RATING 1890 LBS
LOAD RANGE C
MAX PRESSURE 36 PSI
855-15 NYLON TUBELESS
DOT 148 V-1
TIRE PRESSURE 28 PSI

* TREAD DEPTH IN INCHES

The tire noise tests were taken on the right rear wheel of a Laboratory station wagon upon which a new tire was mounted (a Pennsylvania Patrol Special, size 8.55-15). (The tread design and depth of this tire are shown on page 2.) This tire was mounted on a wheel and used on the vehicle only during tests. Between tests it was stored so that unnecessary wear would not change its acoustic characteristics.

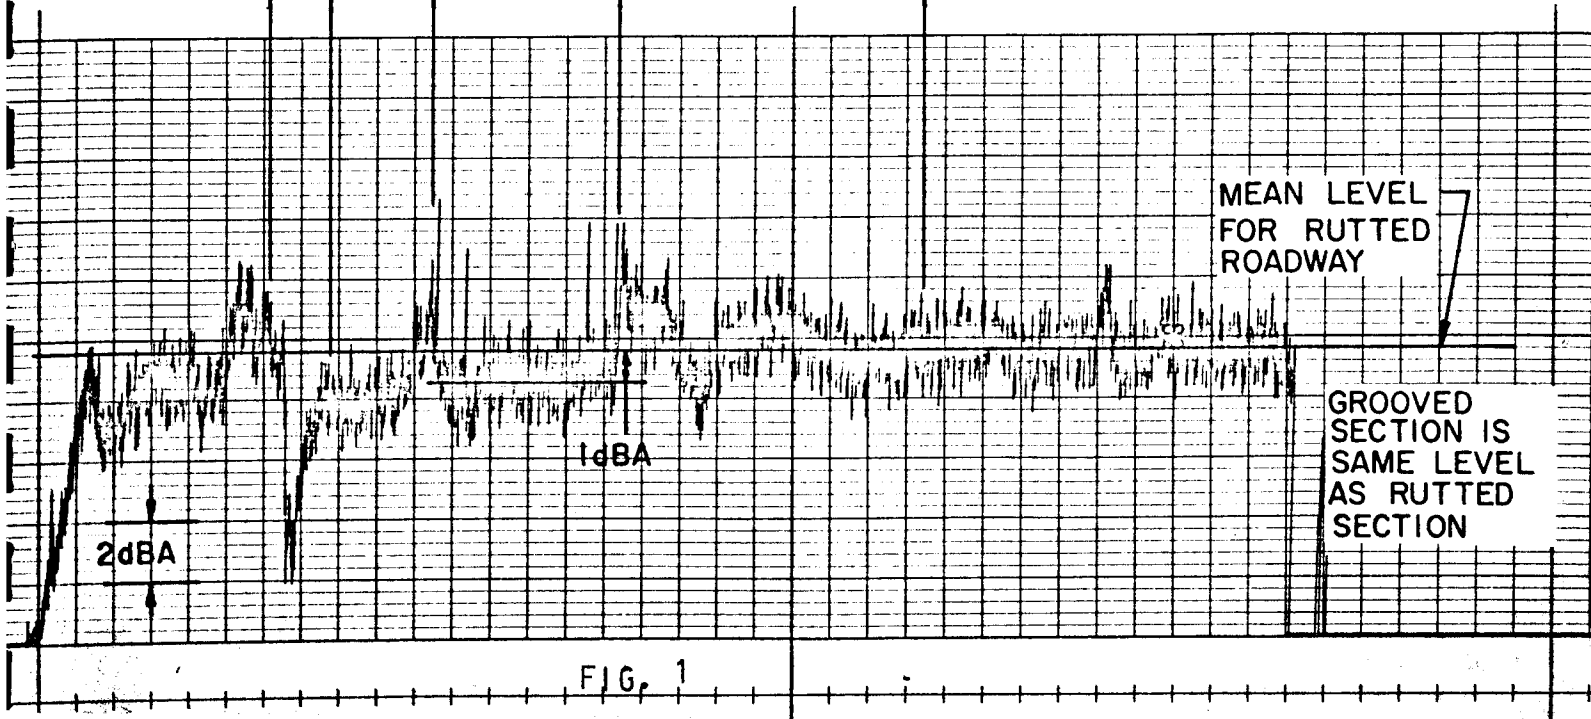
1" ON CHART
PAPER
12.7 SECONDS
931 FEET
AT 50 MPH

I-5 DUWAMISH BRIDGE SOUTHBOUND - CAR SPEED 50 MPH
12 SEPTEMBER 1972

In Fig. 1 a dip is seen as the test tire enters the curb lane; this occurs because the tire has run over an unworn place in the road, and the noise level briefly drops toward that of the original road before wear occurred. The next section is the currently rutted road surface in the curb lane, and this is followed by a section to which Spray-Grip has been applied (still in the curb lane). The next section is a stretch of freeway which is worn and has been grooved to prevent skidding. This is followed by worn highway which has not been grooved or re-surfaced. This graph shows that the noise level from the worn surface is not changed by grooving (unworn concrete might be noisier after it was grooved than it was before). Spray-Grip does not seem to lower the noise level appreciably. As this graph indicates, the sections with this material applied are perhaps only 1 dBA lower at 50 mph.

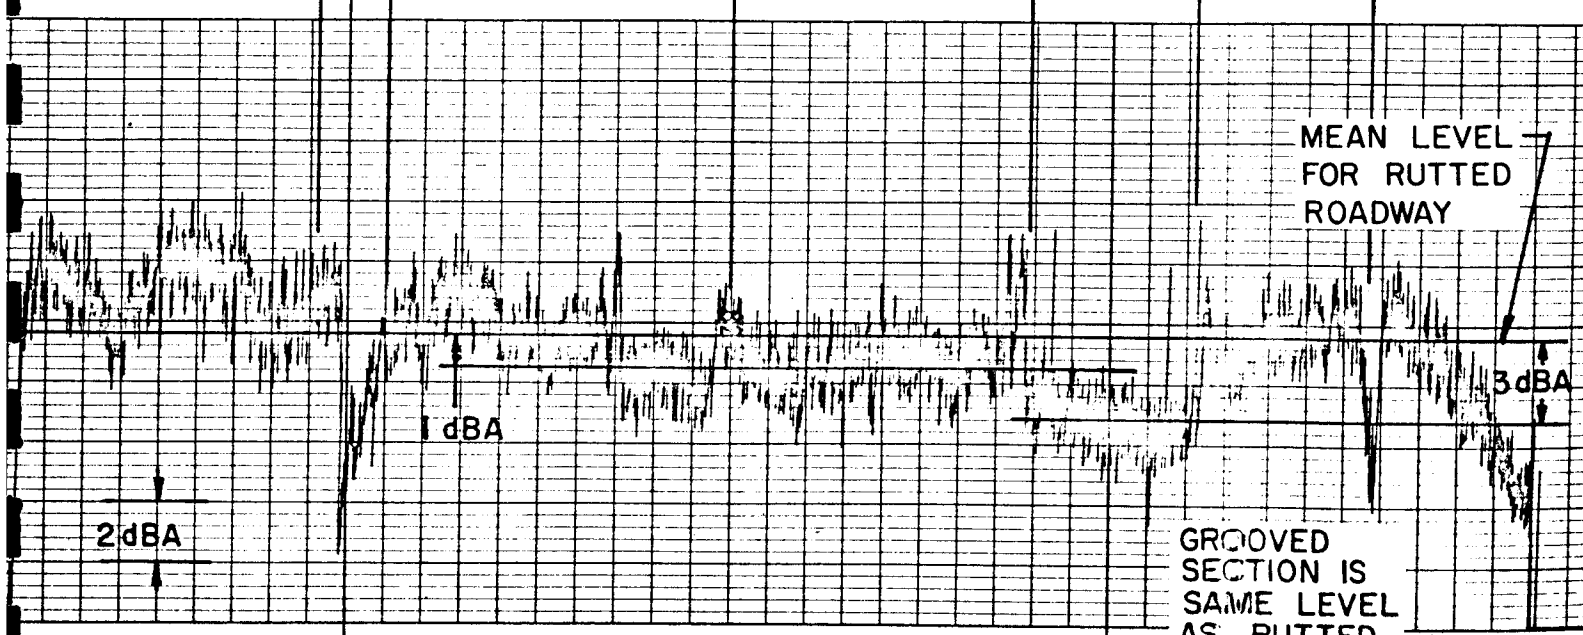
FIG. 2

GROOVED
SECTION IS
SAME LEVEL
AS RUTTED
SECTION

Figure 2 is for a similar run at 50 mph, except it is in the southbound lane. In this case the amount of noise reduction attributable to application of Spray-Grip is about 3 dBA.

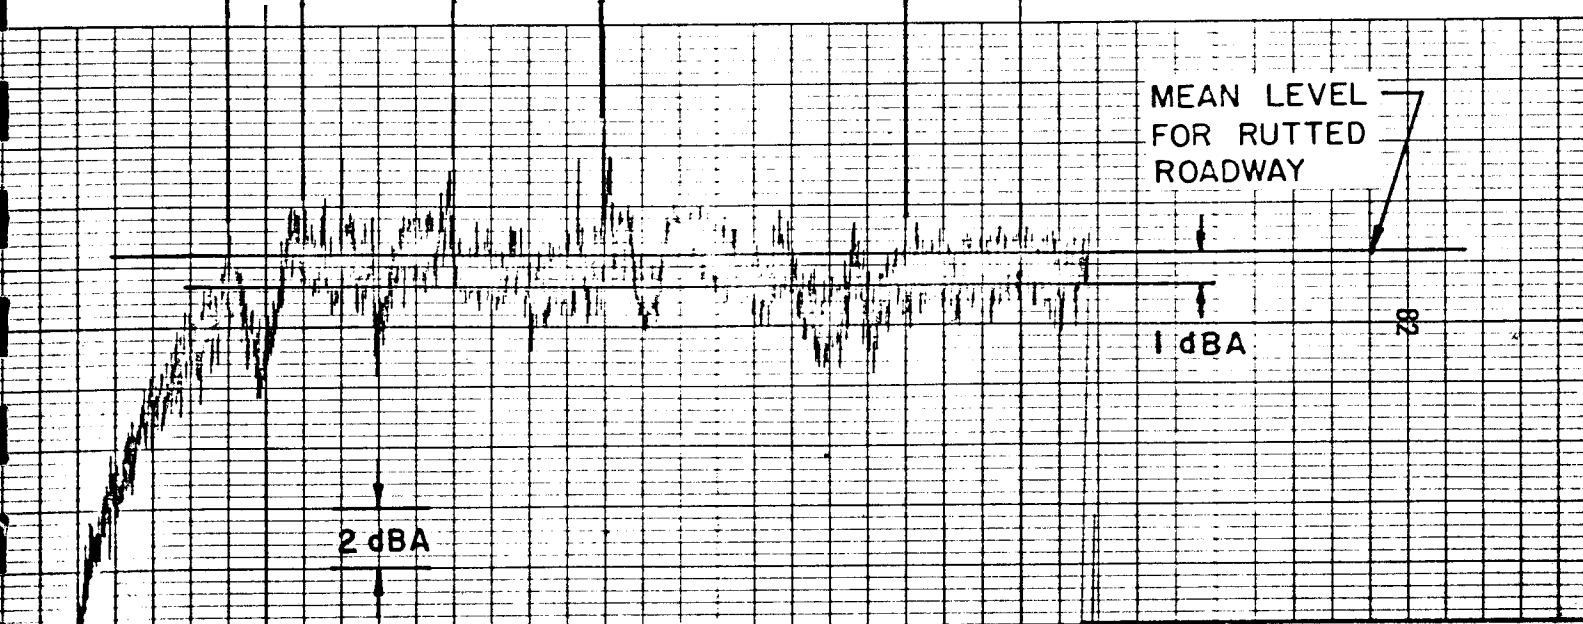
FIG. 3

I-5 DUWAMISH BRIDGE SOUTH BOUND - CAR SPEED 60 MPH
12 SEPTEMBER 1972

Figure 3 shows another run, with the vehicle traveling uphill northbound at 60 mph. The Spray-Grip section is only about 1 dBA quieter than the rutted surface it replaced.

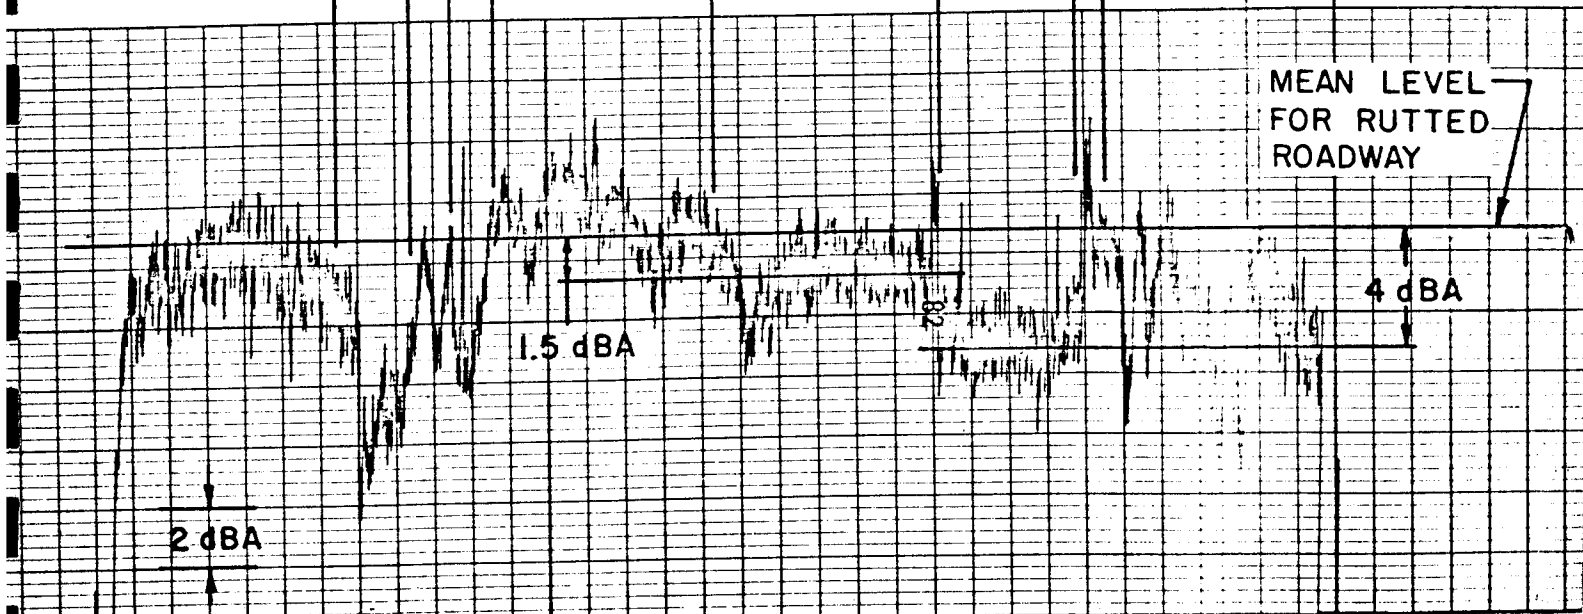
FIG. 4

MEAN LEVEL FOR RUTTED ROADWAY

I-5 DUWAMISH BRIDGE SOUTH BOUND - CAR SPEED 70 MPH
12 SEPTEMBER 1972

Figure 4 also shows a 60 mph run; this time it is southbound, slightly downhill. The lane next to the curb lane was used, and in this particular case, the Spray-Grip surface shows a quieting of almost 4 dBA.

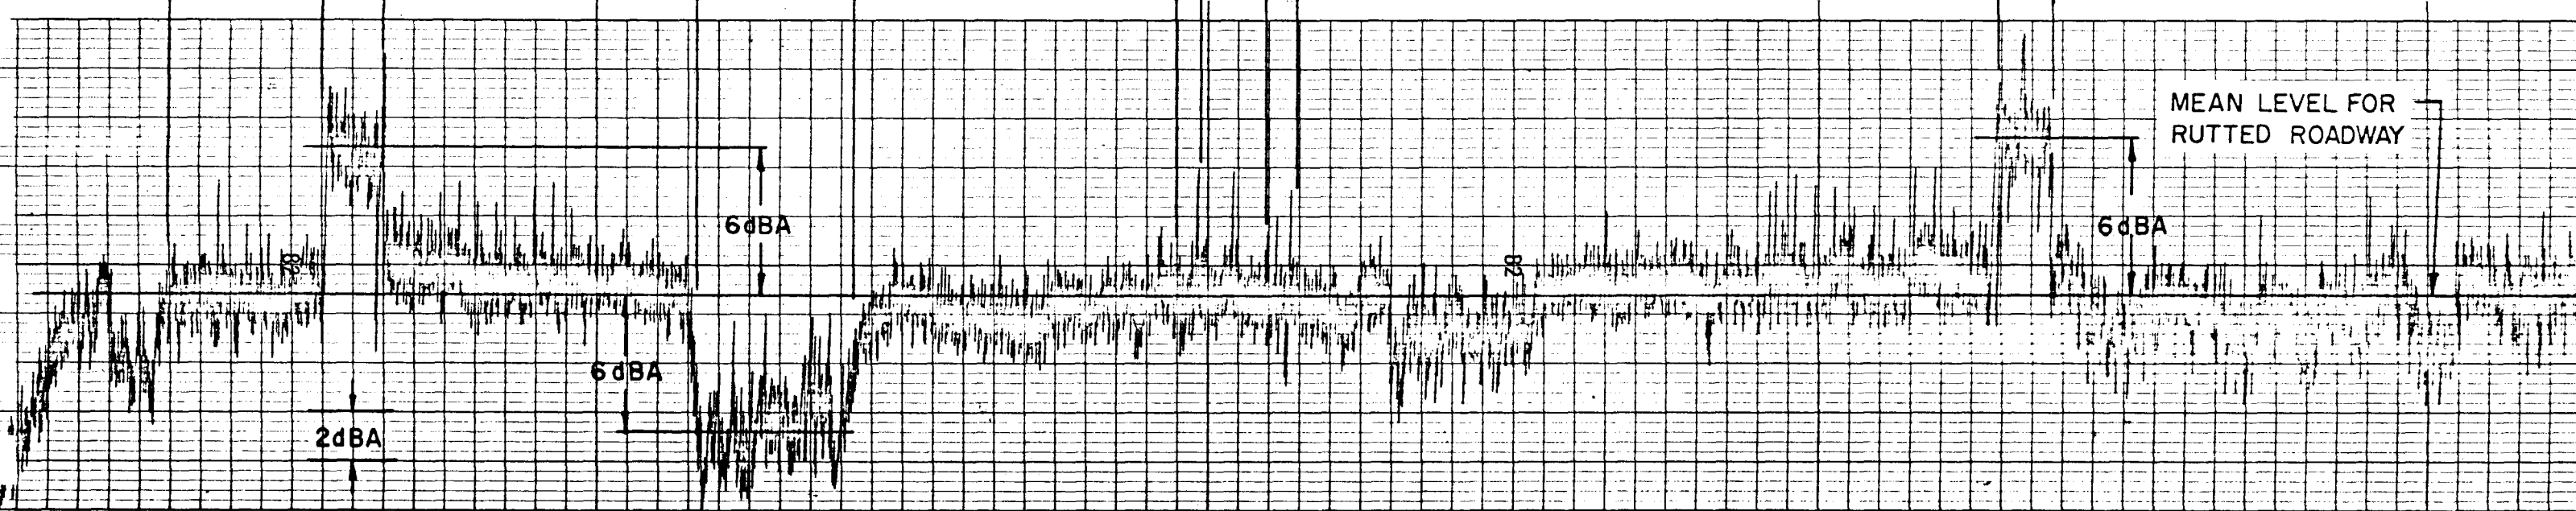
FIG. 7

EVERGREEN POINT FLOATING BRIDGE WEST BOUND - CAR SPEED 40 MPH
BEFORE EPOXY ASPHALT APPLIED
24 AUGUST 1972

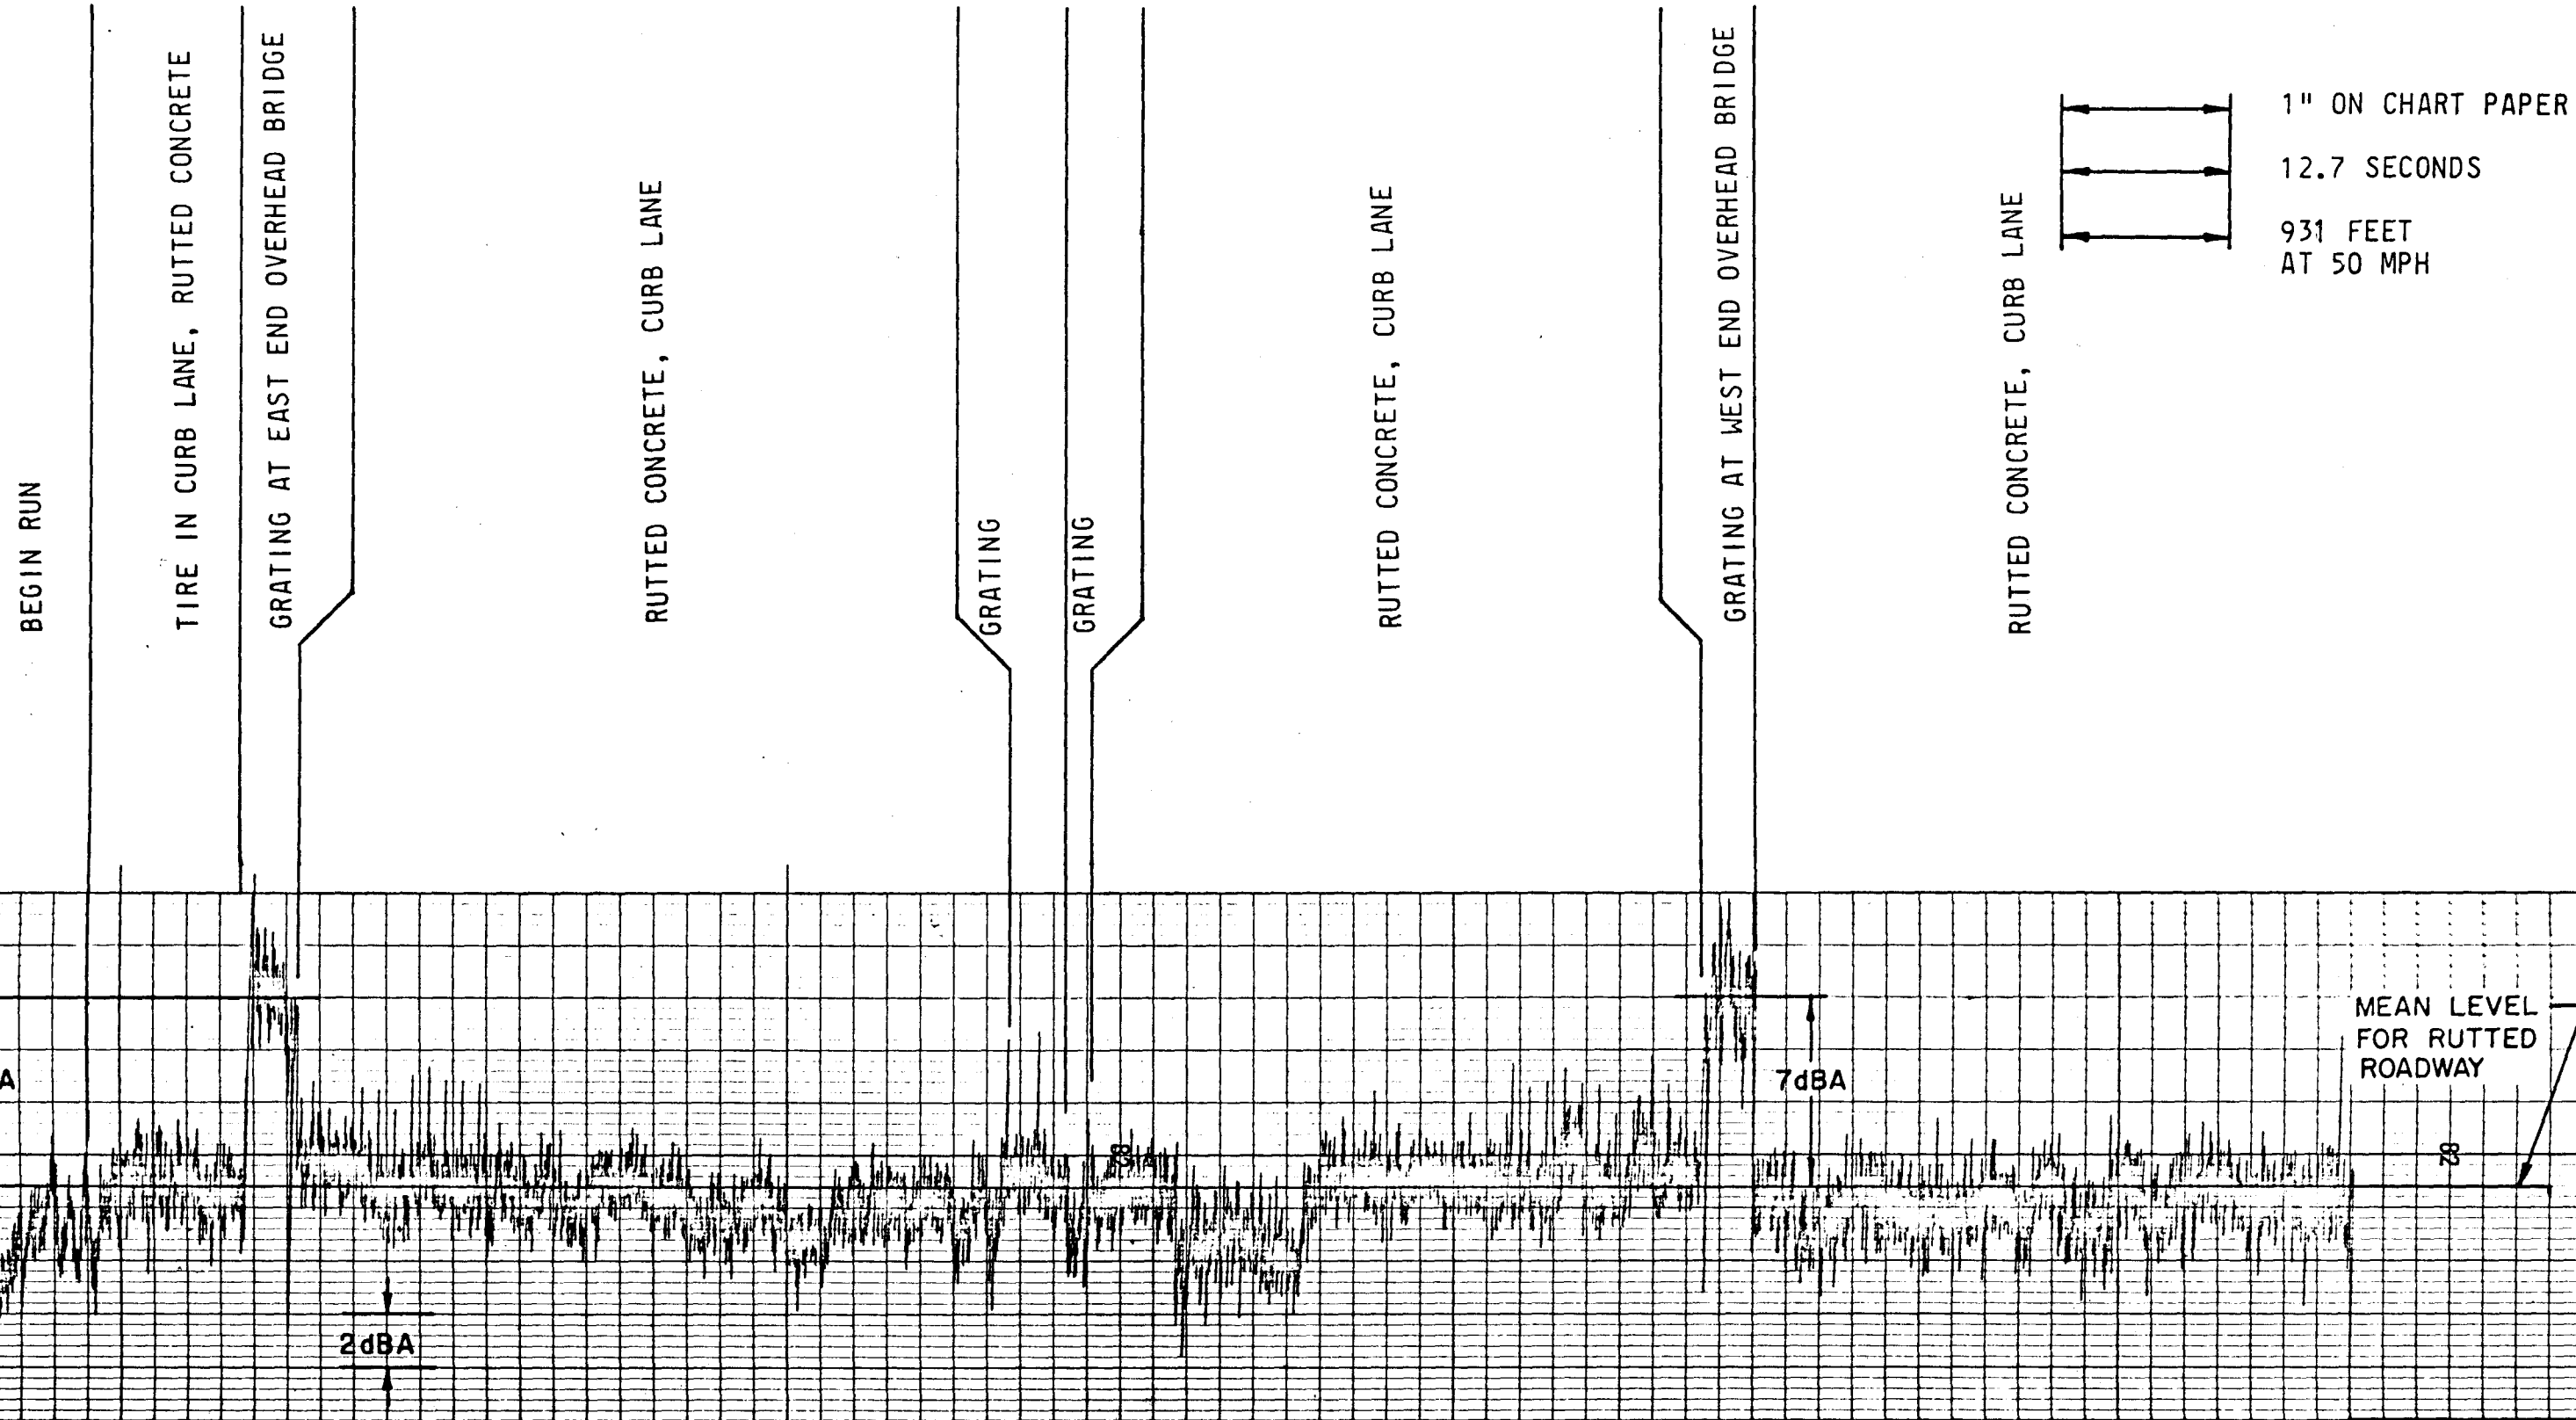
FIG. 10

EVERGREEN POINT FLOATING BRIDGE, EAST BOUND - CAR SPEED 50 MPH BEFORE EPOXY ASPHALT APPLIED

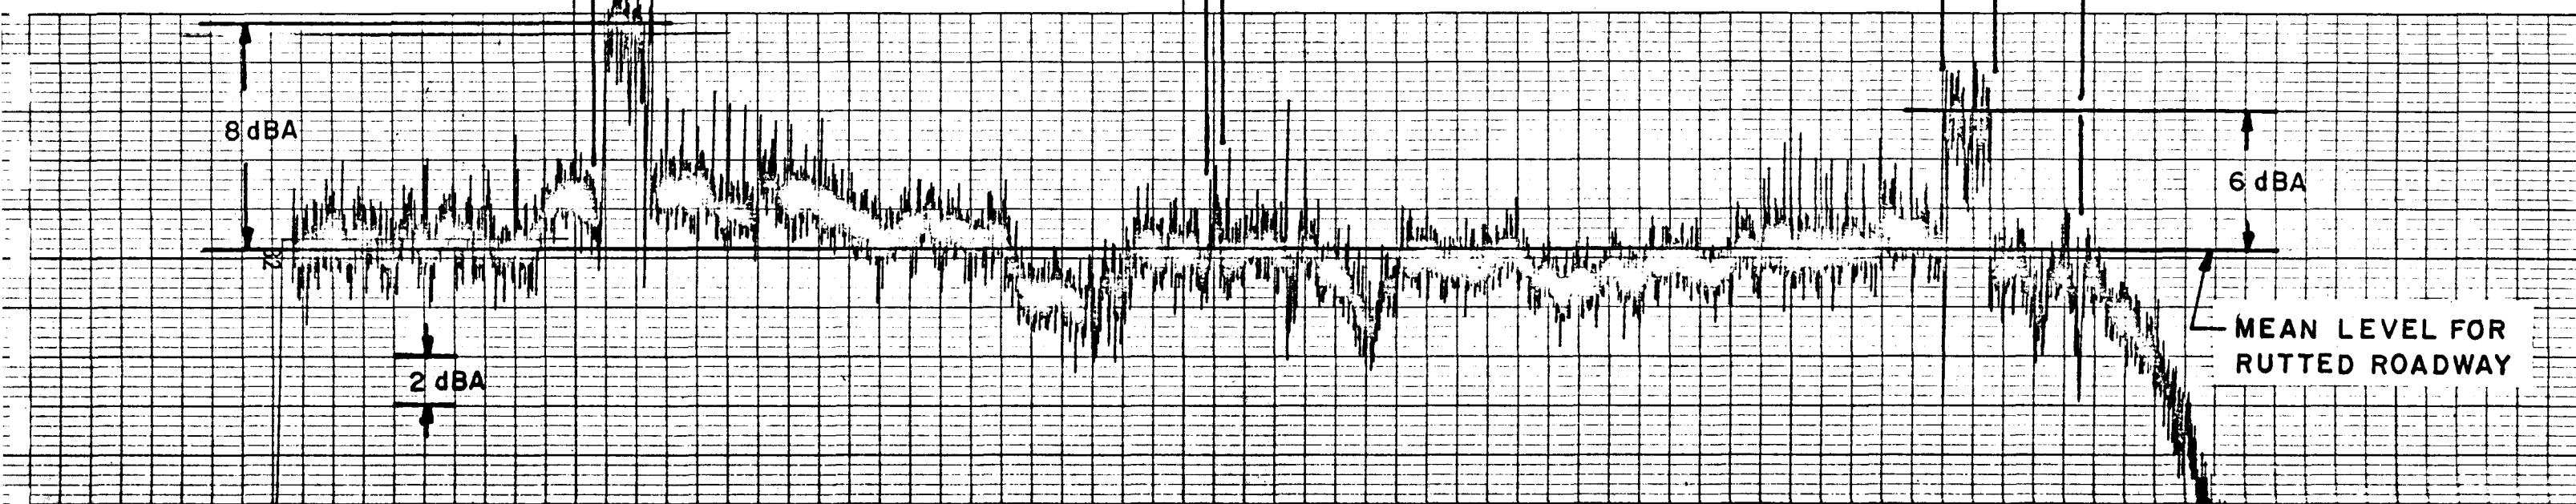
FIG. 11

EVERGREEN POINT FLOATING BRIDGE WESTBOUND - CAR SPEED 50 MPH
 BEFORE EPOXY ASPHALT APPLIED
 24 AUGUST 1972

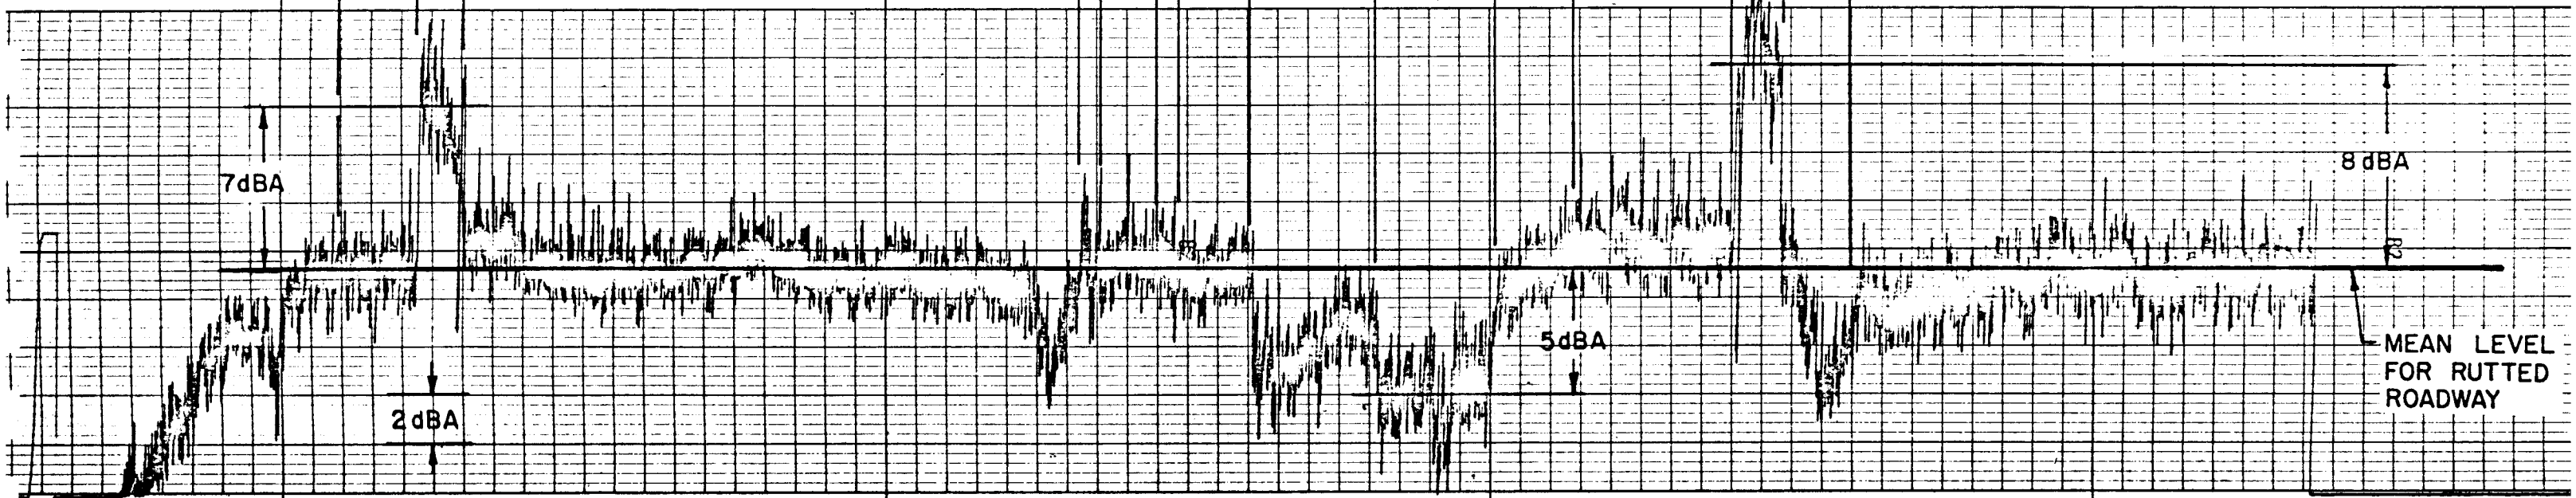
FIG. 12

EVERGREEN POINT FLOATING BRIDGE EAST BOUND - CAR SPEED 50 MPH
BEFORE EPOXY ASPHALT APPLIED

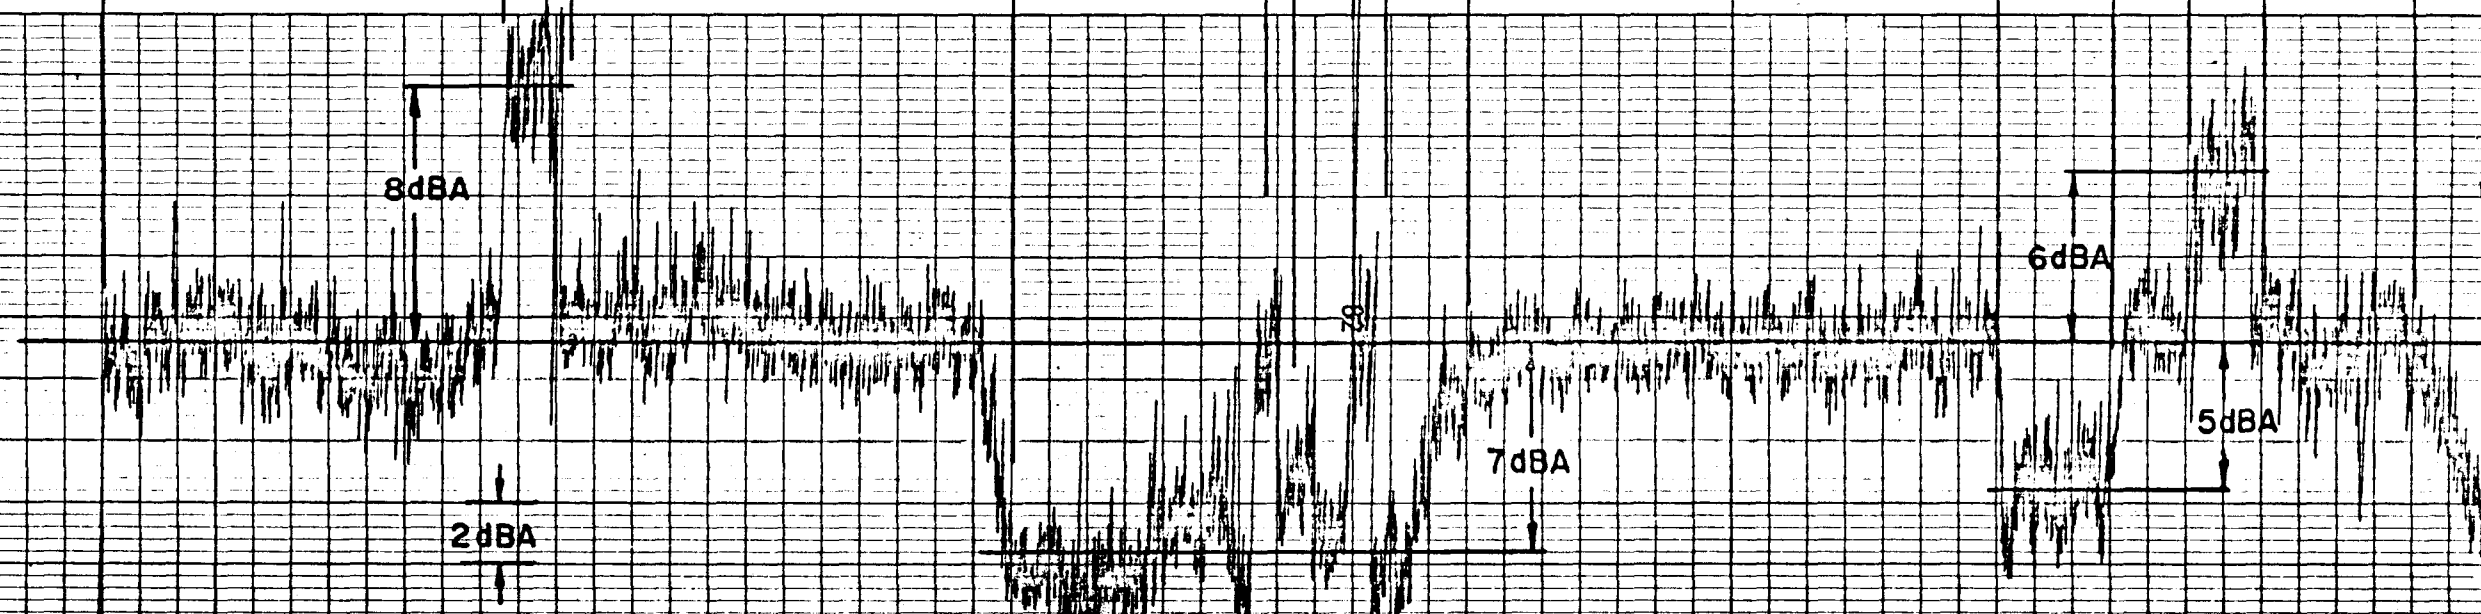
FIG. 13

EVERGREEN POINT FLOATING BRIDGE WEST BOUND - CAR SPEED 40 MPH
 AFTER EPOXY ASPHALT APPLIED
 4 OCTOBER 1972

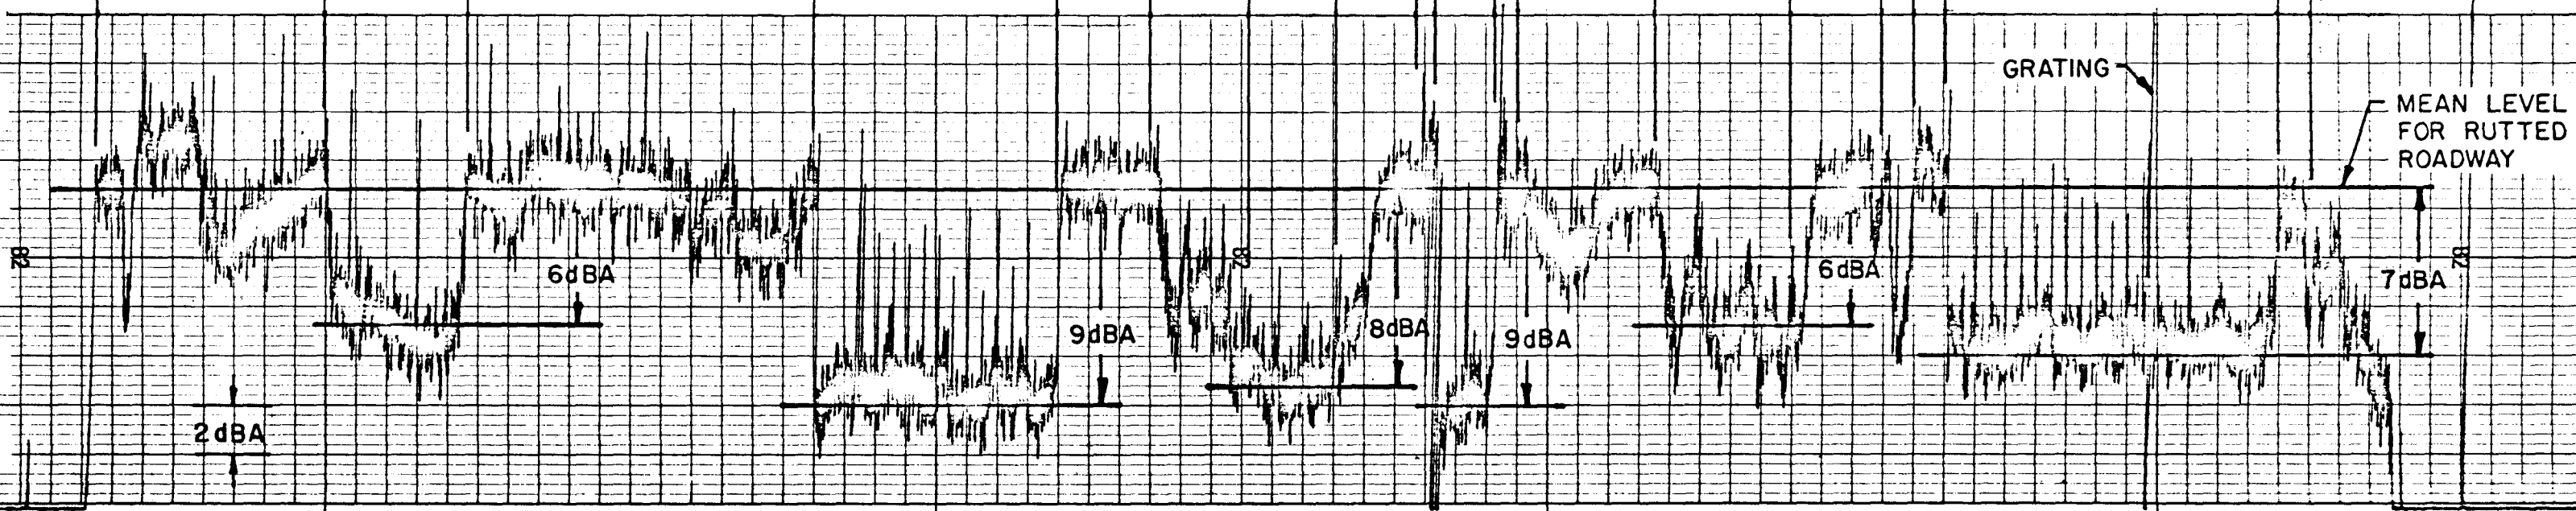
FIG. 16

DOWNHILL

Figures 15, 16, and 17 show that on a 50 mph run, going uphill, the epoxy-asphalt is about 7 dBA quieter than the worn roadway on the floating section of the bridge; going downhill it is typically 9 dBA quieter. Overall then, at 50 mph this coating is 8 dBA quieter than the previous worn surface. It was previously shown that at 50 mph the filled gratings averaged 7 dBA noisier than the rough road surface; this means that the total improvement at the filled gratings has been 15 dBA. This is outstanding because a 15 dBA improvement means that at 50 mph the cupped worn grating was radiating 32 times as much acoustic tire noise power as it does now with the epoxy-asphalt coating. This factor of 32 reduction in noise power is physiologically interpreted by a typical human ear as being 3 times as quiet as it was previously. This represents a very appreciable improvement in tire noise. Further, the sections of ordinary worn roadway which has been covered with the epoxy-asphalt show an 8 dBA improvement at 50 mph; this is a significant noise reduction to the community, since these sections are much longer overall than the noise grating sections.

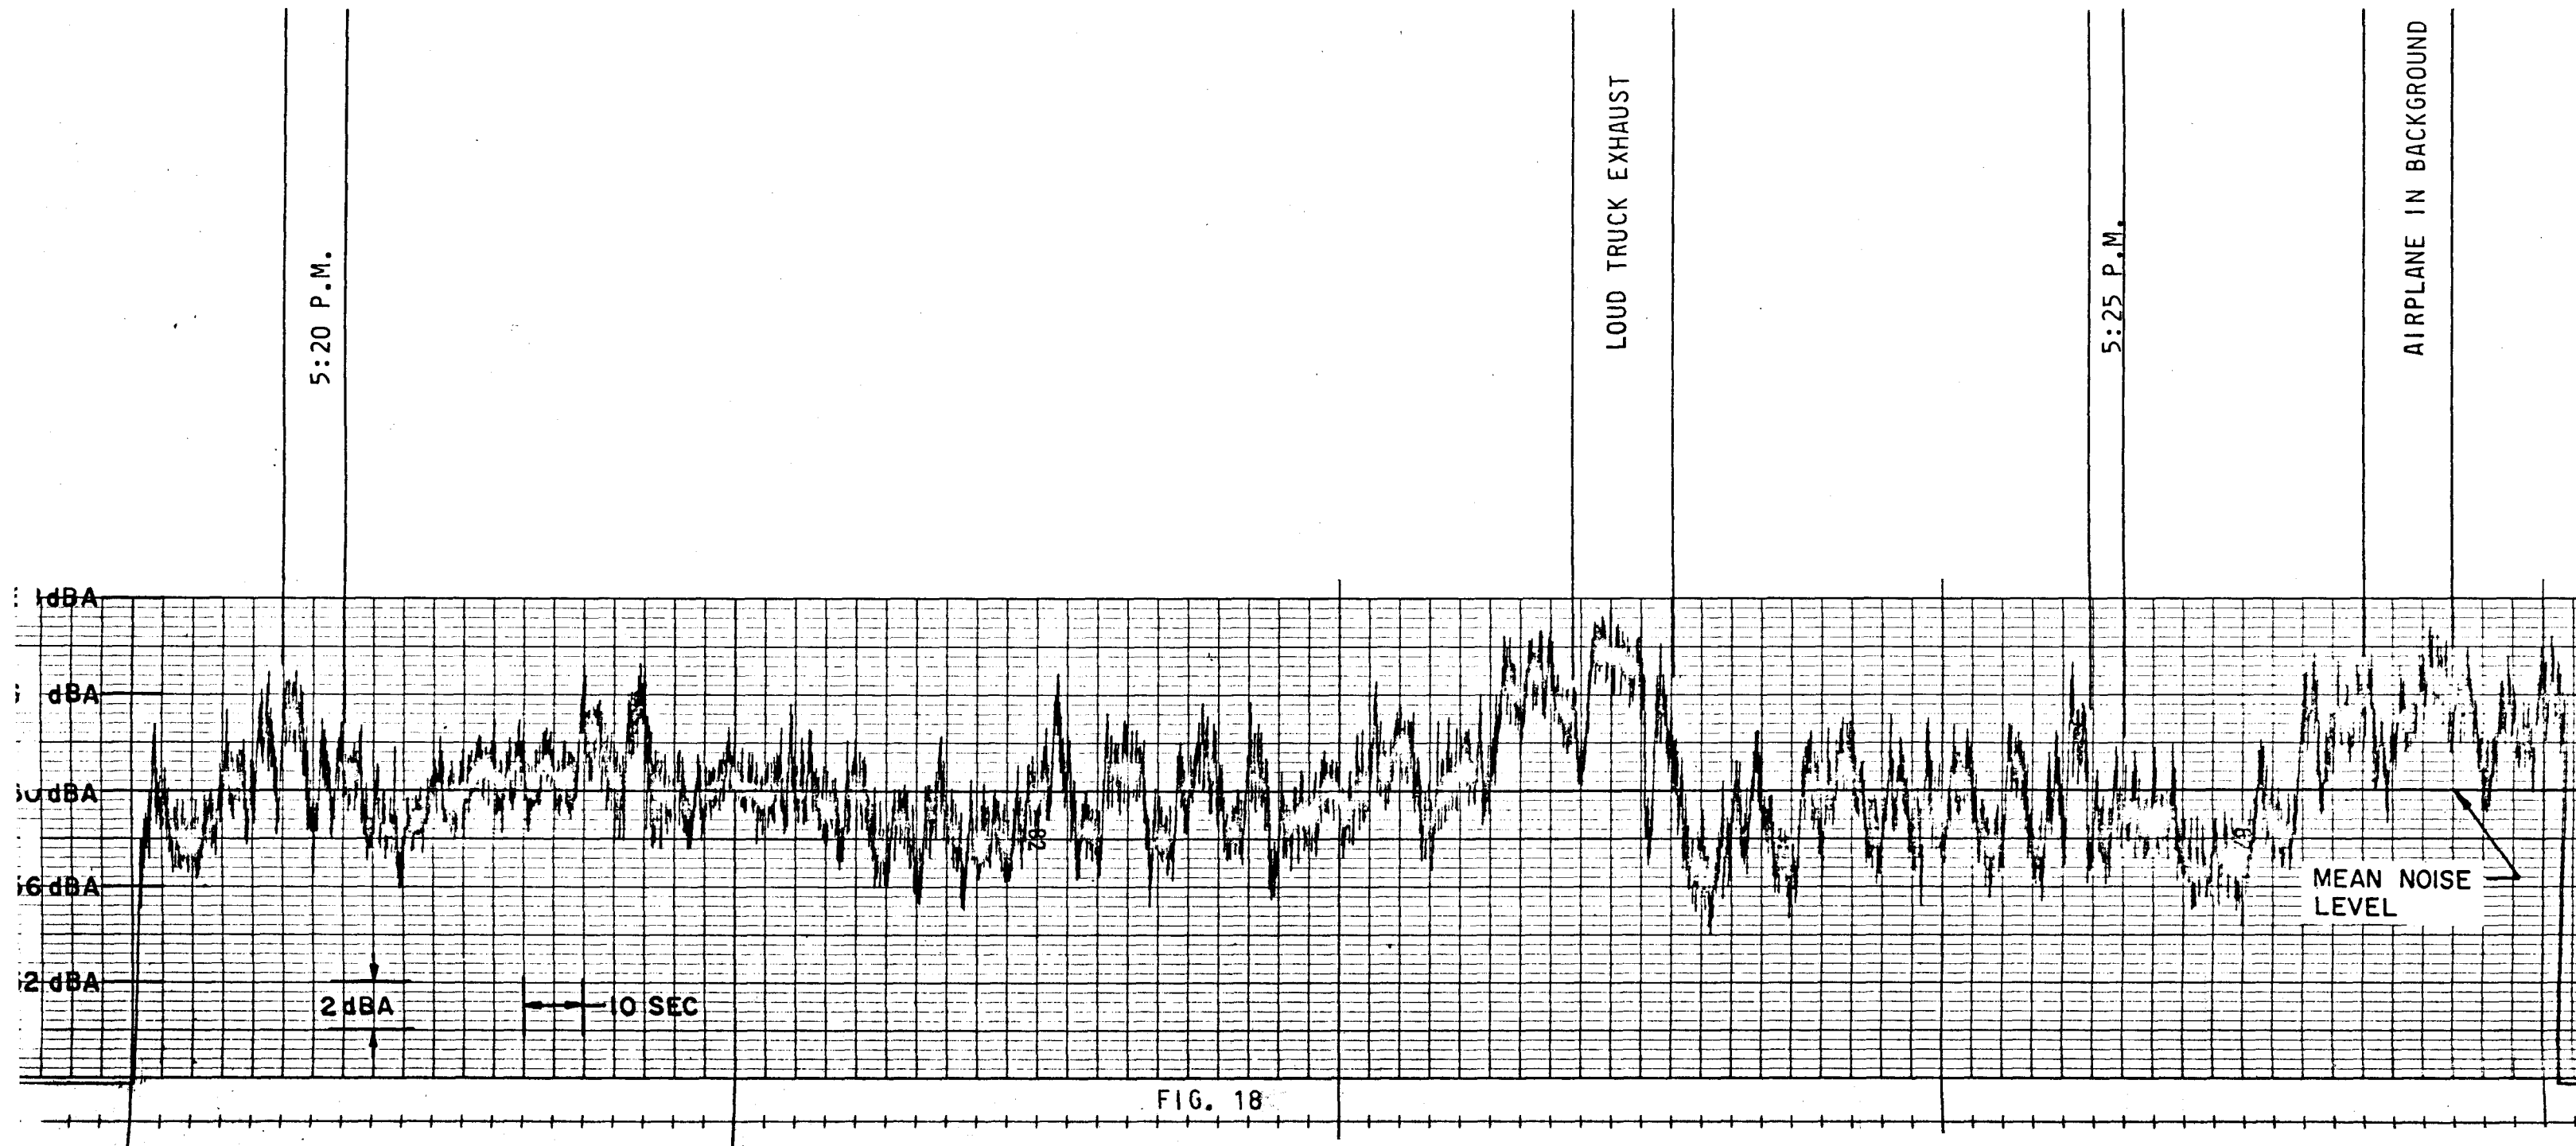
FIG. 18

EVERGREEN POINT FLOATING BRIDGE - BEFORE EPOXY ASPHALT APPLIED
THURSDAY, 24 AUGUST 1972

Figures 18 and 19 show the sound levels obtained on the front porch of a house several hundred feet south of the bridge on the east shore of Lake Washington during the height of the rush hour, around 5:25 p. m. Figure 18 shows the noise level before the epoxy-asphalt application. A typical value was 60 dBA when there were no uniquely loud trucks or airplanes or other disturbances affecting the measurements. Figure 19 is taken from a tape made after the application of the epoxy-asphalt. This time the mean level is about 54 dBA which represents an overall quieting of 6 dBA.

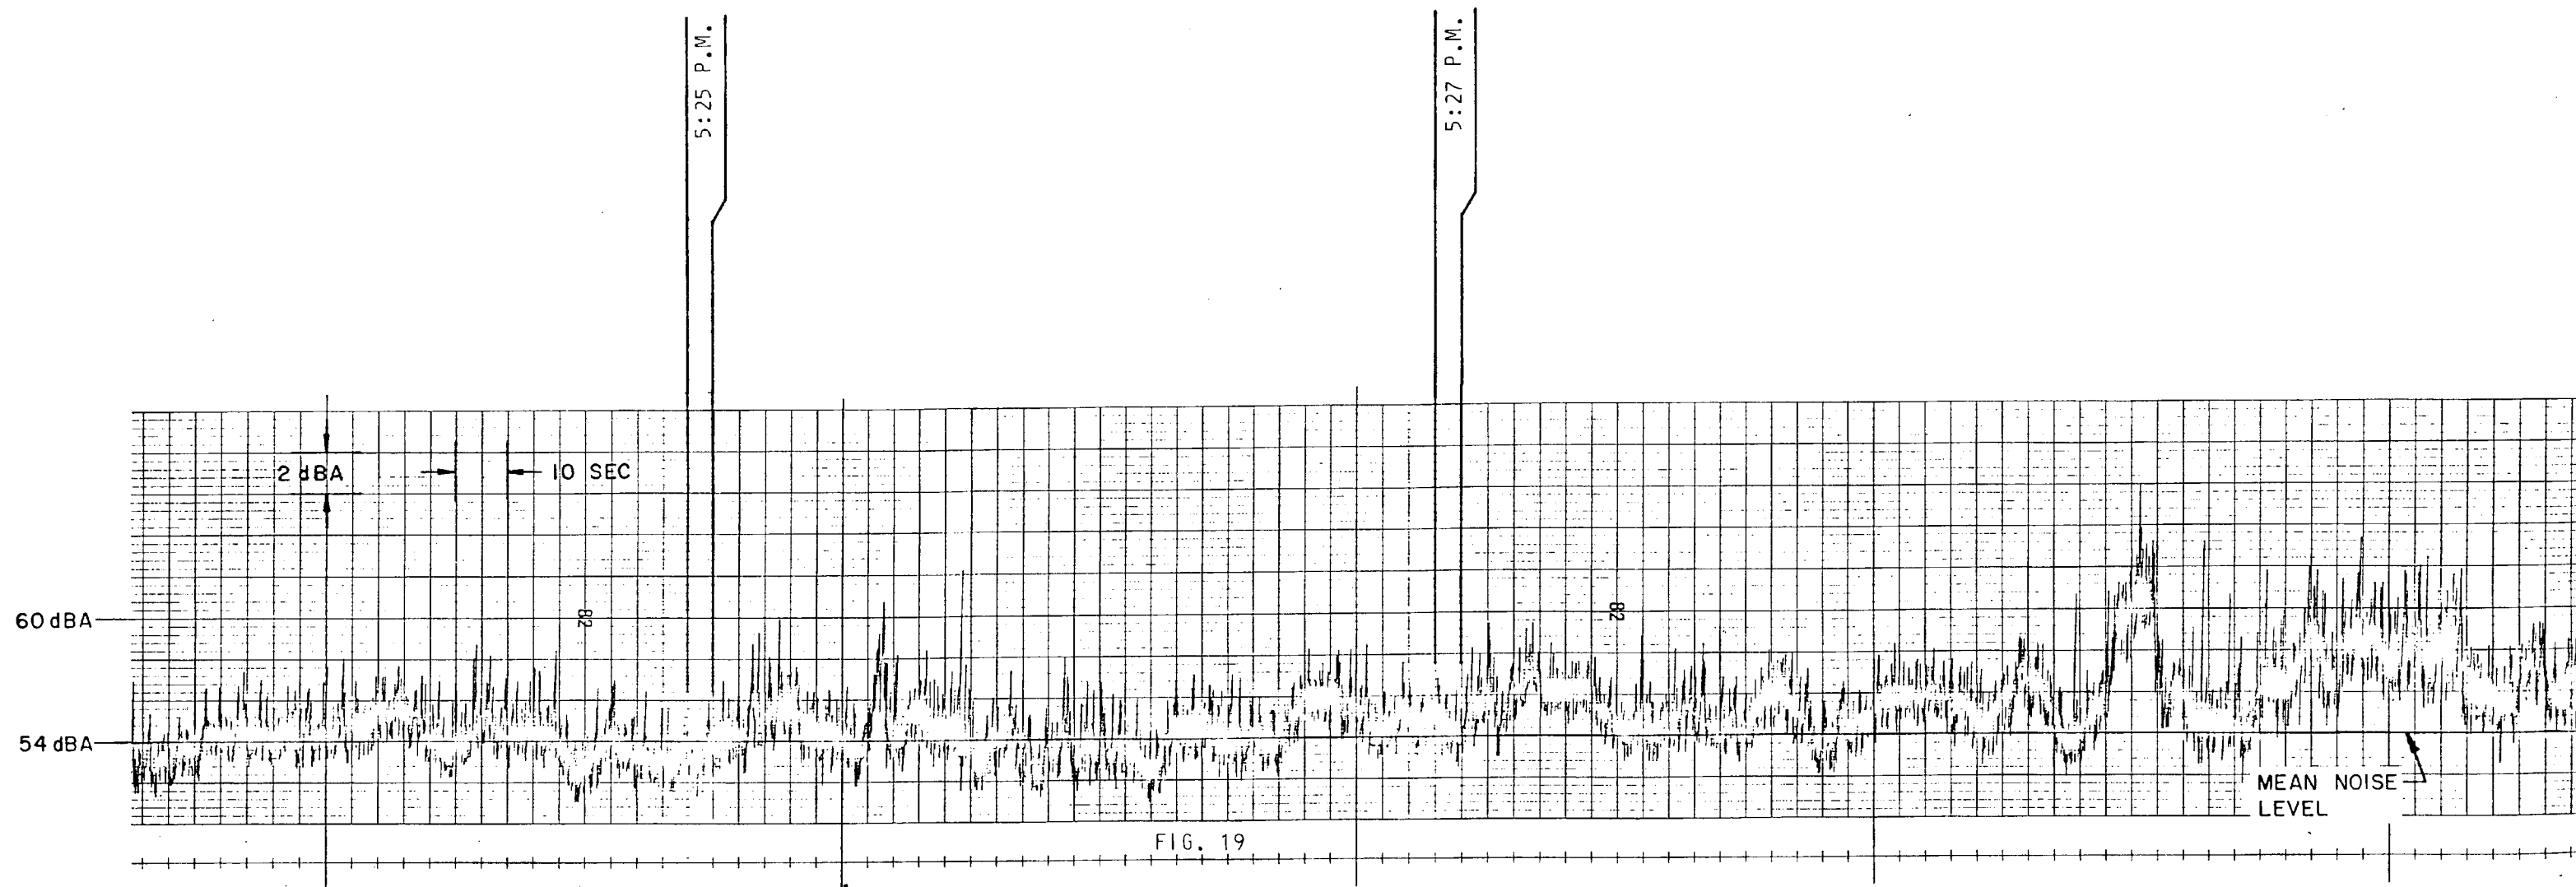
EVERGREEN POINT FLOATING BRIDGE - AFTER EPOXY ASPHALT APPLIED

LOCATION: RESIDENCE ON SHORE SOUTH OF EAST END OF BRIDGE
TRAFFIC HEAVY AND SLOW

WEDNESDAY 25 OCTOBER 1972
