Design Guide for Cut Slopes in Loess of Southeastern Washington

WA-RD 145.2

Washington State Department of Transportation
Planning, Research and Public Transportation Division

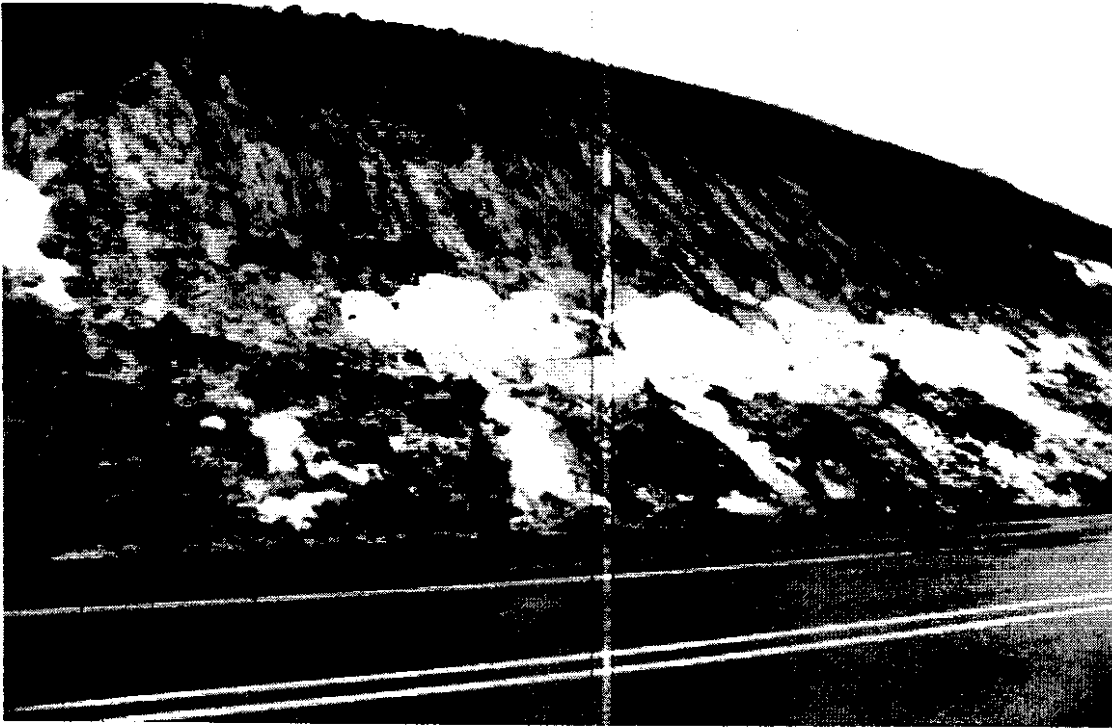
Although not as common, larger slide and/or flows have been observed. The failure mechanism is thought to be the same as for smaller scale failures with a low depth to width ratio for the failure surface. Figure 15 illustrates a larger failure. In all cases where extensive damage from slides or flows was observed, slopes were 2:1 or steeper. No

Figure 15 Failure of Cut Slope in Clayey Loess
