# A PLATFORM FOR PROACTIVE, RISK-BASED SLOPE ASSET MANAGEMENT, PHASE II

# FINAL PROJECT REPORT

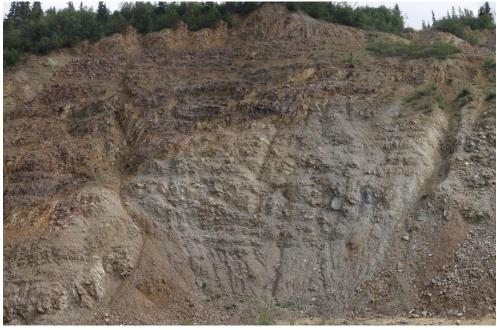
Figure 4 Glitter Gulch rock slope with darker basalt and lighter schist

the area that shows volcanic dikes (Tvim, Tvif) within the Healy schist (PzpCp). The volcanic rock can be clearly seen as the darker rock in Figure 4, with a lighter Healy schist layer below.
