UTC Project Information	
Project Title	Cost-effective bridge safety inspections using unmanned aerial vehicles (UAVs)
University	Oregon State University
Principal Investigator	Dan Gillins
PI Contact Information	dan.gillins@oregonstate.edu
Funding Source(s) and Amounts Provided (by each agency or organization)	University of Washington PacTrans \$39,785 Oregon State University \$39,785
Total Project Cost	\$79,570
Agency ID or Contract Number	DTRT13-G-UTC40
Start and End Dates	January 15, 2015– September 16, 2016
Brief Description of Research Project	<p>The objective of this research is to evaluate how useful UAV technology could be in performing visual bridge inspections. The FHWA requires biennial bridge inspections, evaluating this exciting and emerging technology will provide helpful information to every region in the United States.</p> <p>To accomplish this objective, the project goals are to investigate existing UAV technology, including available platforms, sensors, flight controllers, and mission planning tools. Review FHWA requirements for performing bridge inspections per 23 CFR Part 650. Acquire UAV-based imagery and video for 1-3 representative bridges; develop recommendat

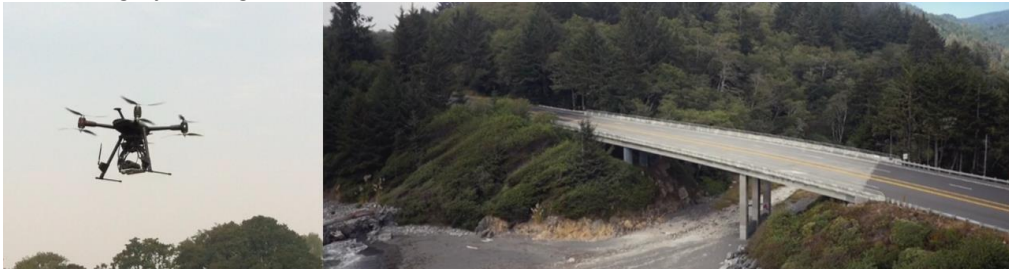
Example of imagery of a bridge acquired from an Aerialtronics octocopter (left). The image shown here was acquired at a relatively large stand-off distance and flying height to capture the entire deck. For high-resolution inspection work, the UAV can be operated at a shorter, fixed stand-off distance and/or a larger focal length camera can be utilized.

<p>Describe Implementation of Research Outcomes (or why not implemented)</p> <p>Place Any Photos Here</p>	<p>In the study, a small quadcopter was flown to collect ultra-high-definition video of a large bridge in Independence, Oregon.</p> <p>A number of minor bridge defects were noted in the imagery, including rust, missing nuts, efflorescence, cracks, and spalling. The videos could be used to satisfy many of the routine and initial bridge inspection requirements of the AASHTO Bridge Inspection Manual (AASHTO, 2011).</p> <p>The imagery may also be useful for in-depth inspections; however, in-depth inspections sometimes require probing and scraping that cannot be accomplished with UAS. In addition, in-depth inspections require the inspector to be at arm's length of the bridge. Obviously, a UAS does not satisfy this requirement.</p> <p>The greatest challenge involves capturing imagery with a UAS with sufficient resolution for an inspection. At arm's length, the human eye has a spatial resolution approximately equal to 0.1 mm. Even within 3 meters of the bridge, the approximate spatial resolution of the high-definition camera onboard the quadcopter in this experiment was 0.7 mm. Flying even closer to the bridge is difficult because of complicated wind eddies that can potentially push the aircraft into the structure.</p> <p>This issue could, potentially be alleviated by flying a heavier aircraft equipped with a camera with a larger sensor size and an optical zoom. Future research remains to investigate other UAS platforms for bridge inspection.</p>
