Design and Construction of a Field Test Site to Evaluate the Effectiveness of a Compost Amended Bioswale for Removing Metals from Highway Stormwater Runoff

WA-RD 724.1

Mark W. Maurer

University of Washington

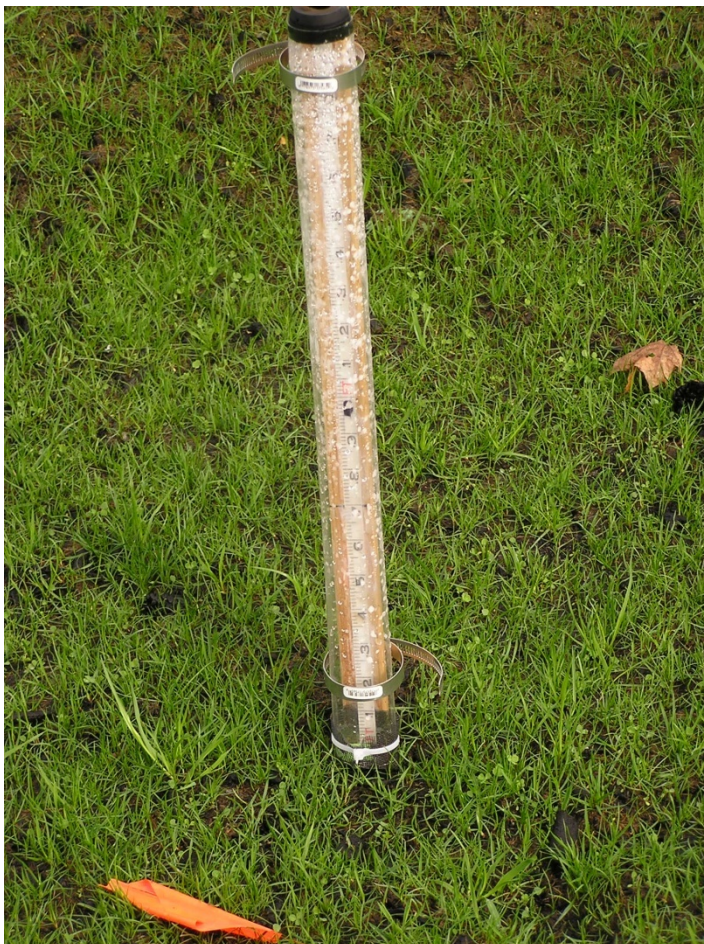
Figure 4. Crest gauge

Three water level “crest gauges” per swale are used to determine the maximum depth of flow in the swale per storm and to determine if the maximum depth is consistent along the length of the swale. The crest gauges are tubes with cork dust and an inlet in the bottom. As the water rises in the gauge the cork dust floats on top and leaves a ring on the inside at the maximum depth. After each storm the gauges will be read and the peak water level noted. A small amount of water is used to wash the dust down to reset the gauge (See Figure 4).

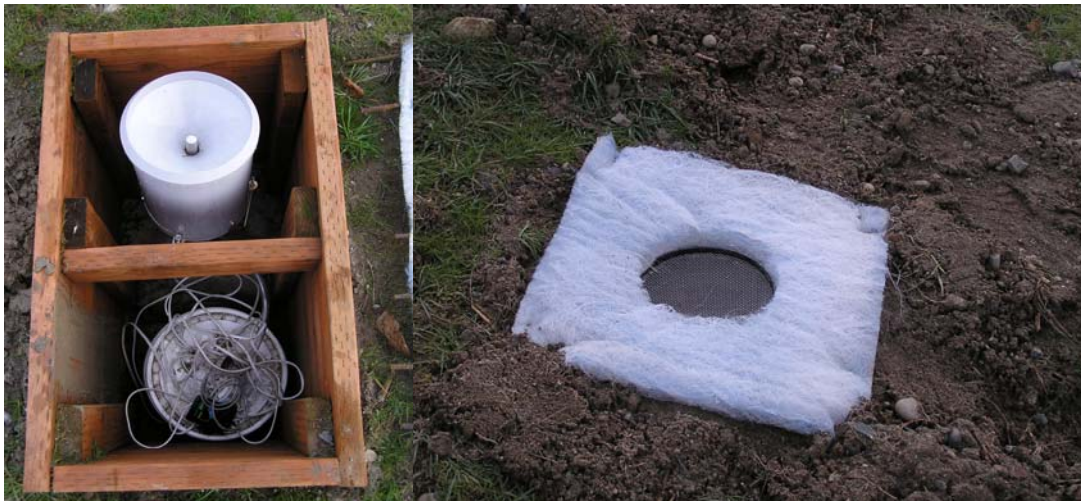
Figure 5. TB3 (left) and ISCO (right) rain gauges installed in housing in pits

The TB3 rain gauge is housed in a treated lumber box that allows room for the rain gauge and an accumulating bucket that is used to check the volume of water that passes through the tipping bucket gauge (Figure 5). The ISCO rain gauge is housed in a well-drained plastic 5 gallon bucket. Both rain gauges have leveling bubbles incorporated into the instrument bodies. The TB3 is mounted on 3 stainless steel rods set in concrete and the ISCO rain gauge is bolted to the bottom of the bucket. The bucket sits on a concrete pad at the bottom of the pit. Native soil is used to backfill around both housing units. A frame covered with home heating furnace air filter fabric is used to prevent water from splashing into the rain gauges. Both pits have a drain pipe leading from the bottom of the pit to a down gradient French drain to facilitate drainage.

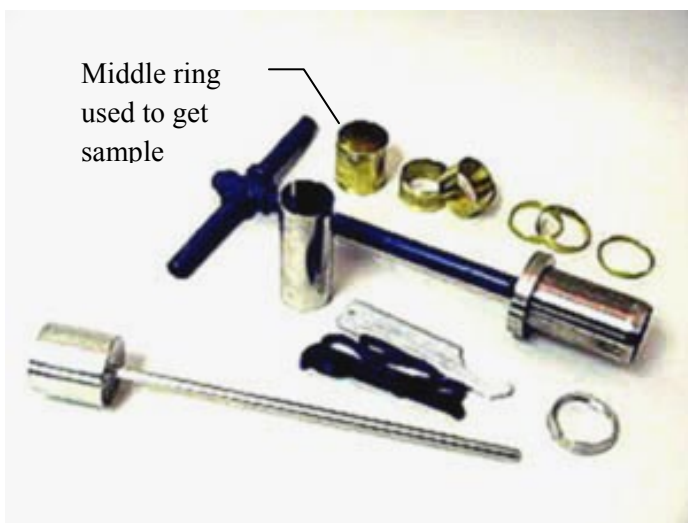
Figure 6. Soil corer used for taking soil bulk density samples - source ICT International

An in-situ soil bulk density test was performed on the Bw2 and C soil horizons (Table 9). A soil impact corer was used to remove a sample from the Bw2 horizon. The impact corer is held perpendicular to a soil horizon and a weighted hammer is used to drive the corer into the soil. The corer is made up of an outer solid ring with a sharp edge. Inside the outer ring are 5 brass rings that slip out of the outer ring. The inner rings hold the soil. The three rings on the end of the core are removed and the soil is struck off across the faces of the two inner rings. (Figure 6) The soil from the two middle rings was placed in a sample bag and marked for further processing.

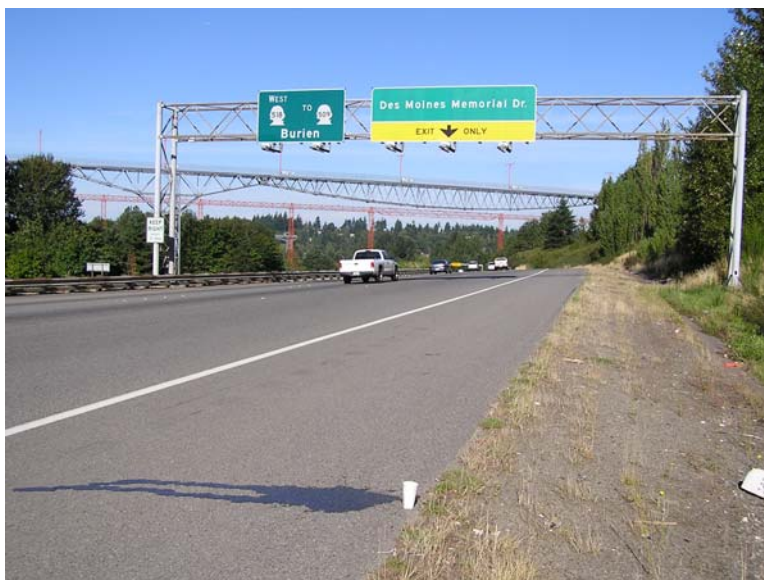
Figure 7. Water poured on the shoulder of SR 518 to determine the contributing area

A simple test was undertaken to determine which way the water flowed on the road. Water was poured on the shoulder to see which way it would flow. (Figure 7) It immediately flowed south

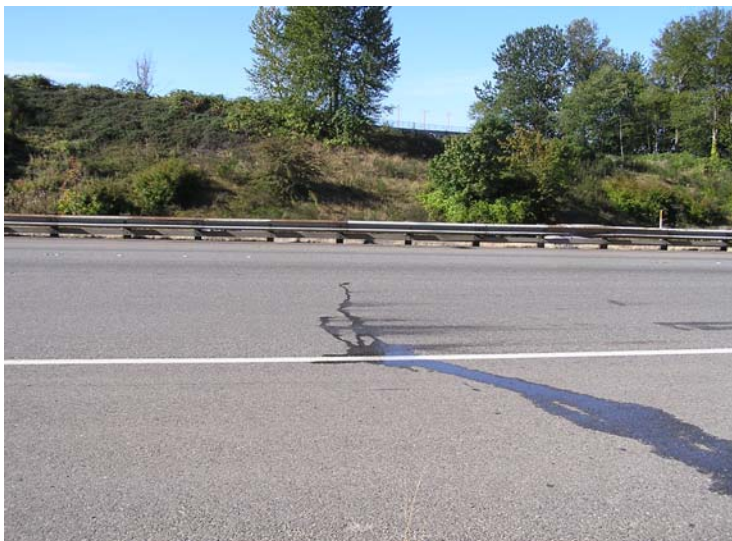
Figure 8. Water flow across the travel lanes from north to south towards curb

across the shoulder and toward the travel lanes. Water was slowly added to the stream and it continued to flow across the travel lanes toward the curb on the south side of the highway. (Figure 8) This test was repeated at the beginning and the end of each contributing area with the same results in each case.

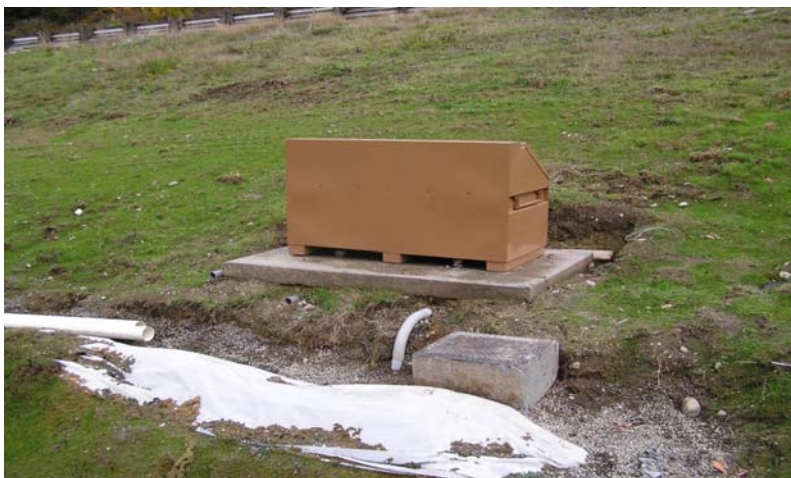
Figure 9. Instrument box on pad

Each monitoring station is equipped with an ISCO automated sampler that is housed in a vandal-resistant and waterproof metal enclosure (Figure 9). Flow rates are measured by routing the water through flumes at the inflow and outflow of each bioswale. Water depth is measured with pressure transducers located in stilling wells at each flume.

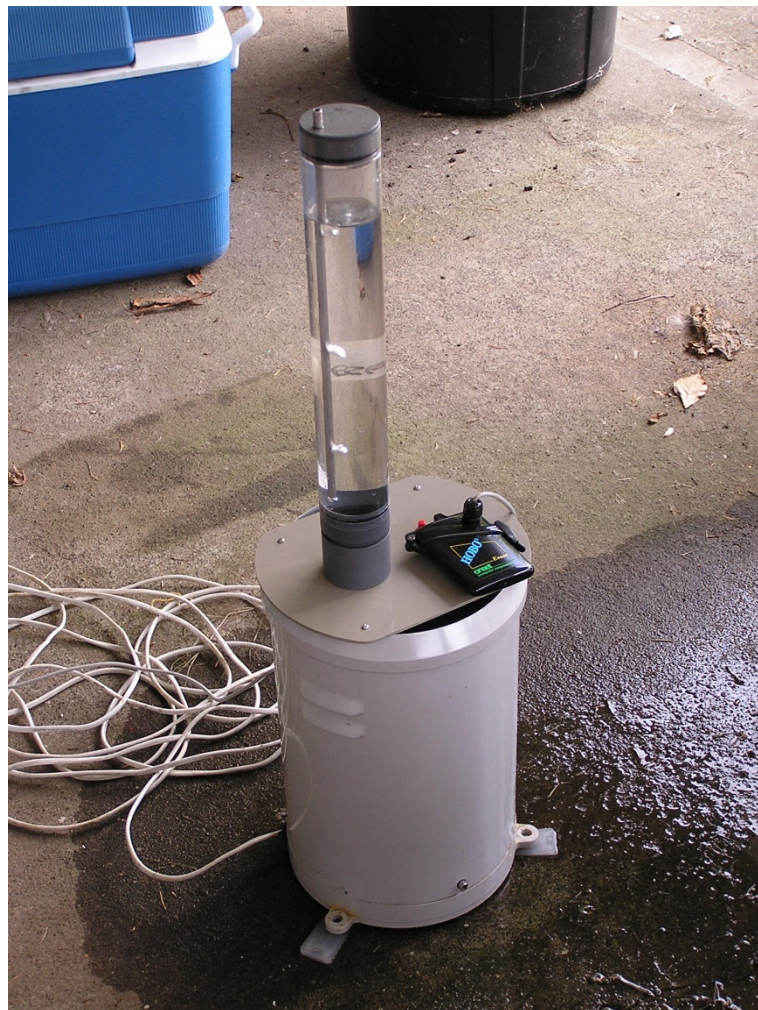
Figure 10. TB3 “tipping bucket” rain gauge calibration with a Hydrological Services TB320 Field Calibration device and a Hobo event recorder

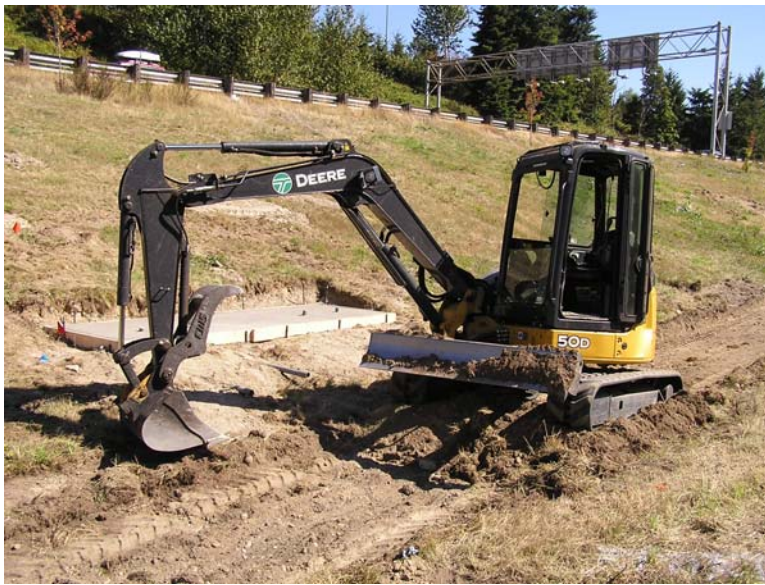
Figure 11. Excavator used to do site preparation

would fit on the site. After the layout was complete, equipment was brought in to prepare the site. A John Deere D50 excavator with a 6.5' wide blade was used to prepare the pads for the equipment, dig the trenches, and construct the bioswales (Figure 11). A laser level was used to control the slope of the bioswales.

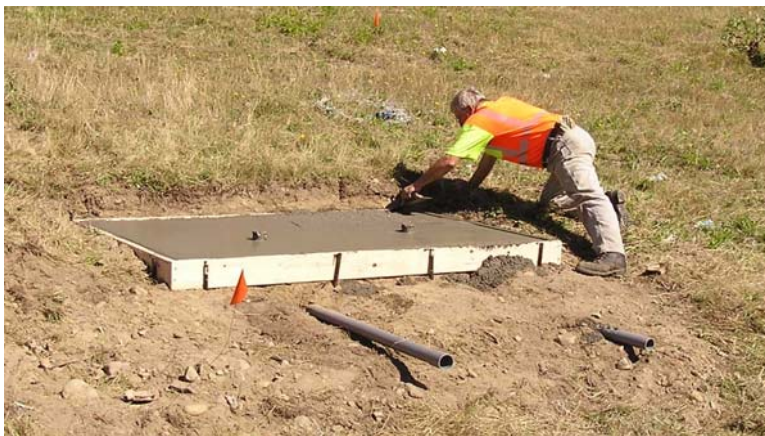
Figure 12. WSDOT employee finishing concrete pad for instrument box

Portland cement concrete pads were installed for the equipment boxes. Two inch conduit was installed in the pads to allow electrical wiring, cables, and tubing to enter through the bottom of the equipment boxes. (Figure 12) Two conduits were installed per box.

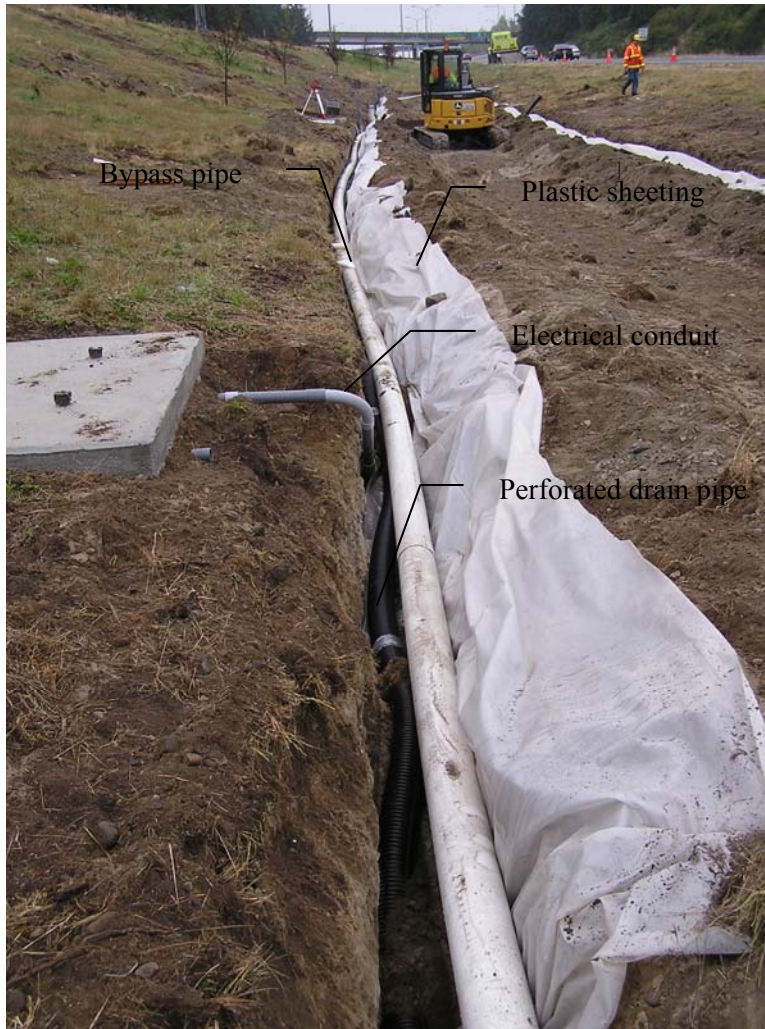
Figure 13. French drain trench with plastic sheet lining, perforated (black) and soild pipe (light), and electrical conduit installed

The trenches for the French drain and pipes from the curb cuts to the bioswales were made with the excavator using a narrow bucket. The trenches for the French drain were dug, at a minimum, to the top of the basal till layer, or two feet, whichever was deeper. The trenches for the pipes and electrical conduit were a minimum of 2 feet deep to meet local building codes for minimum cover for electrical conduit. (Figure 13)

The trenches for the French drains were lined with plastic on the bottom and bioswale (inside) sides. The top of the plastic was draped over the mounded soil from the trench excavation on the bioswale side of the trench and covered with additional soil to hold it in place (Figure 13). Conduit for electrical pipe, a 4 inch diameter perforated pipe, and a 6 inch diameter solid drain pipe was placed in the trenches on the instrument side of the bioswale and a 4 inch diameter perforated pipe and a 6 inch diameter solid drain pipe were placed on the opposite side of the bioswales (Figure 13).

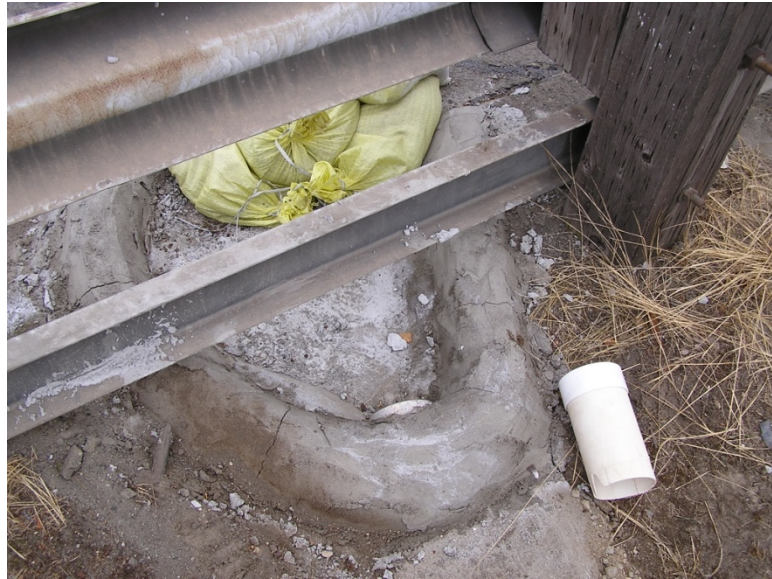
Figure 16. Curb cut and inlet pipe with temporary cap removed and flow blocking sandbags in place

The curb on the south side of SR 518 was cut in two places to create an inlet for the water to flow into each of the two pipes that feed the bioswales. A concrete pad was made behind the curb cut and a 4 inch diameter solid “schedule40” PVC pipe was embedded flush with the bottom of the pad. A concrete curb was built on the pad to funnel water to the pipe. Each pipe

was fitted with a removable cap and sandbags placed in front of the inlet to prevent water from flowing into the pipe until the site was ready to receive the stormwater flows. The existing catch basins were covered and the sandbags and cap removed on March 15, 2009 when the bioswales were ready to receive water (Figure 16).

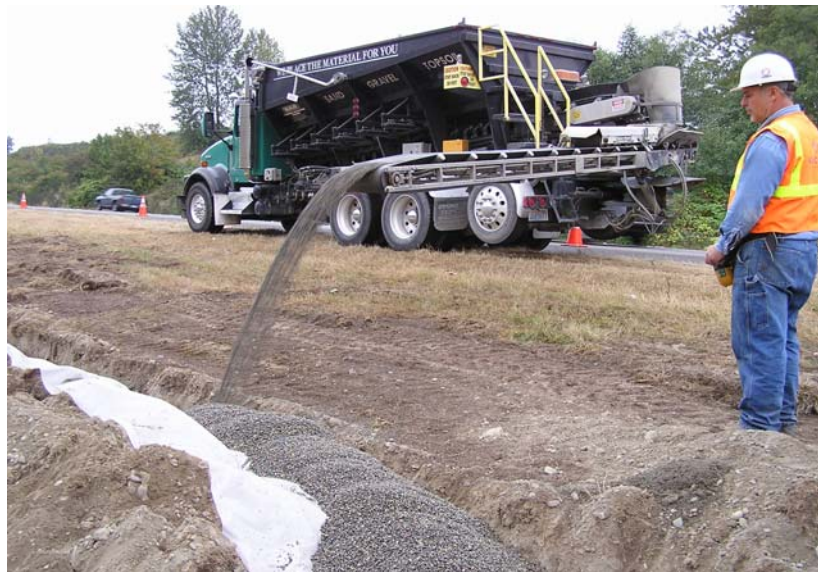
Figure 17. Pea gravel being placed in French drain by an aggregate delivery truck

Permeable “pea gravel” fill was supplied to the trenches using an aggregate delivery truck with a conveyor belt to place the gravel (Figure 17). An alternative option was to bring the gravel in with dump trucks and place the gravel with a front end loader. This truck placed the pea gravel

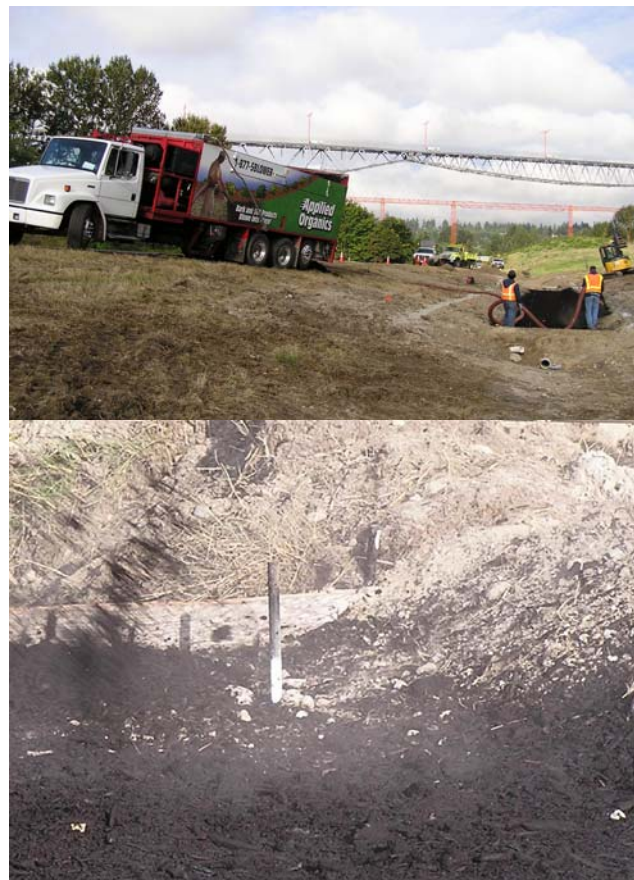
Figure 18. Compost blower truck (top) and steel pin showing final compost depth

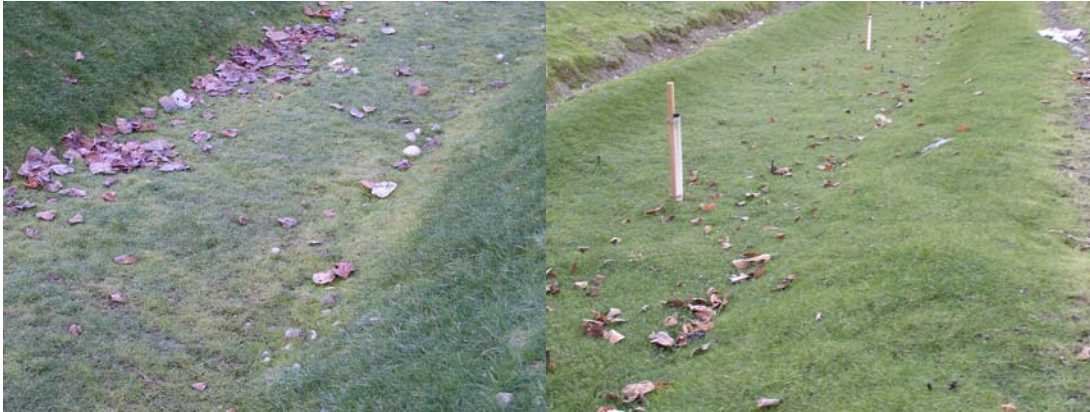
Figure 19. Bioswale 2 (left) and bioswale 1 (right)

The vegetation establishment on the two bioswales is noticeably different. Figure 19 shows the control bioswale and the composted bioswale side by side. The vegetation on the composted bioswale is denser and taller than the control (Figure 20). It is clear from these photos that the vegetation establishment has been enhanced by the addition of compost.

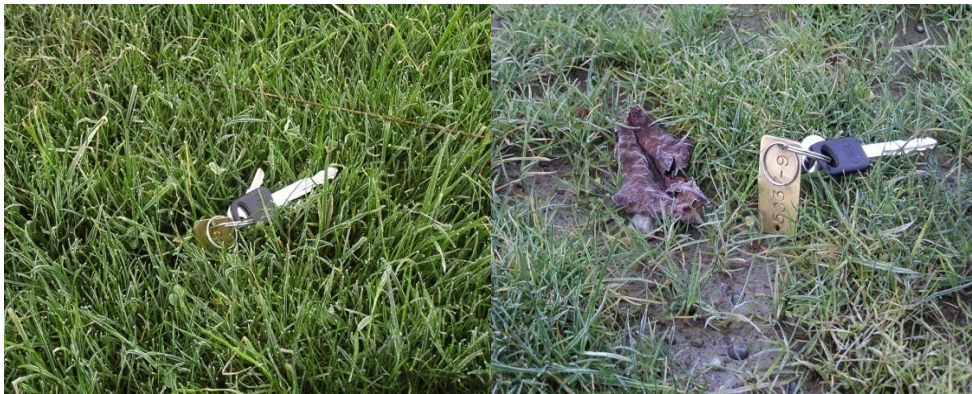
Figure 20. Vegetation on bioswale 1 (left) and bioswale 2 (right) (January 4, 2009)

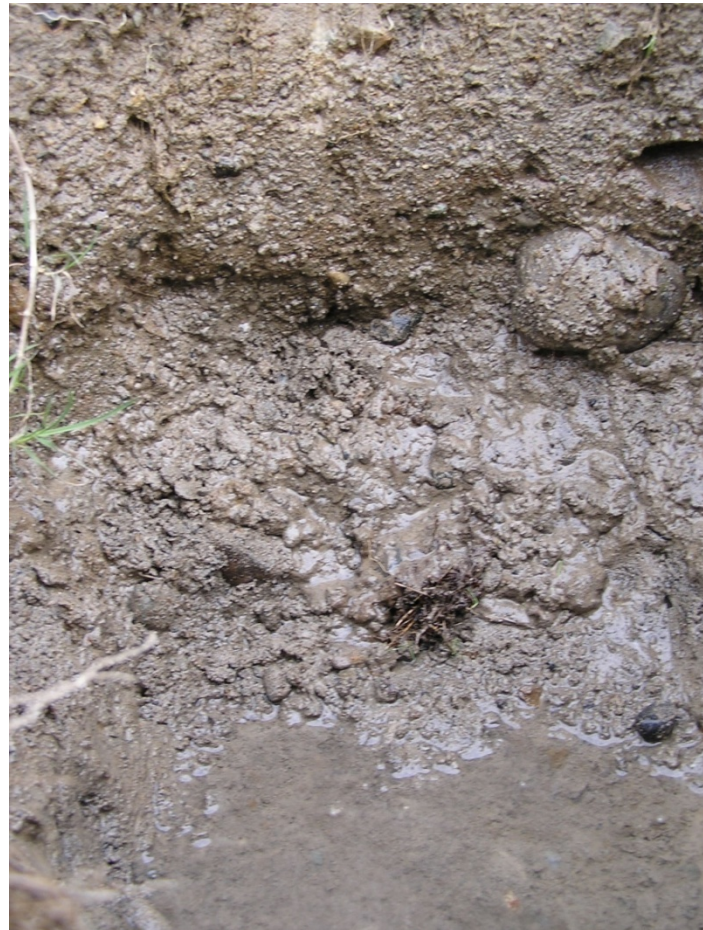
Figure 21. Water seeping from sides of ISCO pit

While digging the hole for one of the pit rain gauges water was observed seeping from the sidewalls of the hole and collecting on the bottom of the pit. The seepage is evident Figure 21.

This seepage is instructive in two ways. First it shows the need to place a drain in the pit to avoid water build up that could back into the rain gauge, but more importantly, it shows why the French drain is important around the bioswale to keep the water

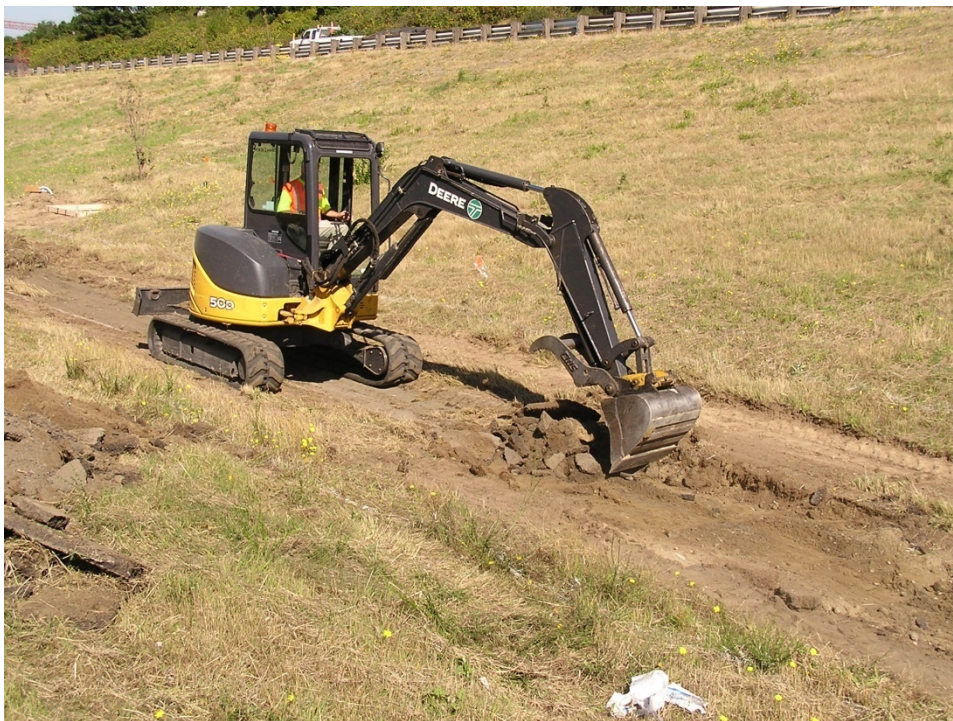
Figure 24. Excavator removing asphalt lining in ditch

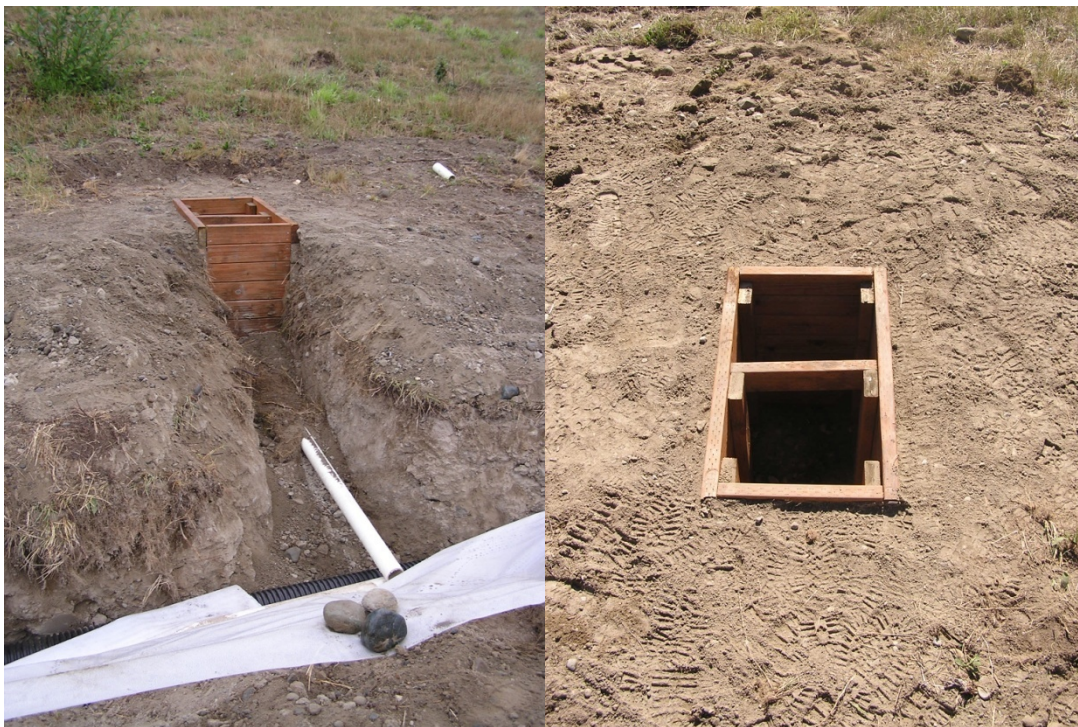
Figure 25. Wood box for TB3 pit rain gauge showing drain to French drain (left) and fully installed

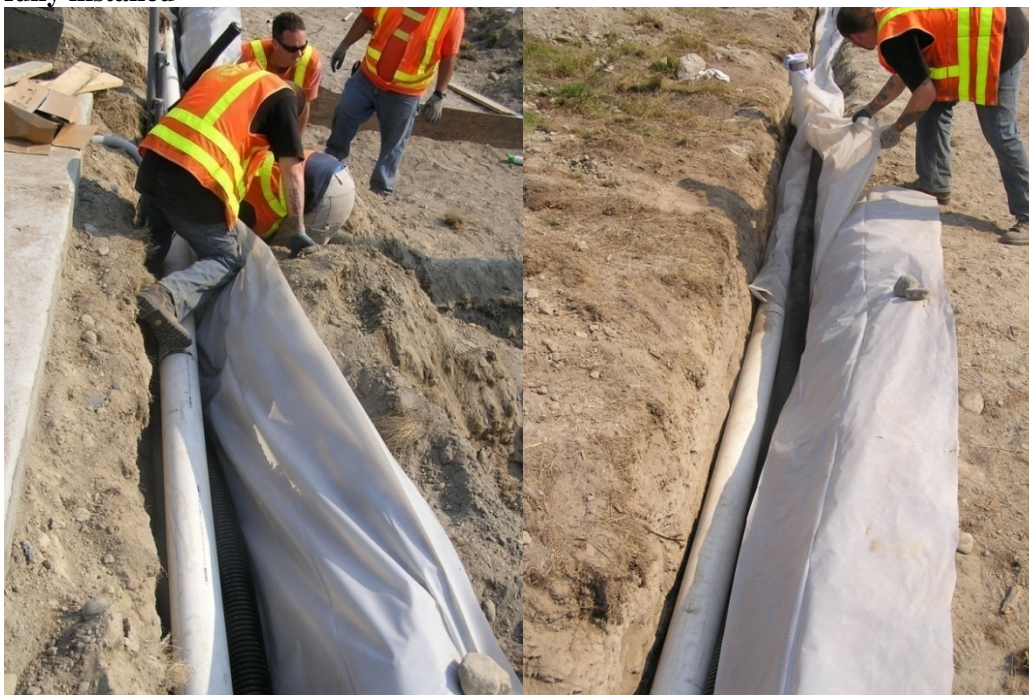
Figure 26. WSDOT workers installing pipe and plastic sheeting in French drain

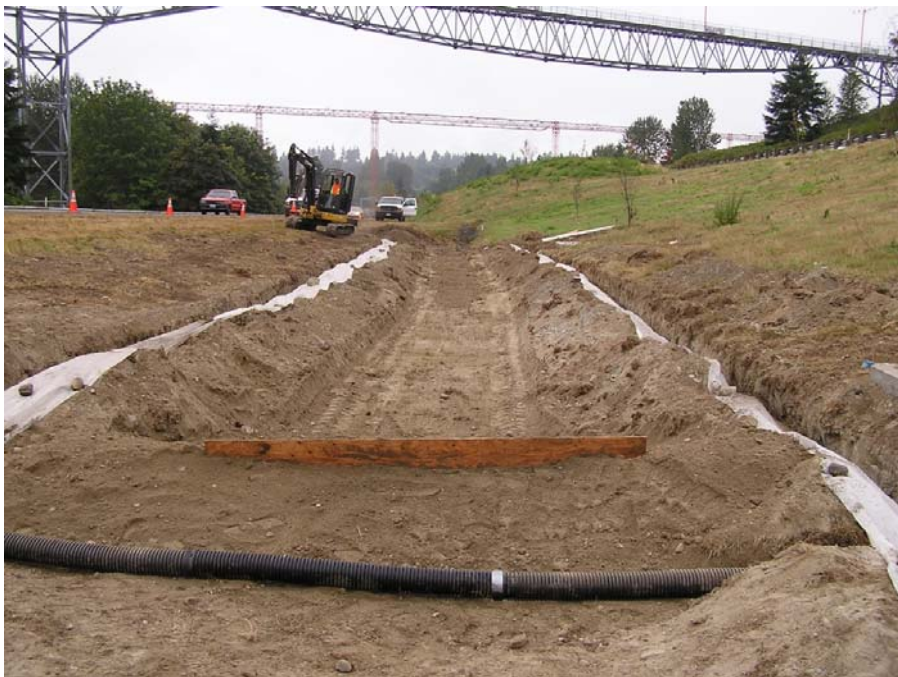
Figure 27. Bioswale 1 with dam at bottom end and French drains

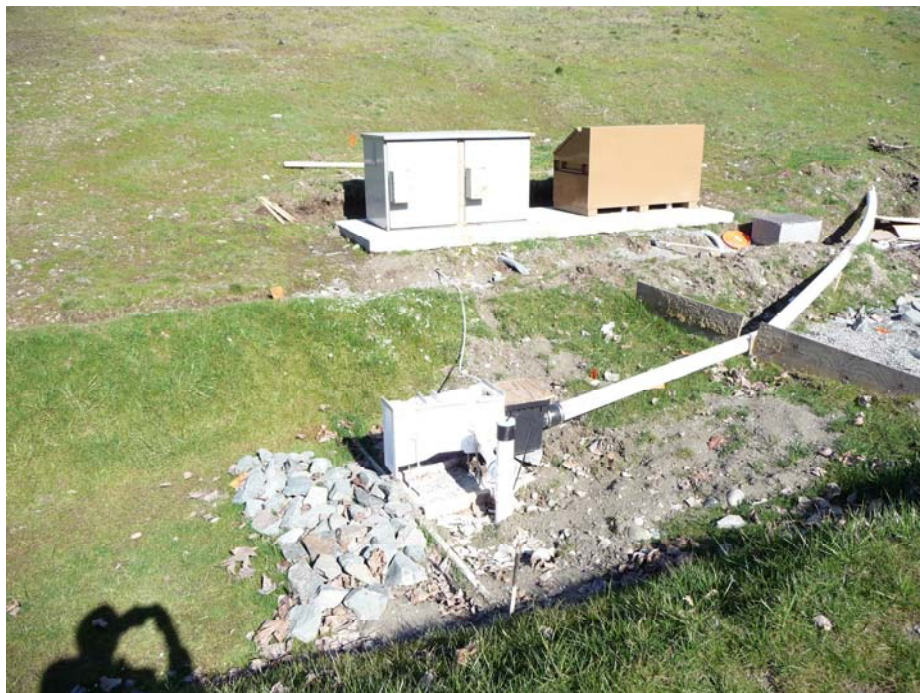
Figure 34. Parshall flume at inlet to bioswale 2

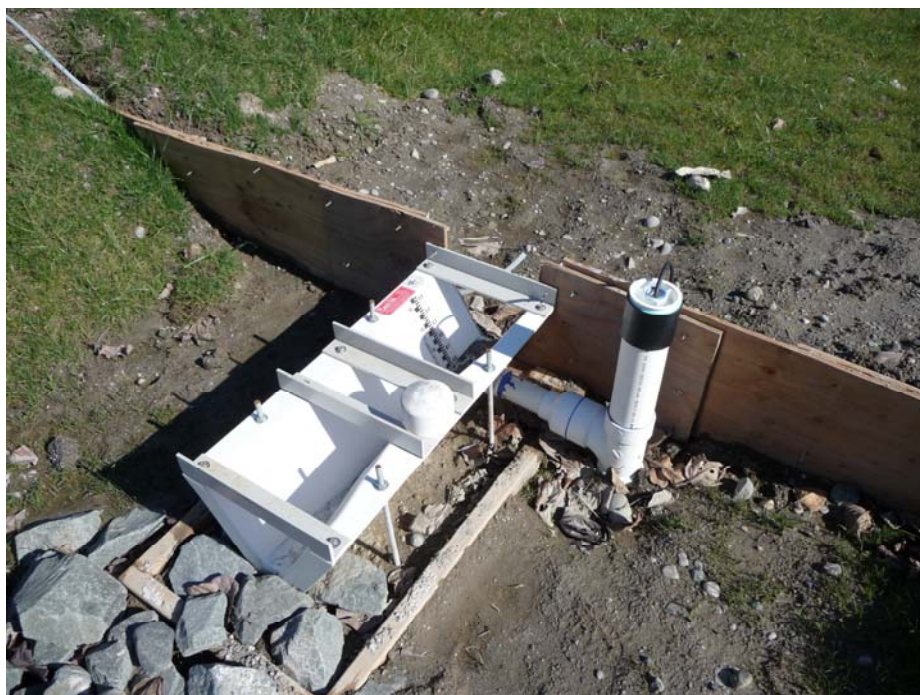
Figure 35. Parshall flume at outlet of bioswale 1
