# Evaluation of Induction Loop Installation Procedures in Flexible Pavements

WA-RD 76.1

Final  
February 1985

by  
Derald Christensen  
Dave Newcomb

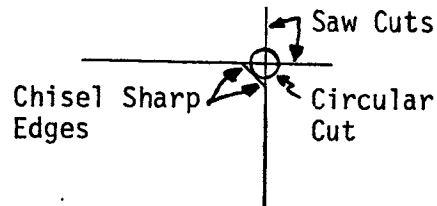
Figure 3. Method to Reduce Stress Concentrations at Corners.

CURRENT METHOD OF  
CORNER-CUTTING CAN  
CAUSE PAVEMENT DISTRESS

THIS METHOD REDUCES THE  
NUMBER OF SAW CUTS

Hale (11) cited problems with corner cutting the loop slots. The triangle formed by saw cuts creates increased stress concentration in these areas of the pavement. The pavement within these triangle are stressed to failure much sooner than the surrounding pavement. To alleviate this, it was suggested that two inch diameter holes be drilled at the corners and the radii of the holes be chiseled out to form rounded corners for the wire. This is illustrated in Figure 3. Hale (11) also noted the importance of having slack in the wire at corners to accommodate pavement movement.

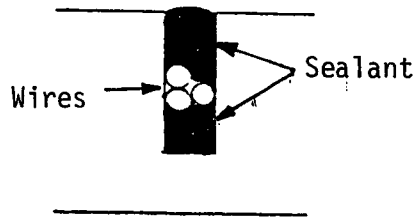
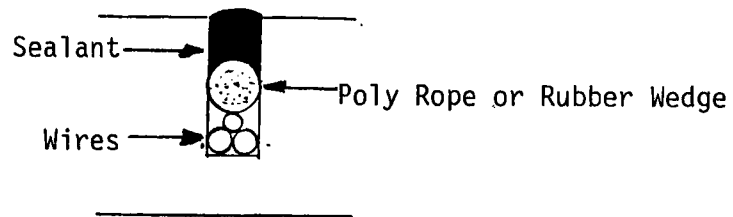
Figure 4. Methods of Sealant Application.

4a. Partial Encapsulation.

4b. Total Encapsulation.

4c. Conduit Method

The success or failure of an induction loop system is largely dependent upon the method and material used to hold the loop in place. There are three general methods used to hold loop wires in place: 1) partial encapsulation, 2) total encapsulation, and 3) the conduit method. These are illustrated in Figure 4. The current WSDOT procedure calls for using the conduit method. De Laski (1) does not recommend the use of the conduit method although no evidence was presented to show that it was any worse than the other methods. Instead, he favors the encapsulation of loop wires because of the "tough-but-rubbery" nature of recently developed loop sealers.
