Research Report
Agreement T1461, Task 26

**UNDERWATER NOISE REDUCTION OF MARINE PILE
DRIVING USING A DOUBLE PILE
Vashon Ferry Terminal Test**

November 2016

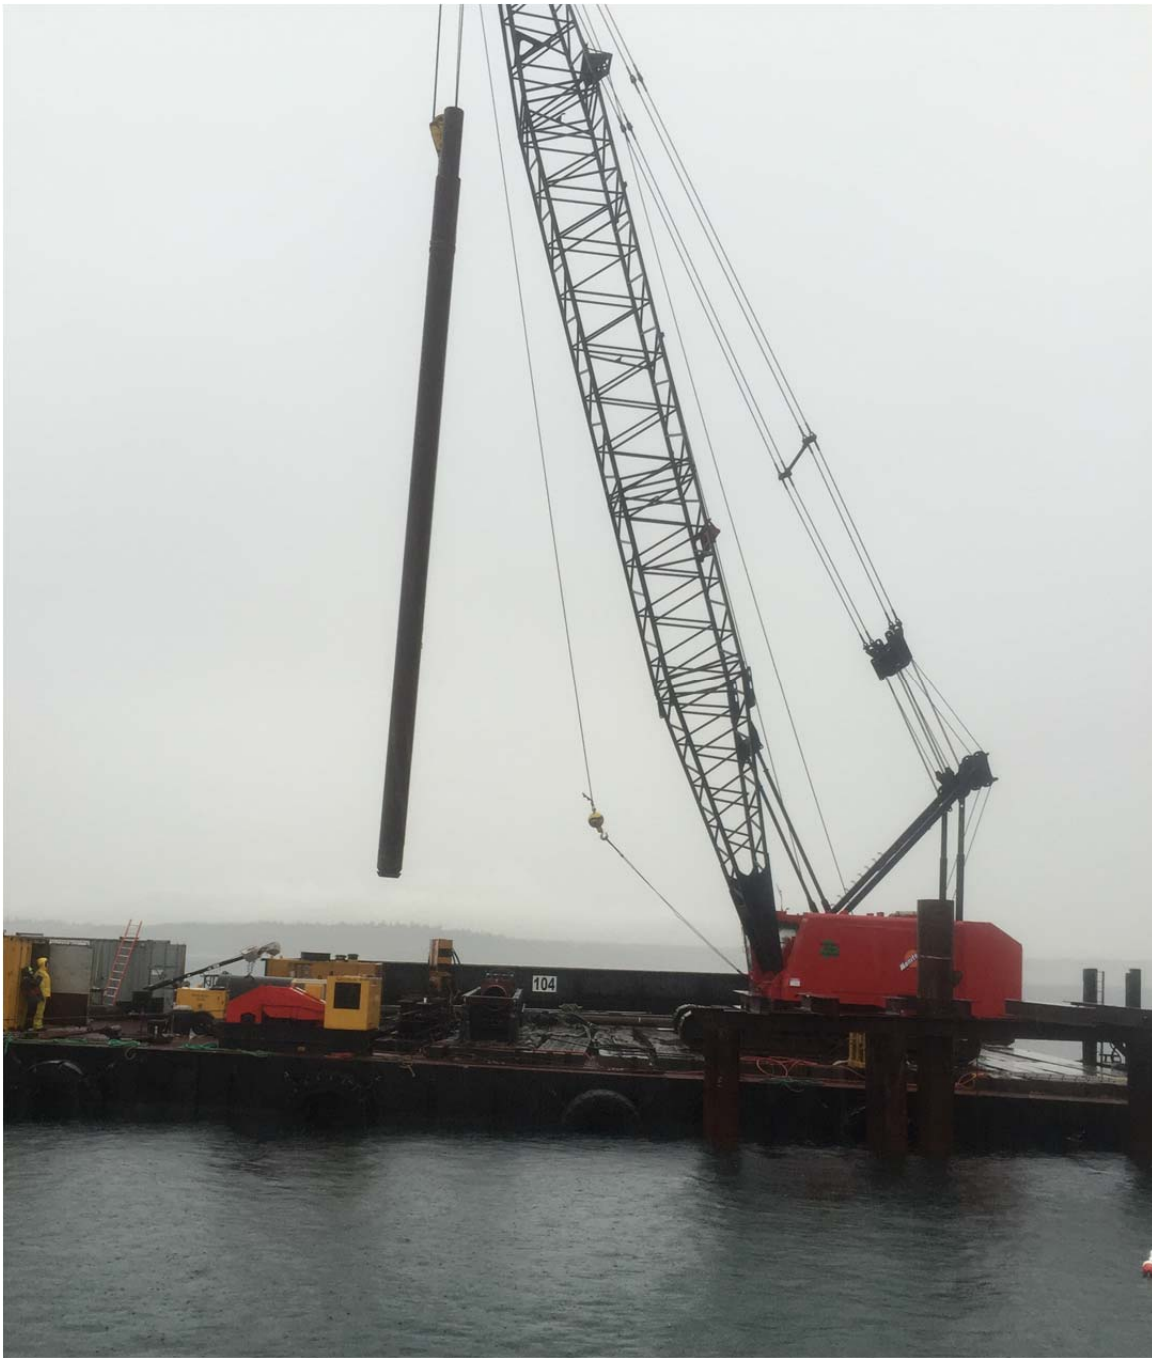
Figure 5: Crane lofting double-walled pile into place. Photo courtesy Jim Laughlin, WSDOT.

Quigg Brothers, the construction contractor for the Vashon Ferry Terminal project, was provided with a standard 76.5-ft-long control pile, a fully fabricated 76.5-ft-long double-walled pile, and a partially fabricated 76.5-ft-long mandrel pile. In the latter, the outer pile and driving shoe had been welded together, but the mandrel had not yet been inserted into the outer pile. Figure 5 depicts the lofting of the fully fabricated double-walled pile into the driving template.

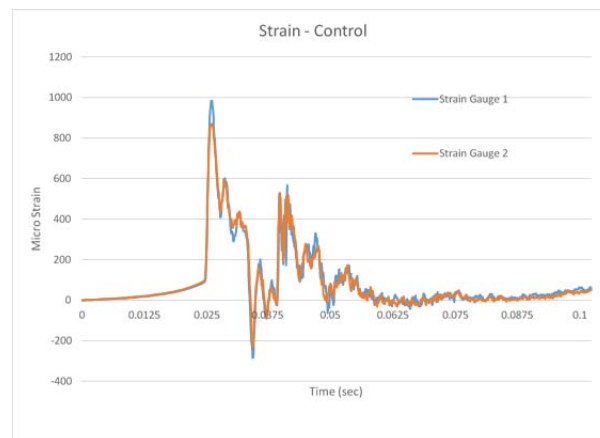
Figure 9. Longitudinal strain in the control pile as measured by the PDA system.

Figure 9 shows a typical strain recording as a function of time for the control pile (blow 50) with a maximum longitudinal strain of approximately 0.1 percent. Figure 9 shows the strain in both the inner and outer piles for the mandrel pile. It can be seen that the maximum strain in the control pile was similar to the strain in the inner pile of the double-walled pile. Note that the hammer only struck the inner pile as the piles were driven into the sediment. The outer piles were connected to the inner pile via a watertight flexible coupling in the driving shoe (Figure 10).

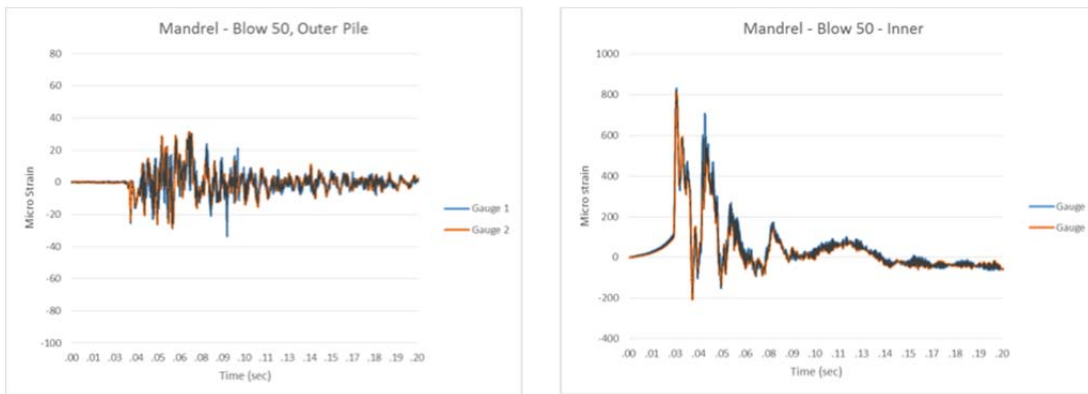
Figure 11. Strain in the outer pile (left figure) and inner pile (right figure) as measured by the installed PDA system

For a detailed description and function of the driving shoe, please see WSDOT report WA-RD 849.1 [7]. Figure 11 shows the strain between the outer (left) and inner (right) pile for a typical hammer strike. The low acceleration in the outer pile was due to the fact the measurement location was close to the top free end of the pile where the boundary condition was stress and strain free.

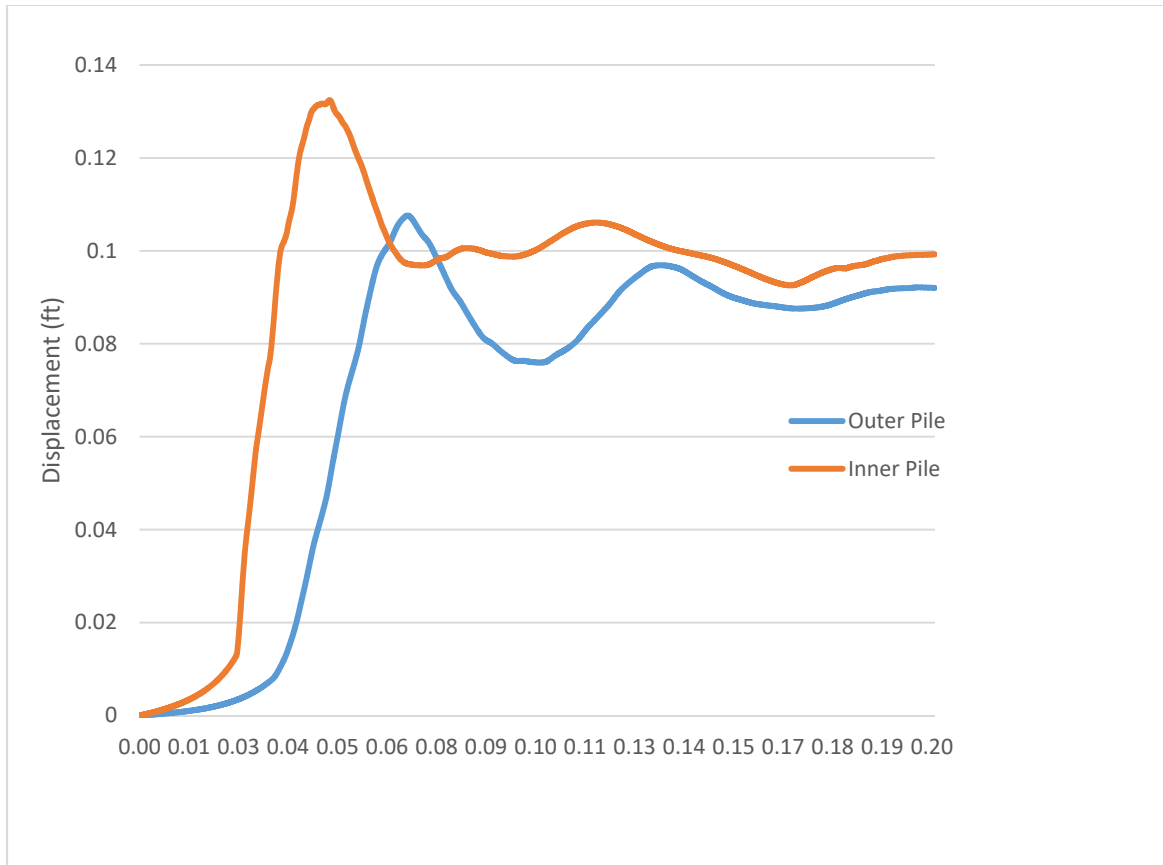
Figure 12. Displacement of the inner and outer pile of the double wall pile after a pile hammer strike (strike 100)

Figure 12 show the displacement produced by a typical hammer strike. The effect of the flexible coupling can be seen in that the displacement of the outer piles lags the displacement of the inner piles. From a drivability standpoint, the test piles required additional blows for the same penetration. This was most likely due to two factors: 1) the

bearing surface of the driving shoes of the double and mandrel piles was larger than the driving shoe of the control, and 2) the stiffness of the polymer spring at the bottom end of the double and mandrel piles was too soft for the sediment type. A higher stiffness would have created higher axial peak stresses in the outer pile, making penetration into the sediment against the skin friction easier. Table 2 summarizes the pile driving record with the driving depth and blow counts for each of the piles.

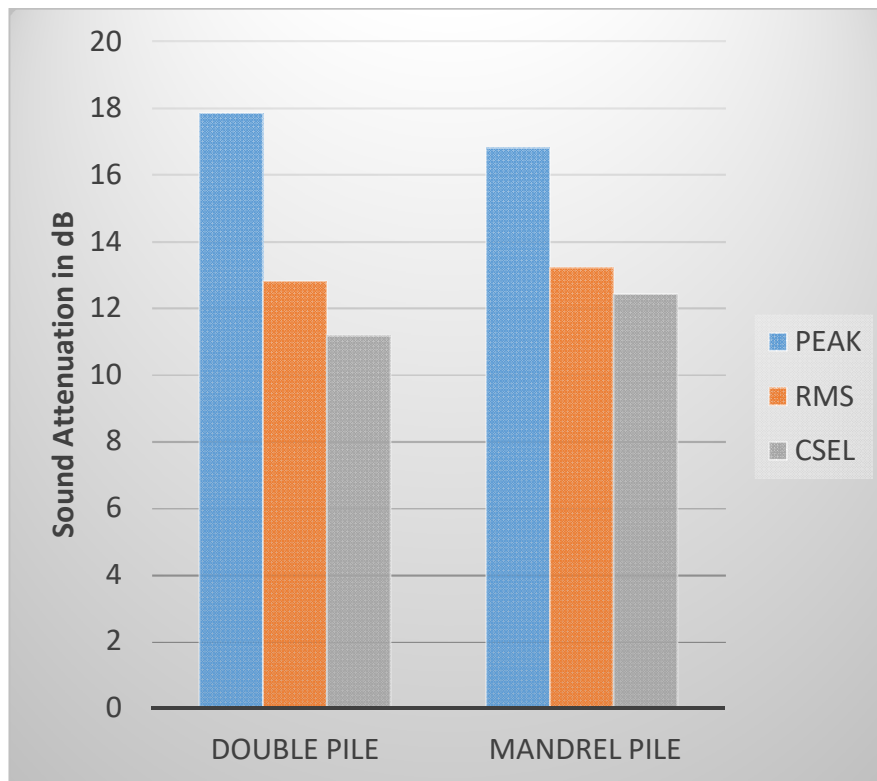
Figure 14. Summary of sound reduction in terms of CSEL, RMS and Peak pressure for the double-walled test pile and mandrel test pile relative to the control pile at a range of 10 m. Averaged over depth and filtered to partially correct for template/pile contact.

Figure 14 summarizes the noise reduction in terms of CSEL, RMS and Peak pressure after the data from all three piles were high-pass filtered using a FIR filter to remove the 75 Hz peak to partially correct for the direct contact with the driving template. A reduction of the peak pressure in excess of 17dB was observed for the double pile and in excess of 16 dB for the mandrel pile. The RMS levels decreased approximately 13 dB and cumulative SEL decreased by 12 dB. Note that the attenuation would most likely have been greater if the effect of the template could have been completely removed (not just its lowest resonance peak).
