JAMS

Effects of Repair Procedures Applied to Composite Airframe Structures

*National Institute for Aviation Research
Wichita State University*

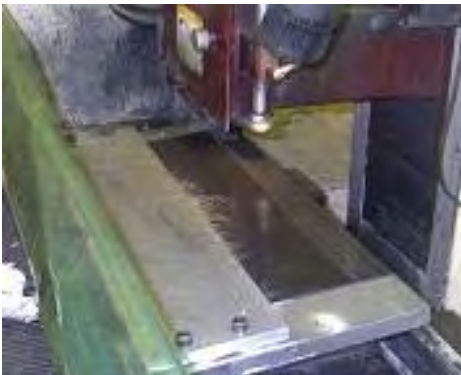
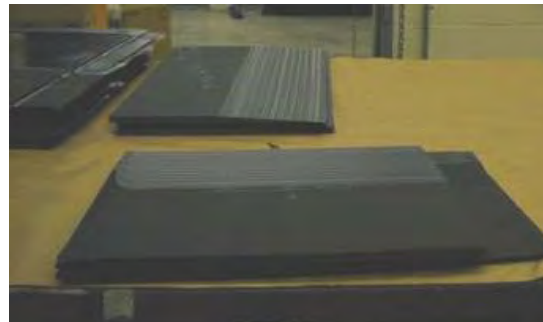
AMS 2980 CACRC using G40-800 6k intermediate modulus fibers with Epocast 52A/B

Laminating resin

➤ 1-D Coupon used to isolate parameters/ effects studied
