PLACENTA ACCRETA SPECTRUM OB ULTRASOUND PROTOCOL

PLACENTA ACCRETA SPECTRUM IMAGE LIST

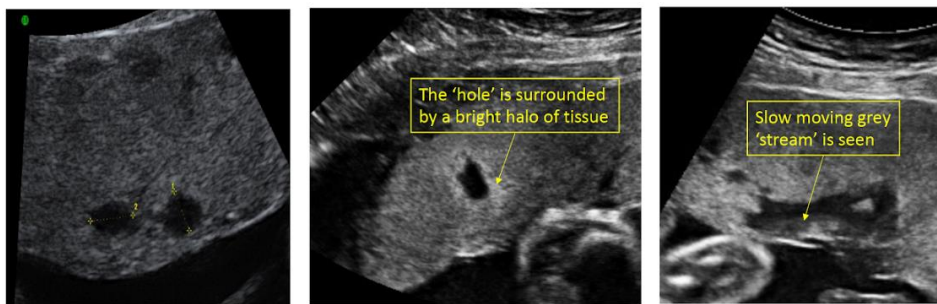
A) Simple placental lakes – note there is no increased brightness in the surrounding tissue

B) Echogenic cystic lesion (resulting from a placental infarct)

C) Placental lake with slow flow visible in greyscale – note the position away from the placental basal plate

Placental infarcts can be differentiated from lakes and lacunae by their hyperechoic rim.
