Watershed and stormwater drainage assessment of the Washington Park  
Arboretum

A project report  
submitted in partial fulfillment of the  
requirements for the degree of

Master of Environmental Horticulture

University of Washington

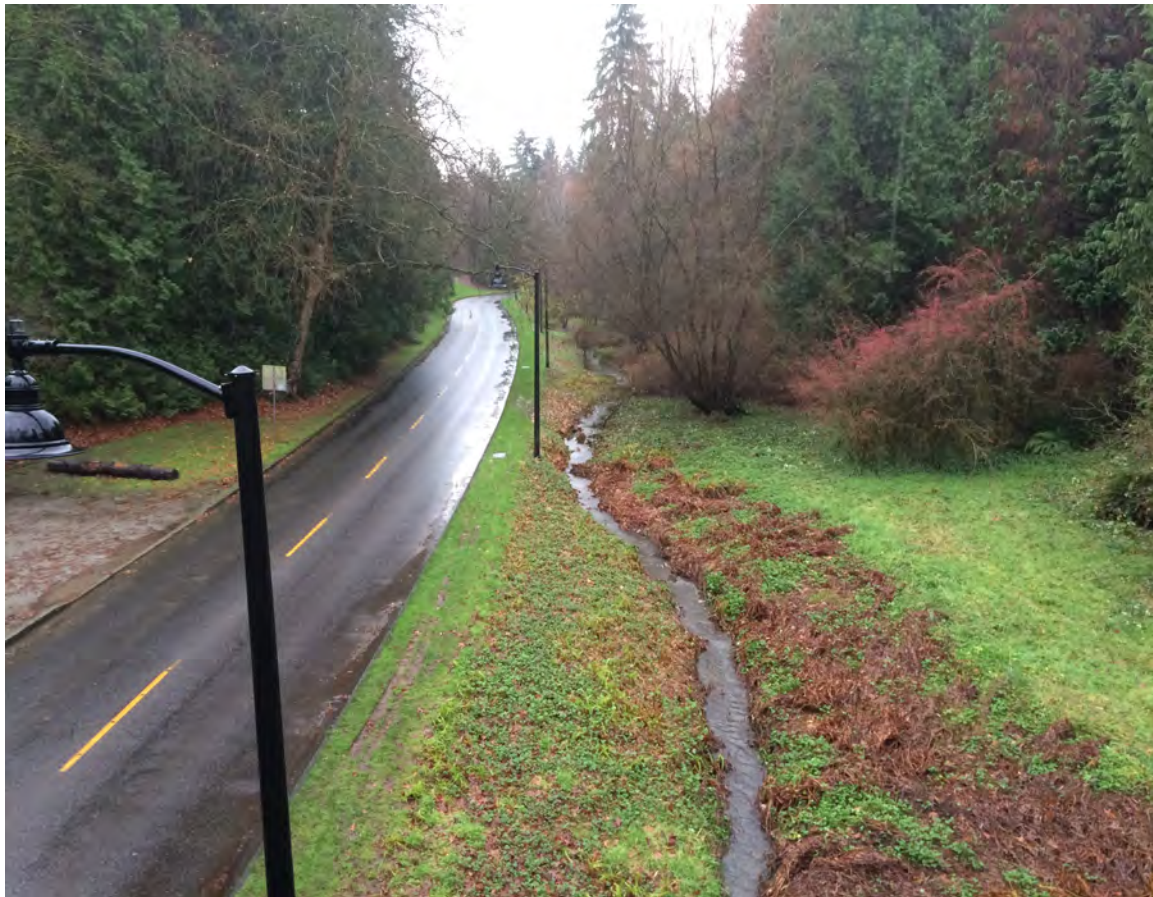
Figure 3. Arboretum Creek viewed from the Wilcox Footbridge

The main waterway that drains the WPA and surrounding watershed is Arboretum Creek (Figure 3). This drainage begins at the south end of Azalea Way in the Arboretum and meanders north across Lake Washington Boulevard, through the east side of the Pinetum, until it flows into Union Bay and Lake Washington. Medbury (1990) describes the headwaters of Arboretum Creek as a “spring-fed brook” that winds through the west border of the WPA, although surface and possibly subsurface flows add to the flow volume. The Arboretum Creek watershed is relatively small when compared to some of the larger urban watersheds in the city of Seattle. However, its importance lies not in its size, but in the cultural, historical, and ecological significance of the WPA to the city of Seattle, University of Washington and all who access the land and plants for various reasons.

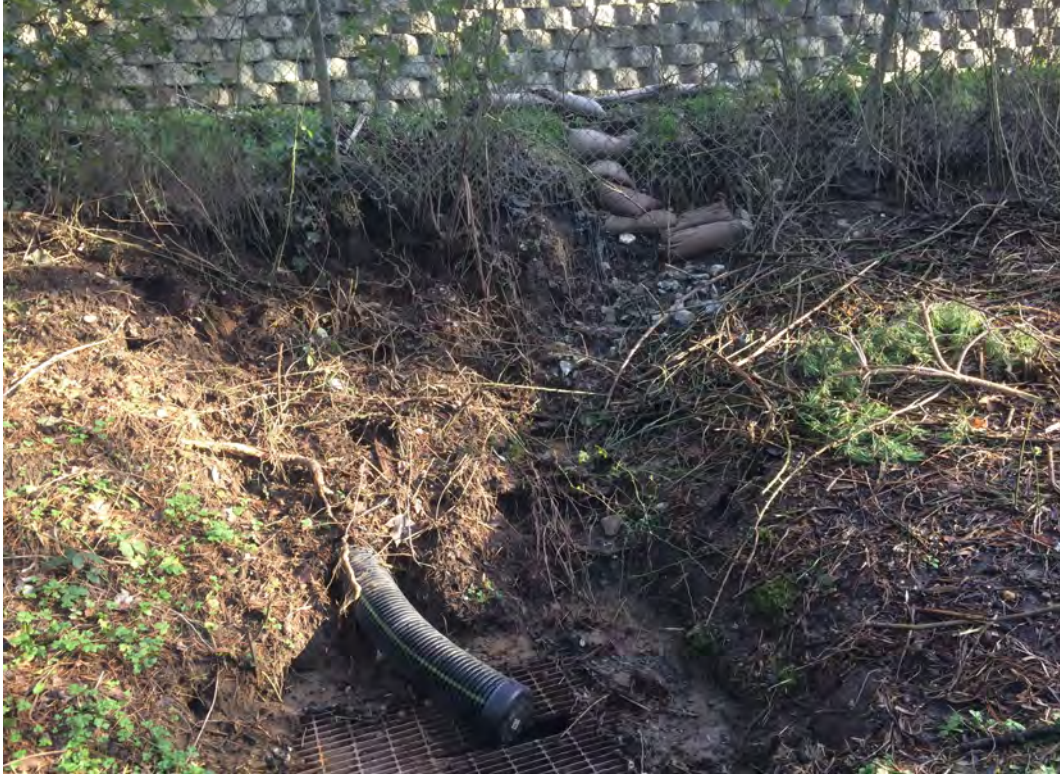
Figure 17. Crabapple Meadow flow accumulation entry point. Note catch basin in foreground and Broadmoor Golf Club retaining wall in background

A third observed runoff entry point into the WPA exists approximately 100 feet south of north entry point (Figure 17). This runoff is quickly captured by a catch basin located approximately 3 feet west of the entry point and is piped directly into the upper pond in the Woodland Garden. Large volume of surface runoff has been observed at this entry point during precipitation events. However, the third entry point is not shown on the GIS analysis. This discrepancy is likely caused by a large grade change that occurred in the Broadmoor Golf Club after the aerial LiDAR data was obtained. In 2007 and 2008, 12,000 cubic yards of soil were excavated to create a lake for the purpose of irrigating the golf course turfgrass. 4,000 cubic yards of soil were used to elevate a tee box located east of the Crabapple Meadow in the WPA and a 24.5-foot tall by 265-foot long retaining wall was constructed to support the tee box (City of Seattle Department of Planning and Development, 2007).

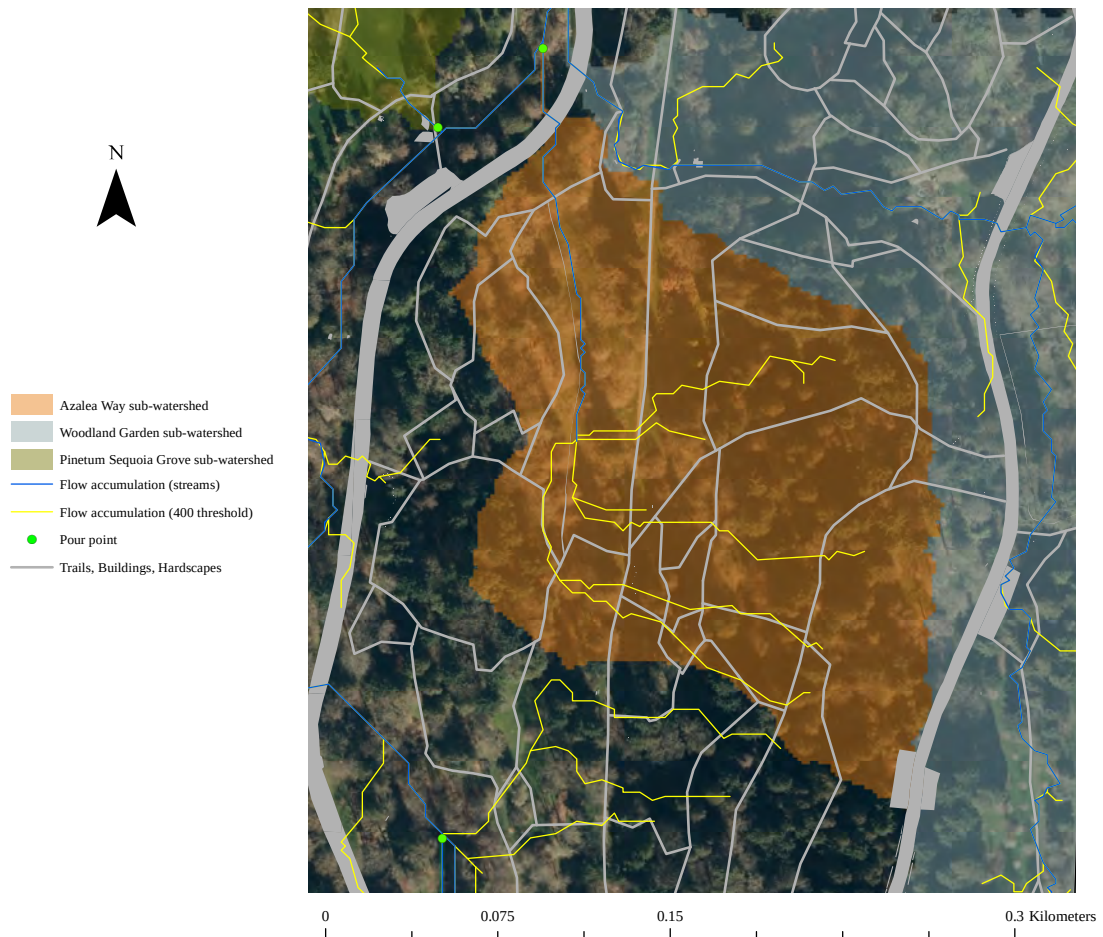
Figure 19. Azalea Way sub-watershed

The Azalea Way sub-watershed occupies the area southwest of the Woodland Garden sub-watershed, including middle section of Azalea Way, the western half Loderi Valley, the Asiatic Maple Collection, the majority of the Magnolia Collection, the east-facing slopes of Honeysuckle Hill and Yew Hill and the low-lying site of the Nut Collection (Figure 19). The high flow accumulation in this sub-watershed is relatively short and begins in the valley created by Azalea Way and Honeysuckle Hill, also known as the Nut Flats (Figure 20).

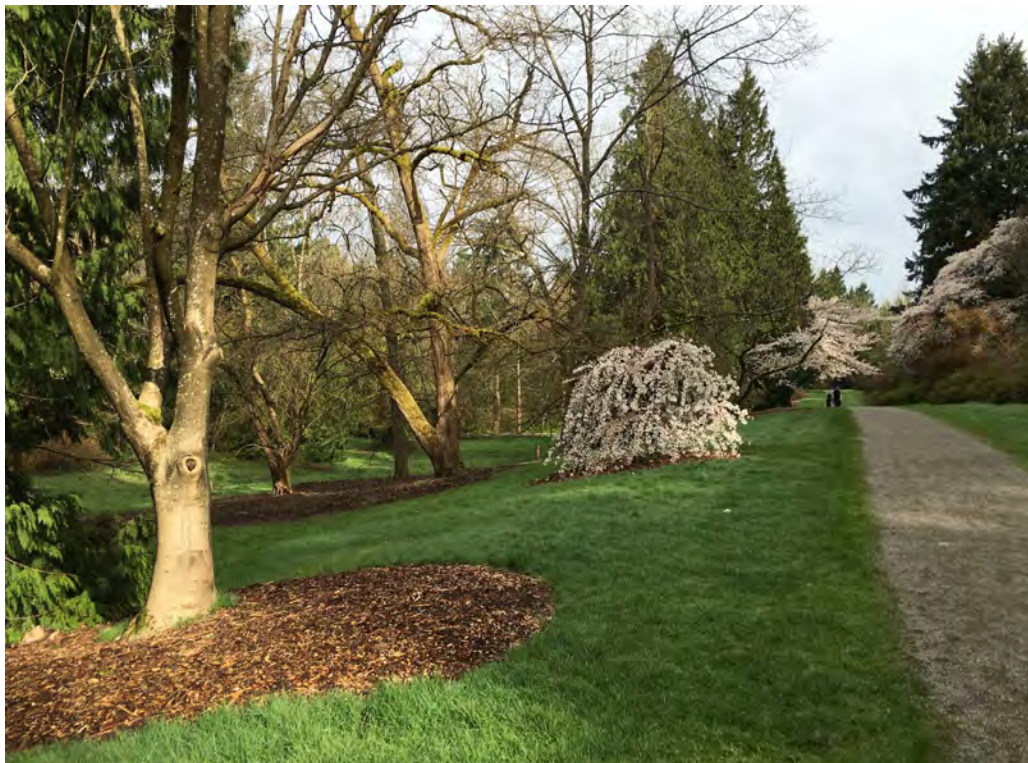
Figure 20. Azalea Way sub-watershed flow accumulation area in the Nut Flats

Soils in the flow accumulation area are seasonally saturated causing low visitor traffic in this area during the winter months. The planned route of a multi-use trail will run along the east slope of Honeysuckle Hill and will add approximately 4,500 ft<sup>2</sup> of impervious surface through this sub-watershed. Using permeable surface in place of asphalt will reduce surface runoff. Adding bioretention depressions along the downhill side of the new trail are recommended to offset the surface runoff created by the trail. The exact location of these features will depend on the final grading and the desired retention volume.

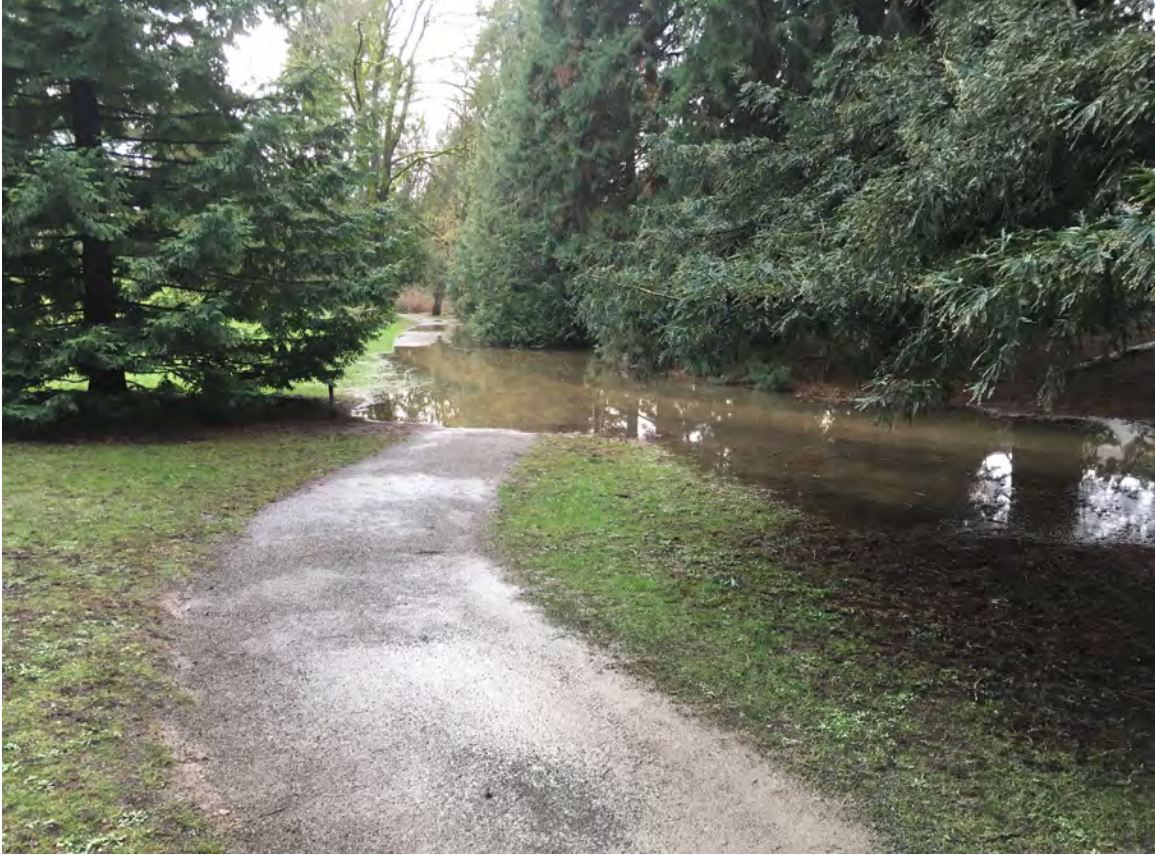
Figure 22. Flooding of trails and turf areas in Pinetum Sequoia Grove sub-watershed

The primary stormwater impact in this sub-watershed is flooding of turf and trail areas following heavy precipitation (Figure 22). Mitigation recommendations include installation of a bioretention depression located to the south of current flood zone and west of the trail. This depression would facilitate the storage and infiltration of surface runoff from the flood zone. The overflow would drain into the existing flow accumulation to the south and enter Arboretum Creek near the Stone Bridge.
