Materials Report

WA-RD-117.1

Asphalt Concrete Class D

Bridge Deck Overlays

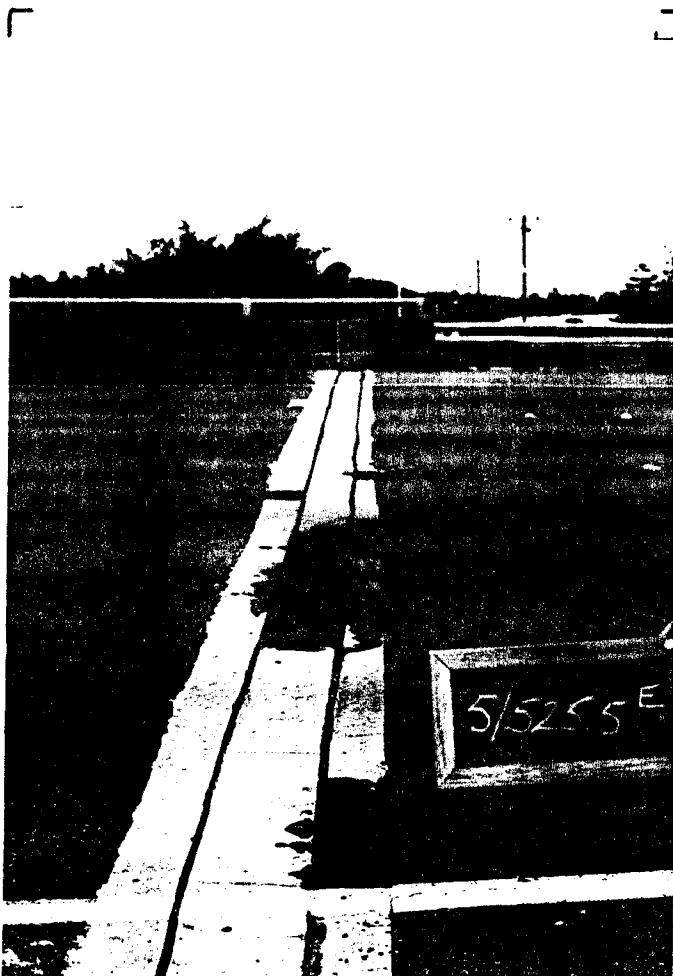
5/525.5 E - Joints at the pavement seats are breaking up.

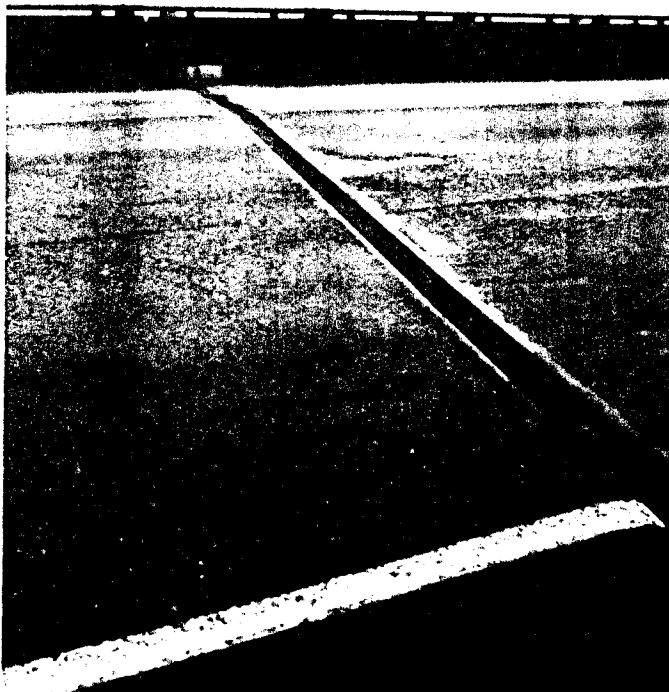
5/645 W - Rutting at joints.

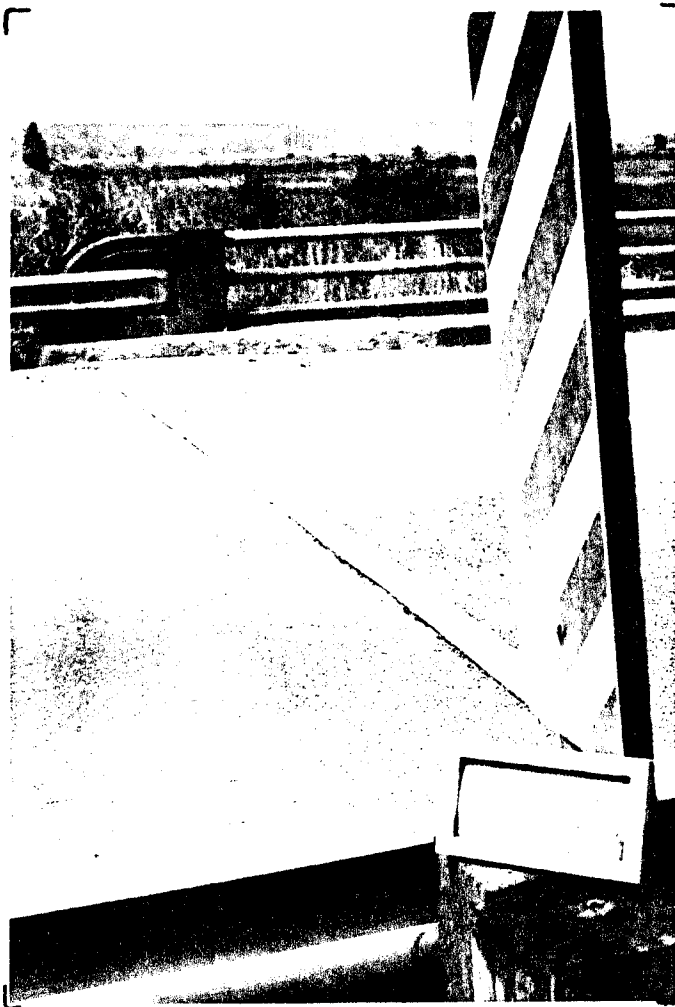
9/117 - Some raveling spots throughout. Moderate to heavy high speed traffic. Paved 1982. Rated 5

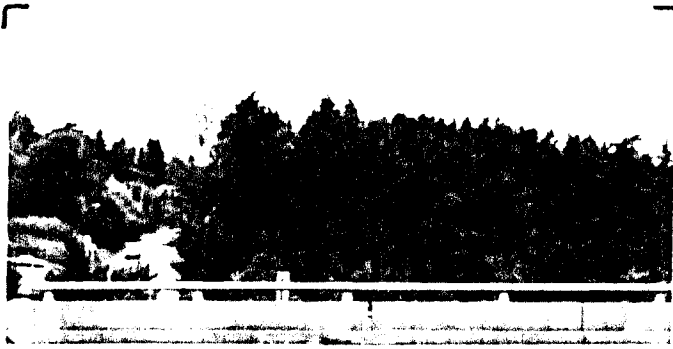
90/50 S - West pavement seat.

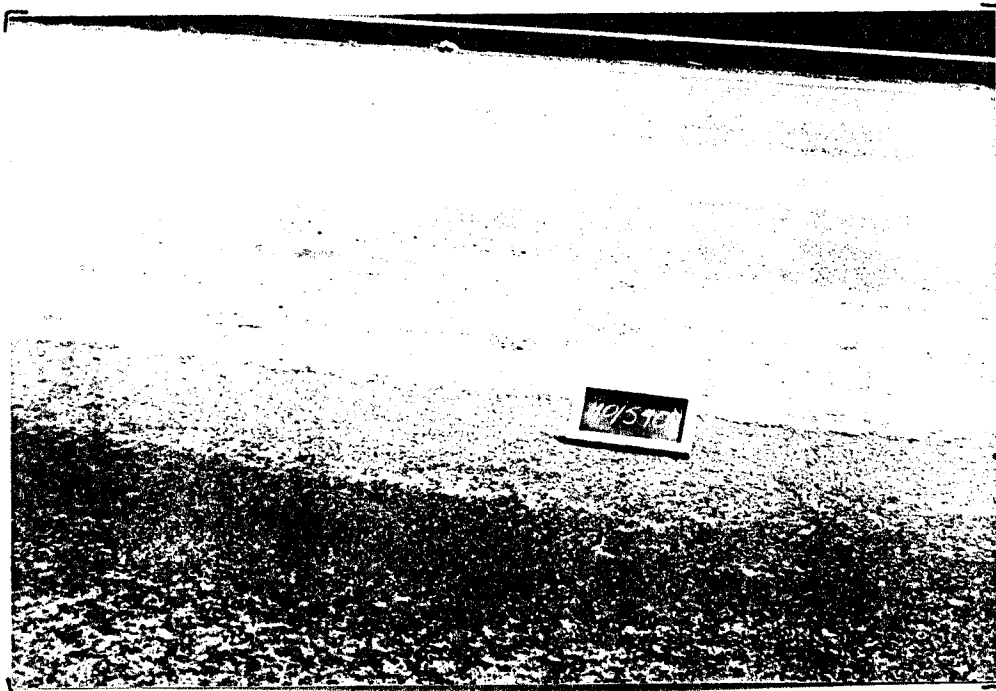
90/540 N - Patching not holding up either.
